REHABILITATION OF REINFORCED CONCRETE BUILDINGS AFFECTED BY 2023 TÜRKİYE EARTHQUAKE

olabi, abdullah melik

MSc Student, civil engineering department Hasan Kalyoncu universite Gaziantep ,
Türkiye

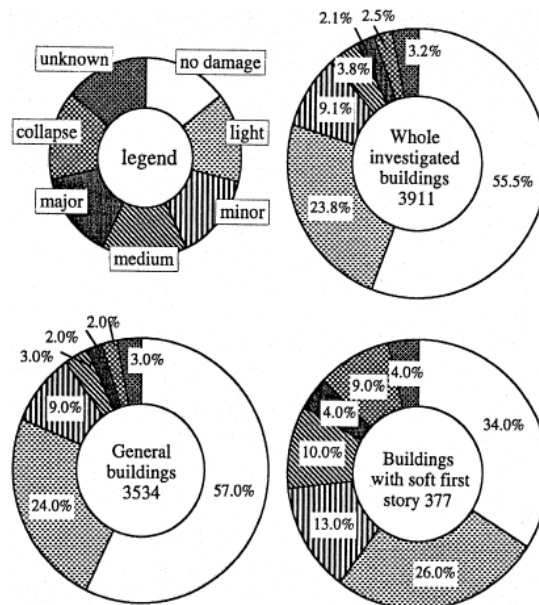
Fig 5: Damage to buildings due to Hyogoken-Nanbu earthquake. (Ref.6).

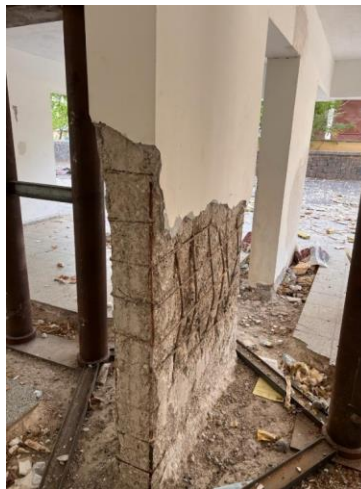
In this building, the collapse of the shear wall between the 2nd and 3rd axes and on the D axis was observed only on the ground floor. When the condition of the collapsed shear wall is examined, we notice the presence of beam connecting it from four sides. On the same axis, we also see the presence of a shear wall at axis number 2 and very close by. Aforementioned two walls are connected to each other by beams 30 cm wide and 120 cm long. It should be noted that there are non-load-bearing walls surrounding the curtain wall on the upper floors where the damage did not occur.

When we examine the damage of the shear-wall between the second and third axes and on the D axis, we see that it is damaged due to the beams in the Y direction, that is, on the 3rd axis. As we mentioned before, there is another shear wall in the x direction and at a very close distance, not exceeding one and a half meters. In addition, since the long side of the shear wall extends along the X-axis, the bearing force of the wall in the x-axis is much greater than the bearing force in the y-axis. Therefore, the moment of inertia on the y-axis is relatively weak.

Fig 12. Damaged element.

There is a difference in the diameter of the longitudinal reinforcement despite the same number of bars. Additionally, there is a significant difference in the number and diameter of the stirrups, which explains the failure in the structural element in this direction.

After evaluating the extent of damage to the element, the following considerations were taken into account: the relatively large size of the damage in the element, poor quality of concrete in this element according to field inspections, in residential buildings usually don't prefer using methods like jacketing for architectural reasons.

In addition, considering that only one element is damaged, we propose the removal of the element and its replacement with a new one according to the required design specifications.

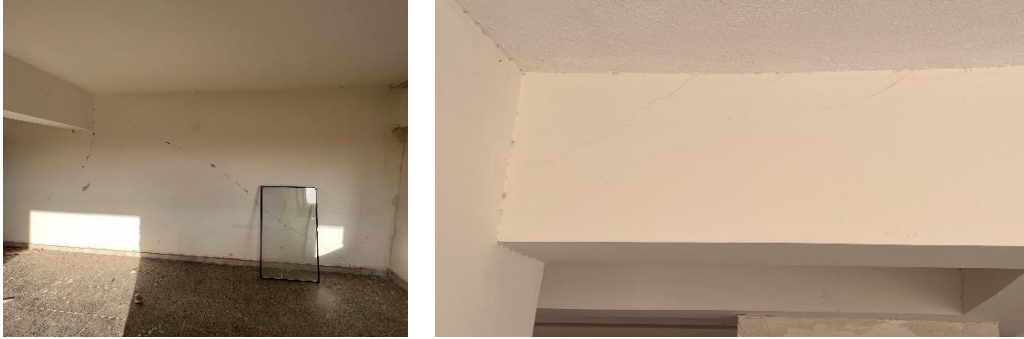
According to field investigations, the structural elements of the building are completely intact on all floors except the element mentioned above. However, there are cracks in non-load-bearing walls and negligible surface damage on some structural elements.

Fig 13: Other elements condition in same building:

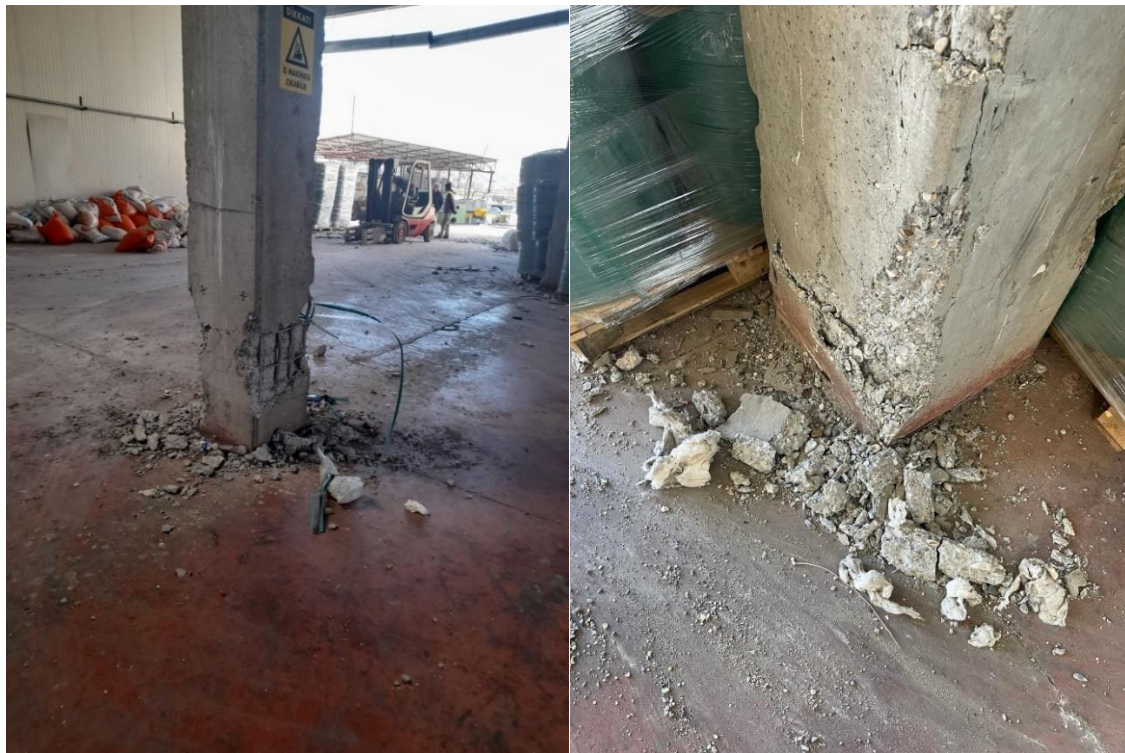
In this building, we notice damage to the lower section of the columns in the area located approximately half a meter after the floor pit. In this type of building, the columns are hinged at the top with pre-fabricated concrete roof elements and fixed (transmit moments) in the bottom with the foundation via a bucket. That is, in this type of building, all earthquake forces are responded to by the columns. This explains why the damage occurred in this area, as the torque resulting from the horizontal forces is greatest in this area.

Fig 16: Damaged element.

As we can see in the pictures, there is damage to many of the building's columns at different levels. There is one central column in very bad condition, as the reinforcing steel has reached its yield stress and the concrete has been damaged in a large percent.

seismic code requirements. It is particularly noteworthy that the confinement region of the ties terminates very close to the ground, not exceeding 50 cm. And there is a shortage in both the number and diameter of the main reinforcement bars. This likely explains the collapse of the columns under seismic forces.

As observed in the table, there is a significant difference between the design section and the actual section in terms of dimensions, number and diameters of reinforcement bars, and ties. Additionally, the short confinement Intensification distance of the ties constitutes a major negative point for the existing columns. This explains the failure observed in this element.

1-) Complete compensation of the column and reinforcement area for significantly damaged columns, with the rehabilitation process extending to non-damaged or minimally damaged columns.

2-) For undamaged or minimally damaged columns with hairline cracks, compensation is made for the difference in area between the design area and the actual area executed in terms of reinforcement and concrete. The procedure involves calculating the variance between the design reinforcement and the existing reinforcement, followed by integrating an equivalent amount of reinforcement into the additional jacketing.

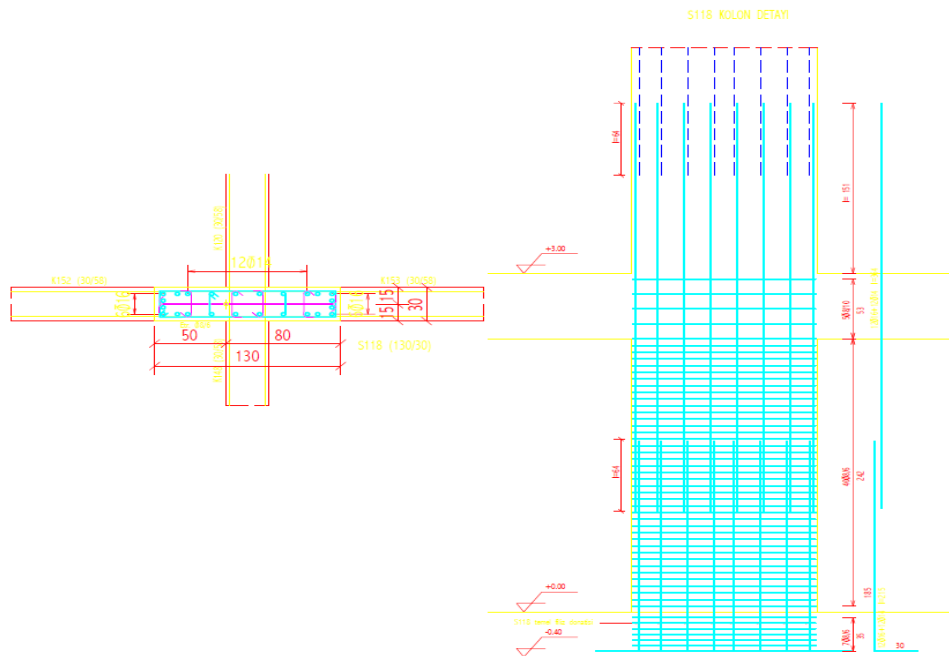
The damaged element withstands the required moments with the dimensions present in reality. However, there are differences in terms of reinforcement between the design results and the results implemented in reality. A comparison table was created below for

Fig 18:Design result for damaged elements (STA4CAD).

This comparison highlights that while the dimensions of the damaged element align with design expectations, there are discrepancies in reinforcement between the design and implementation phases.

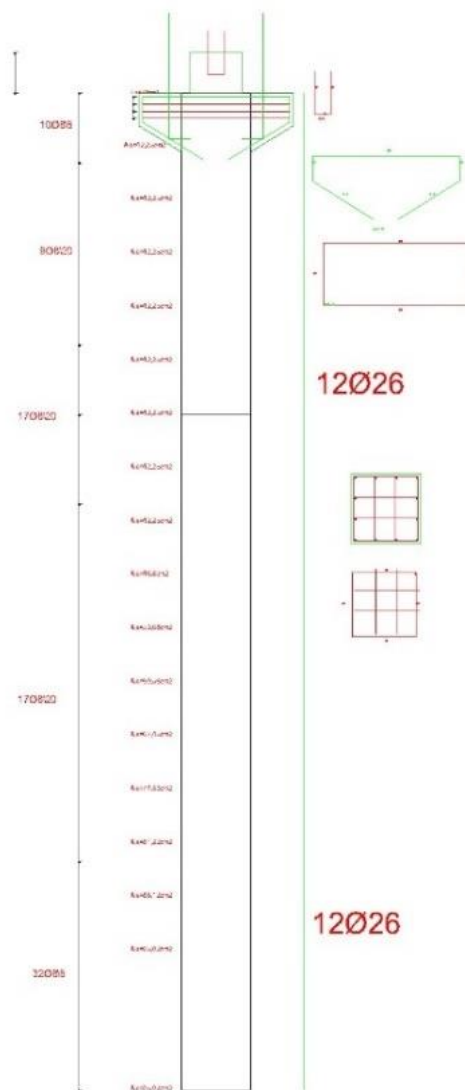
Due to the substantial displacements experienced by the columns, damage to the connections between the column flanges and the roof beam (delta) was observed. A table has been formulated below to compare the design reinforcement with the reinforcement present in the studied element

Fig 20: Design result for damaged elements.
