Evaluation of Pavement Surface Conditions for Luxor International Airport

S. Fathalla* and A. El-Desouky**

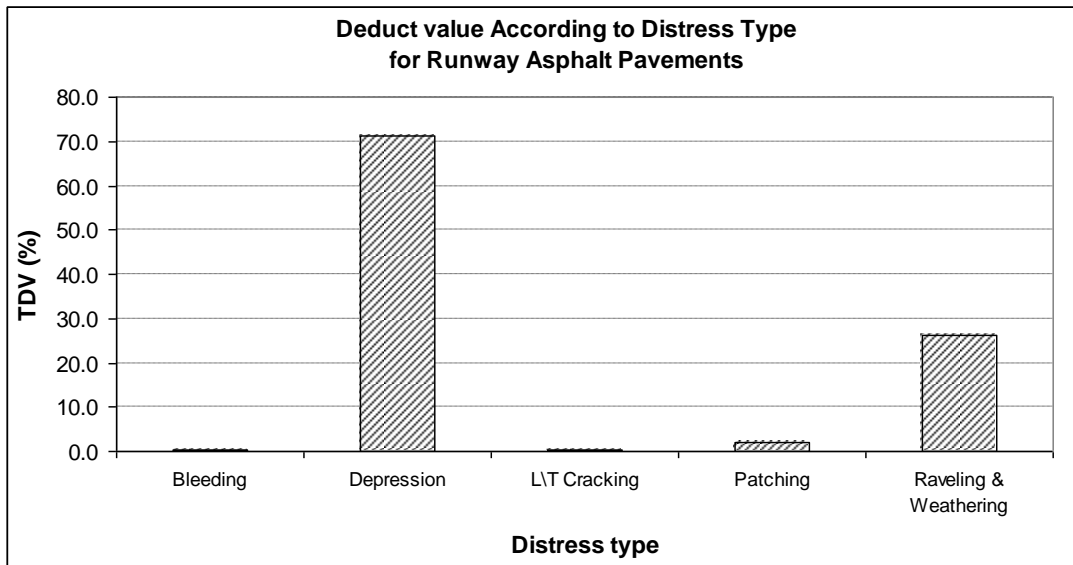
Fig. 3. Distress Contribution in Overall Condition for Runway Asphalt Pavement

From Tables 1 and 2 and Fig. 3, it can be seen that the runway condition can be presented as follows:

- i. Feature R01: PCI was determined to be between 59 and 93 with an average PCI value of 78. The rating of pavement surface was “Fair to Good” and the average rating of this feature was “satisfactory”. The most effective distresses were depression and raveling and weathering. These indicate that the main cause of these distresses is others.

- ii. Feature R02: PCI values ranged from 50 to 97 with the average PCI value of 77. Surface conditions were “poor to good” with “satisfactory” overall rating. The most effective distresses noticed in this feature were depression and raveling and weathering. Again, the main cause of these distresses can be referred as others.

- iii. Feature R03: PCI values ranged from 64 to 98 with an average PCI value of 85. The overall pavement surface condition of Feature 03 was “satisfactory” where the sample unit ratings were “fair to good”. The most effective distresses were depression and raveling and weathering. The main cause of these distresses is also others.

- iv. Feature R04: PCI values changed between 65 and 99 and the average PCI value was 82. Pavement surface ratings were “fair to good” and the overall rating was “satisfactory”. Same effective distresses as in other runway features were noticed.

Main Runway 02-20 is in “satisfactory” condition. The 20 Threshold side seems to be in a slightly better condition. Fig. 3 illustrates the distress distribution for runway flexible pavements. In general, depression is the main distress affecting this runway. Observed depressions are mostly built up during construction (bad leveling both in the longitudinal and transverse directions). Due to the presence of this distress, some sample units were rated as “fair” or even “poor” condition. Also raveling and weathering is another distress covering limited areas of the runway. In the case of Luxor Airport, this distress is mainly due to asphalt mix segregation and bad handling during construction. In addition to the main two distress types discussed above, bleeding, longitudinal and transverse cracking, and patching appeared in some sample units of the runway.

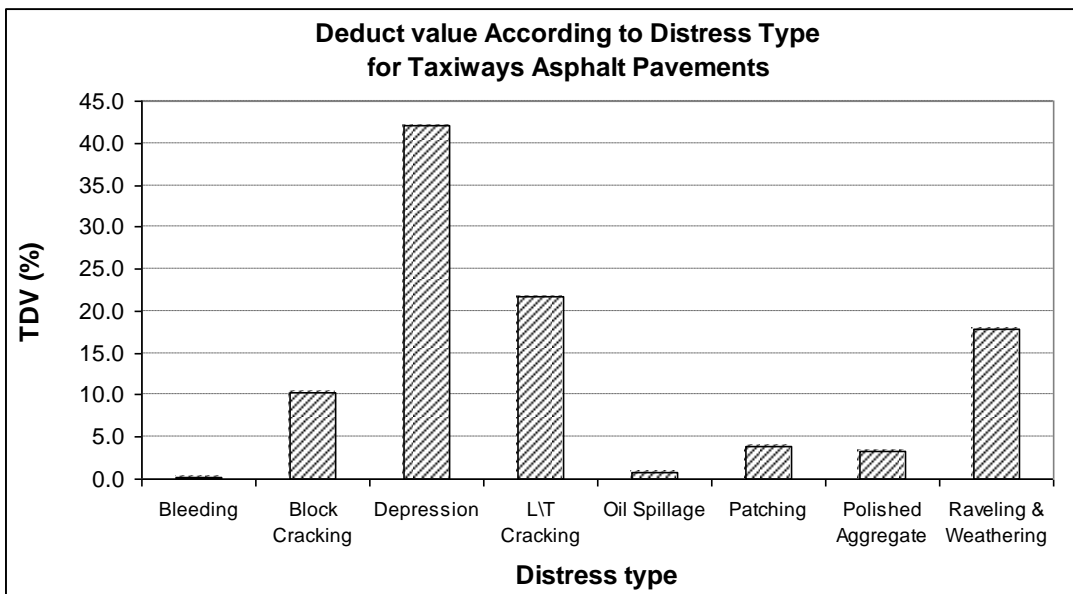
Fig. 4. Distress Contribution in Overall Condition for Taxiways Asphalt Pavement

For the Taxiways (Feature T01), Tables 1 and 2 and Fig. 4 show that average PCI value of 74 were calculated where PCI values for the evaluated sample units were between 59 to 90. The pavement surface conditions were “fair to good” with “satisfactory” overall rating. The main distresses noticed were depression, raveling and weathering, and longitudinal and transverse cracking. Other less effective distresses affecting this feature were bleeding and oil spillage. Both Climate/durability and others are causes of distresses appears on the surface of connectors (Taxiways B ~ J).

The connecting taxiways are generally in satisfactory condition. Connecting Taxiways “G”, “H”, and “J” are in “fair” condition. Fig. 4 shows that depression, longitudinal and transverse cracking, and raveling and weathering are the main distress types observed along the connecting taxiways. Block cracking was observed in a wide area of Taxiway “J”. All these distresses are the result of difficulty in asphalt mix preparation and handling and consequent environmental effects on the mix. Air traffic load is not a cause for any of the observed distresses.

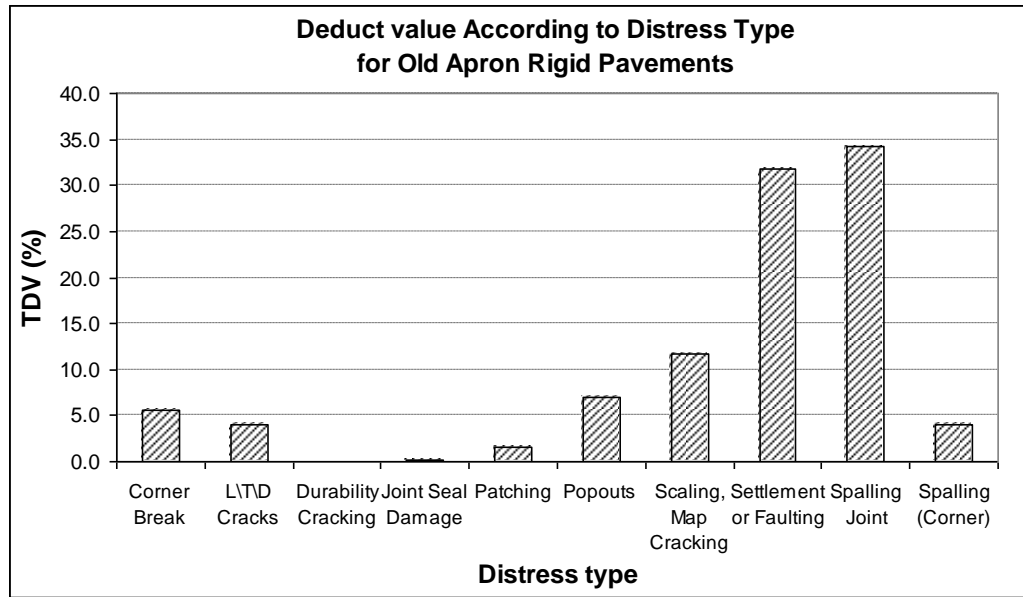
Fig. 5. Distress Contribution in Overall Condition for Old Apron Rigid Pavement

- i. Feature A01: the PCI values were determined to be between 20 and 74 and the average PCI value was calculated to be 37. Ratings of different sample units were “serious to good” with an overall rating of “very poor”. The most effective distresses were, joint spall, settlement and faulting, scaling and map cracking, and popouts (see Fig. 5). The main cause of these distresses is others.

Table 4. introduces a summary of distress distribution for rigid pavement. These data are shown in Fig. 5 for the old PCC apron. The PCC slabs at the old apron are in “very poor” condition. Joint spall in the form of breakdown of the slab edges within 0.6 meter of the side of the joint is one of the most serious distresses in this area. This condition results from excessive stresses at the joint caused by infiltration of incompressible materials or traffic loads. Also weak concrete at the joint (caused by overworking) combined with traffic loads is another possible cause for this distress. Settlement and faulting in the form of difference of elevation at joints due to upheaval or consolidation of the subgrade soil beneath the PCC slabs is another serious distress

observed in the old apron. Some of the observed faulting is built up during construction (bad leveling of adjacent slabs). Map cracking is another noticeable distress manifested in this area. This distress is in the form of network of shallow, fine, or hairline cracks which extend only through the upper surface of the concrete. The main reason of this distress is the over finishing of concrete surface. Also popouts in the form of small pieces of pavement that break loose from the surface is another noticeable distress in these PCC slabs. The use of improper aggregates (expansive) is the main reason for this distress. Overall, aging, inferior concrete quality, deferred maintenance of joint seals, and subsequent over stressing due to traffic and climatic changes are the main factors that lead to this serious condition.

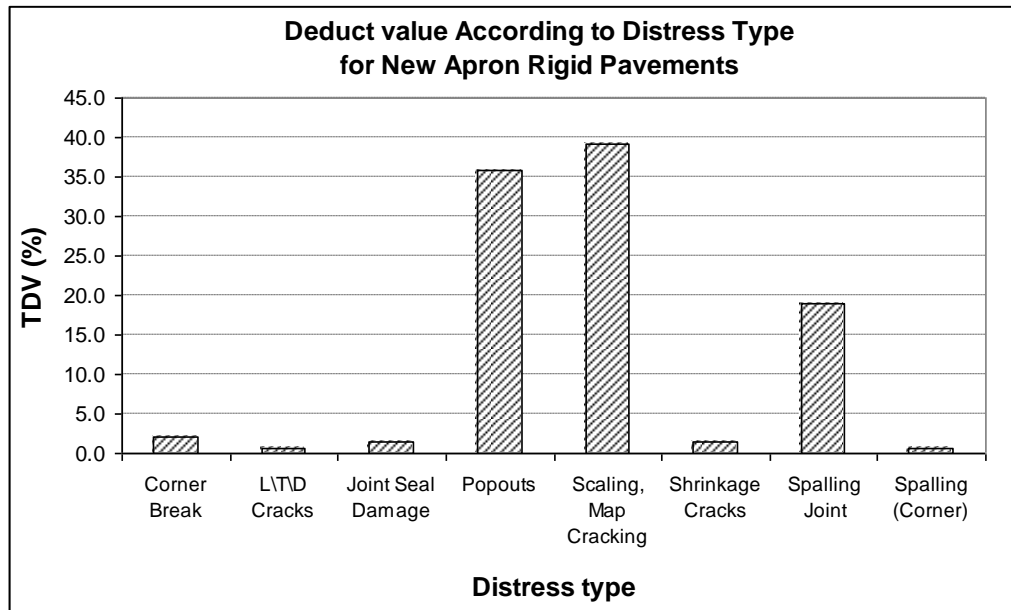
Fig. 6. Distress Contribution in Overall Condition for New Apron Rigid Pavement

- ii. Feature A02: Average PCI value was 87 which is the average of PCI values of all sample units in this feature. PCI values ranged between 75 and 96. Pavement surface ratings for different sample units were “satisfactory to good” with “good” overall rating. The most effective distresses noticed were scaling and map cracking, popouts, and joint spall (see Fig. 6). Main cause of these distresses is others.

The PCC slabs at the new apron are in “good” condition. As shown in Table 4 and Fig. 6, joint spall, joint sealing damage, and popouts are the main distress types affecting the new apron. Low severity joint sealant damage with high extent is also present in some areas of this apron. Although this distress is currently not causing serious drop in condition, this distress can cause rapid deterioration of these slabs. Inferior aggregate quality, deferred maintenance of joint seals, and subsequent over stressing due to traffic are the main factors causing the observed distresses. Restoration of joint sealants needs to be implemented to prevent further deterioration of this apron.
