The Effect of Bad Heat Treatment Technology on Failure Mode of Armor Steel Sheet under EN1522 Ballistic Test

Abstract

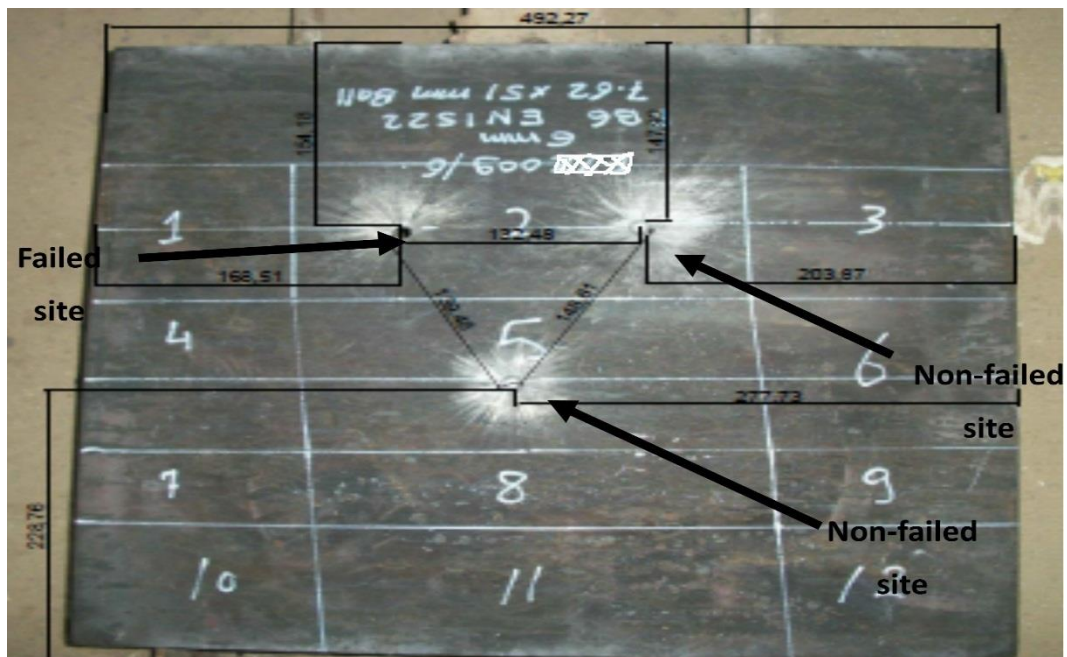
The profile of armor sheet containing failed and non-failed sites Armor steel sheet 6mm thickness has been photographed and visual monitored at different sites to interpret the mechanism of failure. At the meantime, the depth of penetration has been calculated at non-failed sites, as given in Fig.2, and 3. It is clear that the three sites have different positions regarding to 2D coordination axis. In addition, some deviation is observed at the triangle of shooting rather than mentioned in EN1522, but it is still at range. Based on this observation, it is a must to make hardness map for the armor sheet, to evaluate the difference of hardness at different coordination sites, as will be discussed later.

Fig. 2 6mm armor steel sheet after ballistic test.

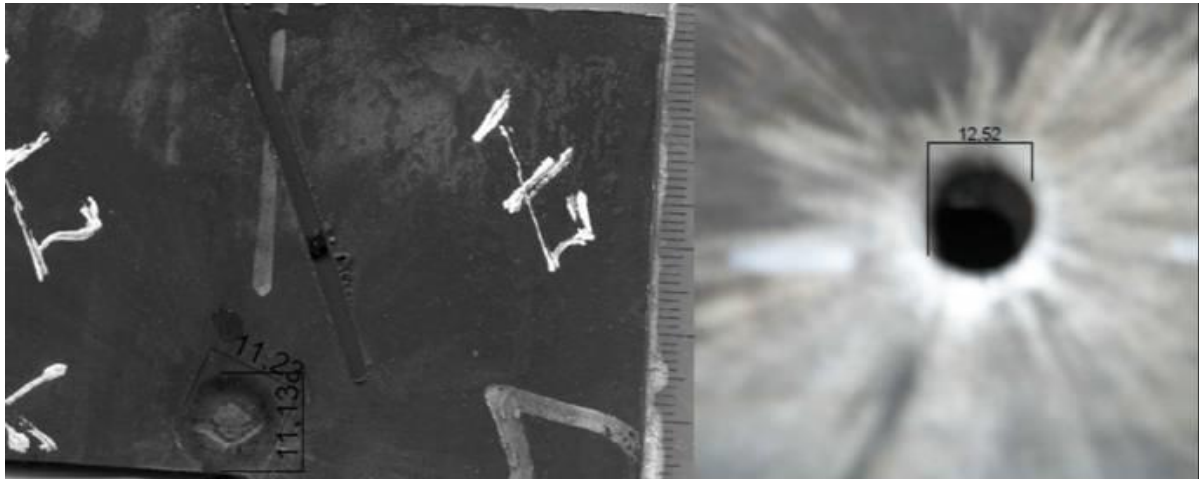
The bullet dimensions at ballistic test according to EN1522 is 7.62mm diameter and height 50mm. The sign of bullet at either Failed or non-failed location has been detected. It was found that there is much plastic flow happened at the failed site, in comparing with non-failed site. Certainly, this indicates that the failed location has a lower plastic strength than non-failed location. Reduction in plastic strength, or yield strength of domain martensite structure should be attributed to precipitation of secondary phase or micro-segregation of alloying elements at this location. Based on strain calculations, it was found that non-failed location has been strained by $(11.18 - 7.62) \times 3.14 = 11.17\text{mm}$ with no failure. However, the failed site was strained by 15.38mm followed by crack at the rear side as given in Fig.3, and 4. These observations indicate that the hole observed at the failed location is ductile hole failure mode rather than other failure modes like ASB failure

Fig. 3 Strain capacity at Failed and non-failed sites in armor steel sheet.

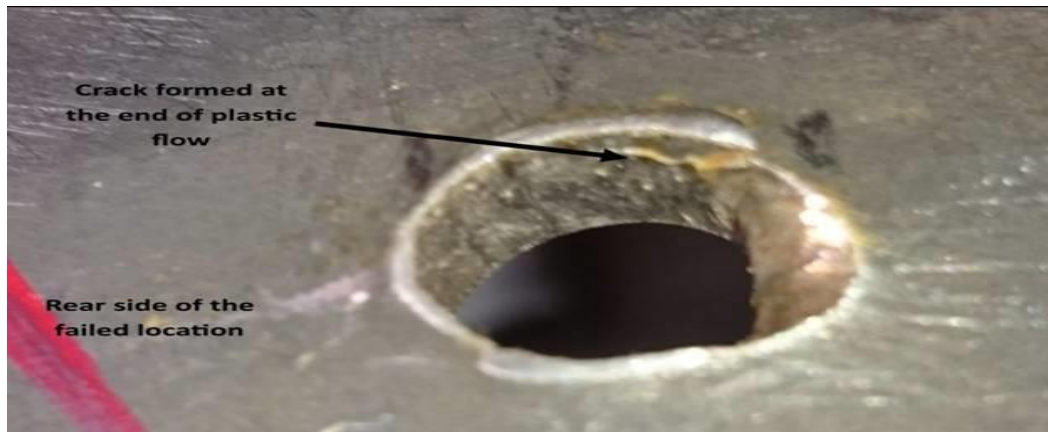
Fig. 4 Failed location at the rear side of 6mm armor steel sheet.

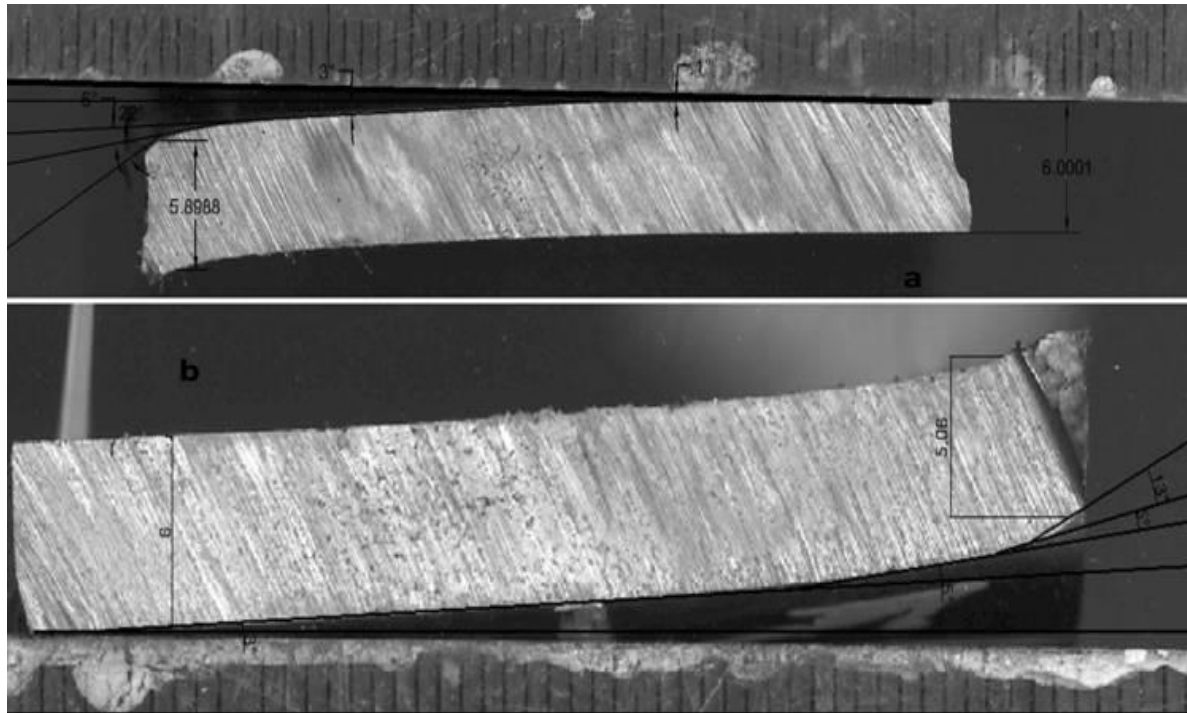
mode, or fragmentation mode, as explained in Fig.5. Based on the deformation at the horizontal axis, it can be observed that the bending strength of non-failed area is higher than bending strength on failed area. Regular bending angle is clearly observed at non-failed area, while irregular bending angle is observed at failed area. The reduction of thickness at non-failed site reaches 16%, while it is 3.3% at failed locations, as given in Fig.6. From these observations and calculations, it should be clear that there is less elastic strength structure has been formed at the failed area, which can reduce the plastic strength of this area to its ultimatum.

Fig. 6 Monitoring the deformation at the horizontal axis, a. failed area, b. non-failed area.

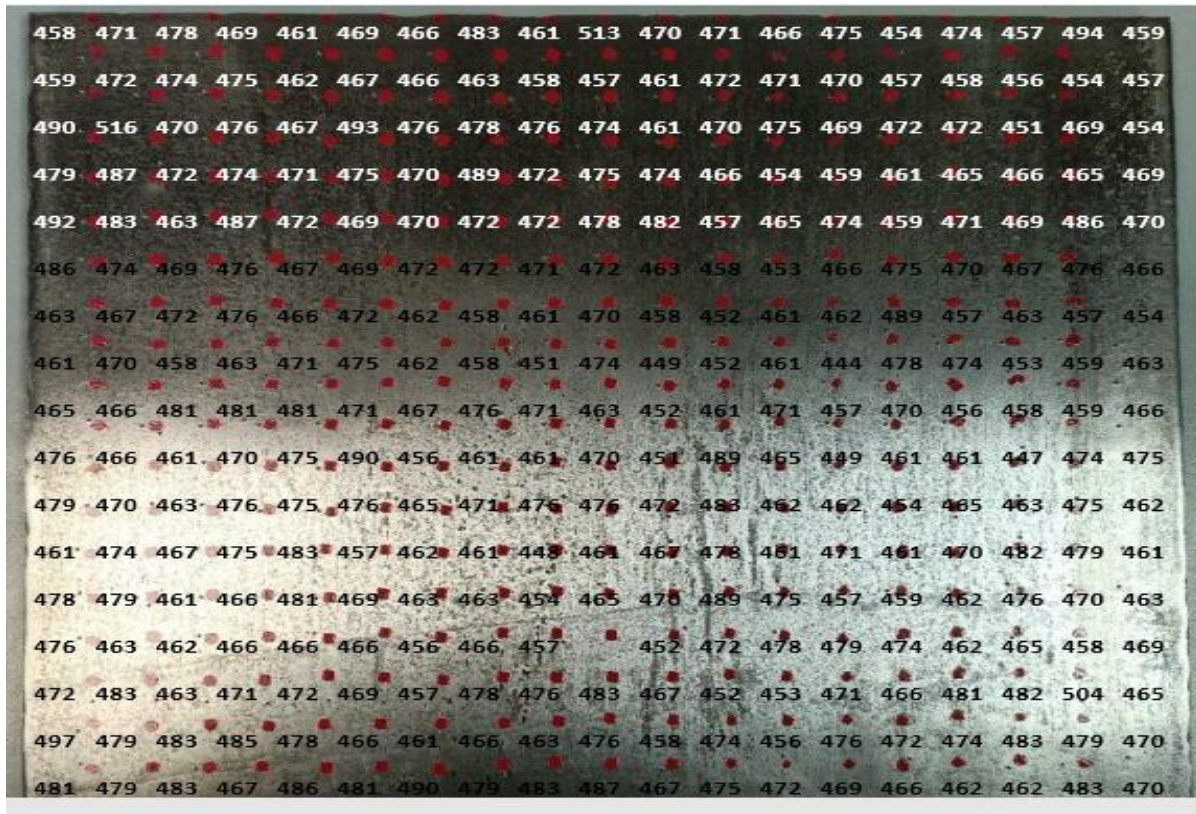
segregation of alloying elements. However, the increment of hardness on one side of sheet at the expense of the other side is a clear guide to the poor conditions of heat treatment. While, the segregation can be represented by peaks up and down in hardness among the steel sheet.

Fig. 8 The hardness map among the armor steel sheet.

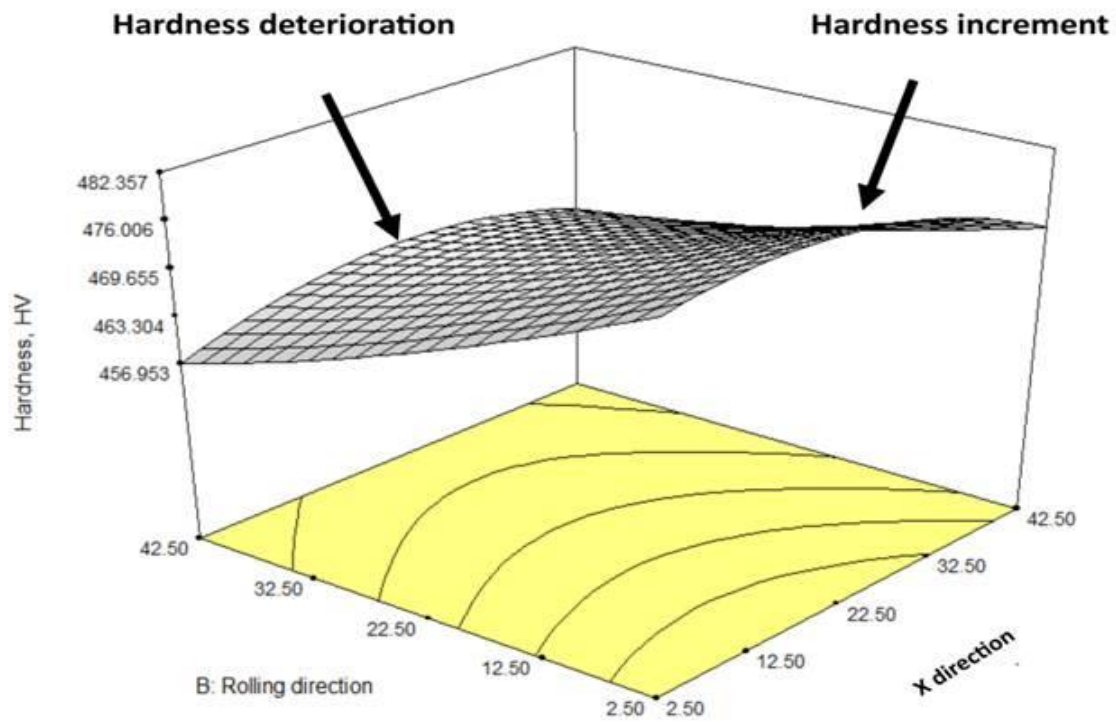
Fig. 9 The hardness contour among the armor steel sheet.

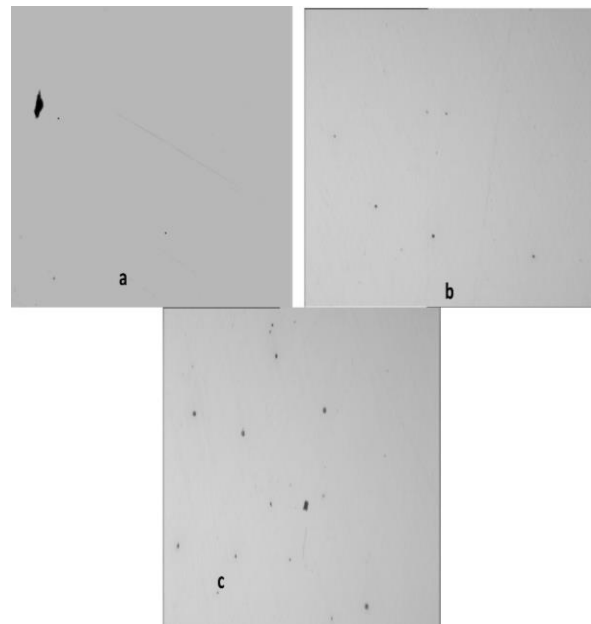
Non-metallic inclusions are such micro-constituent that represent a stress concentration sites, and thereby they can act as a crack initiation site, promoting the premature failure of the matrix. Hence, they should be reduced to their lower rate. Non-metallic inclusions have been monitored and evaluated by using ASTM-E45 [10]. They have been monitored at different locations, including the ballistic tested locations, as given in Fig.10. It is observed that non-metallic inclusions are at their lower rate. In addition, they are following the low rate of thin inclusions according to ASTM E-45, as given in table 2.

Fig. 10 NMI distribution at failed and non-failed sites of armor steel sheet.

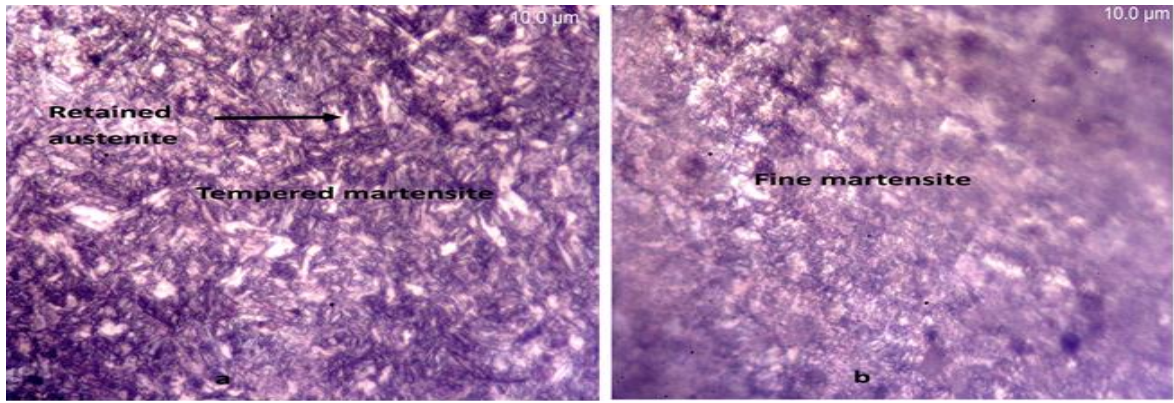
locations. However, the lath martensite of non-fail sites converted to very fine martensite close to knock locations, as given in Fig. 11, and 12. Surely, this interprets the twinning character of lath martensite against plastic deformation, and it is expected that this will reflect hardly on the hardness as will be discussed later in micro hardness observations. Figure 13 shows that tempered martensite at the failed site has never been transformed into fine structure, which is completely different from that has been observed at non-failed sites.

Fig. 11 Microstructure of non-failed site far and closed to knock location.

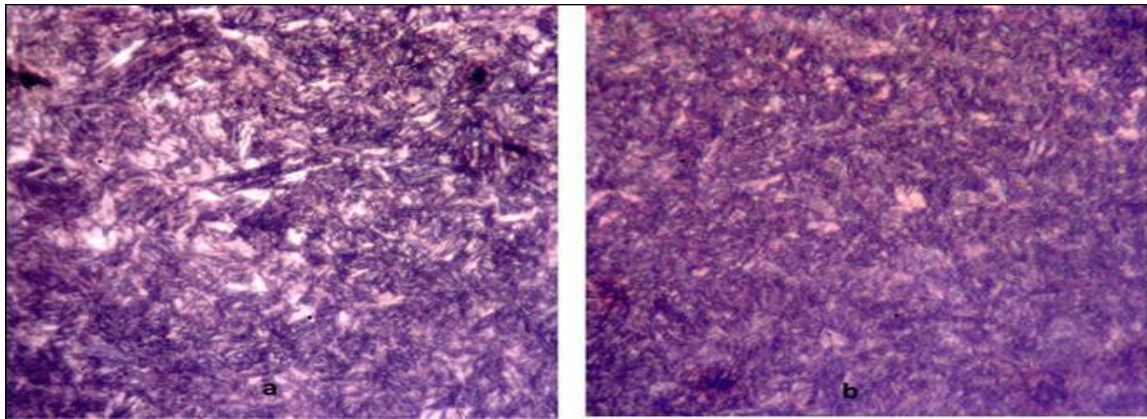
Fig. 12 Microstructure of non-failed site far and closed to knock location.

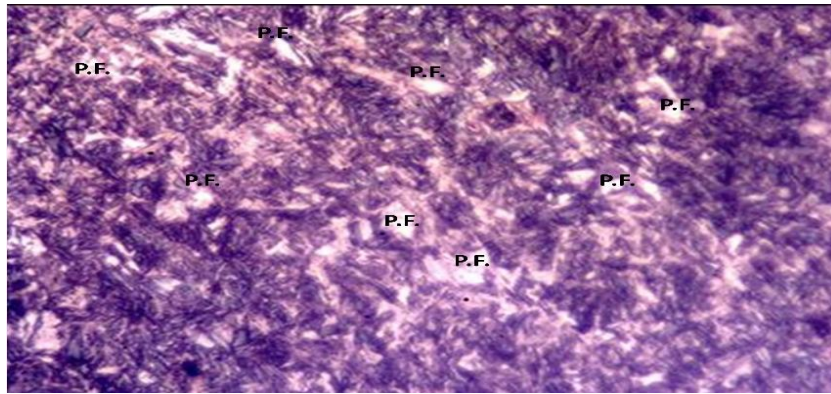
Based on this microstructure, plastic deformation was less established at the failed location in comparison with that established at non-failed locations. Clearly, microstructure observations at the side of the hole at failed location refers to high fractions of polygonal ferrite. In addition, it is believed that the bright band should refer to either shear bands or poor carbon containing martensite as given in Fig.14. Certainly, micro hardness observations could be witness on which is the bright band.

Fig. 13 Microstructure of failed site closed to knock location.

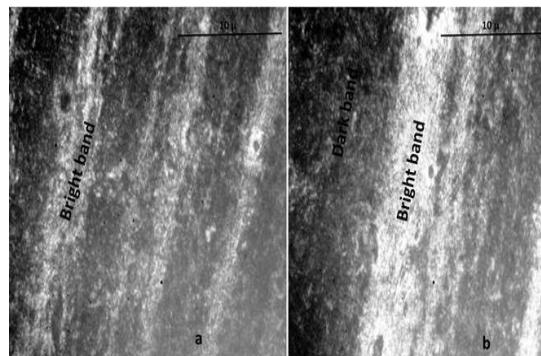
Fig. 14 The bright bands that have been observed inside the hole of failed site.

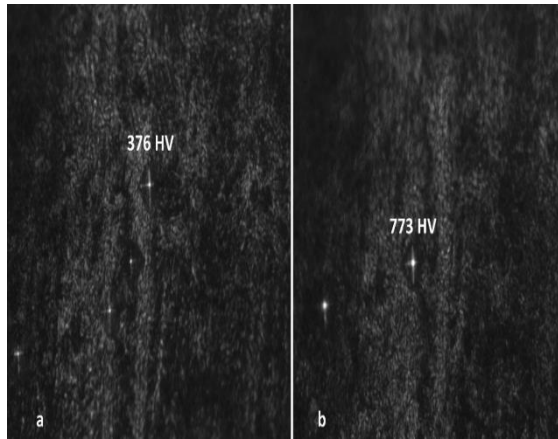
Fig.15 Microhardness of the martensite domain closed and far from the knock area of non-failed sample a. closed to knock area, b. far from knock area

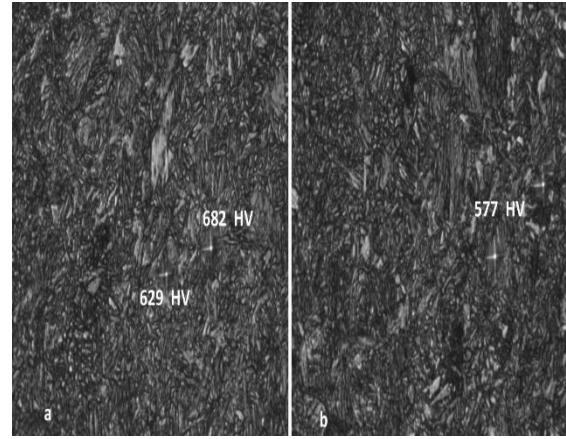
Fig. 18 Microhardness of the bright and dark band at the failed hole, a. bright band, b. dark band

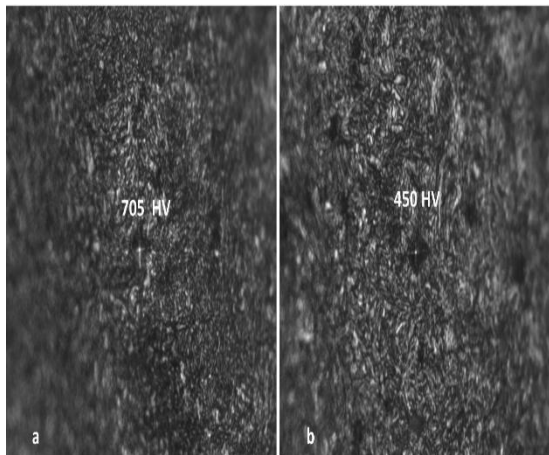
Fig. 16 Microhardness of the martensite domain closed and far from the knock area of non-failed sample a. closed to knock area, b. far from knock area

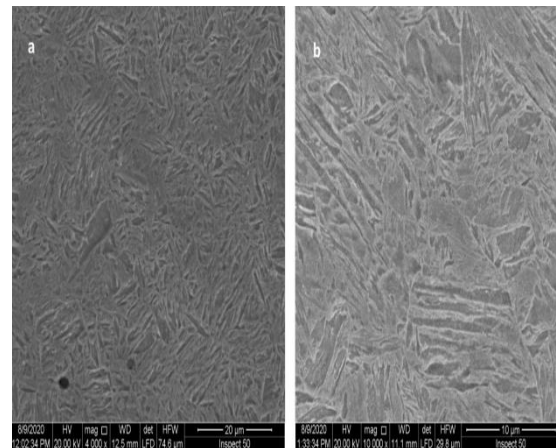
It was mentioned before that the main structure of the armor steel investigated is tempered martensite, which should be observed clearly in either failed or non-failed structure. However, fine tempered martensite is observed in non-failed samples, with clear boundaries. While, there are blurred coarse martensite, and polygonal ferrite have been observed at the failed structure, as given in Fig. 19, and 20. In fact, blurred martensite is referring to bad condition of tempering either in term of time or temperature. In fact, the differentiation in the martensite morphology and size

Fig. 19 SEM observations of non-failed structure

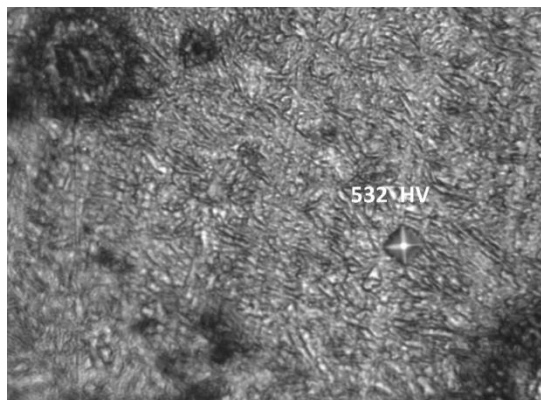
Fig. 17 Microhardness of the martensite domain closed from the knock area of failed sample

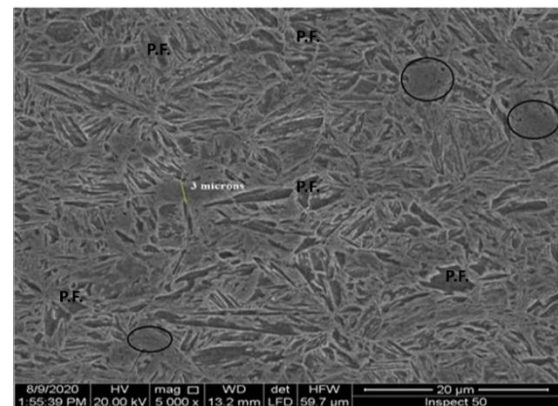
Fig. 20 SEM observations of failed structure

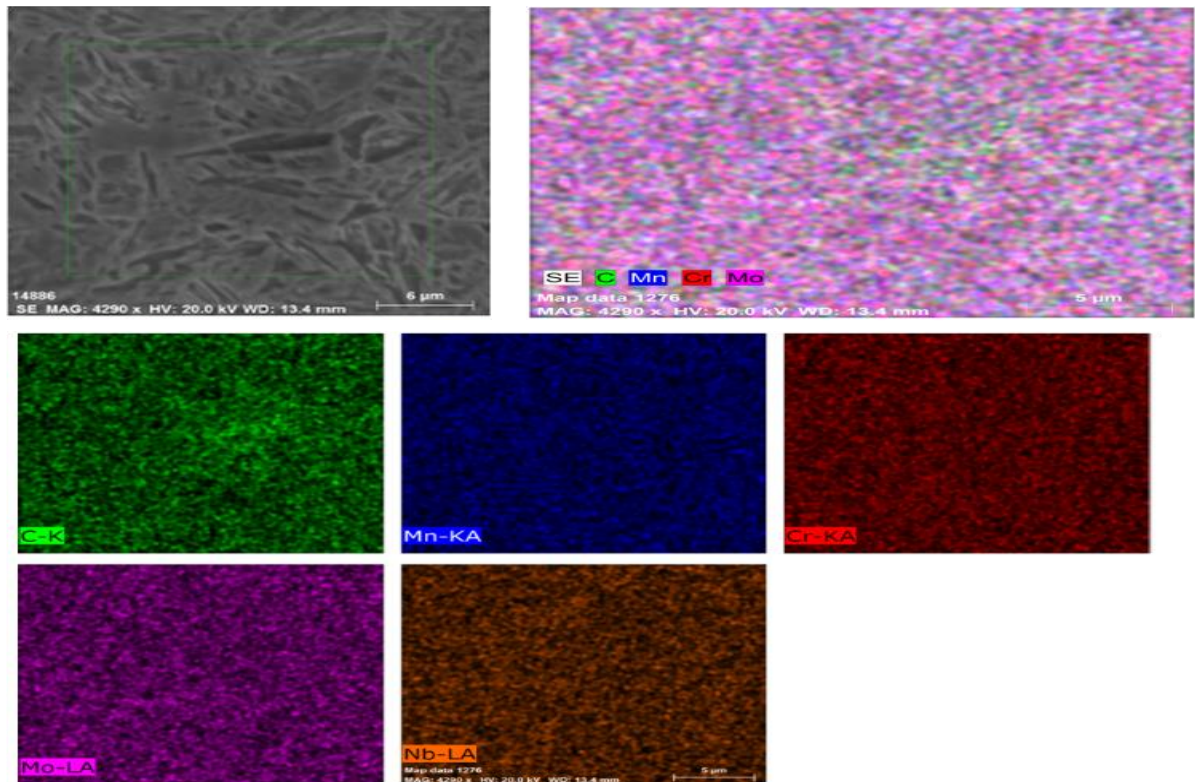
Fig. 21 EDX Mapping of alloying elements at the failed sample.

should be in relationship with its chemical compositions that will be observed by using EDX. Micro-segregation was tracked by using map technique for different alloying elements, including carbon, and it is clear that no segregation sign has been detected at the failed sample, as given in Fig. 21.

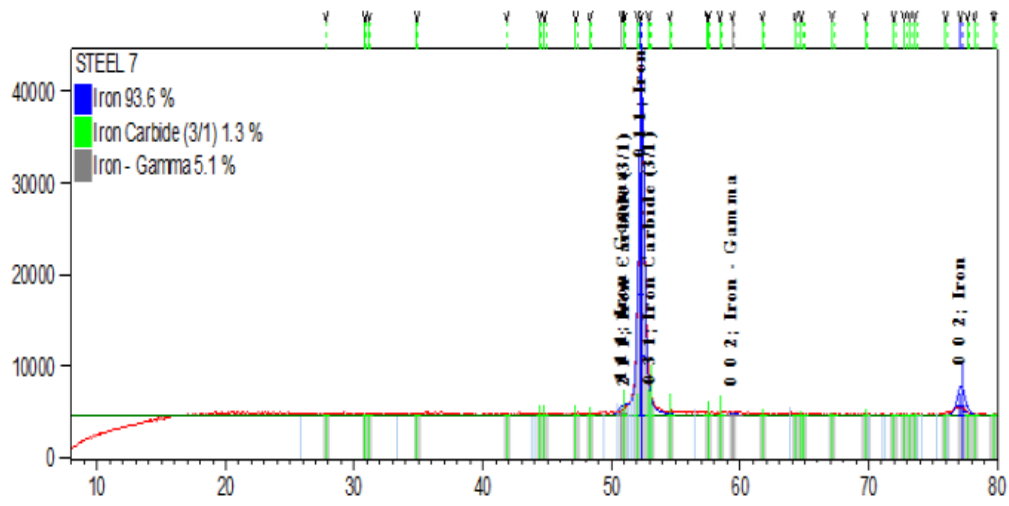
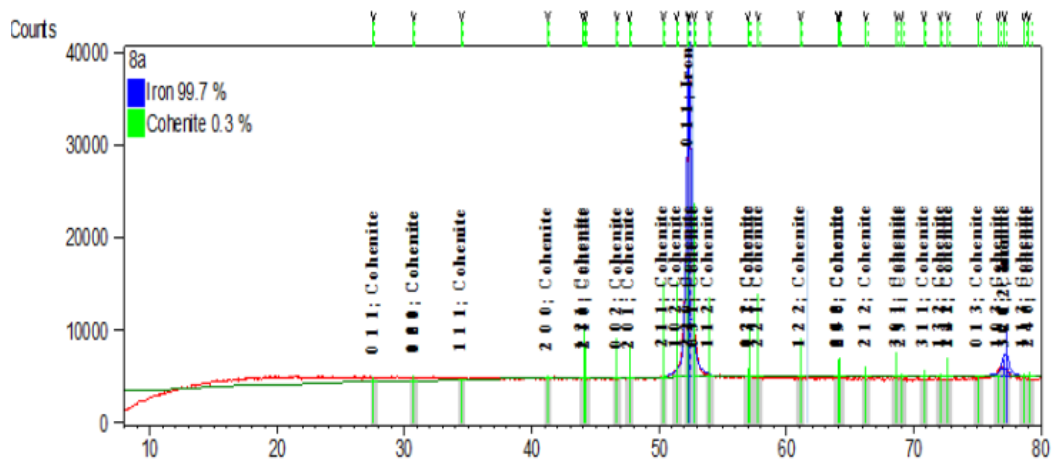
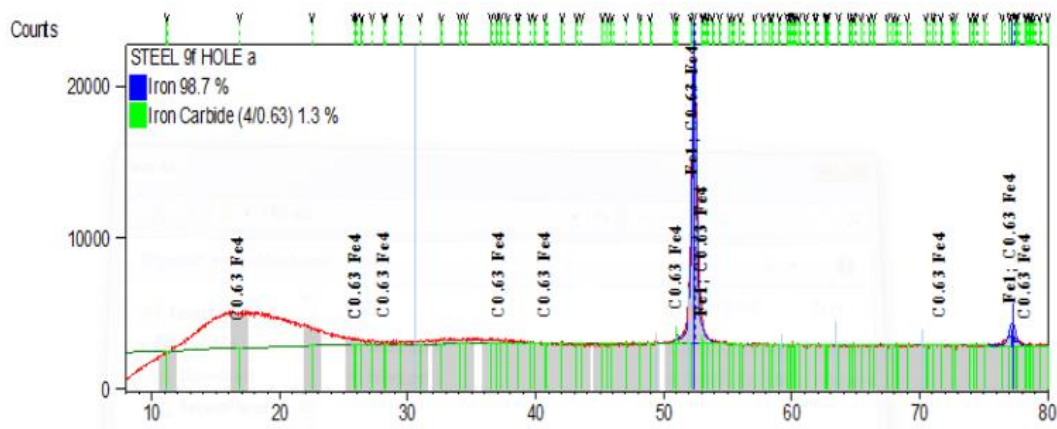
Fig. 22 XRD of three knock area at the ballistic test

The constituent phases in term of crystallographic have been identified, using X-ray diffractometer Cobalt source. The variation in the constituent phases among the armor steel sheet was strongly detected. Figure 23 explains that the samples from the three knock sites have a different constituent phase. By comparing between the result of X-ray diffraction and the depth of penetration, it can be concluded that as long as Fe_3C precipitates, the depth of penetration is increased. Moreover, it is believed now that Fe_3C is the root cause of failure through the ballistic test. On contrary, as increasing retained austenite (FCC structure), the depth of penetration decreases, avoiding the failure at ballistic test. Then, it can be said that the unstable retained austenite is decomposed at some areas among the armor steel sheet into ferrite and cementite or bainite and cementite, and cementite promote the temper embrittlement. This observation is matched to what has been observed at SEM. In addition, FWHM of bcc at the main 2θ structure, and microstrain value have used

to calculate the martensite crystallite size, using Scherrer's equation, and the dislocation density. It was found that the martensite crystallite size at failed site is much coarser than that was found at the other two non-failed sites. It is well known that the density of dislocation among tempered martensite is inversely proportional to the tempering parameters (temperature, time). The mechanical meaning of reducing the density of dislocations is enhancing its mobility, which reflects on its low plastic strength as mentioned before. The density of dislocation has been calculated by using Eq.2 [11].

As mentioned before, retained austenite was observed at one site of two non-failed sites by few fractions 5%. It is well known that the stability of retained austenite is proportional to its carbon content. Based on XRD pattern, the carbon content is calculated as 1.2 wt %, by

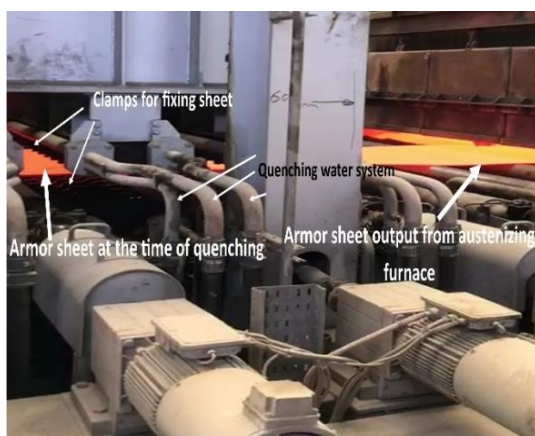
As being observed, inhomogeneous microstructure should be considered as the root cause of the premature failure happened in armor sheet 6mm thickness. Inhomogeneous microstructure should be attributed to the bad condition in heat treatment process. Thereby, the water quenching process at the industrial site has been monitored to evaluate the condition of the heat treatment process, as given in Fig.23

It is believed that heat transfer conduction mechanism can be established at the austenizing armor sheet through emerging from the austenizing furnace, which can generate high fraction of polygonal ferrite instead of full martensite matrix. Certainly, high stress interface between the martensite and polygonal ferrite can promote the premature failure through the ballistic test of armor sheet.

Fig. 23 The quenching mechanism of the armor steel sheet at the industrial site.

1. poor heat treatment conditions should have a significant role on deteriorating the ballistic property among the armor steel sheet 6mm.
2. Quenching temperature must have been controlled to be appropriate for the low modulus geometry as sheet. In addition, optical, SEM show that inhomogeneity in structure was established among failed and non-failed sites of the armor sheet investigated. Precipitations accompanied

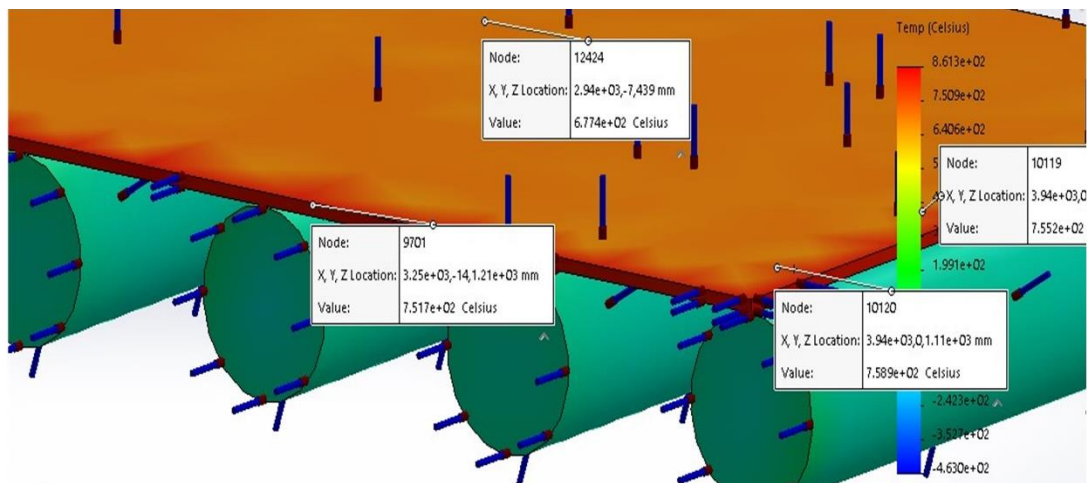
25, and 26. It is observed that much reduction in the austenizing temperature at the armor sheet can be established, regarding to its low modulus profile (high ratio of surface area: volume). In addition, at fractions of seconds the temperature of the studied sheet has been reduced rather than the austenizing temperature 830oC by more than 100°C, which will affect directly on the percentage of ferrite and martensite. In addition, it can be observed the high fluctuation of temperature at the same time among the surface of the armor sheet.

Fig. 25 FEA of the transient heat transfer among the armor sheet through 7 seconds before quenching regime.

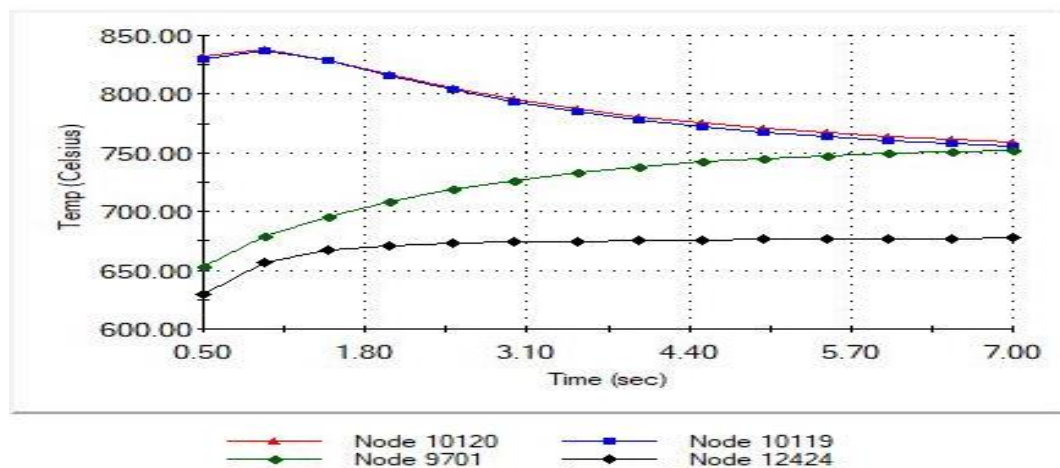
Fig. 26 Transient heat transfer diagram at different locations among the austenizing armor sheet.
