## Conservation Techniques of an Archaeological Copper Tray in the Islamic Art Museum in Cairo

A copper tray dating back to the Mamluk era, kept in the stores of the Museum of Islamic Art in Cairo, registered under No. 9315. It was broken into six separate parts with several holes. Its edge is serrated by a line in the prominent Naskh script. The tray suffers from various deterioration phenomena, such as pits and holes in different places of the tray, and the wrong restoration, as it was welded incorrectly with the aim of assembling some of its separate parts. Various examinations and analyses were carried out. The results of the X-ray diffraction analysis showed the presence of Cuprite ( $Cu_2O$ ), Atacamite and Paratacamite. Treatment and conservation of the tray was carried out, including mechanical cleaning and chemical cleaning. The assembly process was carried out for the separate parts. The holes were completed using mixture of epoxy with natural oxides and calcium carbonate with microballoon as filler. The tray was also isolated using 3% benzotriazole to protect it from exposure to corrosion.

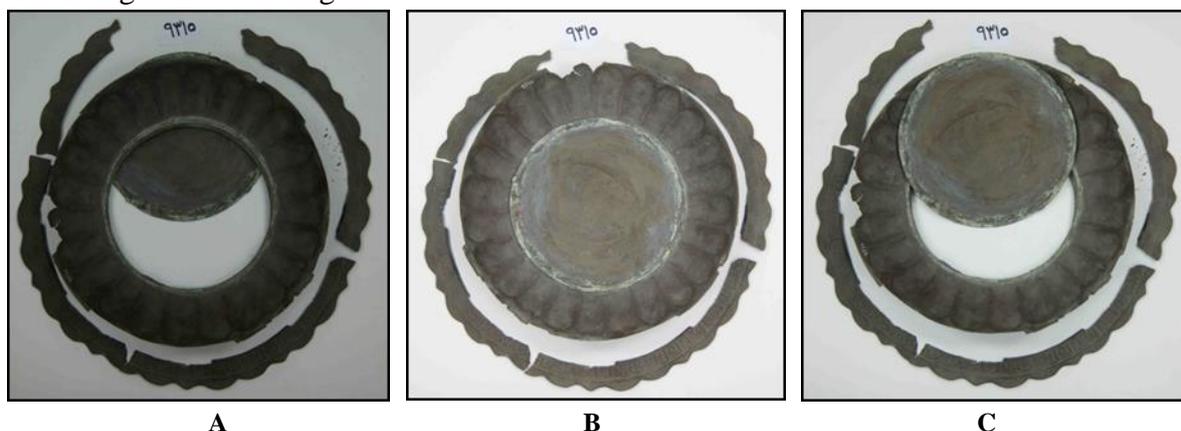
The Museum of Islamic art is considered one of the most important museums that contain copper metal artifacts dating back to the Mamluk era, (Russell, 1962). An example of copper antiquities in the Museum of Islamic Art is a copper tray registered with No. 9315, preserved in the stores of the museum of islamic art, with a line in the prominent Naskh script reading from it (Al-Maliki al-Alami al-Amili al-Adly al-Fadi al-Mujahid al-Mujahid al-Murabati al-Azid al-Afdal al-Awda al-Amiri al-Kabir al-Mandi al-Saifi referred to by someone who looks like from presenter class). The Mamluk copper tray was executed in the style of grooving or engraving. The method of decoration by engraving or grooving is one of the methods of shaping inherited since antiquity in historical times in Egypt, (Ward, R., 1998) and this method is implemented using steel pens whose shapes vary according to the decorations to be formed (Allam, N., 1989). In the Mamluk era in particular, this method reached the height of its prosperity in the decoration of small spaces (Atil, 2002) and fine bands such as ornamental frames, (Geza, F., 1992). This method was used in a way that suggests the embodiment of some decorative elements by making precise lines and inscriptions (Maher, S., 1986) that cover a lot of vitality to show the subtle branches that make up the decorations and securitizations (Geza, F., 1992). This copper tray suffers from many deterioration signs, for example, thick corrosion layers, pits and holes containing copper corrosion compounds. In addition to prominent welds on the surface of the tray resulting from the wrong restoration of the tray parts assembly, also broken and separated parts amounting to six parts beside that missing parts in the outer serrated edge of the copper tray, fig. (1), A, B and C. This research aims to study the components of the Mamluk copper tray and its corrosion compounds, in addition to carry out treatment, restoration and conservation processes for it and protects it from being deteriorated again.

Fig. (1) , A,B and C, The Mamluk copper tray, kept in the stores of the Museum of Islamic Art in Cairo, registered under No. 9315.

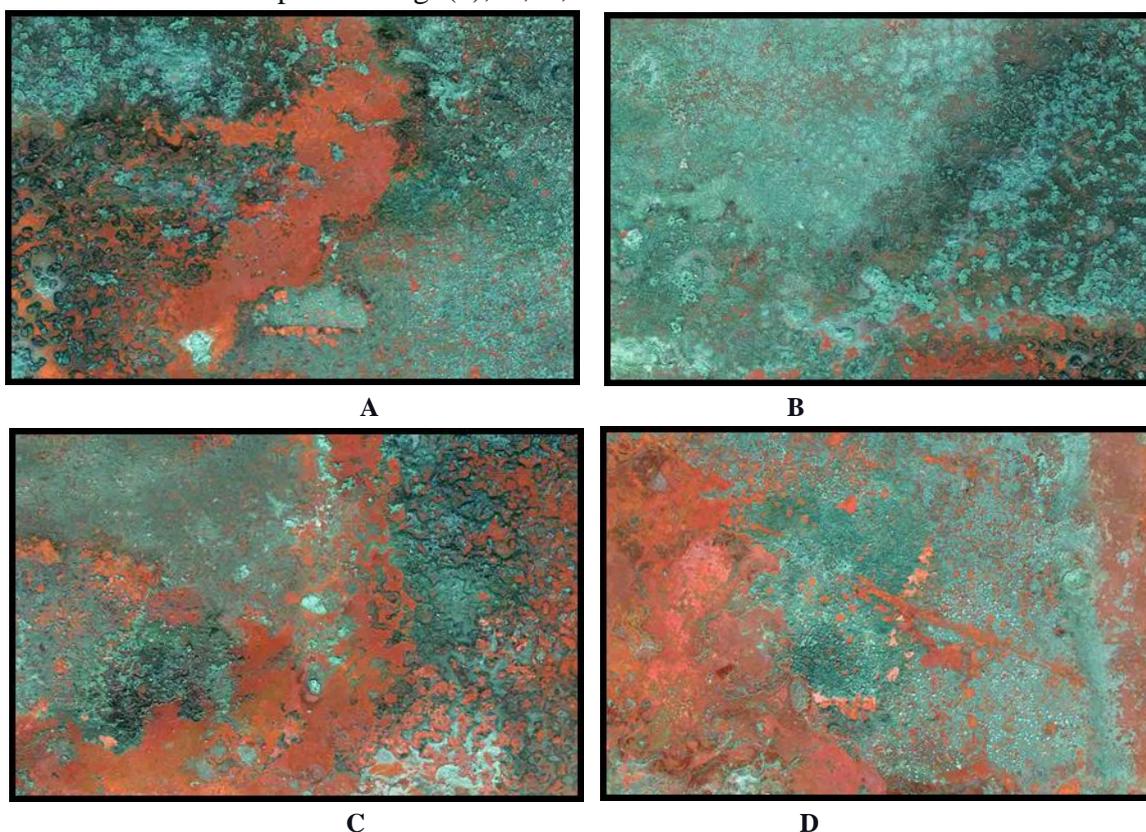
The light optical microscope was used for the corrosion layers on the surface. The optical microscopic for examination of the corrosion layers showed that it differs in color, from green to chalky green and in thickness, from thin to thick. The surface of the copper tray was appeared in a reddish-brown color, Examination of the nature and shape of the surface revealed the presence of some irregularities and regular surface erosion with the presence of some pits. It was also found that there is a color gradation of the corrosion products, which ranges from dark green, to a light green color with a chalky appearance due to the presence of different corrosion compounds. Fig. (2), A, B, C and D.

Fig. (2) A, B, C and D corrosion products with green and reddish brown colors on the copper tray surface, (40X).

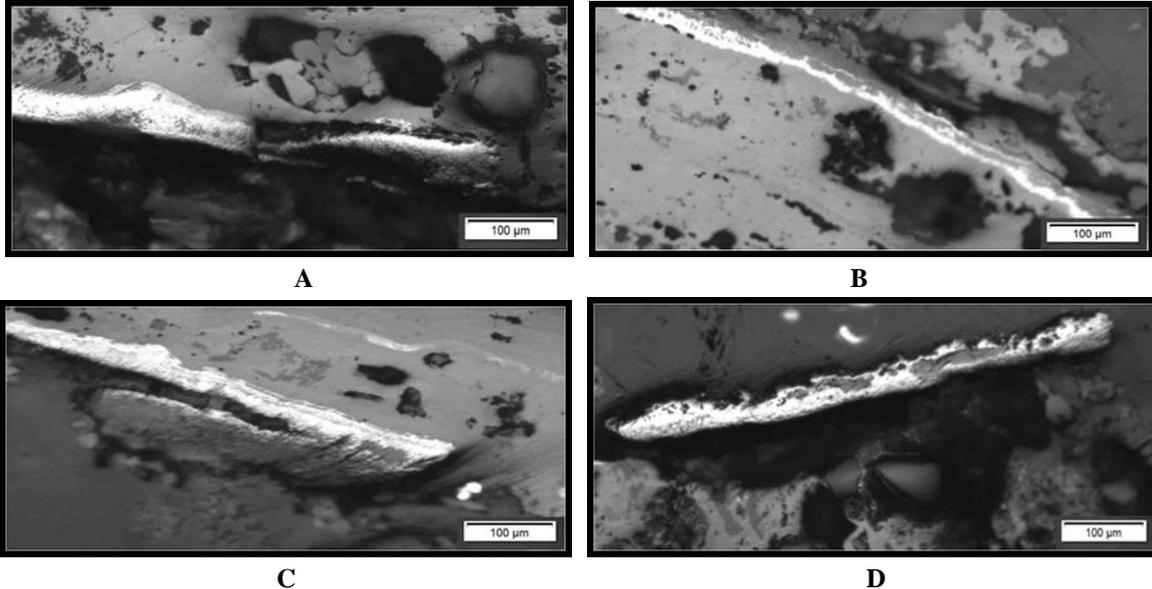
Inverted research metallurgical microscope system [PMG3-F2] was used to investigate samples from the copper tray. It shows that, erosion of copper metal of the tray, corrosion compounds, clay minerals and grains of quartz as impurities. The examination revealed the presence of corrosion, roughness and irregularity in the surface due to the transformation of some metal components into corrosion compounds fig. (3), A, B, C and D.

Fig. (3) A, B, C and D metallographic photomicrographs of the copper tray samples show corrosion layers and erosion of copper with clay and quartz minerals.

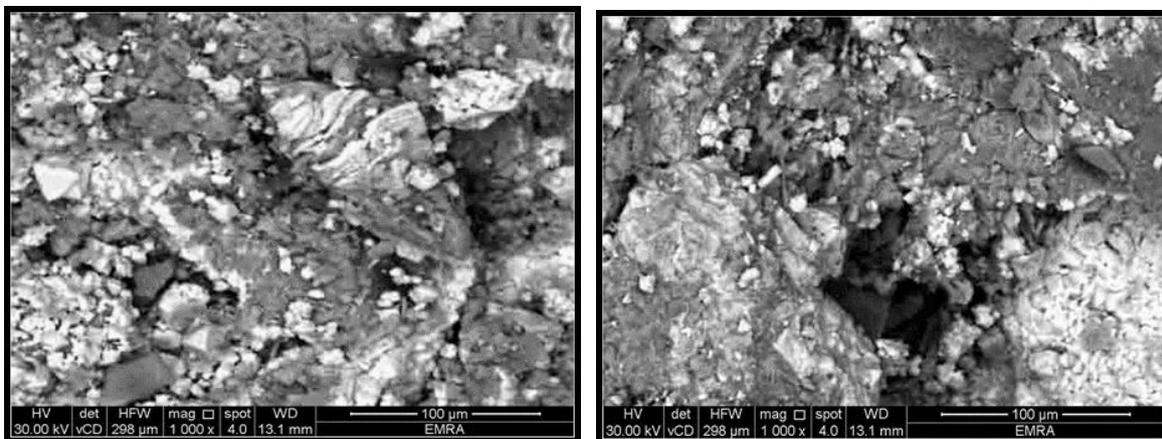
Investigations of the copper tray samples by Scanning electron microscope showed that the presence of erosion, voids, micro-cracks, and pits, Fig. (4), A, B, C and D.

Fig. (4), A, B, C and D. SEM photomicrographs of the copper tray samples Show erosion, corrosion layers, voids, and micro cracks

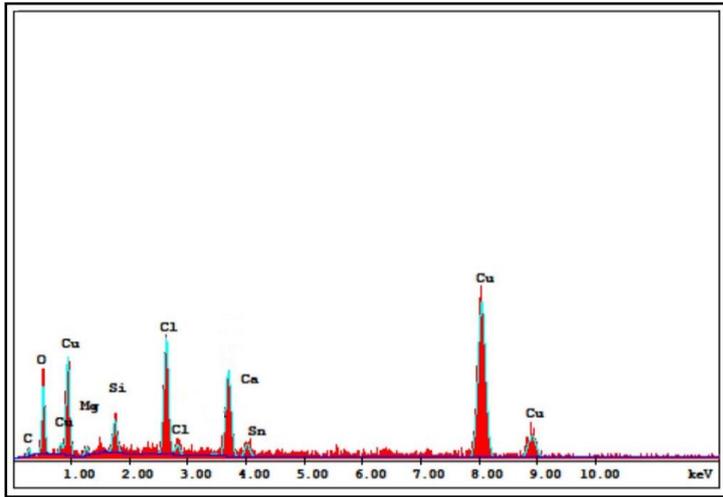
Corrosion samples were analyzed by the (EDX) unit attached to the scanning electron microscope (SEM). It showed that, the presence of Cu by 49.69 %, Ca by 8.3 %, Sn by 0.72 % . Ratios of other elements have been found and the results are complete shown in fig. ( 5 ).

Element	Wt %	At %
C K	5.24	13.75
O K	19.64	38.67
Mg K	1.85	2.40
Si K	3.93	4.41
Cl K	10.63	9.44
Sn K	0.72	0.19
Ca K	8.30	6.52
Cu	49.69	24.63
Total	100.00	100.00

Fig. ( 5 ) Shows EDX pattern of corrosion products sample.

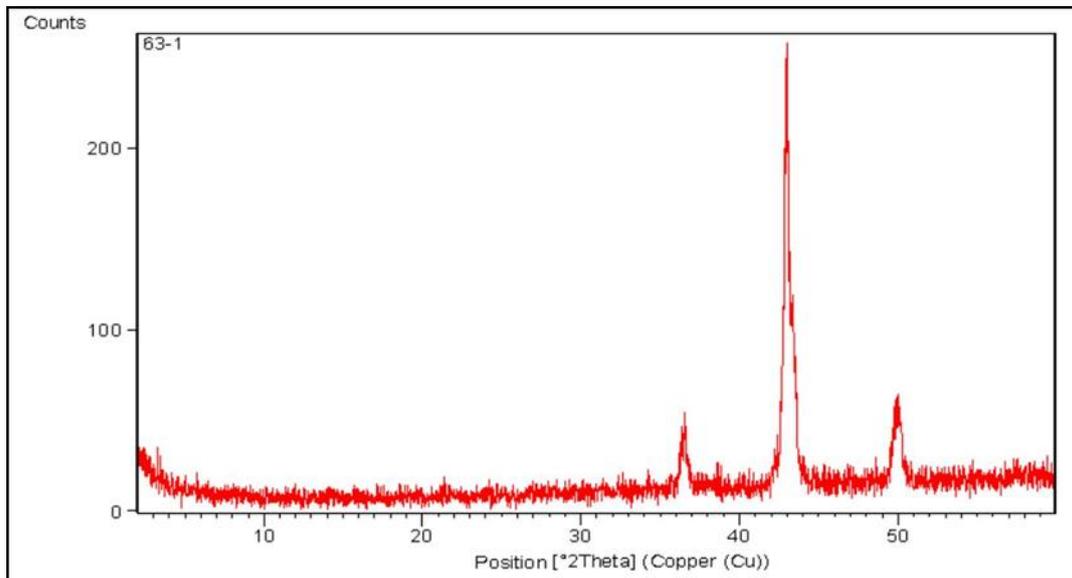
More than one sample from different places and in different colors was analyzed from the corrosion formed on the surface of the metal tray, and the results were similar in all the samples that were analyzed. The XRD spectrum of the samples consists of Atacamite  $Cu_2Cl(OH)_3$  [2-146] , Paratacamite  $Cu_2(OH)_3Cl$  [2-146] and Cuprite ( $Cu_2O$ ) [05-0667] , Fig. (6) illustrates the XRD Pattern of this sample.

Fig. (6) Shows XRD pattern of corrosion sample.

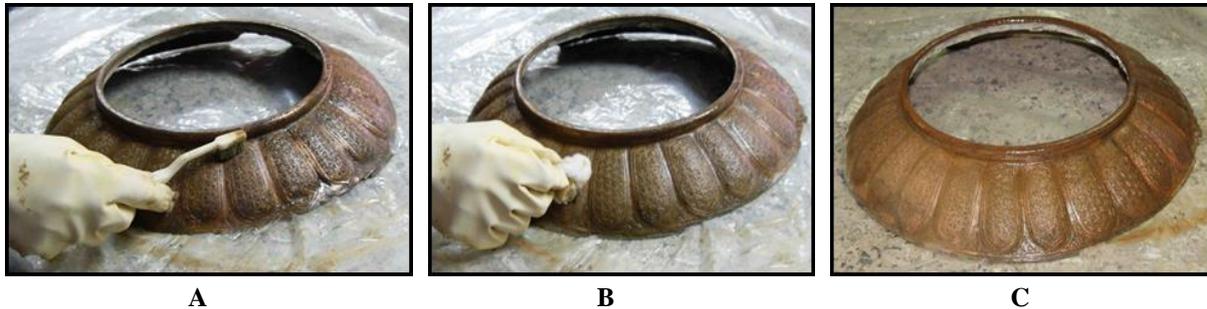
Fig. (7), A: During Mechanical cleaning of the copper tray, B: during chemical cleaning and C: after mechanical and chemical cleaning.

Soft brushes were used in different sizes according to the condition and thickness of the Corrosion layer. The frieze was used parallel to the surface to remove excess parts of the weld, which had been done in a previous restoration, to obtain a flat surface, (Ingo G.M., 2019). The Frieze was also used to clean the pits that contain corrosion compounds, taking great care to choose the heads that match the corrosion layer and the condition of the copper tray to preserve the patina layer.

Chemical cleaning baths were made in the plastic basins so as not to interact with the effect with the continuous observation of the treated parts. These baths contain rochelle salt then, citric acid at a concentration of 3%, then successive baths containing calcium bicarbonate, to neutralize the alkali with the acid, (Petiti, C. et al, 2020). Medical cotton was used to remove layers of corrosion and dirt after the copper tray parts were removed from the plastic basins. Successive baths of distilled water were made to remove any residual chemical cleaning agents. Finally, the dryer was used to ensure the drying of the effect after successive baths of distilled water (at low temperatures so as not to damage the copper tray), fig. (7), A, B and C.

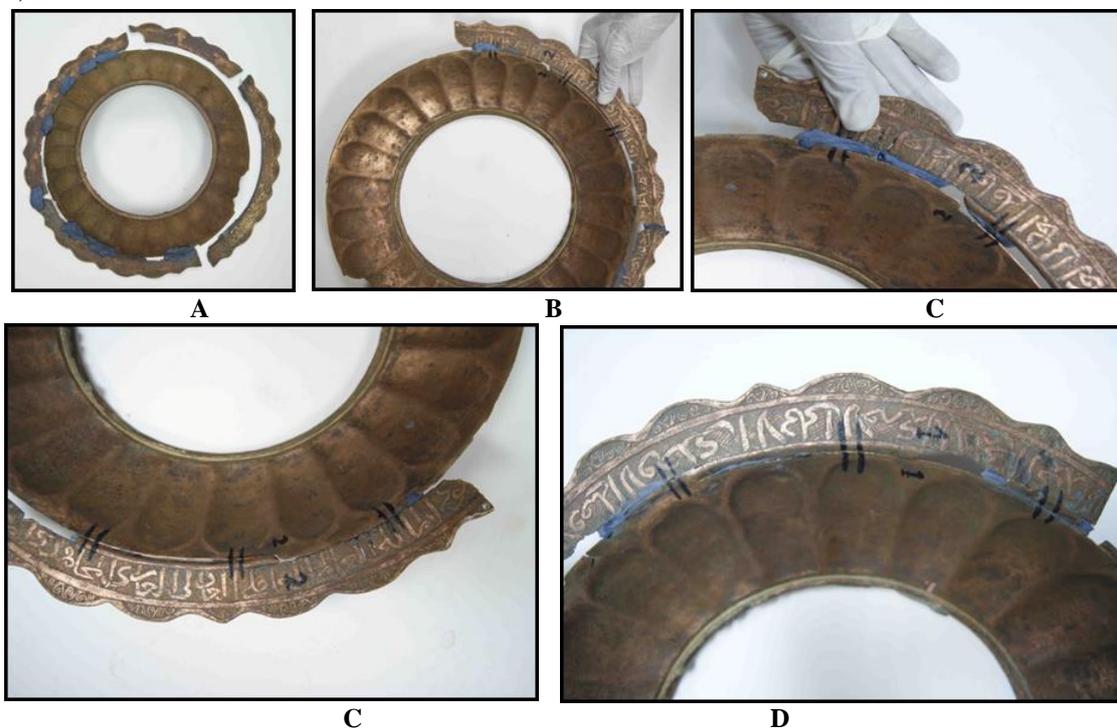
Fig. (8), A, B, C, D, and E, shows steps of the assembly process for the copper tray parts.

The different parts of the tray were numbered and recorded to determine their locations to return them to their original locations during the assembly process. A mould was made of layers of dental wax to fix the separate parts and to put the filler to fill the spaces between the separate parts that make up the copper tray, (Park, J., 2020). The dental wax was isolated with Paralloid-B72 at a concentration of 3%. Silicone and gauze were used to reinforce the separate parts of the tray to be fixed using epoxy pastes (consisting of monomer and hardener). The monomer was mixed with natural oxides and calcium carbonate with the microballoon as filler and placed in a large container. Only the quantity that will be used is mixed with the hardener, (Petiti, C. et al, 2020). It was noticed during the assembly process that there was a completed part that was cast in a different color from the rest of the tray parts because of a previous restoration. It is noted that the part completed during the previous

restoration on the edge of the tray takes the same inscription text, which indicates that the restorer who completed this part took his fingerprint from the part in the copper tray, and this explains that the text around the edge of the tray is incomplete, but it is repeated, fig. (8), A, B, C, D and E.

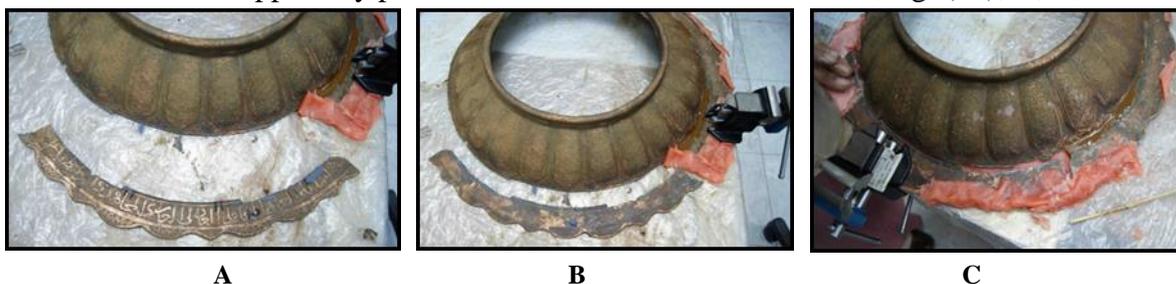
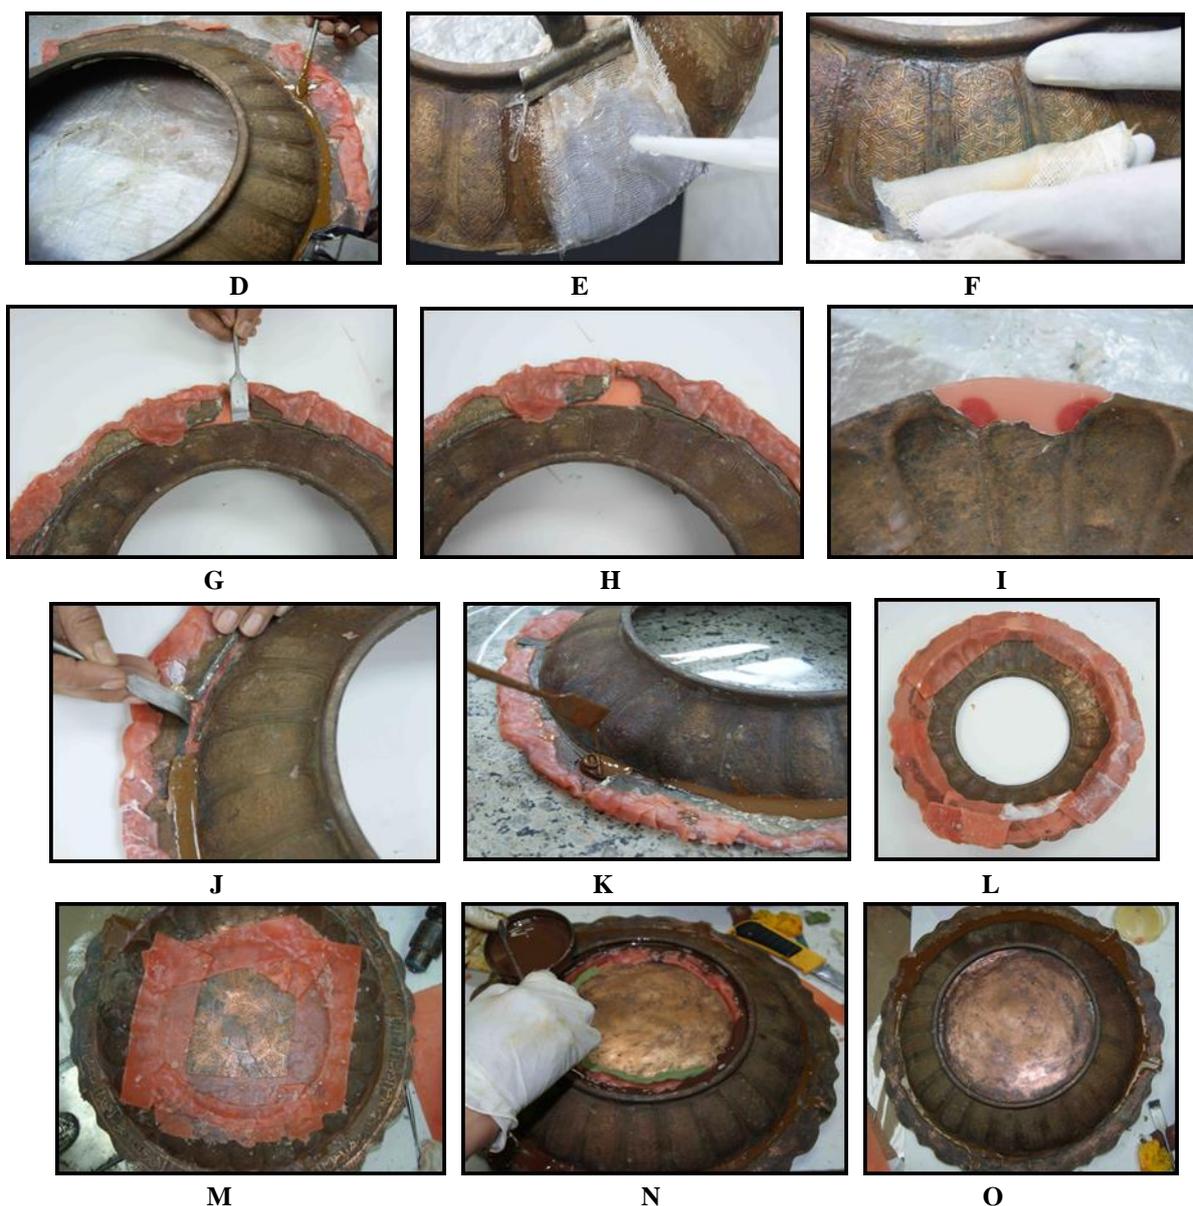
Fig. (9), A - O, shows steps of completion process for the copper tray parts.

Three layers were used to support the completion process for the separated part, where a layer of silicone was used, then after drying another layer of silicone is placed, then a layer of silicone and gauze. Each layer must dry before applying the next layer, (Park, J., 2020), and then the gauze layer is fixed with a metal clip until this piece is fixed in place correctly. After the mold that supports the separated part has dried for 24 hours, the existing joints (voids) are completed using (epoxy paste with natural oxides and calcium carbonate with microballoon as filler), (Ingo G.M., 2019). The mold was fixed with a sickle and allowed to dry for 42 hours. Dental wax was used by taking an imprint of the missing part of the edge of the copper tray and it was completed with epoxy paste, fig. (9), A – O.

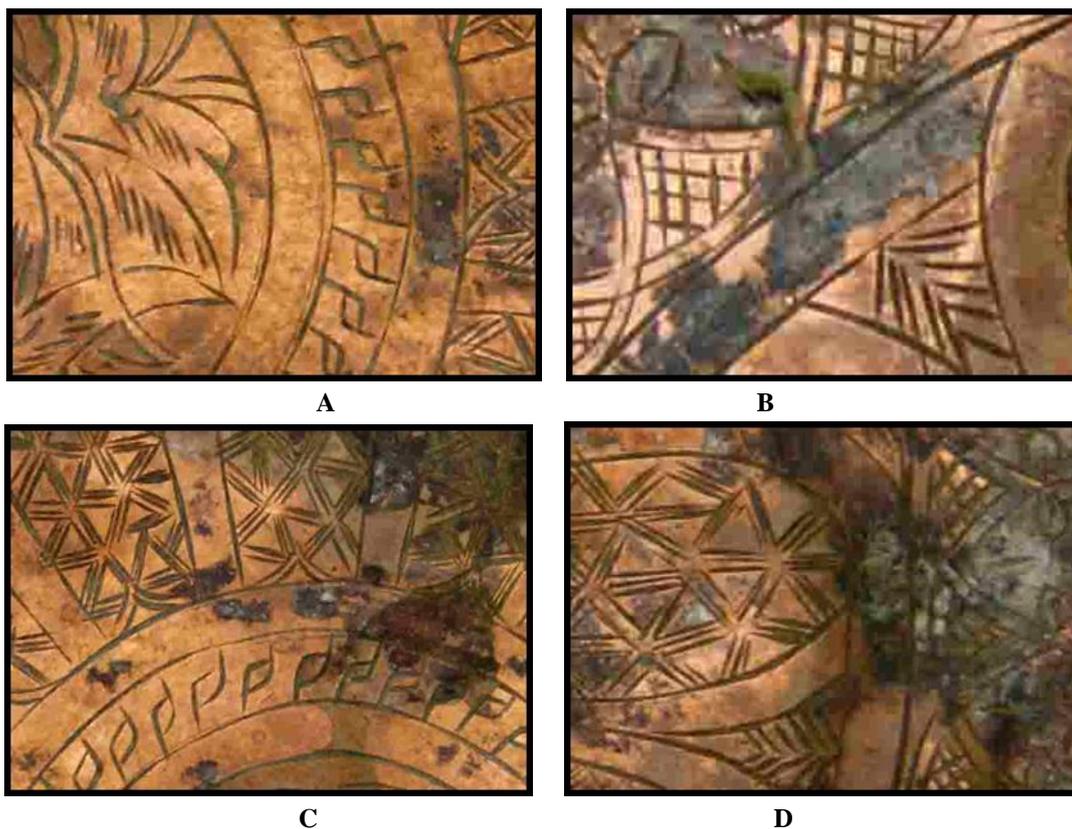
Fig. (10), A, B, C and D, shows details of the Mamluk copper tray after treatment process.

The freezing machine was used after the completion process to remove any unintended excess parts that formed during the completion process. The levelling of the surfaces of the contact areas between the copper tray parts was also taken into consideration, fig. (10), A, B, C and D.

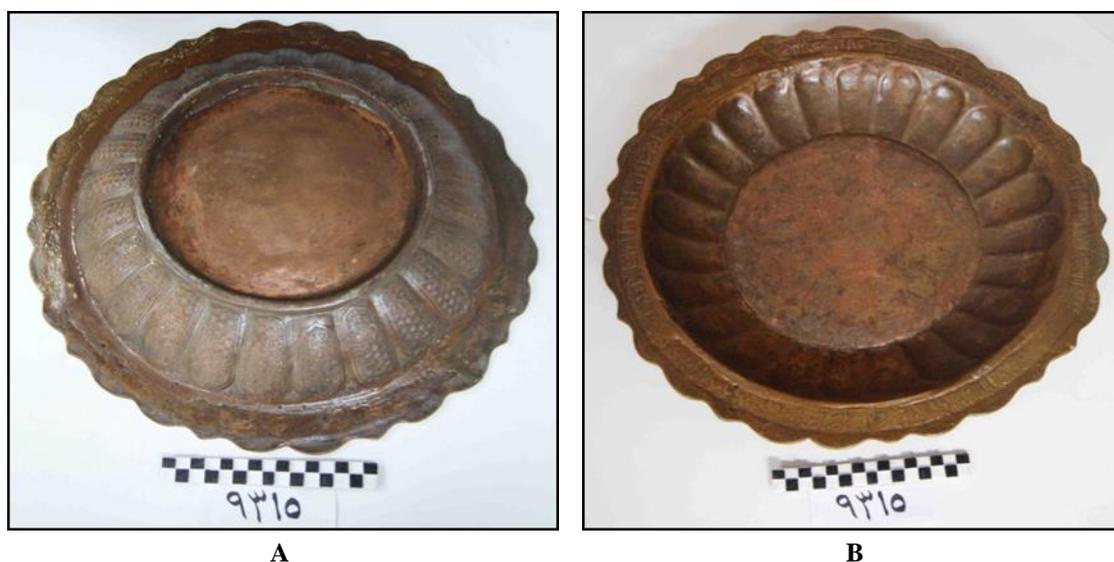
Fig. (11), A and B, shows the mamluk copper tray after treatment and conservation processes.

The surface of the copper tray was protected using benzotriazole at 3% (taking all precautions so as not to affect the health of the restorer), (Walker, R., 1970) such as wearing gloves in the hands and a mask on the nose during implementation, fig. (11), A and B, shows the mamluk copper tray after treatment and conservation processes.
