Preliminary Study of the Armored Door at Al-Zaher Barqūq's Mosque, Condition Assessment, and Previous Conservation Campaigns

KEYWORDS: Al-Zaher Barqūq's Mosque, Armored Door, Copper-Alloy Sheet, Corrosion, Examination, Analyses, Conservation

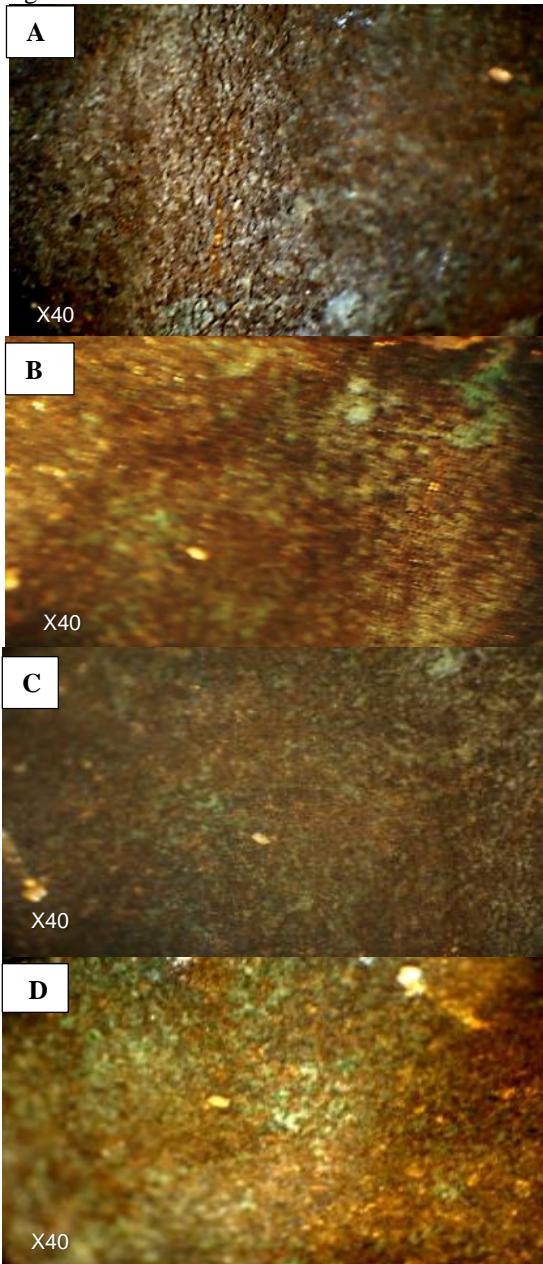
Traces of inlays with gold remain. Different samples were investigated by stereomicroscope to reveal the distribution of corrosion products adjacent to the characterized the rate of corrosion reactions on the armored door. The panel surface appeared in pinkish-red color, seen with a natural green patina shown in Fig. 8.

Fig. 8. Stereomicroscope results of the plaques patina. (A and B) Investigation result of the interface of the planks/wood. (C and D) Investigation result of the exterior layer

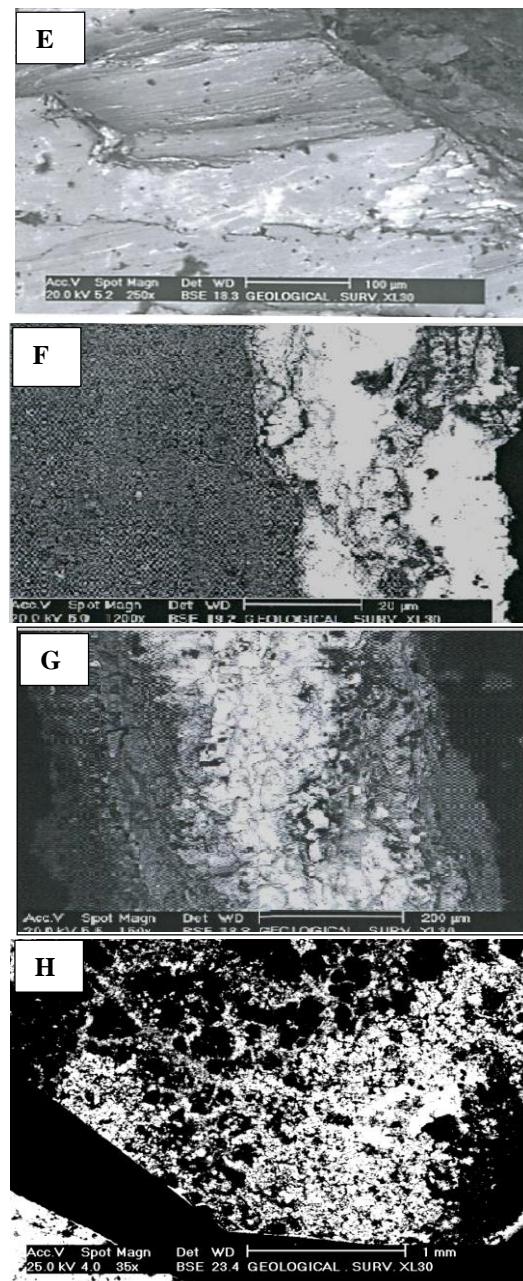
Fig.9. SEM images of different samples representing the morphology of the plaque surface. E: Sample of corrosion products of bronze alloy. F: Sample of corrosion products mixed with foreign materials made up of the bronze patina. G: Sample of active corrosion on the brass alloy. H: Sample of silver inlays on the surface adherent to its corrosion products [26].

Fig. 9, E: The Scanning electron microscope image of the bulk sample revealed the morphological characteristic of bronze with zinc and lead, as deep cracks on the surface. Distribution pits were caused by segregation of the insoluble lead grains. **F:** The Scanning electron microscope image shows surface fretting damage and cracking caused by chloride and sulphide ions associated with salts. **G:** The Scanning electron microscope image shows stress layered and intergranular corrosion forms on decorative elements.

H: The Scanning electron microscope image shows surface degradation of inlays resulting from active corroded areas.

According to the EDXS results of sample (E), central decorative elements are made of quarterly alloy (Cu 75.77 wt.%, Sn 2.35 wt.%, Zn 8.29 wt.%, Pb 9.20 wt.%). The copper alloy plaques have zinc and lead as major alloying elements. Tin was detected at more than 2% in the microstructure of the corroded surface. Other elements were identified in low percentages as iron and chloride ions. Pitting corrosion is the main form in this area; chloride ions were detected in the surface pits.

area, chloride ions were detected in the surface pits. EDXS results of sample (**F**) show that copper was detected in a small proportion overlapping with white stains caused by gypsum salts initiated by dusting. They are likely due to gap-filling with stucco during earlier conservation works. Aluminum and silicon were detected in a high percentage, likely caused by surface contamination with copper corrosion products. In addition, decuprification occurred by selective Cu dissolution of this area.

Sample (G) appears to be a brass deterioration with bronze disease; sulphur and chloride ions were detected in high proportions in the silver inlays, as well as seen in sample (H), revealed by a discoloration in those areas. Also, gypsum salts were detected in this area. Pure silver is the main component for inlaid inscriptions; electrum alloy was not used. EDXS results of sample (I) demonstrate that the purity of copper used in forming brass alloy was composed of more than 88 wt.%, with zinc added for the remaining 12 wt.% for the framing. Na^+ is accompanied by the presence of Ca^{2+} and K^+ , in samples (F) and (G) were detected, but in samples (E), (H), and (I), and were not detected. They are alkaline elements which were affected by the surrounding environment.

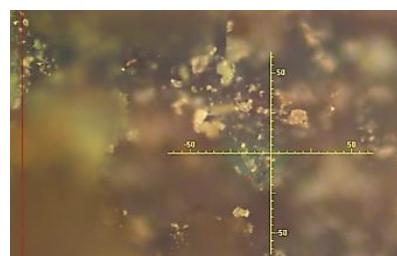
Fig.10. Optical microphotographs of corrosion products on the plaques

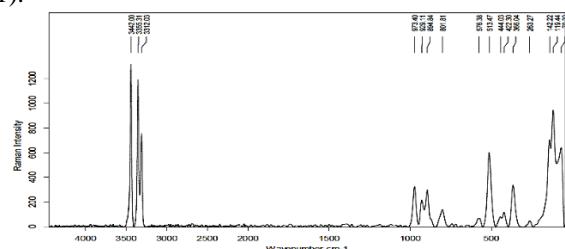
Raman spectroscopy to the surface provided a sensitive in situ probe of copper and iron corrosion products in the rusty-brown area. The peak shift was concluded with smoothing. The results show that the corroded surface samples were in contact with iron nails (Figure 11).

Figure 11. Raman shift of corrosion products of copper-alloy sheet

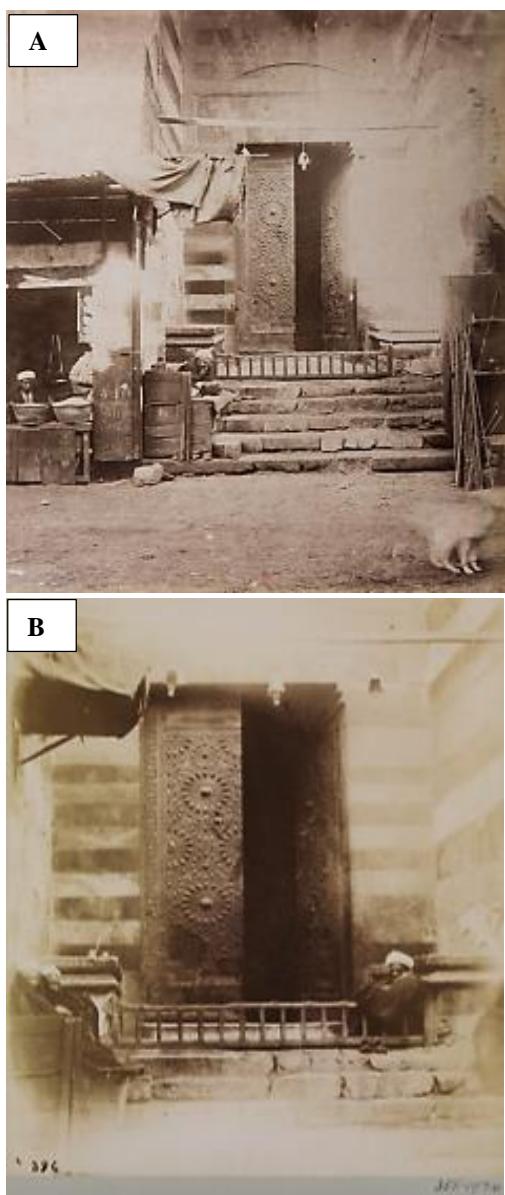
The plaque condition is assessed from the perspectives of its chemical structure, its residual properties, and its environment. Al-Mu'izz Street is a crowded tourist destination with human made-deterioration lead to increase the corrosion rate of the Islamic metal works. Careless and uninformed treatments represent the major problem facing Al-Mu'izz Street heritage, because of the quick expansion of the urban network. Construction damage to the stone gate initiated the destruction of the building elements, and became dilapidated and partially in ruins by the second half of the 19th century (Figure 13).

Fig.13. Old photos show serious damage of the entrance door at the funerary madrasa of Barquq before the refurbishment [20]

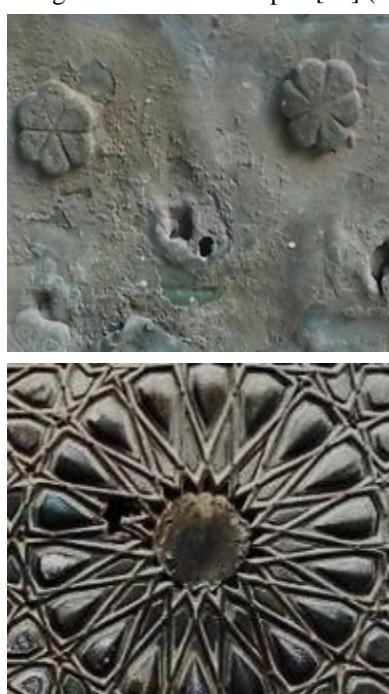
The interface (wood/metal) consists of copper corrosion products covering with a noble patina; the exterior layer is formed by green corrosion products of activated corrosion area and other salts [40]. Copper-alloy plaques were covered by mixed encrustations of grayish-green patina compact with dust. EDXS results revealed that sulphur and chloride ions were detected in high content with copper and silver corroded products. Pitting corrosion deeply is observed which lead to weight loss and surface pits [41] (Fig. 14).

Fig. 14. Accelerated corrosion voids

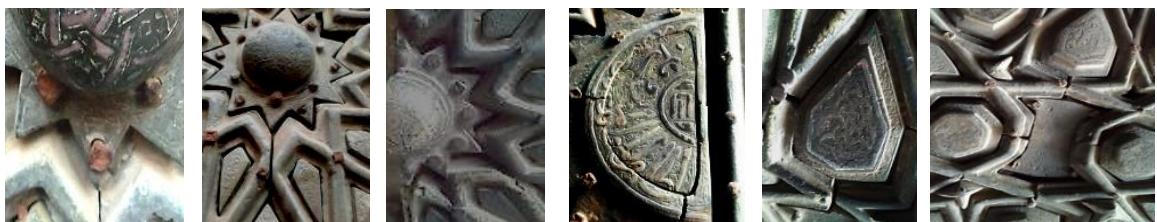
Some decorative elements were replaced and moved from their original places during conservation procedures, resulting in cracking (Fig. 15).

Fig. 15. Edge cracking of the placement of the decorative elements

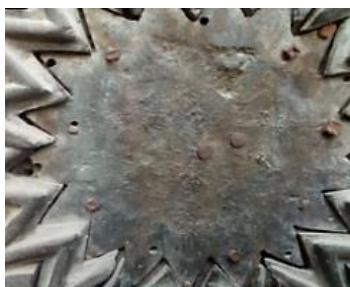
Many studs and nails were absent, leading a bundle and four decorative elements to be lost (Fig. 16, 17 and 18). Intricate arabesque door knockers/ hammers with pointed tips that touched the panel are missing (Fig. 19). Those preserved in the David Collection in Copenhagen coordinate with the door design [9]

Fig.16. Lost bundle and nails

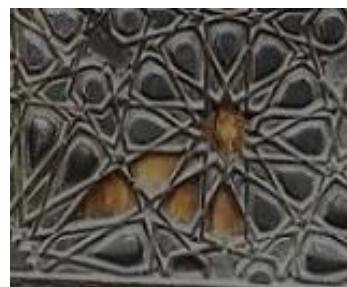
Fig.17.Missing decorative units on the right wing of the planks

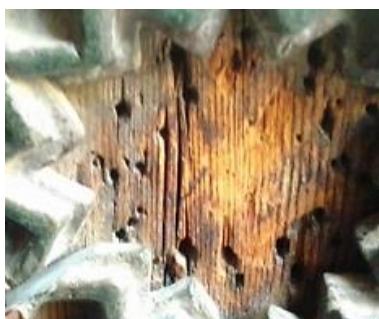
Fig.18. Nail holes along its borders

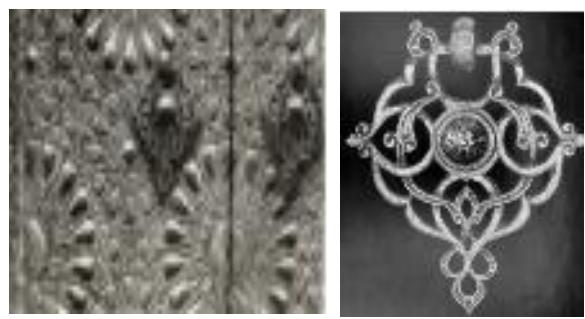
Fig.19. Missing artistic door knocker embossed star unit

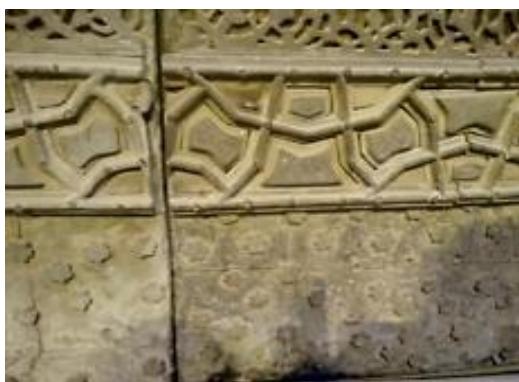
Increased damage is seen on the lower section of the door, near its edge, due to the high ground moisture and salts, as well as the friction of the moving door (Fig. 20).

Fig.20. Erosion in the lower parts of the plaques

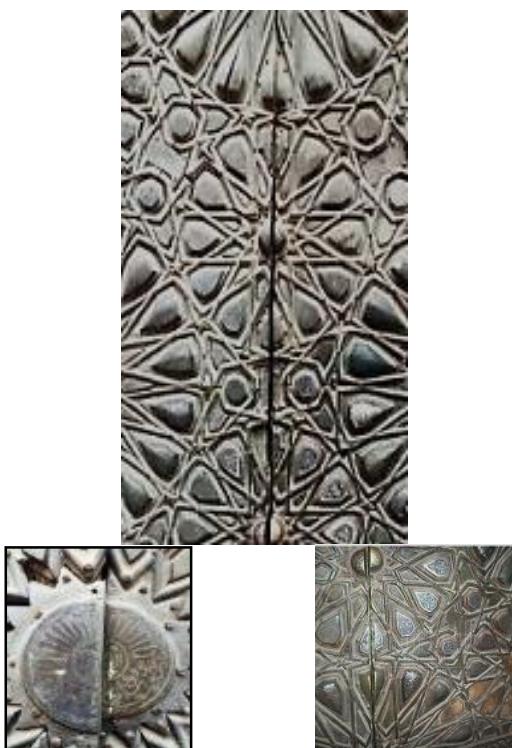
Recently, significant destructions were human-made vandalism. Precious metals such as brass, gold, and silver were an obvious target for looting. Both door leaves do not match, as one side was reworked and redecorated after revival works (Fig. 21).

Fig. 21. Two leaves of the planks not matching

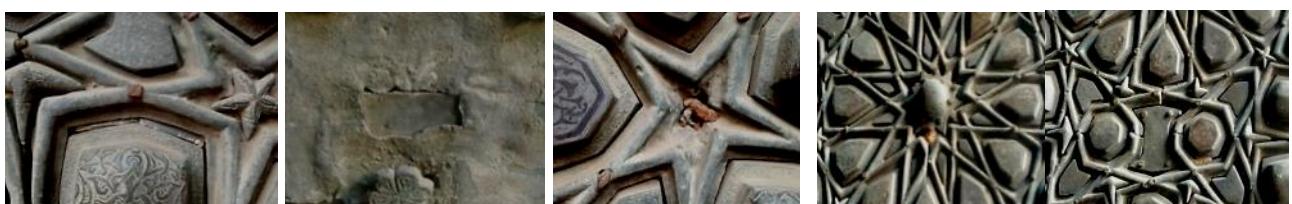
Fig.23. Gap-filling of missing parts and hollows loosen by corrosion

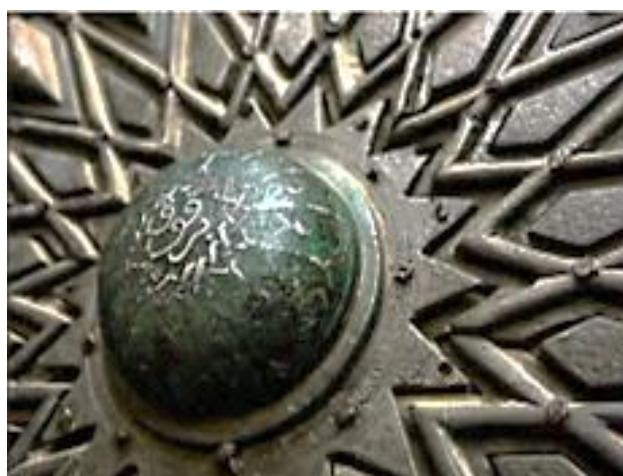
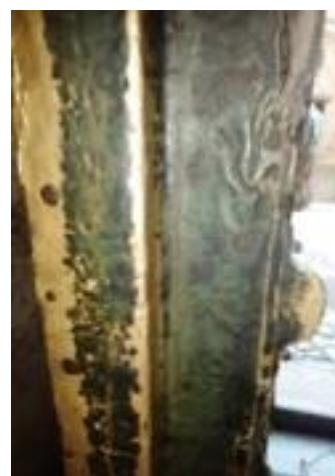
Past conservation interventions and replacements were probably performed by metalworkers and artists who made the pieces without much supervision. The style and decorative repertoire are evidence that the artisans experienced in producing portable objects were responsible for these doors [10]. Green oil-based coatings were used to polish and add shimmer in many spots of the plaques (Fig. 24).

Fig. (24) Green paint as artificial patina on some parts of the plaques

(a)Yellow framing supported by the presence folded edges. (b)The bundle with green paint as artificial patina [49]
