A LABORATORY STUDY FOR THE CHARACTERIZATION AND
TREATMENT OF AN ARCHAEOLOGICAL RIFLE FROM DHAMAR MUSEUM,
YEMEN

Ali, N. & Megahed, M.

Conservation dept., Faculty of Archaeology, Fayoum Univ., Fayoum, Egypt.

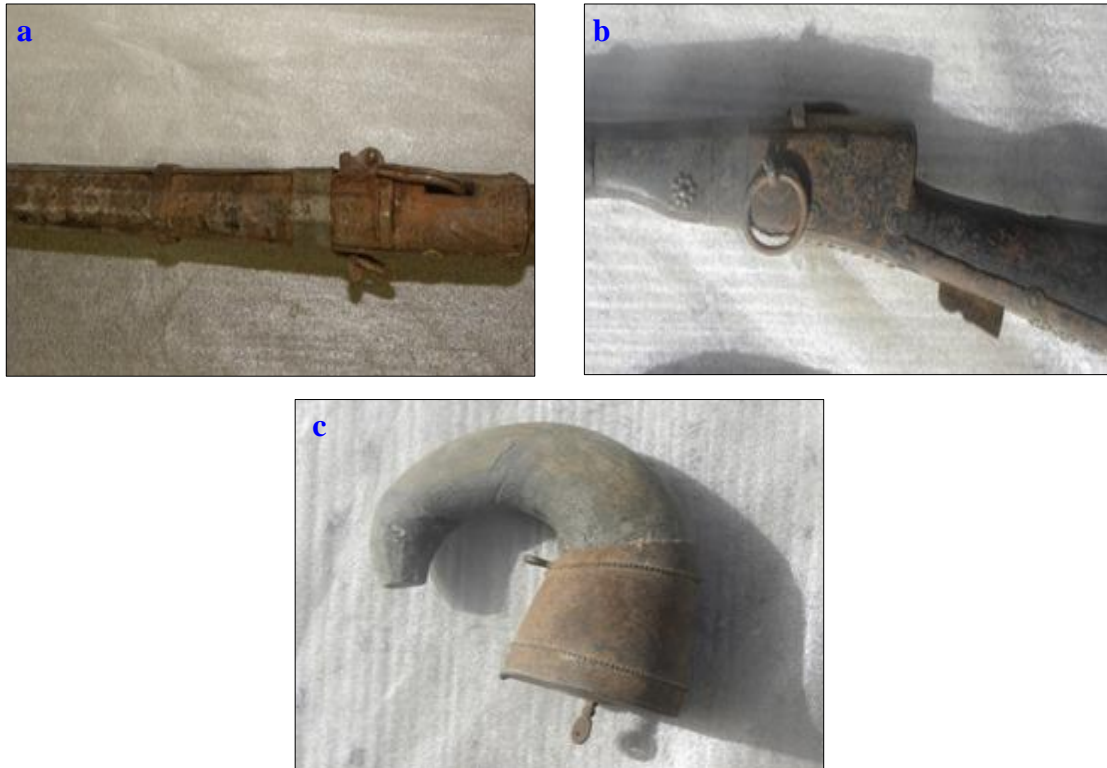
It is a rifle that belongs to the Ottoman period in the collections of Dhamar Museum, Yemen. It is made of iron and wood, and there are 8 rings of copper strips, connecting the iron parts with wood. It is 148 cm long, with a muzzle diameter of 1.2 cm. Its back part is rectangular of 14×6 cm. The rifle shows many manifestations of deterioration such as corrosion of the iron parts and dirt and micro-cracks on the wooden

part. The second object is the ammunition pouch, which is a big, hollow, made of an animal horn, with a cover made of iron. Its length is 36 cm, and its diameter sloping from 10 cm at the opening, to 2.5 cm at the end. It suffered from damage, such as corrosion in the iron parts and dirt and discoloration on the wooden parts and the animal horn, fig. (1-a, b, c).

Figure (1) Shows different parts of the rifle before the treatment **a.** the front part, **b.** the back part, **c.** the ammunition pouch

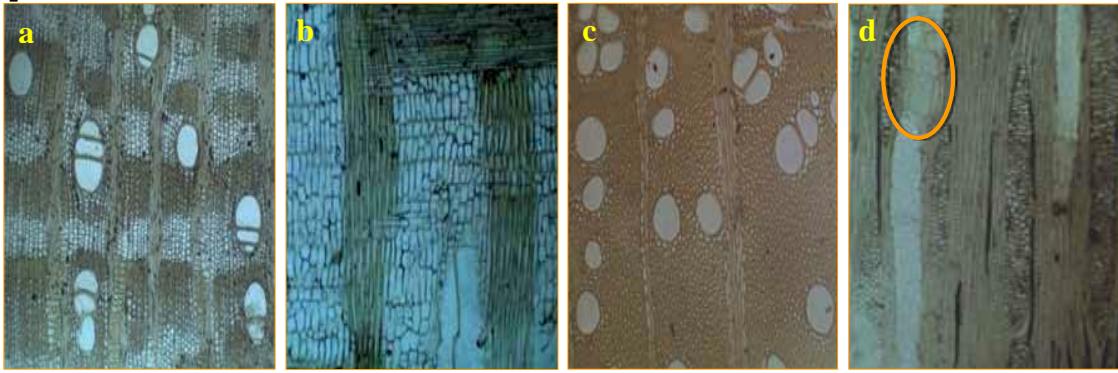
The microscope examination showed that the rifle's wood belonged to two kinds of wood, *the rifle's front parts, Tamarix Tetrandra*, where a cross section of *tamarix* showed ring boundaries growth is distinct by the difference in the vessel size, fig. (2-a, b)[12]. It is an evergreen high shrub that grows in sandy

and salty deserts and wadi [13]. The second kind of wood was *Syacamore Ficus* was at the back of the rifle. The cross section showed that growth rings were absent and vessels were diffused, with a tangential diameter of 90-240 μm and a radial diameter up to 300 μm , as shown in fig. (2-c, d) [14].

Figure (2) Shows **a.** cross Section of Tamarix, **b.** tangential section of tamarix, **c.** cross Section of Syacamore, **d.** tangential section of Syacamore.

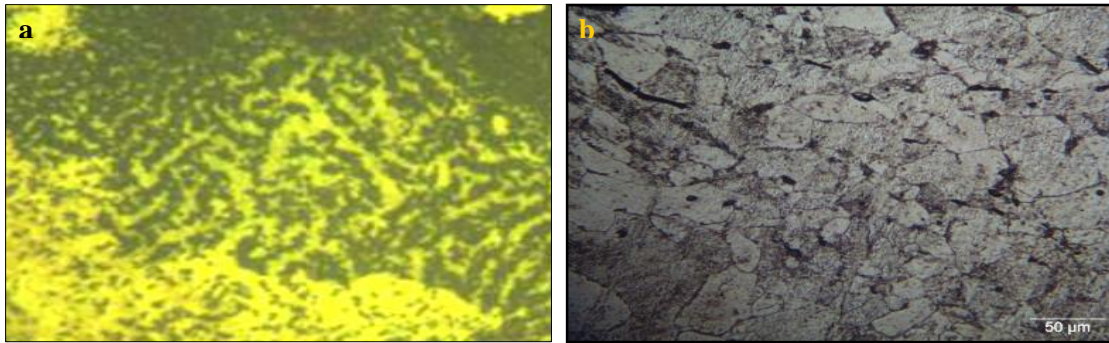
Metallographic examination of the metallic parts of the rifle and the ammunition pouch showed that micro

cracks and pitting corrosion spread on the surface, fig. (3-a, b).

Figure (3) Shows metallographic capture **a.** for the rifle showing the micro structure of the metal on the surface, **b.** for the surface of ammunition pouch showing pitting corrosion and micro cracks dispersed

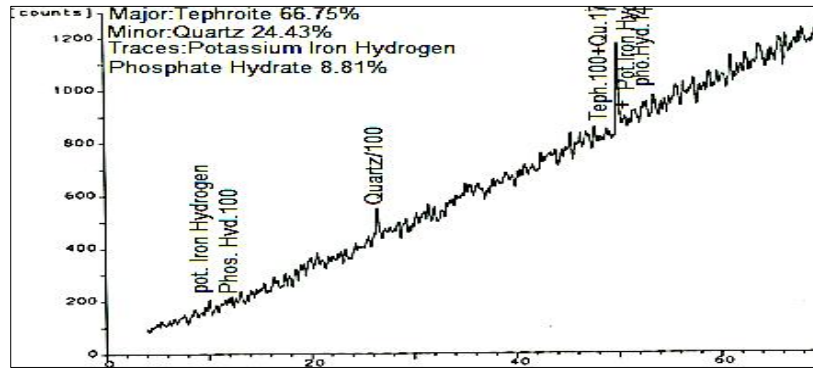
it is stable or not and the suitable conservation treatment. The obtained diffraction-scan was given in fig.11, and the identified compounds were represented in table (2) & fig. (4).

Samples	Major Minerals	Minor Minerals	Trace Minerals
<i>Rifle corrosion</i>	Tephroite [Mn ₂ SiO ₄]	Quartz [SiO ₂]	Potassium Iron Hydgen Phosphate [K Fe H ₁₄ (PO ₄)8.4H ₂ O]

Figure (4) Shows XRD pattern of the corrosion products of the rifle

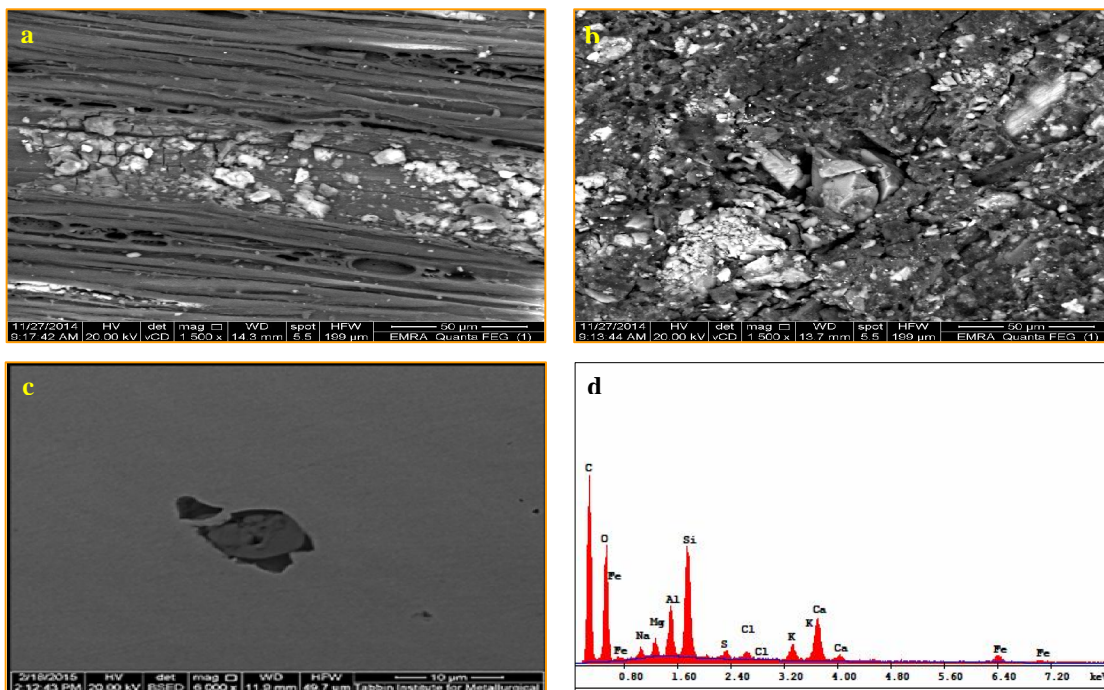
SEM investigations of the wooden part in the Ottoman rifle showed the presence of rust between wooden structures. Where, the rifle's ammunition pouch, (the horn) showed rust between the pouch grains, and the presence of rust was less between wood fibers. In addition, the metal parts showed the microstructure of deterioration spots, all of these features

are shown in fig. (5-a, b, c). EDX analysis proved that the structure of the horn consisted mainly of (C, O, Na, Mg, Fe, Al, S, Si, Cl, and K). Therefore, (Fe and O) were the elements of rust corrosion, (Si, Al, Mg, and K) were the elements of dirt and (Na and Cl) were the elements of Halite salt, fig. (5-d).

Figure (5) Shows SEM photomicrographs of the rifle **a.** the existence of rust between wood fibers X-1500, **b.** the existence of rust between horn grains X-1500, **c.** pitting corrosion and disturbing the of the metal of the ammunition pouch **d.** EDX analysis of the horn structure that consisting of (C, O, Na, Mg, Fe, Al, S, Si, Cl & K)

to protect from other elements. Figure (5-b) showed the microstructure of deterioration spots affected the metal parts through spots. These spots were very tinny because rifle had a good metallic state with some slightly pits in different places. *EDX analysis* showed that the structure of the horn consisted of (C, O, Na, Mg, Fe, Al, S, Si, Cl, and K). Therefore, (Fe and O) were the elements of rust corrosion, (Si, Al, Mg, and K) were the elements of dirt and (Na and Cl) were the elements of Halite. These results mean that there were iron and dust among the grains of the ammunition

pouch. Hence, conservation process of the rifle was conducted. Figure (5-c) of the ammunition pouch, (the horn) showed rust between the pouch grains. The presence of rust was less than those between wood fibers because spaces between horn grains were less than those between wood fibers. So, the percentage of absorbing rust was lower. This rust wrenches the horn surface and plays a role of the accelerated factor to change air pollution gases to diluted acids which destroy horn as an organic material.

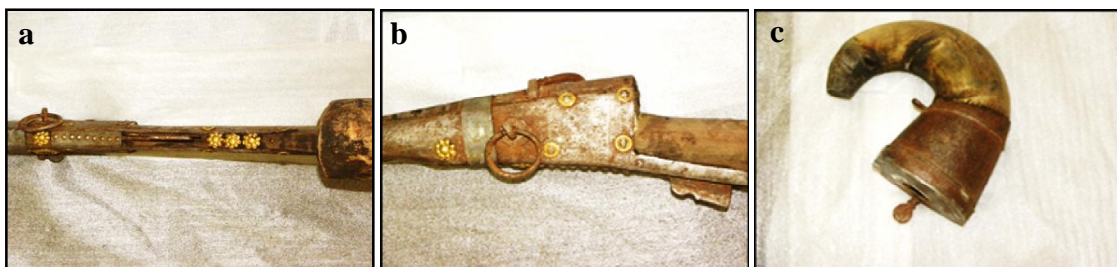
Figure (5) Shows **a.** & **b.** the back part of the rifle, **c.** the ammunition pouch after the treatment after the treatment

nical cleaning was used in a limited area because the rust was a thin layer but it was acceptable after making a test on a replica and in hidden parts with selected solutions. Then, the chemical cleaning was performed on some wooden parts. Here, the rifle and its ammunition pouch were mechanically cleaned, first. Then, the chemical cleaning was performed on some wooden parts that were separated to save them from acids and alkaline solutions. Chemical cleaning of the wood was included using some mixed solution of (1 Alcohol: 1 Toluene) to remove the rest of the rust layer which damaged the surface of wood and horn. Wood and horn consolidation was an important process. Regalorz 1094 was very suitable for brittle wood and horn; this polymer was diluted in toluene of 5 % concentration which was applied with injection technique. The organic parts were left for 48 hours until they were dry in the ambient air. After that, the surface was covered with a thin layer of 2 % Regalorz in Toluene. To clean iron objects, dirt, grease and loose or flaking rust must be removed before applying protective coatings. Such deposits can be removed using chemical or mechanical techniques. Chemical cleaning include using soapy solutions to dissolve grease and remove surface dirt. For example, aqueous alkaline solution (caustic soda) was used to remove grease and paint. Concentrations in the range of 20-40 g. of sodium hydroxide per liter of water are normally used. Corrosion products can be removed using a solution of 50 g. of citric acid in

water. While citric acid is relatively safe on most objects, care should be taken to ensure that cast iron, cast steel or spring steel, or combinations of them are not left unattended for long periods because they will actively corrode. Prolonged gas evolution (which you will be seen as bubbling) indicates that the iron surface is corroding. With harder alloys, this can also cause hydrogen embitterment in which hydrogen is generated within the metal and the stress of the gas pressure cracks it. Gas evolution can also result in pitted, weakened or destroyed objects. Simple wire brushing can be used. There is doubt regarding the type of iron or the duration of acid treatment, more time should be spent removing corrosion products by mechanical means. Once the worst deposits are removed, short treatment in citric acid should clean the object, with reduced risk of damage. Some forms of corrosion leave spots on the object, which cannot be removed by citric acid and can be mechanically removed. On treating large objects, it is difficult to find large enough containers or tubes to immerse the objects for caustic or citric treatments. If sand blasting is inappropriate, the acid or alkaline stripping solution can be applied to the surface using a bentonite paste or absorbed cotton. Finally, washing the object by deionized water, which should be repeated perfectly to ensure flushing capillaries to remove any chemical residues. Then, soft and clean cloth is used for drying. Coating the rifle and the storage with 3 % solution of Benzotriazole (BTA) soluble in Ethanol, fig. (6-a, b, c).
