A STUDY OF REPAIR PROCEDURE OF AN OLD STEEL **ORTHOTROPIC DECK BRIDGE**

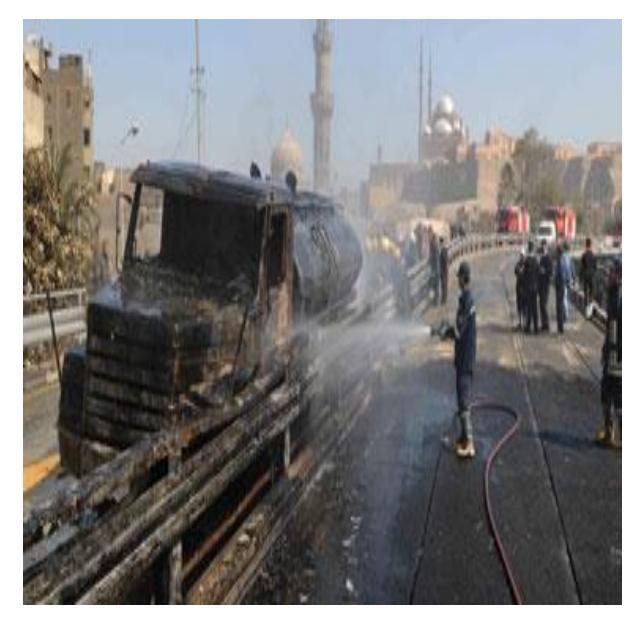
Figure 5: Truck On Fire At The Middle Part Of Bridge

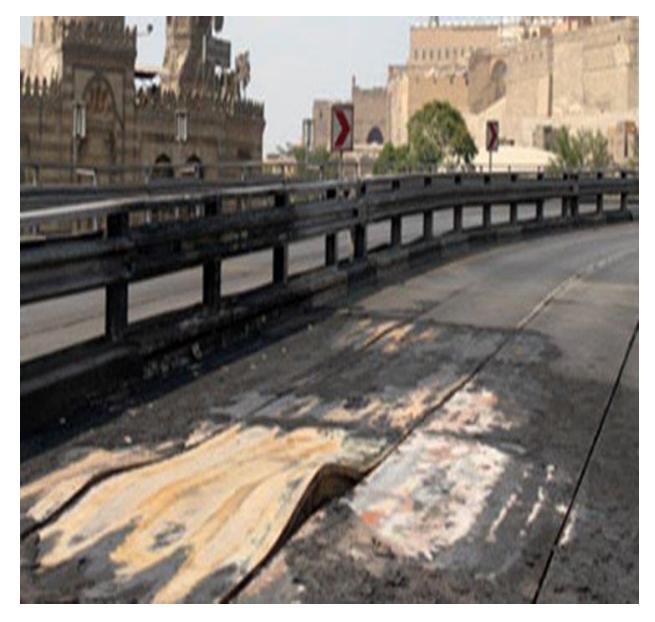
Figure 6: Permanent Deformations In Bridge Deck

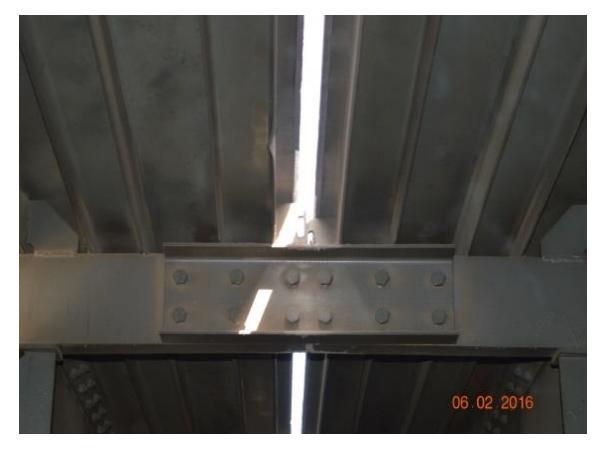
Figure 7: Loss Of Expansion Joints And Large Observed Distance Between Deck Parts

* Lack Of Expansion Joints.

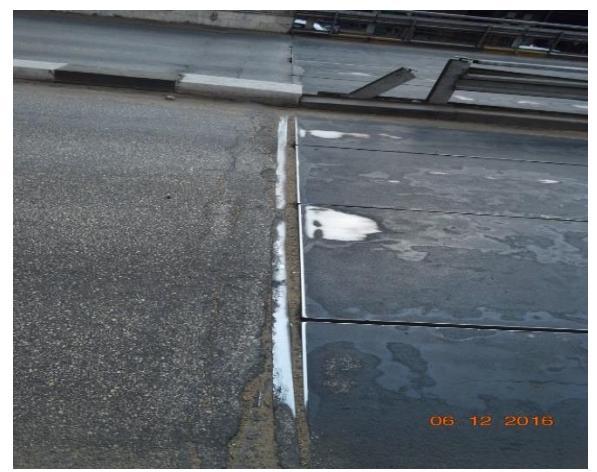
Figure 9: Loss Of Asphaltic Layer And Exposure Of Metallic Deck

* Loss Of Top Asphaltic Layer And Exposure Of The Steel Plates.

* Replacing Of Asphaltic Wearing Surface For The Whole Bridge.

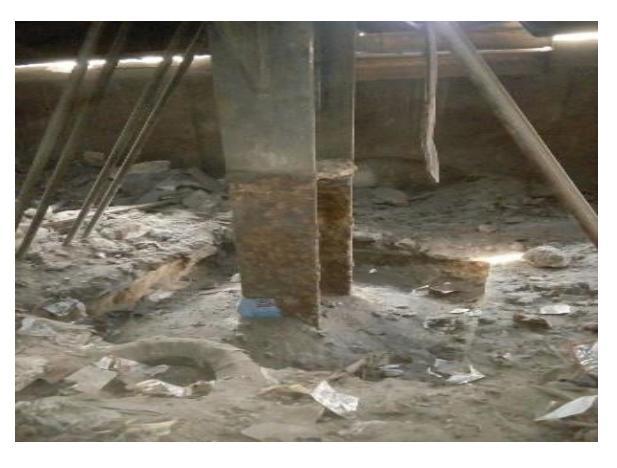
Figure 8: Corrosion At Bottom Of Bridge Columns

* Corrosion And Loss Of Parts Of The Steel Section For Some Members.

* Removing Of Corrosion At Bottom Of Columns By Sand Blasting And Adding Steel Plates As Substitution Of The Lost Area As Shown In Figure 19.

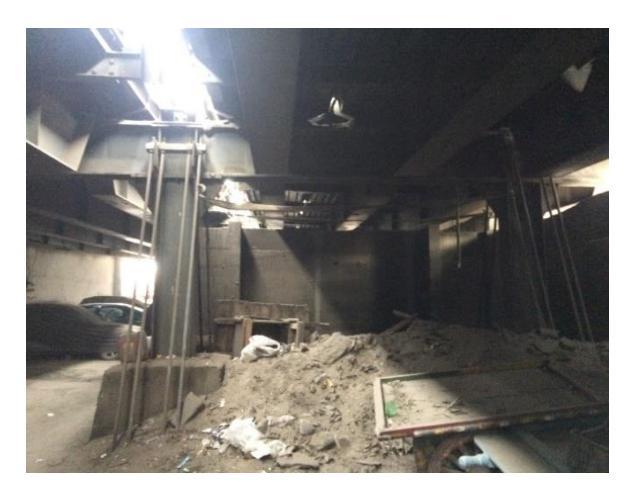
Figure 10: Accumulation Of Garbage Around Supporting Elements

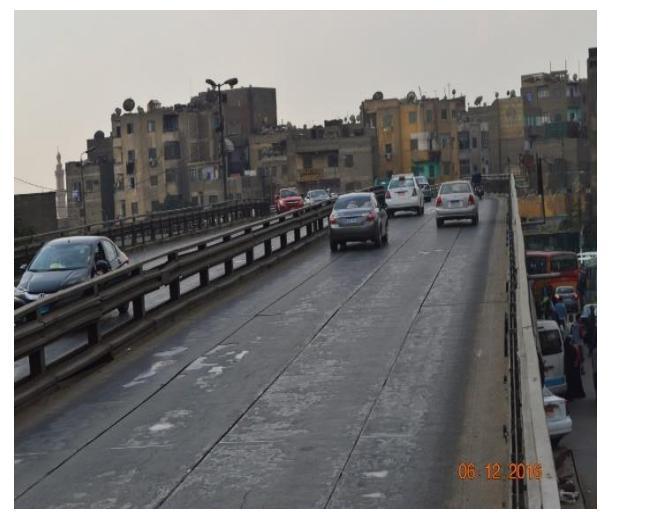
Figure 11: Lack Of Speed Limit Signs

* Lack Of Road Signs.

* Adding Proper Traffic Signs Indicating Bridge Curvature And Limiting Velocity On Bridge.

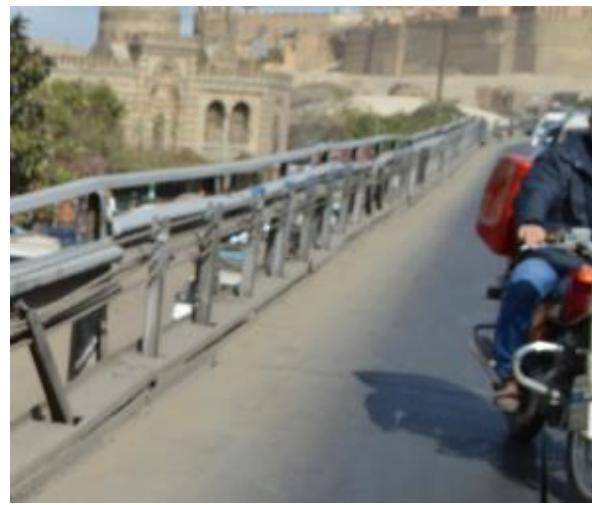
Figure 12: Bad Condition Of Guardrail

* Repairing Of Damaged Parts Of Guardrail.

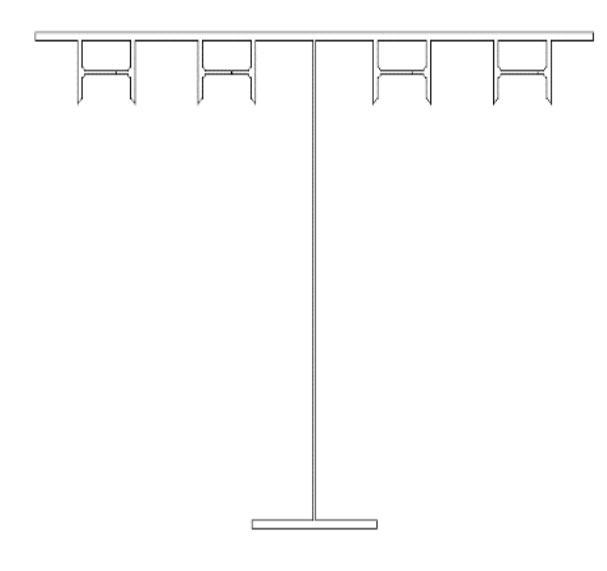
Figure 14: Stress Distribution For The Longitudinal Supporting Beam

Steel Structures (Ecp 2007). For Example, The Cross Section Of The Main Beam At Was Found To Be Under Increased Tensile And Shear Stresses At Middle And Edge Of Beam, Respectively. This Was Checked By Determining The Nominal Flexural And Shear Capacities Of The Existing Section And Comparing It To The Straining Actions Due To The Applied Loads. Moreover, Beams And Columns Of The Different Supporting Frames Were Checked And It Was Found That Column Section At Some Locations Are Subjected To Straining Actions Exceeding Their Supporting Capacity. Upon Checking The Connection Between Main Girder And Moment Resisting Frames Shown In Figure 16, It Was Found That The Existing Bolts And Decreased Section Properties Are Not Sufficient To Resist The Applied Shear.

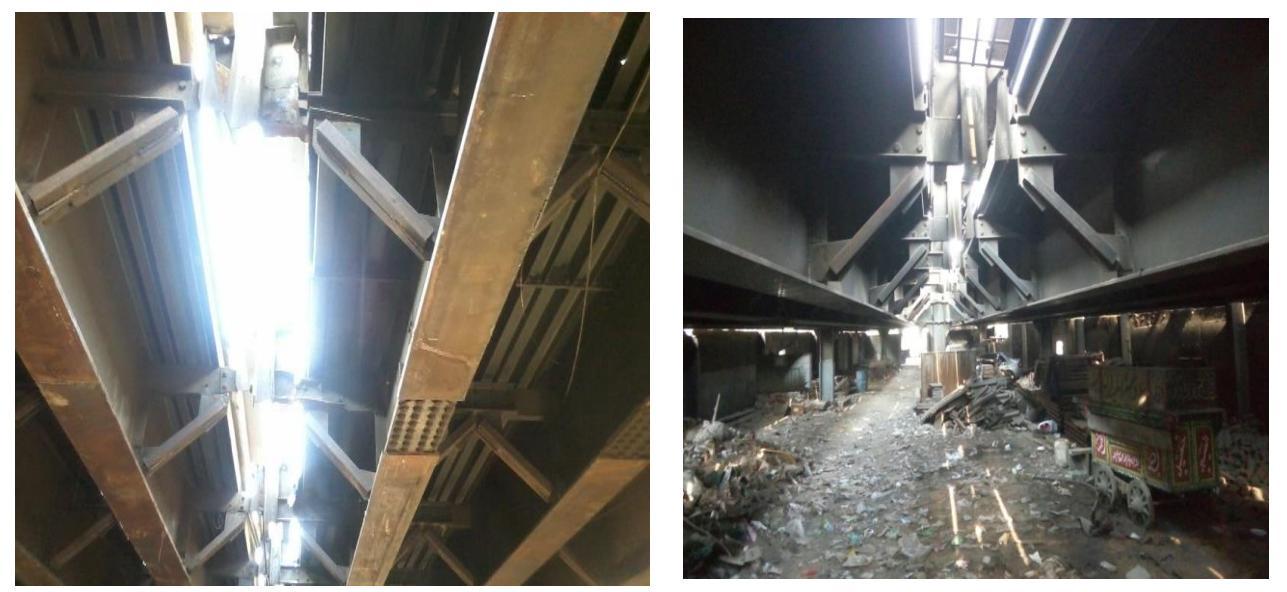
* Increased Stresses In Main Beam, Cross Beams And Supporting Moment Resisting Frame Columns When Considering Increased Traffic Loads.

Figure 18: Adding Bottom Steel Plates To Increase Stiffness Of Supporting Beams And Diagonal Bracing To Cross Beams

* Strengthening The Main Beams By Adding Bottom Steel Plates As Shown In Figure 18. The Additional Plates Had A Width Larger Than The Width Of The Existing Bottom Flange Of Beams And Were Connected Using Two Lines Of Fillet Welding. A Special Joint Was Used To Bridge The Existing Bolted Splices. Figure 18 Shows The Bolted Splice. * Strengthening Of The Cross Beams By Adding Diagonal Box Braces As Indicated In Figure 18.

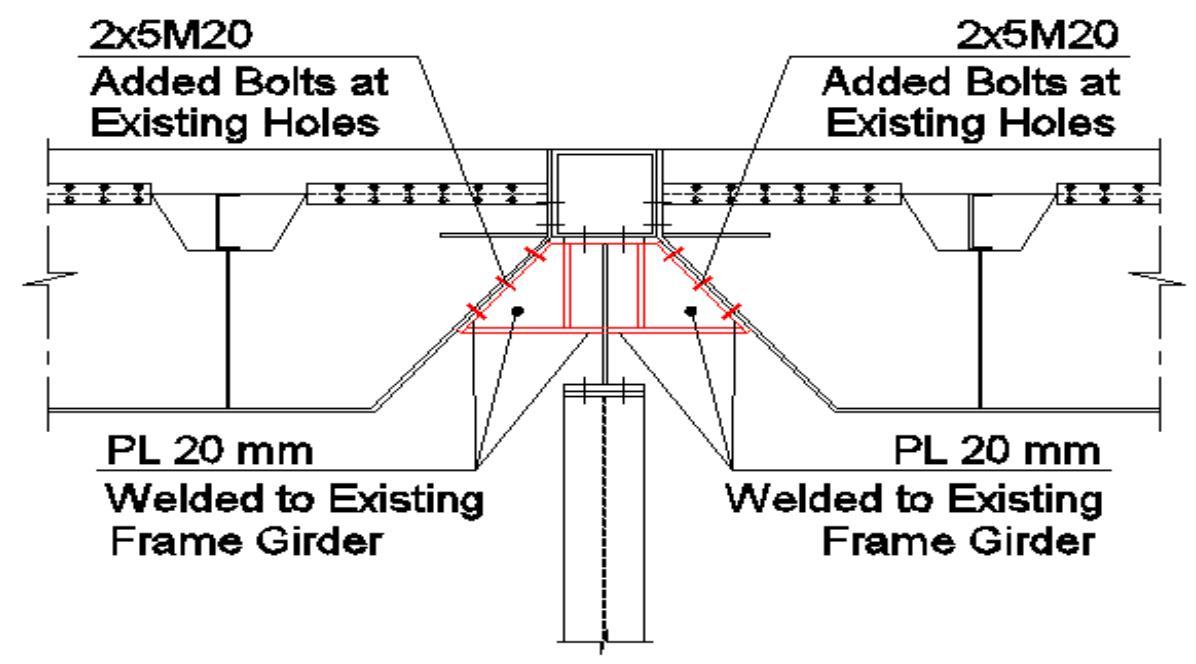
* Insufficient Number Of Bolts At Main Beam Shear Connection.

Figure 20: Strengthening Proposal Of Main Beam End Connection

* Strengthening Of Main Beam Shear Connection As Shown In Figure 20.

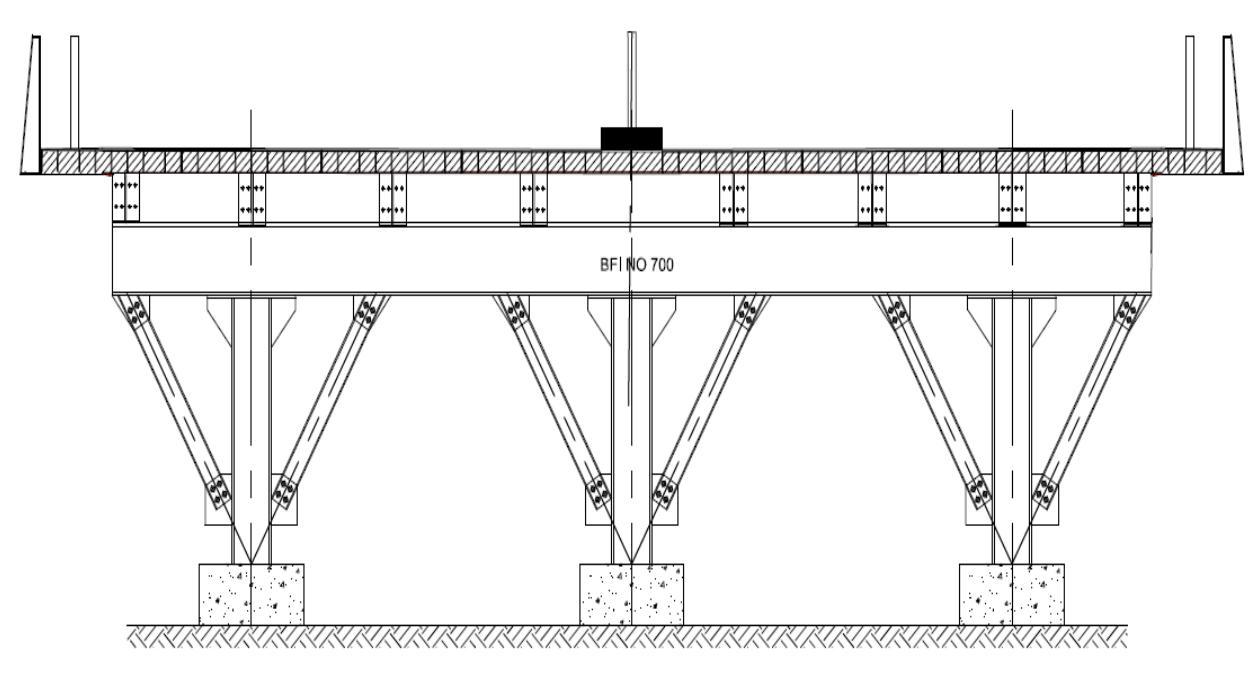
Figure 21: Stress Distribution For The Longitudinal Supporting Beam

* Strengthening Of Supporting Moment Resisting Frame By Adding Bracing Members As Shown In Figure 21.
