Experimental investigation of hydrogen embrittlement to stainless steel charged by sulfuric acid at $\pm 20^{\circ}\text{C}$

ABSTRACT

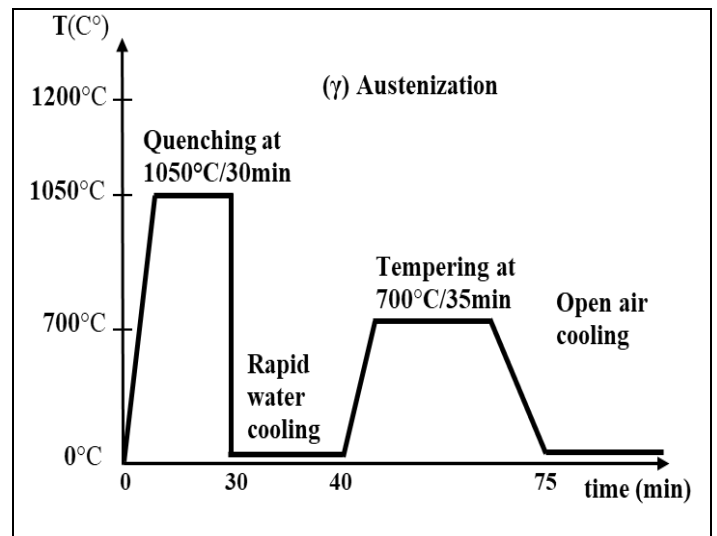
Figure 2: Heat treatment cycle applied [34].

After the manufacture of the specimens, an austenization treatment was carried out according to the thermal cycle given in (Figure 2) [34].

It consists of heating for 30minutes at 1050°C, followed by water quenching (Rapid water cooling). To obtain a homogeneous and stable austenite structure (γ Austenizing), the next step consists of applying tempering at 700°C for 35minutes and then cooling in ambient air (Open air cooling).

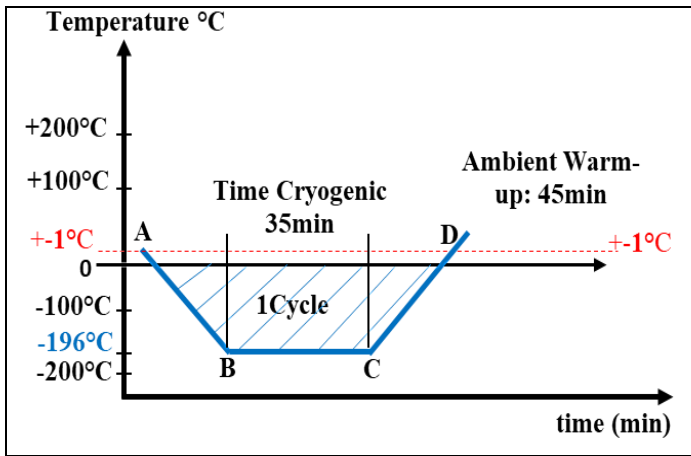
Figure 3: The cryogenic quenching cycle used at -196°C [34].

After the austenization treatment cycle, the specimens are cold quenched at a temperature of -196°C of liquid nitrogen (N₂), (Cryogenic treatment), following the thermal cycle presented in (Figure 3) [34]. The test specimens are kept in the liquid nitrogen tank for 35minutes, followed by a slow heating in ambient air for approximately 45 minutes.

This cold treatment cycle of the test specimen was repeated twenty times (x20).

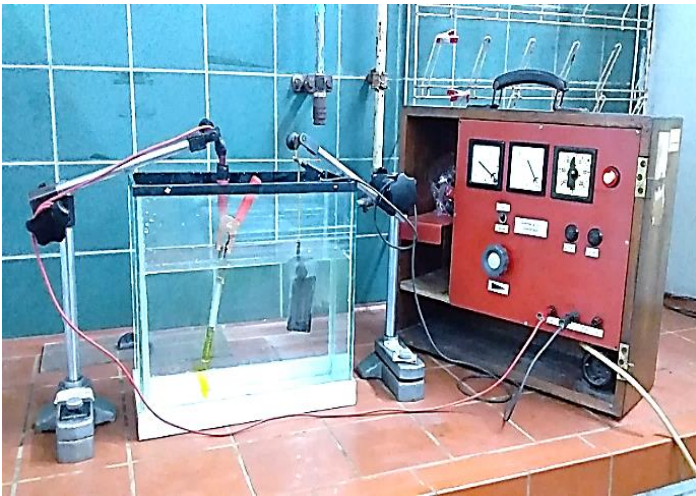
Figure 4: Pyrex glass cell (hydrogen pre-loaded specimen in solution aqueous 0.1N H₂SO₄, /100mA/Cm²/pH=1.32)/ [13], [14], [21], [23], [26], [28], [30], [31].

After the cyclic cryogenic quenching treatment, the specimens are electrolytically (hydrogenated) pre-charged with hydrogen. The method consists of using a pyrex glass cell enclosure containing a 0.1N H₂SO₄ solution acid sulfuric equipped with two electrodes, an unattackable platinum anode, and a cathode connected to the specimen, see (Figure 4).

Charging was carried out at room temperature with a with a conditions industrial adopted [13], [14], [21], [23], [26], [28], [30], [31], current density equal to 100mA/Cm² for different durations of the pre-charging time from 01hours to 13hours with a step of 01hours.

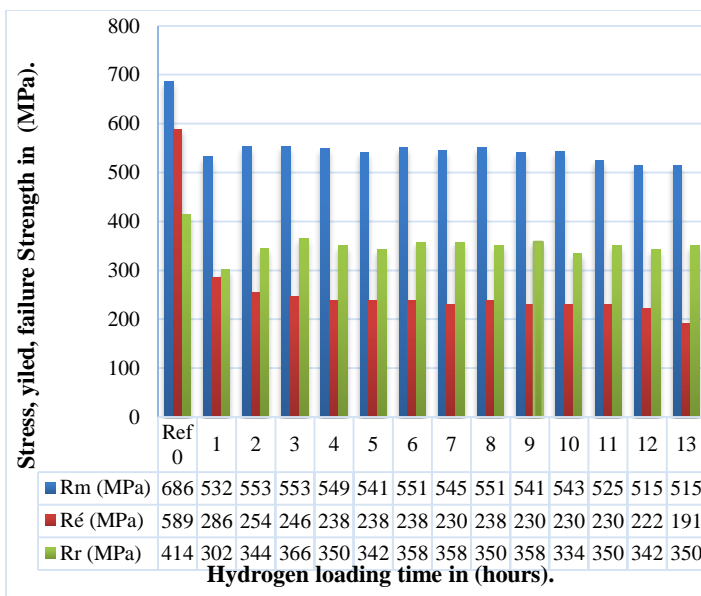
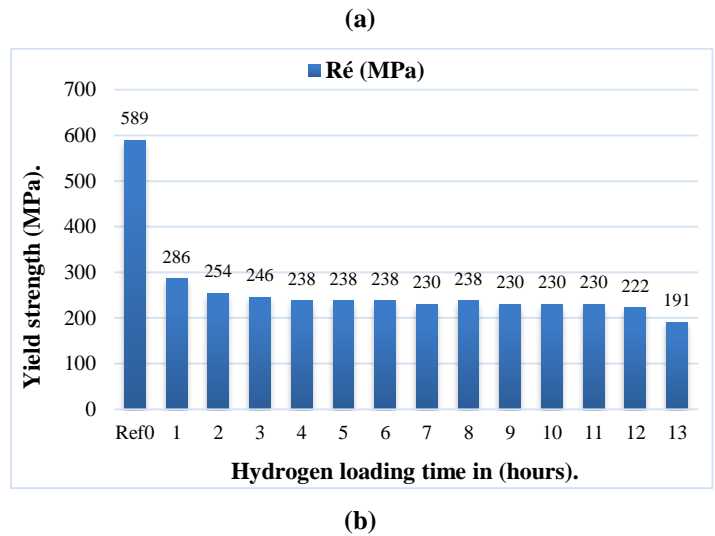
Figure 6: (a): (R_m, R_é, R_r) stress, yield, failure strength variation of resistance in (MPa), (b): (R_{éH}) Yield strength in MPa of AISI304L steel with hydrogen loading time in hours.

The analysis of these curves shows a slight decrease in the resistance of the material as a function of the quantity of absorbed hydrogen represented by the loading duration, see (Figure 6) (a) and (b). This is in agreement with the work carried out by various researchers who stipulate that hydrogen, by diffusing in the form of (H+) cation in the material, regroups in the form of H₂ gas to occupy the existing defects and consequently exerts internal pressures [15], [21], which reduces resistance [23], [29].

Firstly, (Figure 6) (a), represents a decrease sensitive to the values of the mechanical resistance stress strength (R_m) as a function of hydrogen pre-charging time in hours. In parallel, a comparison of these values with the reference sample which presents a significant value is greater of the order of R_{m(Air)}: 686(MPa) to R_{mH}: 532(MPa) or the mechanical resistance passes through a minimum value of the order of R_{mH}: 515(MPa), see (Table 3).

Secondly, a behavior expected by an yield strength (R_é) in (MPa) as a function of the level of number of hours of hydrogen pre-charging, which represents a progressive reduction at these yield compared to the Reference0(Air) is of the order of R_{é(Air)}: 589(MPa) to R_{éH}: 286(MPa), up to the duration of 13 hours or this yield strength passes through less significant values of the order of R_{éH}: 191(MPa) see (Figure 6) (b). According to the two parameters of the variation of the mechanical resistance: stress strength (R_{mH}), yield strength (R_{éH}) in (MPa), which undergo drops and progressive reductions compared to the reference0 (Ref0 Air) value.

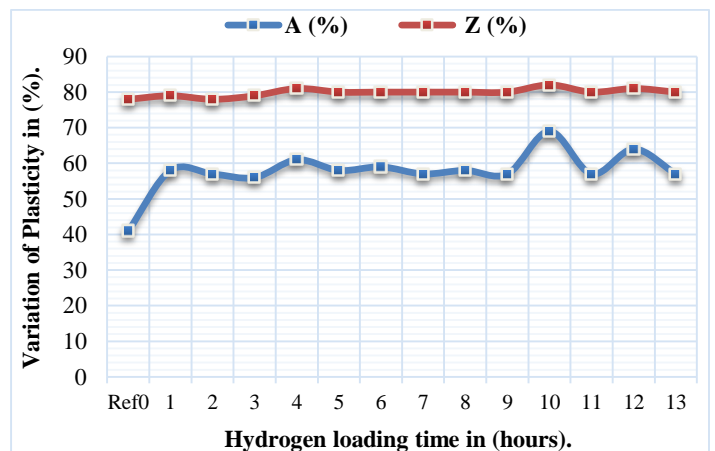
Figure 7: Influence of hydrogen loading on the plasticity A, Z in (%) of AISI304L stainless steel.

Observing (Figure 7), we notice a slight improvement in plasticity as a function of hydrogen loading times. This result is in agreement with the work of [24], the latter were able to conclude that the reduction in resistance yield strength (R_é) [23], and failure strength (R_r) can be caused by increasing the temperature of the tempering treatment, which induces an increase in the ductility of the material studied and significantly improve their plasticity which is associated with the elongations A(%) in percent, comparing with the reference0(Air) i.e. from 41.0(%) to A_H: 58.0(%) in order to achieve a value of being stable throughout the hydrogen loading stage in hours up to 13 hours, i.e. by a value that was important is: A_H: 57.0(%). In parallel, the data on the Z strictures (%) in percent explained by significant increases are even significant compared to the reference is of the order of Z(Air): 78.0(%) to Z_H: 79.0(%), or these strictures go through improvements in order to be stable at Z_H: 80.0(%). The result is that the plasticity of the steel studied increases significantly and remains almost constant throughout the hydrogen loading stage in hours, due to the sets of heat treatments of tempering at 700C°, thus the use of the protocol immersion in succession following the cycle applied, see (Figure 3) by cryogenic quenching at -196°C.

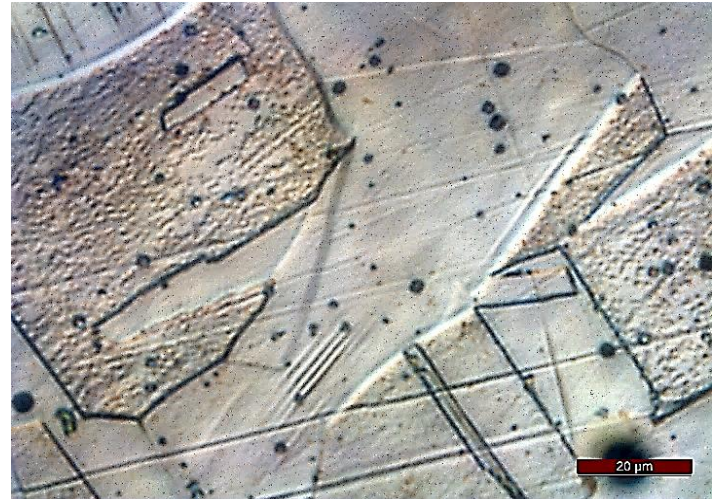
Figure 9: Optical microscopy images of, (a): the rough microstructure of AISI304L stainless steel (x20µm), (b): of the AISI304L stainless steel loaded time in 13hours with hydrogen (x20µm).

After the mechanical tests by fracture, the study of the facies of the broken specimens, see (Figure 8) (a) and (b) as well as the microstructure of the AISI304L steel was carried out by different techniques: Optical microscopy (OM), x-ray diffraction (XRD), and scanning electron microscopy (SEM). Observation under an optical microscope, after mechanical polishing and chemical attack with the 10% solution of oxalic acid ($C_2H_2O_4$), including the composition of 10grams of oxalic acid in 100milliliters of distilled water with an attack duration of 10 to 45 seconds under a voltage of 6 Volts to reveal the microstructures represented using a Leica DM4 GMBH brand optical microscope (MO), see (Figure 9) (a) and (b).

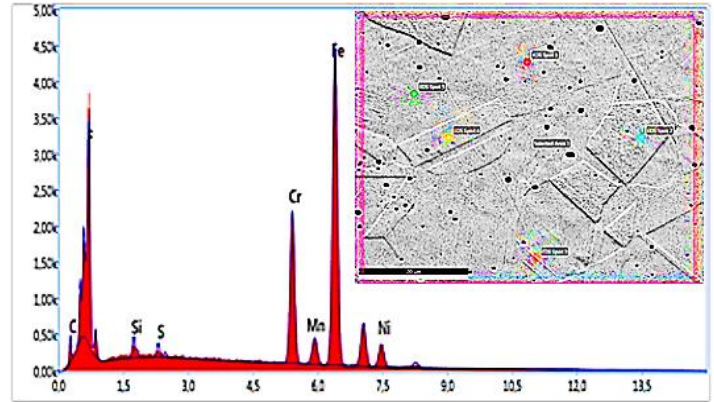
Figure 12: Scanning electron microscopy by (EDAX), microanalysis of ODA of hydrogen-loaded of AISI304L stainless steel.

The EDAX analysis of the reference SEM (FEI Quanta FEG 650), that the observation of the dark area (ODA) shows a reduction in the quantities of carbon, iron and chromium compared to the raw material without treatment [15], [21], see (Figure 11) and (Figure 12) below. Comparing the two figures we notice the total absence of sulfur in the raw structure while the microanalysis of the ODA [15] shows the appearance of this element which, by interacting with hydrogen, can form H₂S which can be responsible for the phenomenon of hydrogen embrittlement (H.E) of AISI304L stainless steel. The result is that the sulfur (S) element clearly appears to be harmful elements with respect to resistance to hydrogen embrittlement (H.E).
