IMPACT OF COVERING CANALS ON QUALITY OF IRRIGATION WATER: CASE STUDY 5th GANABIAT BAHR FAKUS, EGYPT"

Sherien Abdel Aziz¹, Abdelazim Negm², Gamal Mustafa³, Mohamed Nassar³

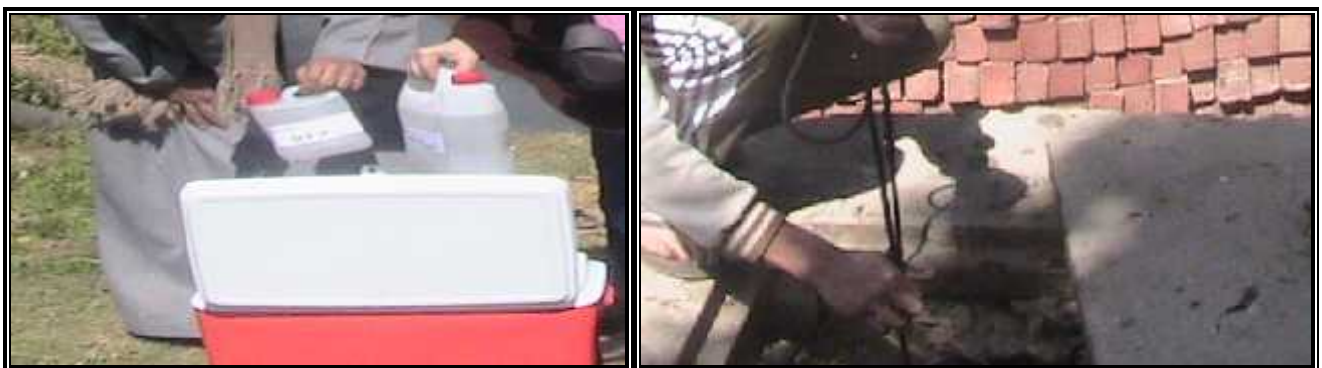
Figure 3 (a) The Preservation of the collected samples (b) Collection of a sample from a manhole.

- 2- The samples were collected according to the standards [5] followed by CLEQM of NWRC, MWRI. Fig. (3-a) shows the preservation of the collected sample. Fig. (3-a) shows a sample collection from a manhole.

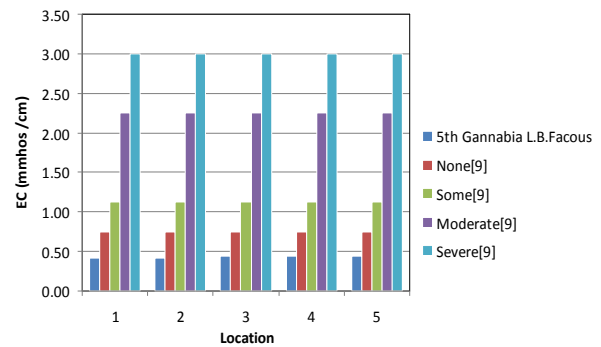
Figure (8) Measured values of EC (mmhos/cm) at different locations compared to international standards [9]

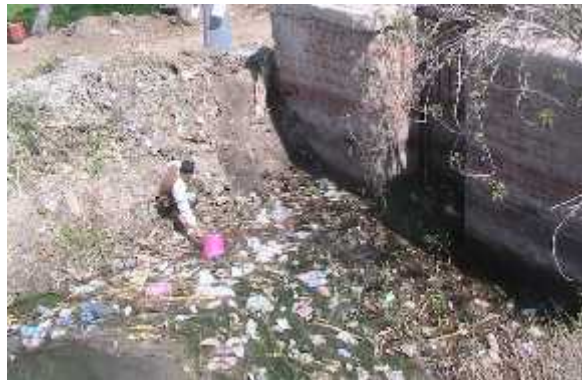
Figure (9) Collecting sample for the point of inlet (Just before the existing screen).

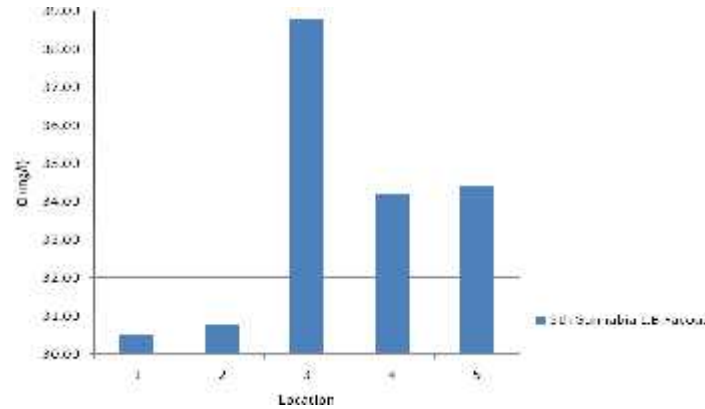
Figure (11) Measured values of Cl (mg/l) at different locations

The analysis of water samples for the five locations indicated that the values ranged from 30.5 mg/l to 38.8 mg/l which is below the safe value (70 mg/l) for all types of plants, Tanji (1990)[10]. Figure (11) shows the variation of chloride values at the five locations. The higher value at the manhole may be due to the interaction between the CL and the RC

concrete. The decrease in the values at locations 4 and 5 are lesser and support this assumption. This point needs more investigation at the location of the manhole to study the impact of the covering materials on the quality of irrigation water. Chlorides under the condition of pH less than 10 increased the risk of corrosion. All the study locations had pH less than 10. In most cases, however, excessive amounts of chloride in concrete originate from external, CCAA(2009)[15].

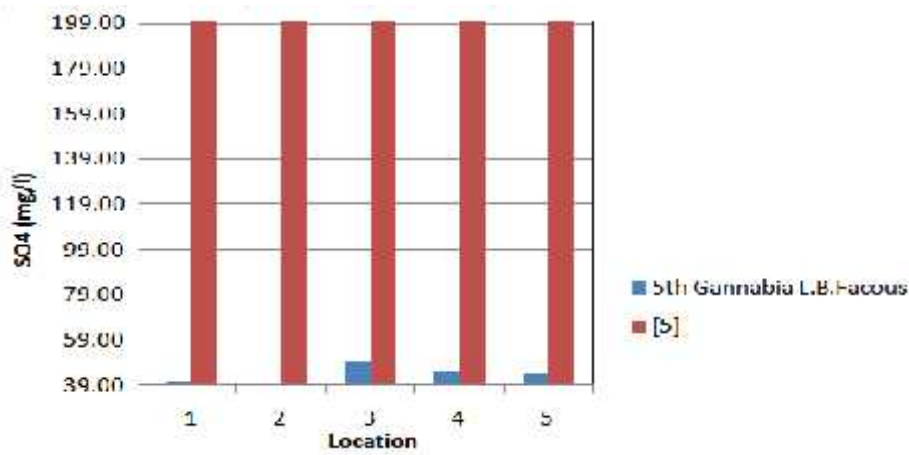
Figure (12) Measured values of SO₄ (mg/l) at different locations compared to local standards [5]

Sulfate ion is a major contributor to salinity (TDS) in irrigation waters. Sulfate in irrigation water has fertility benefits. A few studies have reported sulfate toxicity to some aquatic organisms, including some fish and aquatic mosses at concentrations at or below 200 mg/l. The values of sulfate in irrigation water for the canal under consideration as shown in Fig. (12) is below the safe limit. However, the sulfate itself may have an adverse impact on the covering materials which should be studied to determine the extent of such impact. The construction material exposed to mild sulfate/sulphate attack according to **The constructors civil engineering home (2012)[16]**. Where all manholes points values were less than 150mg/l.

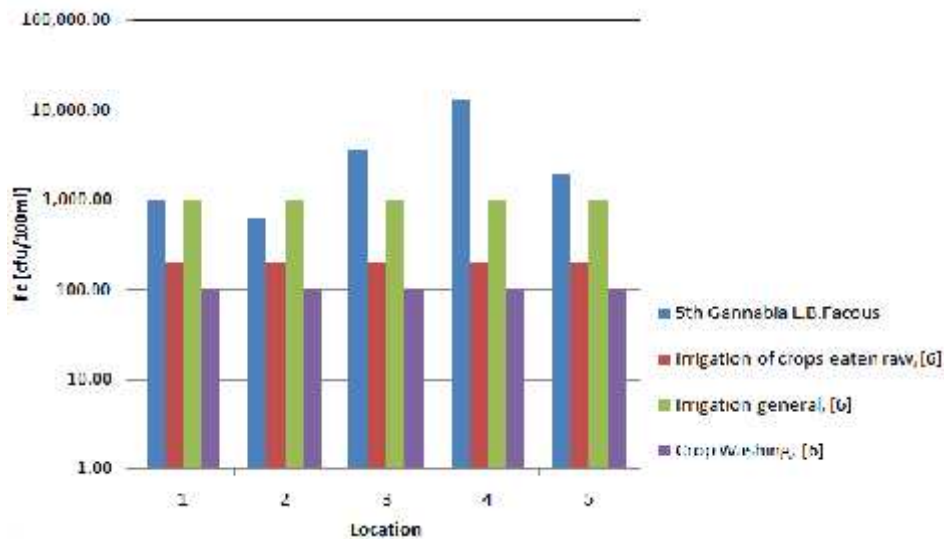
Figure (16) Measured values of FC (cfu/100ml) at different locations for the three sites compared to international standards[6]

The presented values in table 1 and in Fig. 16 indicated that all the values at all the five location are higher than permissible values [6]. This is due the sewage water which is drained in the canals as a result of the absence of sanitary networks. The values of FC increases gradually at the manhole location and attains the maximum value at the outlet of the covered part.
