Upgrading the load-carrying capacity of old riveted steel bridge – Case study

Abstract: This paper describes a comprehensive structural assessment of a heritage riveted steel bridge laying over a navigation lock. This bridge was constructed over 135 years ago and is in service till now. The bridge was subjected to severe deterioration due to aging problems. The challenge was to set up an intensive rehabilitation program while increasing the bridge's load-carrying capacity to accommodate new heavy traffic loads. Site inspections were conducted for the original bridge structural and mechanical parts. The structural performance was evaluated using dynamic and static in-situ tests. Eight accelerometers were mounted and distributed across the bridge area. Modal analysis was conducted before and after strengthening. The strain was also recorded at the end of the retrofitting process. The concept of strengthening was to create a stiffer structural system capable of decreasing the stress level on the old system. Additional thermal stresses caused by extensive welding, especially for the main riveted girders, were avoided during the strengthening program. Moreover, the original bracing sys

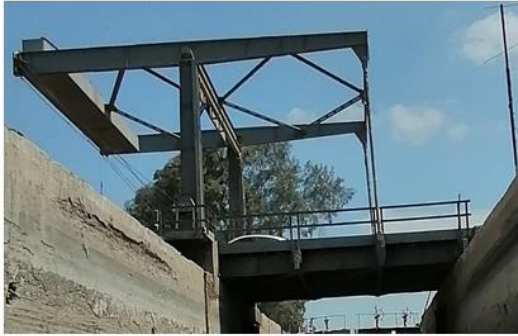
FIGURE 2. General view of the steel bridge before rehabilitation

captured from original design drawings at the owner's archive. The bridge rests on a masonry abutment from one side while the other side is also a masonry guide wall. Figure (2) shows a photo of the bridge from the upstream side. The bridge is composed of mainly three built-up girders connected using rivets and has a total depth of 620 mm. The bridge also has two built-up cross girders, 600 mm depth, at 1/3 and 2/3 of the bending span. At the time of opening, the bridge is hung from the ends of one of these two cross girders. The system of the main girders is connected at the edges using an end beam that transfers the superimposed loads directly to the abutments through three bearings at each side. Additionally, four secondary beams of hot rolled sections, IPE 300, are arranged in between the main girders at equal distances. This group of beams is overlaid by a grid system of stringers spacing 500 mm in the main bridge direction and 300 mm in the opposite direction. The stringers' sections are hot rolled sections of sections IPE140, and IPE200 arranged along main and perpendicular bridge directions, respectively. The bridge is braced using angles 70x7 riveted to the main girders through gusset plates. The bridge's clear width was originally 8.0 m with two sidewalks each of 650 mm width. Figure (3) shows a real photo of the arrangement of the sleepers during removal for repair. The sleepers are covered using a steel plate of 12 mm thickness and finally overlaid with approximately 20 mm asphaltic layer.

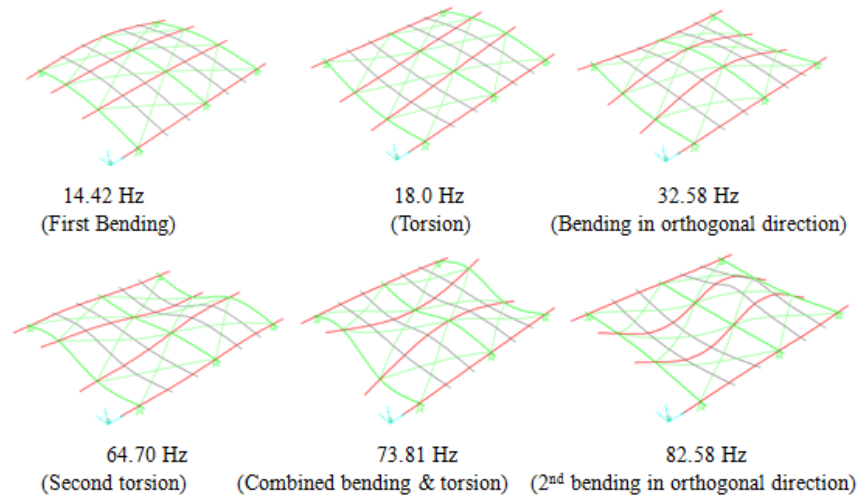
Additionally, modal analysis was conducted using the simplified Model (C). Frame elements were used to represent the main carrying system of the bridge. The simplified model presented the bridge main system only without any additional masses as the stringers and hangers were removed during the experimental dynamic test. The model was replicated twice; one represented the original state of the bridge while the other presented the strengthened state. The first dominant six modes were determined. Figures

(13 and 14) show the dominant modes for the original and strengthened systems, respectively. The figures indicate that however, an increase in the overall mass of the strengthened bridge, its fundamental frequency exhibited an increase of 59% over the original bridge state. The first bending mode frequency was raised from 14.42 Hz to 22.86 Hz. This also indicated good enhancement in the structural static stiffness of the bridge after strengthening.

FIGURE 13. Mode shapes from numerical modeling for the original system

FIGURE 14. Mode shapes from numerical modeling for the strengthened system

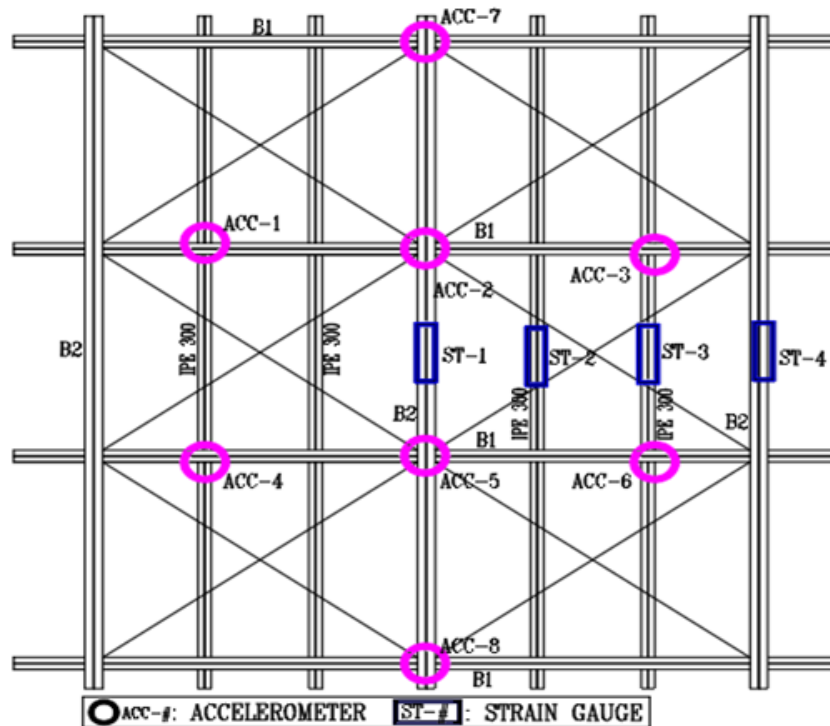
FIGURE 17. Plan showing the locations of accelerometers and strain gauges

The dynamic characteristics of the bridge were determined before and after strengthening. Eight uniaxial piezoelectric accelerometers of a resonant frequency of more than 10 kHz. were used. Line-powered signal conditioners were used to provide constant current excitation to the sensors. The acceleration time history in the vertical direction was only recorded. To capture the contribution on higher modes, particularly for strengthened bridge, as well as to obtain data with high resolution, a reasonable sampling rate of 500 Hz was used. The bridge was excited using a sludge hummer of mass (5 Kg.) and the free vibration wave was recorded just after impact. The accelerometers were mounted and distributed among the bridge as shown in Figure (17). This test can be considered as one of the non-destructive quality control tests during the rehabilitation process. The acceleration time histories of the bridge were recorded on the main carrying system of the bridge while having the deck and stringers removed. The hangers were also unattached during the test. Modal analysis was conducted, and the mode shapes and corresponding frequencies were obtained. The obtained natural frequencies were obtained and compared before and after strengthening. Figures (18 and 19) show the obtained mode shapes for both the original and strengthened system, respectively. The figures elaborate that the enhancement along the main direction of the bridge was enhanced significantly compared to the orthogonal direction. It was also depicted that the frequencies of the first and third modes – representing the first and second in-plane bending modes were increased. Whereas the frequencies of the orthogonal direction were slightly changed. It was noted that the enhancement in the natural frequency of the first bending mode for the
