Lessons Learned From Inspecting Steel Railway Bridges In Egypt

Abstract

and damage are evident, requiring well-planned rehabilitation. ENR, being a publically funded State Authority, is responsible for the reliability of the infrastructures along the entire network of the country. ENR appointed EHAF in 2014 as a specialized consulting engineering firm, a contract to examine 75 bridges, including a significant portion exceeding hundred years old. Most of these unique structures are crossing the Nile, the main navigation river of the country, some are provided with moveable swing bays to allow for navigation along the river. The oldest of these bridges was constructed late in the nineteenth century, as shown in Fig.(1), while the most recent came into service in the sixteenth of the twentieth century, Fig.(2).

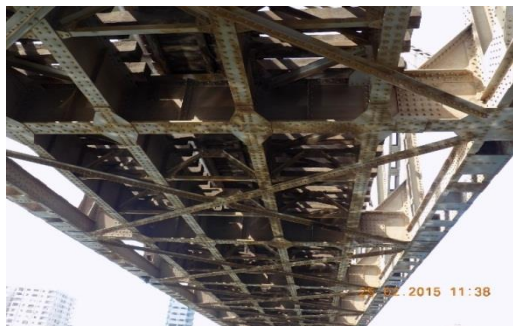
Fig.(4) Corrosion and rusted floor members – Banha Bridge

The two figures (4&5) show the spreading of rusting at the exposed lower surface of the floor beams of the bridge and a totally damaged gusset plate due to severe rust.

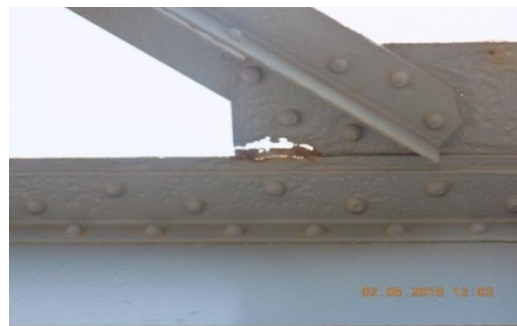
Fig.(5) Corroded plate due to severe oxidization – Kafr El Zayat Bridge

The severity of corrosion ranged from surface light corrosion to serious corrosion leading to decreasing the sectional area. Generally, the corrosion of steel bridges is much larger than the reinforced concrete bridges.

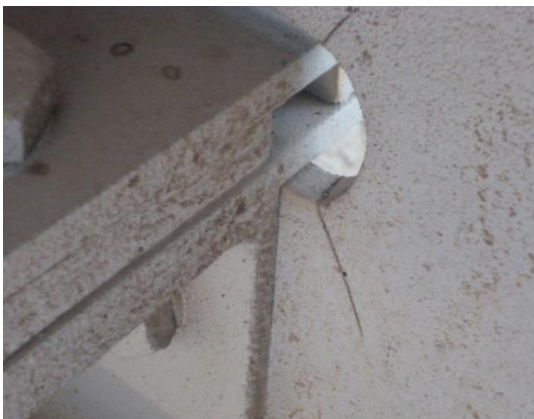
Fig.(6) Fatigue Crack at Stringer-to-Cross Girder Connection, Abo Shosha Bridge

In conclusion, visual detection of fatigue cracks in steel bridge component is a very difficult task to perform successfully. Non-destructive techniques for identifying fatigue cracks with a high precision is needed. The prioritization of member replacement by determining the actual capacity of specific individual members within the structure to safely and economically maintain railway bridges in service for longer time. Figure (6) shows a propagated fatigue crack at the web of cross girder. The crack is observed at the lower slotted hole introduced to allow connecting the top and bottom flanges of the stringer beam.

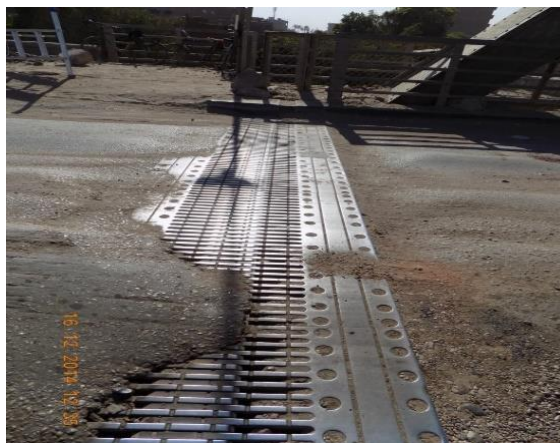
Fig. (8) Creep of Asphalt over the Expansion Joint, Marazek Bridge

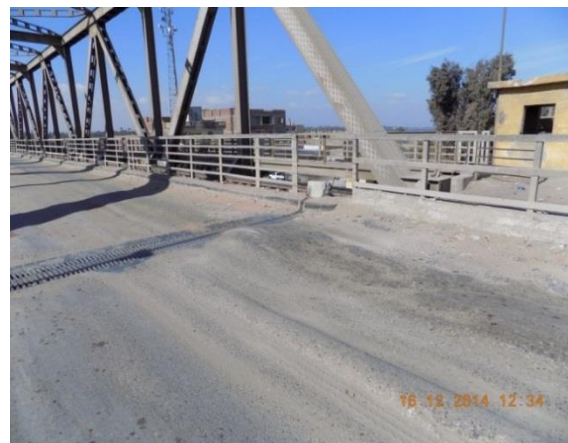
Fig. (9) Settlement of Approach Slab at Entrance of Roadway Lane, Marazek Bridge

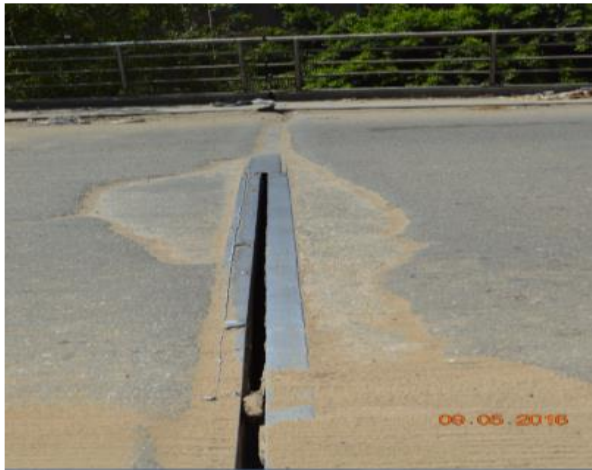
Deck expansion joints are also critical bridge components. In our case of these old bridges, almost coming to the end of their design life, expansion joints are susceptible to endanger the whole traffic unless regularly inspected.

Fig. (10) Poor Condition of Expansion Joint, Sanae Bridge

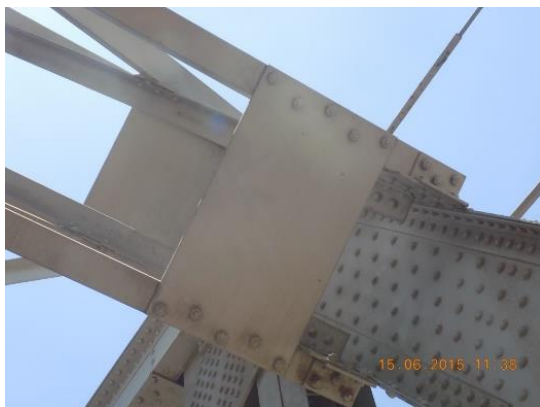
Fig.(11) Replacement of rivets with bolt – Dessouk bridge

the attached plates so that the transverse load across the joint is resisted solely by friction rather than the rivet shank’s strength. This indicates that replacing a lost rivet by a high friction bolt does not by anyway improve the

capacity of the joint. It is thus preferable to replace any lost rivet by a normal ordinary bolt as in both systems the load is transferred only by shear. In all cases however, holes of lost or corroded rivets and bolts should be first identified then filled properly to avoid eccentric

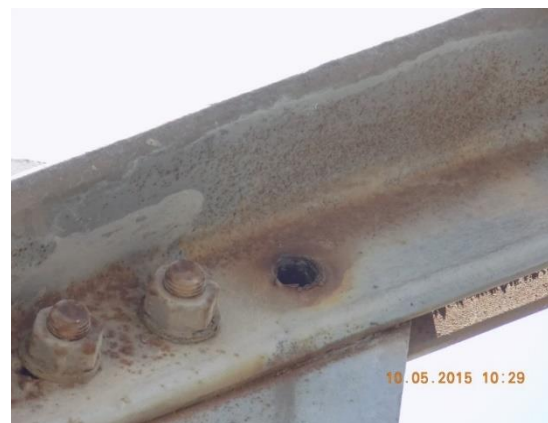
Fig.(12) Missing rivet – Edfina bridge

Lost or loose rivets in an existing connection will need replacement by new fasteners. Nowadays, the use of bolts or high strength friction bolts is only available, as riveting technology is almost abandoned and not any more used. The replacement of lost rivets in these old bridges can be done using bolting techniques. The structural function of mechanical fasteners differs from one connection type to the other. Figures (11 to 18) denote the main defects observed during our assigned job of examining the bridges. These defects are missing rivets, combining rivet with high strength bolts in one connection and eccentric connections.

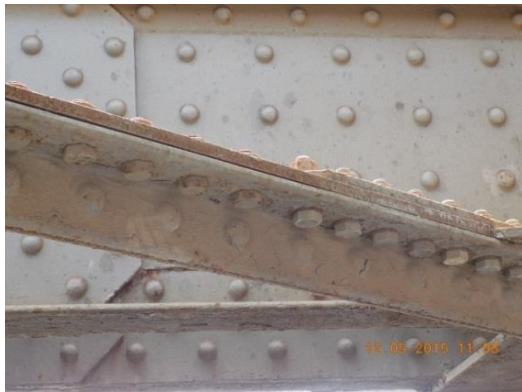
Fig.(13) rivet and bolt in one connection – Edfina bridge

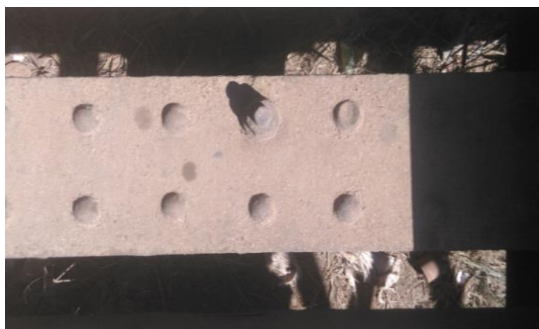
Fig.(15) rivet and bolt in one connection – Abo Sheashae bridge

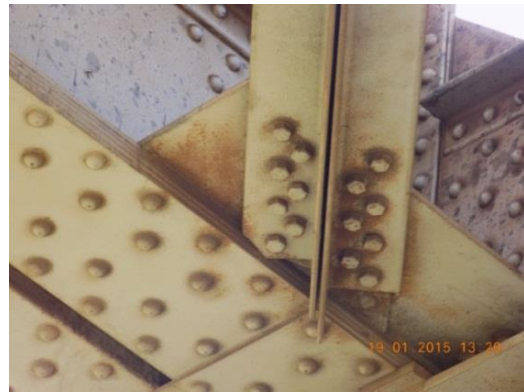
Fig.(14) Replacement of rivets with bolt – Kanater bridge

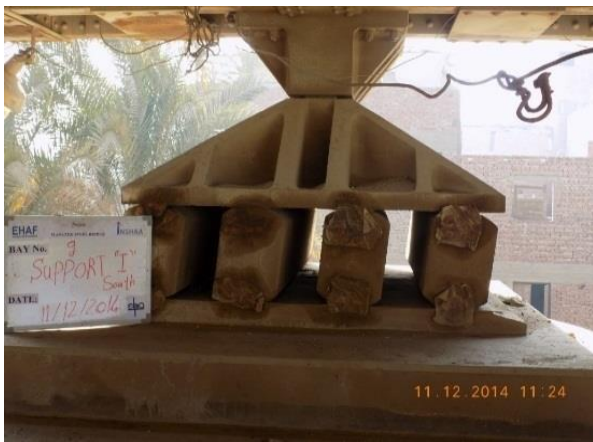
Fig.(17) Distortion of Roller Bearing due to Abutment Movement

Figure (17) shows the mechanical roller bearing distortion created by a horizontal thrust of the abutment. While Fig.(18) shows the longitudinal displacement of the bridge due to the lateral earth pressure of the soil behind the abutment.

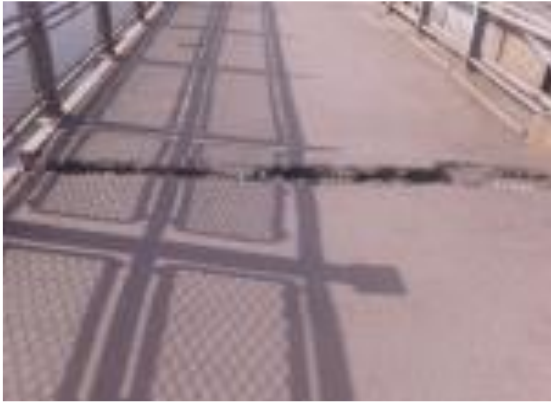
Fig.(19) Cracking of Concrete, Imbaba Bridge

forces resulting from moving vehicles. Accordingly, defects at such as cracks and loss of parts of slab were observed at many walkway slabs

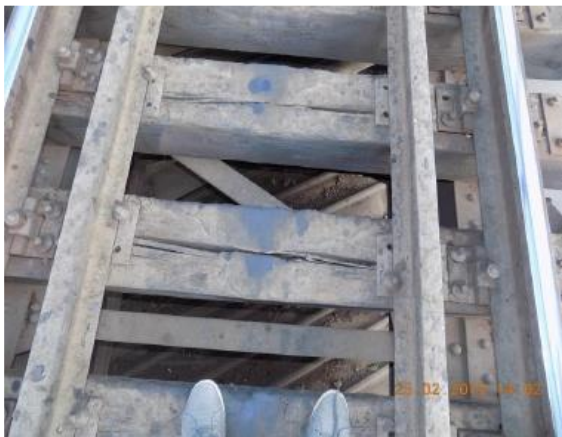
Fig.(21) Condition of Sleepers, Banha Bridge
Rail and slipper defssionses

inspected bridges, cracked sleepers and loose rails were detected Fig.(21).

Such defects lead to increasing the dynamic effect on the supporting steel structure under the applied loads. Hence, corrective actions and periodic maintenance need to be applied in order to sustain accepted level of performance. Bridges need to possess a clear drainage system as specified by different specifications in order to discharge allocated water away from concrete or steel structural elements. For the

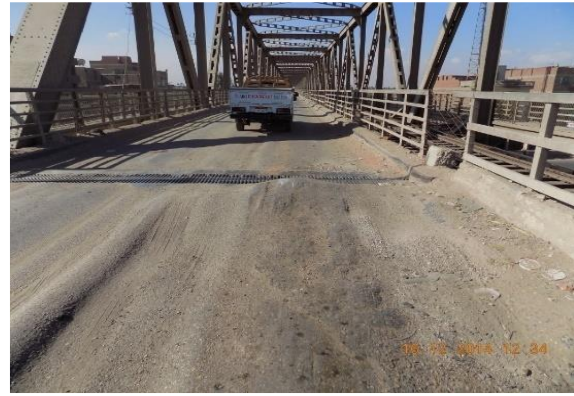
considered bridges, ancillary bridge elements were inspected and defects were determined and categorized. For RC slabs used at bridge approaches, defects included settlement of the approach slab which was attributed for the inadequacy of soil layers’ compaction below

Fig.(20) Settlement of Wearing Surface, Marazek Bridge

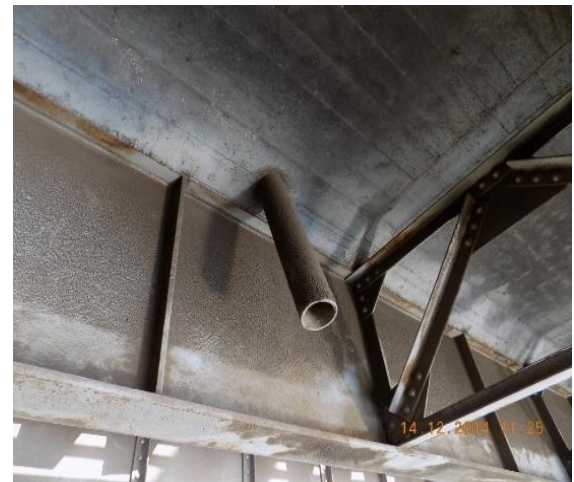
Fig.(22) Improper Drainage System, Marazek Bridge

inspected bridges, it was observed that there was not a clear drainage system Fig.(22). Only separate pipes discharging in the crossed waterways were available. In addition to drainage, introduced lighting systems at different inspected bridges. It was found that most of the inspected bridges lack sufficient lighting service or power supply items Fig.(23).

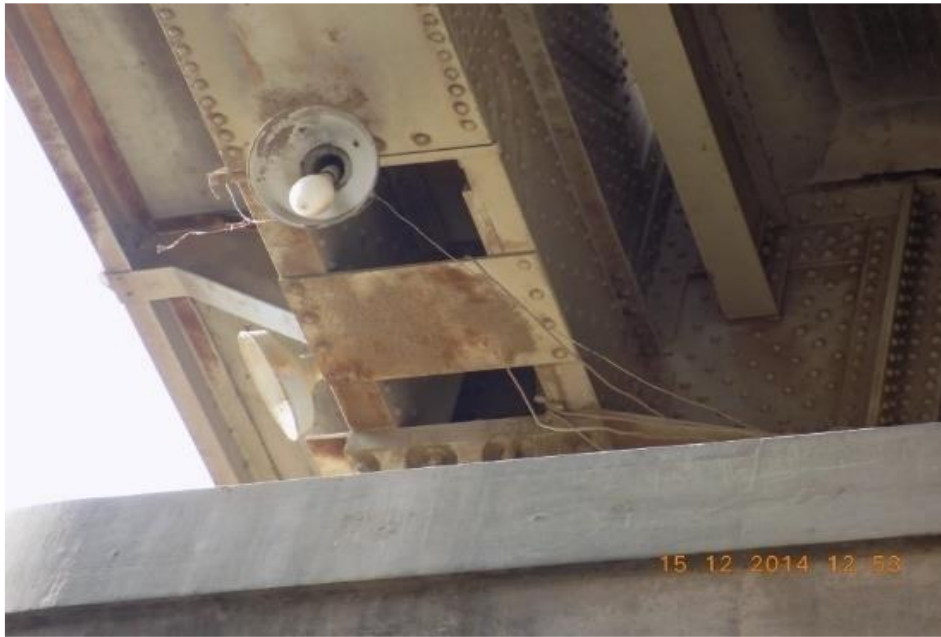
Fig.(23) Poor Lighting System, Marazek Bridge
