Effect of Er,Cr:YSGG Laser Surface Treatment on Microshear Bond Strength of Monolithic Extra Translucent Zirconia to Resin Cement (An In-vitro study)

Aim: The aim of this study was to evaluate the effect of Er,Cr:YSGG laser surface treatment at various power settings on the microshear bond strength between extra translucent zirconia and resin cement, comparing it to sandblasting. **Methodology:** Thirty-six sintered Cercon xt zirconia specimens were divided based on surface treatment (n=9): Group SB: Sandblasting with 110 μ m alumina particles, Group 6W: Er,Cr:YSGG laser at 6W, Group 8W: Er,Cr:YSGG laser at 8W, Group 10W: Er,Cr:YSGG laser at 10W. One sample per group was analyzed using scanning electron microscope (SEM). Subsequently, all samples were treated with zirconia primer, then resin cylinders were prepared and light cured. Samples then underwent a microshear bond test until failure. SEM was used to determine the failure mode for each group. **Results:** One Way ANOVA test showed no statistically significant difference between the groups (p=0.902). Sandblasted samples had noticeable micromechanical roughening and mixed-type bond failure. Laser-treated surfaces had reduced

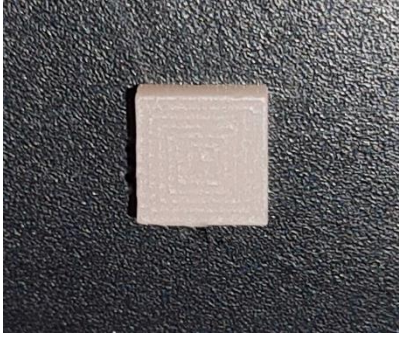
Figure (1): Zirconia sample post sintering

36 quadrangles were designed using Meshmixer software and then dry-milled from extra translucent zirconia blocks (Cercon XT, Dentsply Sirona, USA) with dimensions of 4×4×2 mm using 5-axis milling machine (inLab MC X5, Dentsply Sirona, USA) (**Figure 1**). The samples were then sintered in a sintering furnace (Sirona in Fire HTC Speed, Dentsply Sirona, USA) according to the manufacturer's instructions. For ease of handling, a customized polyvinyl chloride mold (25 mm internal diameter, 12 mm height) was used to create a resin base for each sample. The mold was filled with self-cure acrylic resin, embedding each sintered sample. After the acrylic fully set, the base was extracted and refined to remove any excess material.

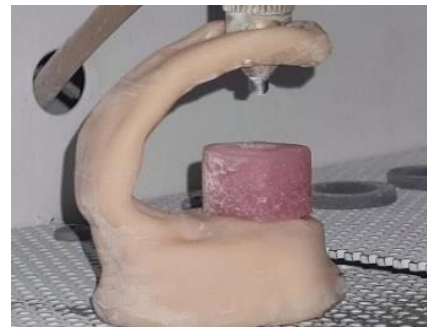
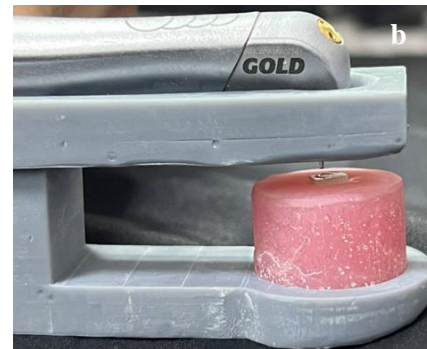
Figure (2): Custom-made 3D-printed holders designed to standardize the specified standoff distances during sandblasting (a), and laser surface treatments (b).

Samples were randomly divided into four groups (n=9) based on the surface treatment performed. Group SB: samples were air abraded with 110 μm aluminum oxide powder in a dental sandblasting unit, under 2-bar pressure, at a 90° angle and a distance of 10 mm for 10 seconds; Group 6W: samples were treated using an Er,Cr:YSGG laser (WaterlaseiPlus, Biolase, San Clemente, USA) at a power of 6W; Group 8W: samples were treated using an Er,Cr laser at a power of 8W; Group 10W: samples were irradiated using an Er,Cr laser at a power of 10W. All laser groups used the same settings: 20 seconds duration at 20Hz frequency with 150mJ energy, and 140 μs pulse duration. Sandblasting and laser surface treatments were performed using custom-made 3D-printed holders designed to standardize the specified standoff

distances (**Figure 2**). To evaluate the morphological surface traits post surface treatments, one sample from each group was examined with SEM at 1000 x and 10,000 x magnifications. Thereafter, the samples were cleaned using alcohol and air dried using an oil-free compressor.
