Flexural Behavior of Beams Reinforced with Hybrid Steel Rebars using Sea-Water Mixed concrete

Ahmed M. Ahmed^{1,2}, Magdy M.M. Genidi³, Ahmed Mohamed Elsherbeany⁴, Waleed Fouad Tawhed⁵

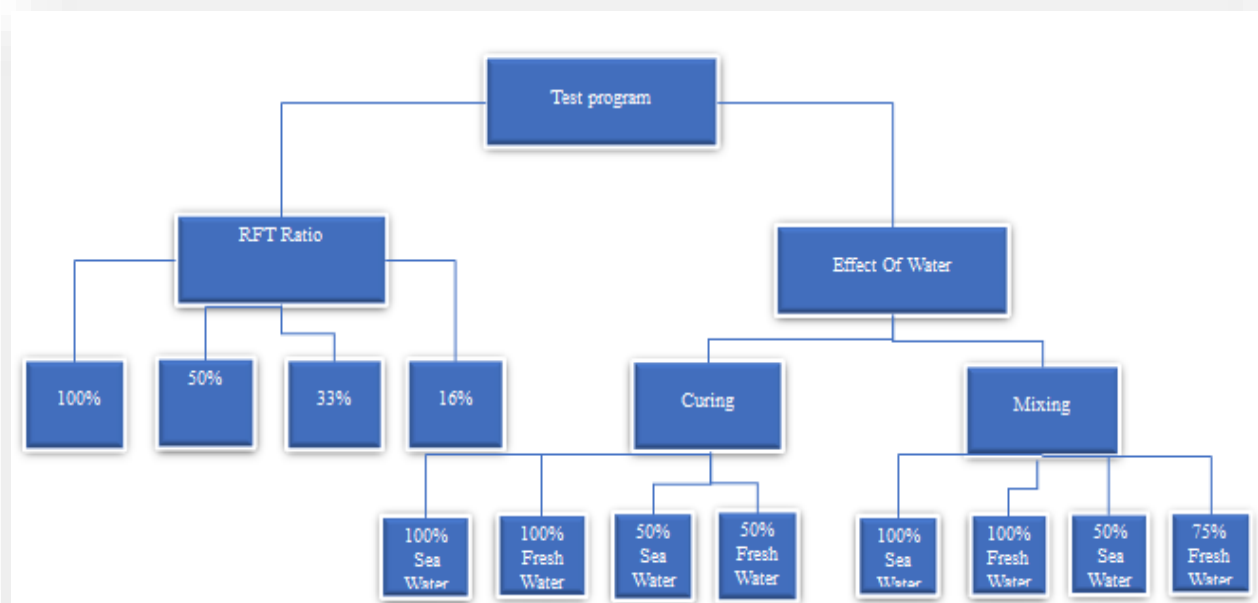
Fig 2. Main program test

The experimental program was divided into two parts. Part (A) consisted of testing cubes and cylinders, while Part (B) involved testing 13 concrete beams, each with dimensions of 150 mm in width, 300 mm in thickness, and a total length of 2000 mm. All beams were subjected to centric loading. Twelve of the beams were reinforced with hybrid steel at varying percentages—16%, 33%, 50%, and 100% of the total bar diameter. The mixing water used for these beams was either freshwater or seawater, with different ratios. Table 1 provides the details of the reinforcement (RFT) for all specimen beams.

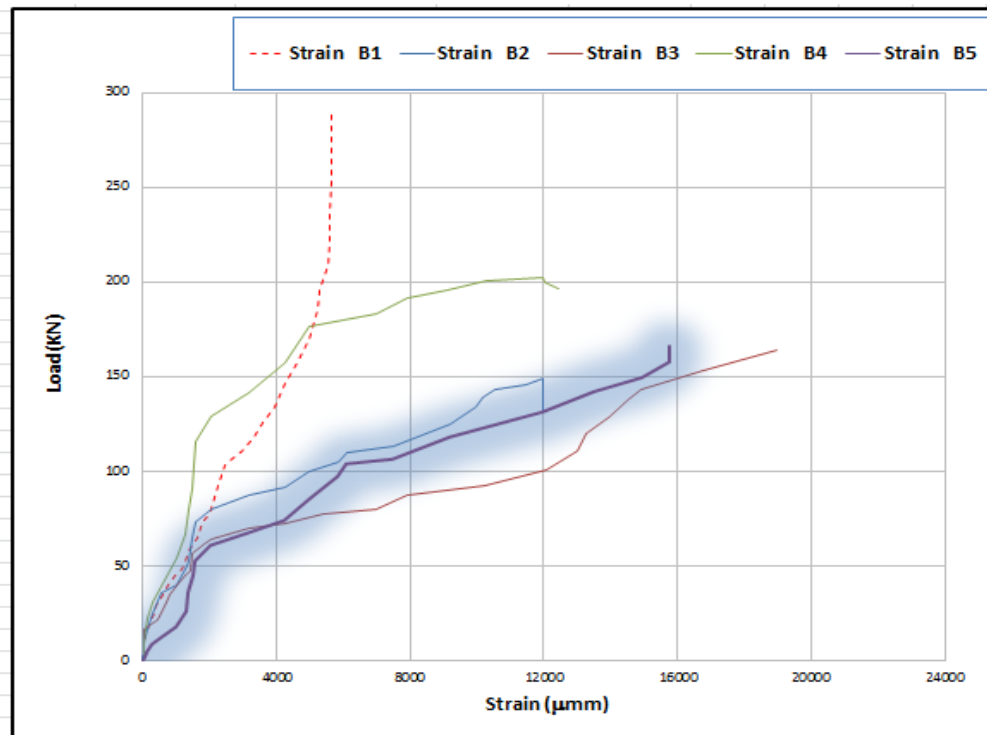
Fig 10. Strain for the group 1

relationship was linear for the five specimens only specimen number 5 Linear till the case of failure load was reached. We observe that max strain in upper quarter part of the RFT bar equal to 2003,9744,11891 and 7001 which founded into(B1-Gf0%-(0%Fw.100%Sw)), (B2-Gf100%-(0%Fw.100%Sw)), (B3-Gf16%-(0%Fw.100%Sw)), (B5-Gf50%-(0%Fw.100%Sw)). We observe that max strain equal to 14231 which found into (B4-Gf33%-(0%Fw.100%Sw)). Strain curves shown in Figure 10.

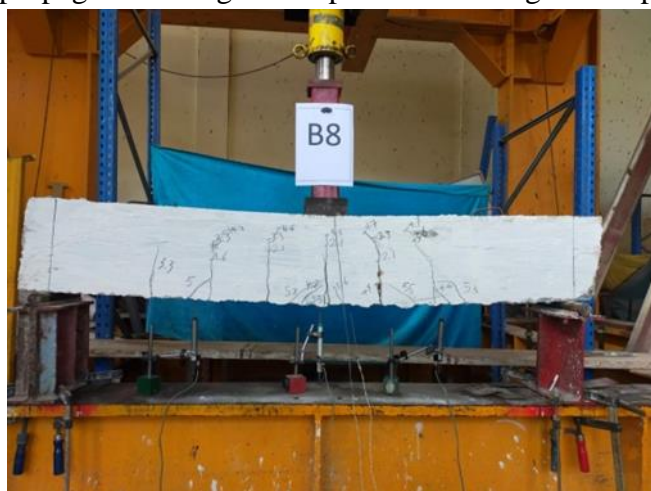
Fig 14. Crack pattern for B8.

beam (B8-Gf 50%-(50%Fw.50% SW).) containing volume fraction (V_f) = 50%, the first crack appeared at a load of about 23.41kN. By increasing the load, more cracks appeared passing the upper quarter of the beam and the beam failed at load of about 177.87 kN. beam (B9-Gf 16%-(50%Fw.50%Sw).) containing volume fraction (V_f) = 16%, the first crack appeared at a load of about 21kN. By increasing the load, more cracks appeared passing the upper quarter of the beam and the beam failed at load of about 214.56kN. The failure crack patterns of the two tested beam (B8 and B9) were nearly similar, in that concentrated loads caused cracking and the major propagated through the bottom zone n loading area concentrated loads caused cracking and the major propagated through the top zone n loading area experiments for Group one tested specimens.

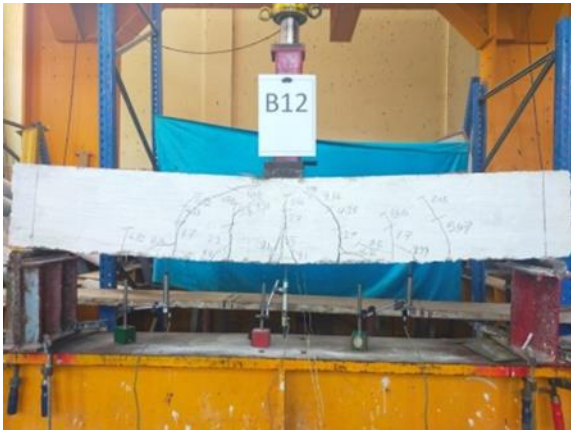
Fig 20. Crack pattern for B12.

beam (B12-Gf 50%-(100%Fw.0%Sw).) containing volume fraction (V_f) = 50%, the first crack appeared at a load of about 35.2 kN. By increasing the load, more cracks appeared passing the upper quarter of the beam and the beam failed at load of about 257.64 kN beam (B13-Gf 16%-(100%Fw.0%Sw).) containing volume fraction (V_f) = 16%, the first crack appeared at a load of about 36 kN. By increasing the load, more cracks appeared passing the upper quarter of the beam and the beam failed at load of about 226.8 kN. The failure crack patterns of the two tested beam (B12 and B13) were nearly similar, in that concentrated loads caused cracking and the major propagated through the bottom zone n loading area.

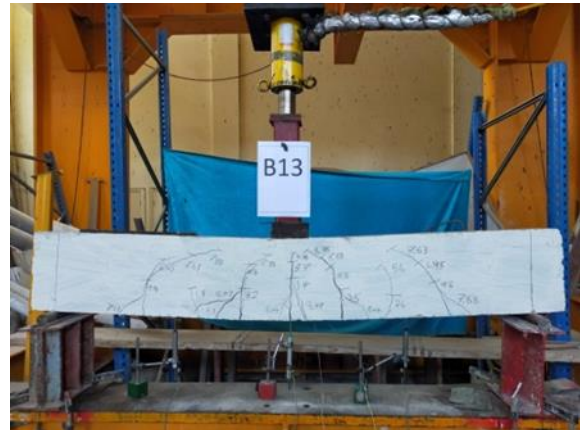
Fig 21. Crack pattern for B13.

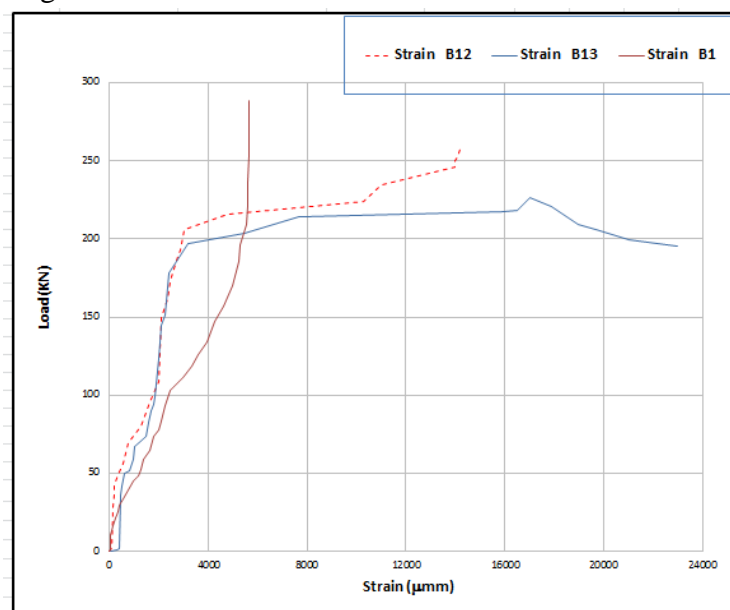
Fig 22. Strain for the group 5.

The strain gauges were located in the mid height beam attached to the main reinforcing steel bars. From the results that observe that (B12-Gf 50%-(100%Fw.0%Sw)), (B13-Gf 16%-(100%Fw.0%Sw)). The relationship was linear for the two specimens. We observe that max strain in upper quarter part of the RFT bar equal to 14115 which founded into (B12-Gf 50%-(100%Fw.0%Sw)).

We observe that max strain equal to 17101 which founded into (B13-Gf 16%-(100%Fw.0%Sw)), Strain curves shown in Figure 22.
