An Experimental Study to Evaluate the Additives Used to Improving the Properties of Completing Mortars of Archaeological Stone Statues with an Application on Rams Road in Luxor- Egypt

This research aims to evaluate the used additives in improving the properties of completing mortars of archaeological stone statues with an application on Rams road in Luxor, Egypt. Stone samples were taken from these statues, analyzed by X-ray diffraction and examined by Polarizing and scanning electron microscope, soil and groundwater samples were taken to determine their components. The stone was found to be Nubian sandstone, the soil type was found to be sandy soil, and the soil contained halite due to the presence of groundwater at the site, which has a high salinity. An experimental study has been done to evaluate additives to improve the properties of the completion mortar, the materials are: Addibond 65, primal AC33, polyvinyl acetate (PVAc) , clay and fired bricks powder . The physical and mechanical properties were measured to choose the best mortar. The mortar A (Lime + Sand+ White cement + Limestone powder + addibond 65) (1:3 :1:1 : 15%) is the best one which had achieved the best values

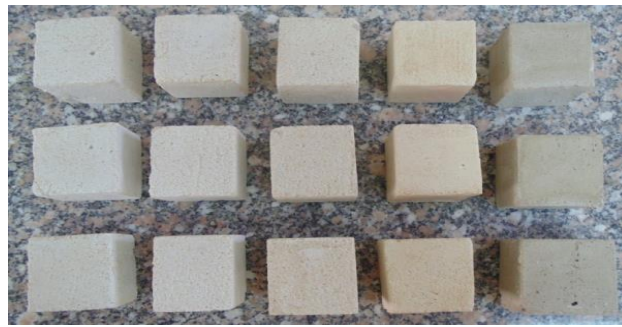
Figure 6. The mortars samples after processing and complete drying.

- 1- The mortar samples were prepared in the form of cubes with a size of (5 cm x 5 cm x 5 cm) and waiting until they are completely dry.
- 2- The cubes were dried in an oven at a temperature of 105°C for 24 hours to ensure dryness and stable weight. Then, after preparing the mortar samples, tests are carried out on them to determine the physical and mechanical properties and to study the effect of the different weathering cycles on them, Table (1), Figure (6).

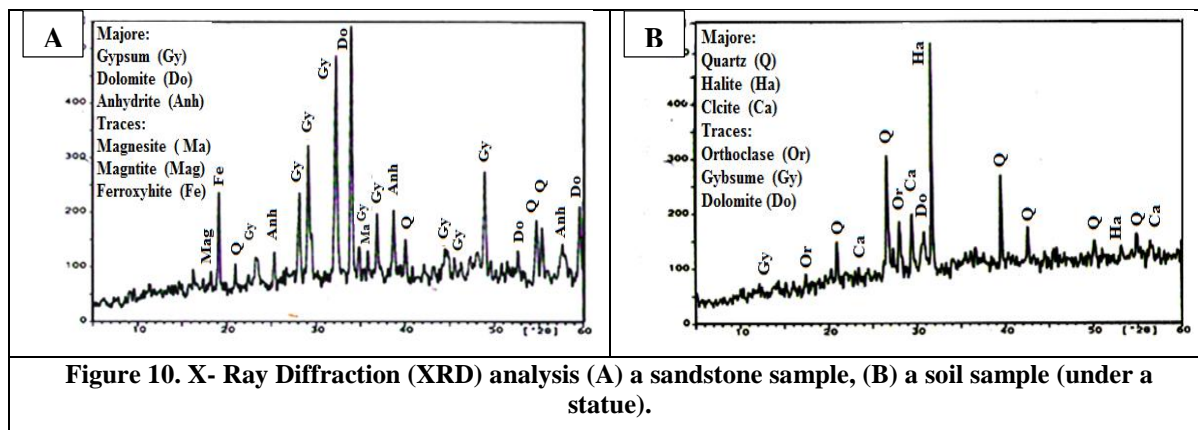
XRD analysis of sandstone samples showed that they consisted mainly of quartz, gypsum, dolomite and anhydrite, in addition to magnetite, magnesite and ferroxite. This shows the displacement of the binding material of the quartz grains that make up the sandstone. Deposition on a surface in the form of a dark solid layer by the impact of groundwater¹⁴.

The chemical analysis results of the soil sample showed that it is a sandy soil; it consists of quartz, halite and calcite, in addition to orthoclase, gypsum, and dolomite, which indicates the presence of halite in a high percentage in the soil due to the ground water existence, Figure (10).

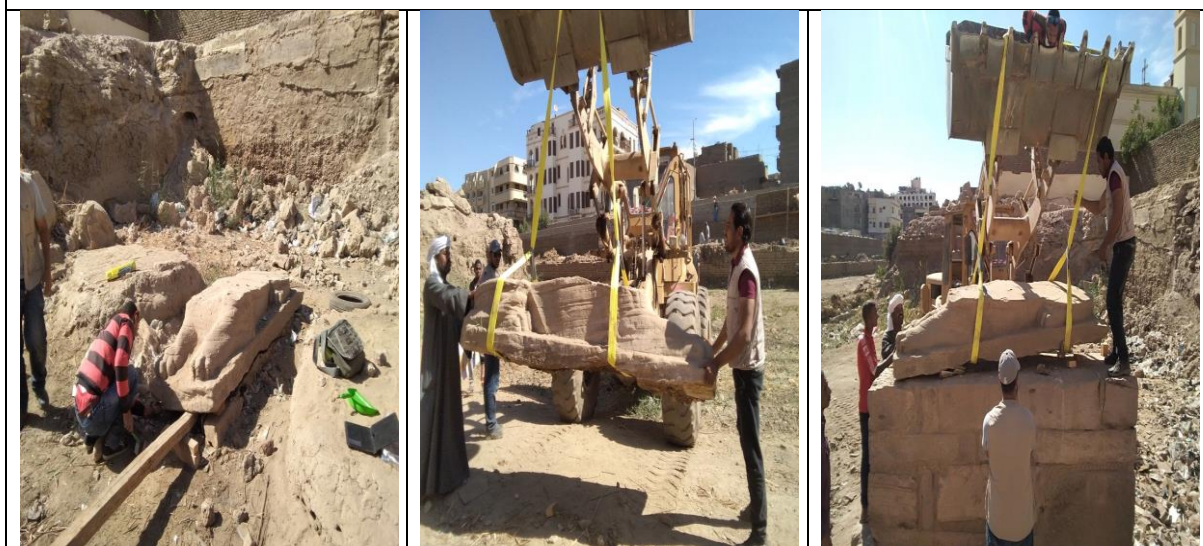
11- The body of the restored statue, which is sandstone, is lifted to the pedestal by silk ropes and appropriate lifting machinery is used to prevent the body from being damaged by the force of the load. It is installed on the base.

12- The body is fixed to the base with the same mortar that is used to connect the base courses together, Figure (15).

Figure 15. Shows the process of raising and fixing one of the statues' bodies on the base after reconstruction processes.

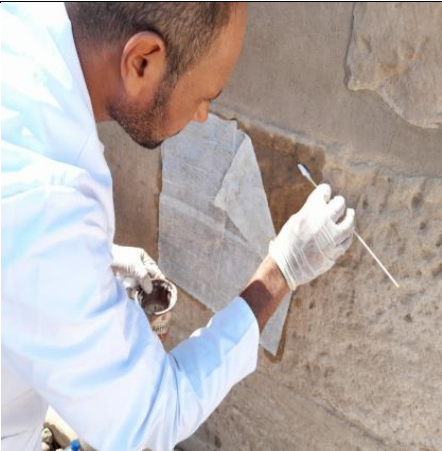
<p>Figure 16. The cleaning process of the statue's base.</p>	<p>Figure 17. The consolidation with Wacker (OH) 100 + nano silica 3%.</p>

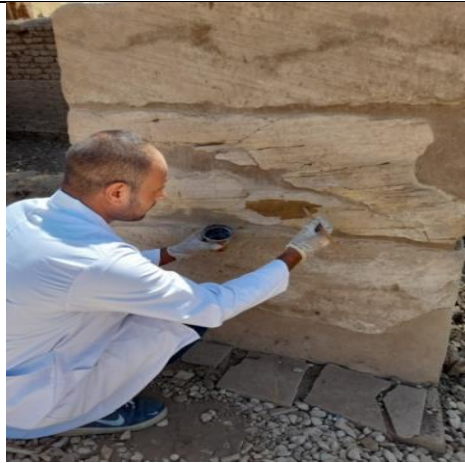
B- The body was consolidated with Wacker (OH) 100 + nano silica 3% using a brush¹⁵, Figure (17).

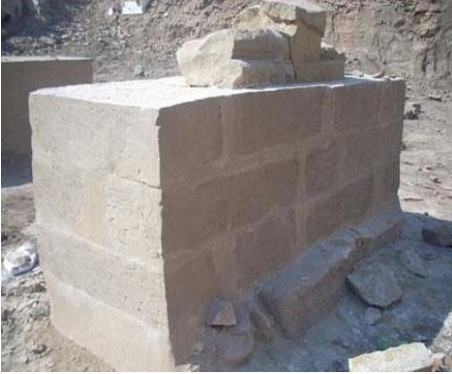
D- Missing parts are completed with a mortar, so the assembly and finishing process takes place directly on the base¹⁶, Figure (18).

<p>Figure 18. The completion of the missing parts in the base with a mortar.</p>	<p>Figure 19. The installation of the statue's body on the base.</p>
<p>A</p>

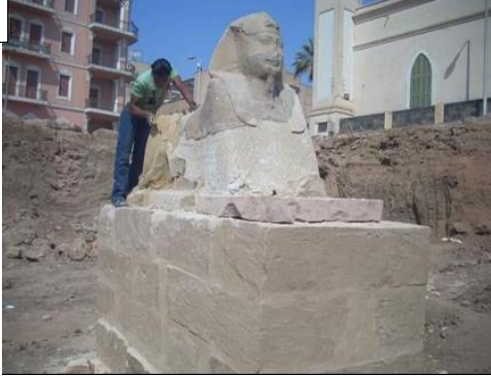
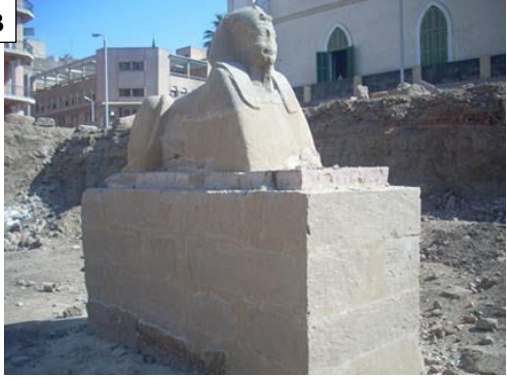
E - Use a mortar which was chosen in the experimental study consisting of (lime + sand + white cement + stone powder + Addibond 65) and mix with lime water in a ratio (1:3:1:1:15%) considering completion conditions, differentiation and homogeneity, Figure (19-20).

<p>Figure 20. The completion processes of the chosen statue (A) During (B) After.</p>
