## **Weathering and Degradation Risk Assessment of Nubian Sandstone Roofs of Buildings in Medinat Habu**

**Ahmed Gelany \***

Department of Restoration, Aboukir Higher Institute for Restoration of Antiquities and Art  
Collections, Alexandria, Egypt

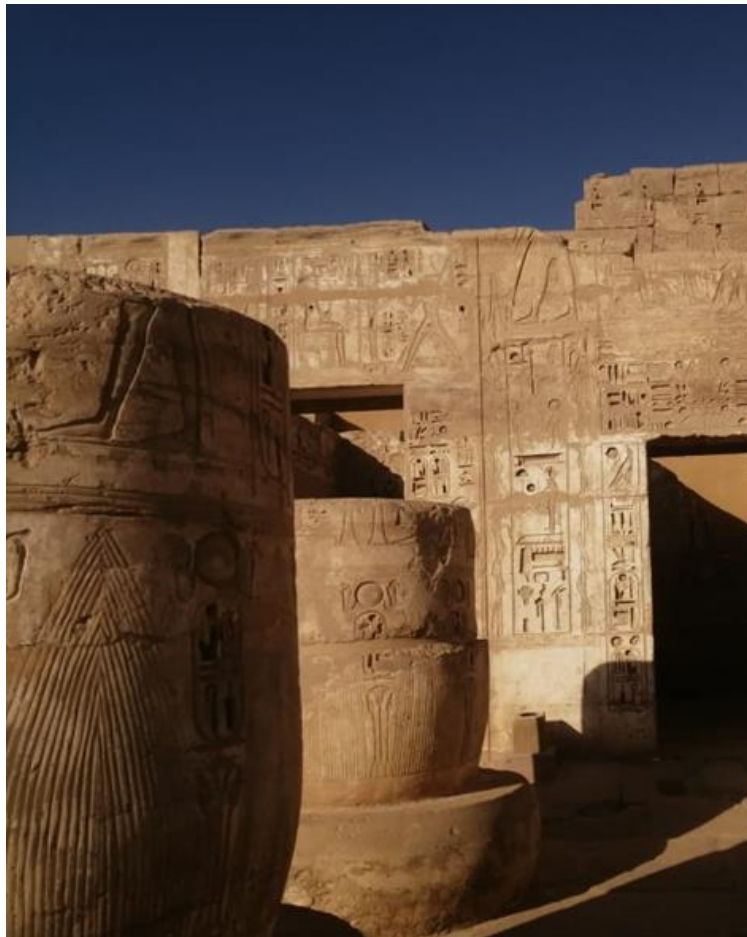
Figures 1 and 2 illustrate that the areas experiencing the most significant damage in the building stones are primarily the outer surfaces and the edges. These regions are directly impacted by various damaging factors, making them particularly vulnerable. The outer surfaces

and edges of the stones have become weak, crumbled, and brittle to the extent that samples can be easily detached using just fingernails. The complexity of the damage is attributed to a multitude of environmental factors. The primary contributors include the intensity of sunlight, which causes thermal expansion and contraction, leading to cracks and surface degradation. Additionally, wind erosion continuously wears away the stone surfaces, exacerbating the crumbling effect. The erosion and subsequent accumulation of rainwater on the stone surfaces further accelerate the deterioration process. Rainwater, often slightly acidic, can dissolve certain minerals within the stone, leading to further weakening and breakdown. Moreover, the interaction between these environmental factors can create a synergistic effect, amplifying the rate of damage. For example, wind can carry abrasive particles that continuously scour the stone surface, removing material and exposing fresh surfaces to further erosion and chemical reactions. In summary, the damaged areas of the building stones are primarily the outer surfaces and edges, with the damage being driven by a complex interplay of environmental factors such as sunlight, wind, and rainwater erosion. These factors collectively contribute to the weakening, crumbling, and brittleness observed in the stones. (17), (18), (19).

*Figure 1. shows deterioration of the edges of the building stones on the roofs of Madinat Habu*

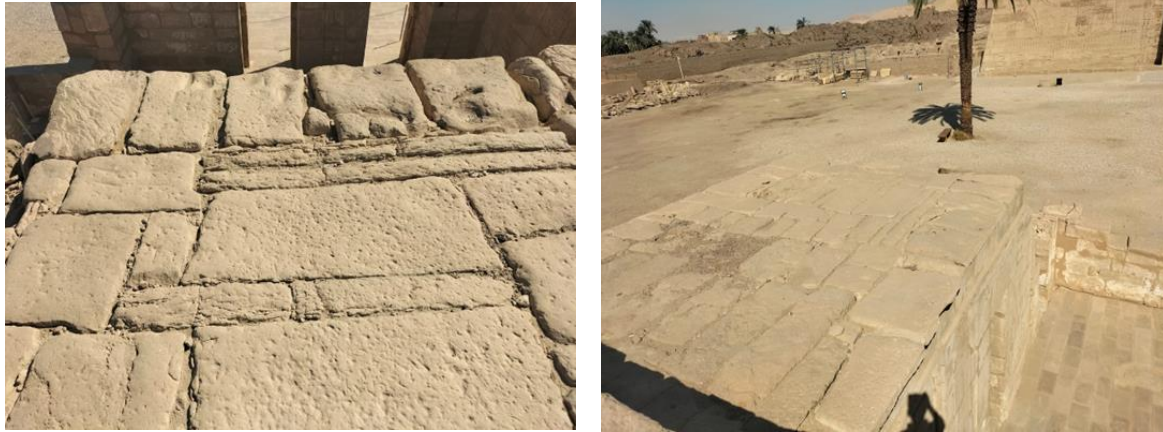
Figure 2a, b shows deterioration of Surface layer of stones on the roofs of Madinat Habu
