Structural Safety in Egyptian National Project (Decent Life) To Confront Geotechnical Environmental Changes (Case study of the reconstruction of the Al-Ataween historical Mosque)

Ahmed Gelany *

Department of Restoration, Aboukir Higher Institute for Restoration of Antiquities and Art Collections, Alexandria, Egypt

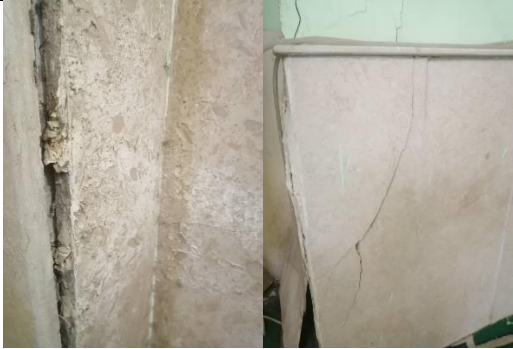
<p>The appearance of salts, small and large cracks, damage to the marble</p>

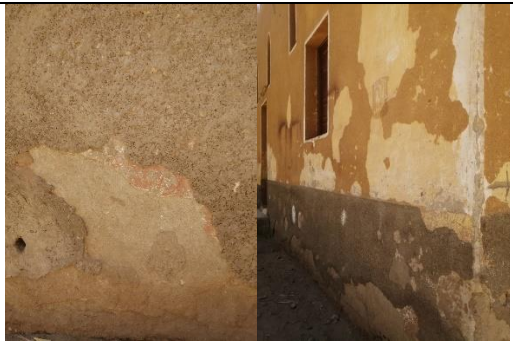
<p>The foliation and the falling of layers of plaster and colors from the walls</p>

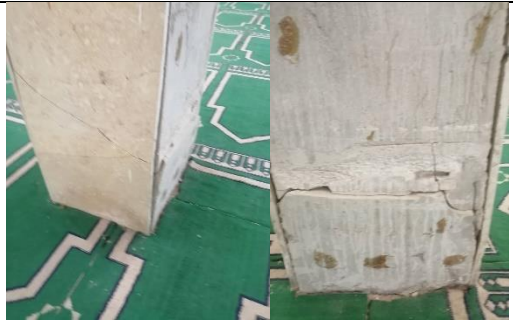
<p>Subsidence in the mosque's columns</p>

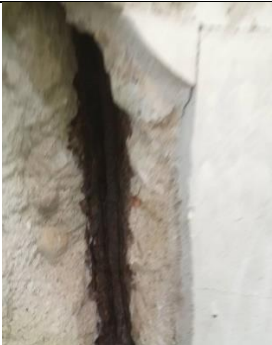
<p>Rusting of the reinforcing iron</p>

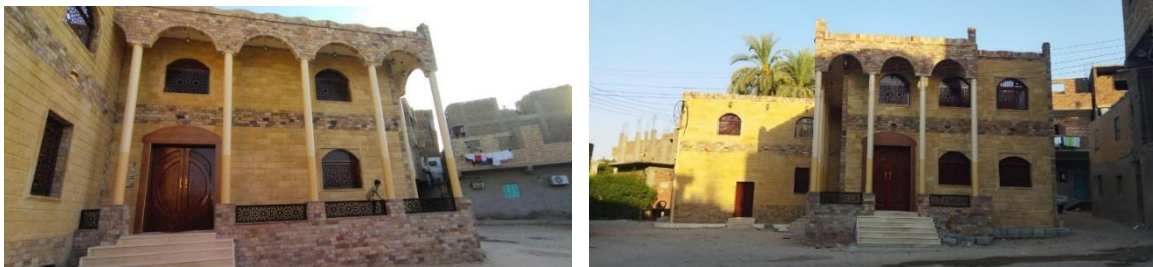
Figures 4. A, B raised from the ground by about 120 cm, with reinforced with stones.

The reconstruction process was supervised by the Engineering Department of the Luxor Endowments Directorate, which was concerned with taking the necessary measures to address the recurrence of damage resulting from geological processes in the historic mosque building, and ensuring structural safety, which is followed up by the Decent Life Program Administration. The construction was carried out on the same area of the mosque, 225 square meters, with an increase in the depth of replacement from 120 cm to 220 cm, with a quantity of 300 cubic meters, with compaction operations for all layers, after the process of isolating the foundations and bases with no less than 400 meters of bitumen. As for the reinforcement process, it was carried out according to the Egyptian code with 10 tons of high-quality reinforcing steel for the foundations, and to overcome the geological factors, in addition to isolating the foundations, they were raised from the ground by about 120 cm, in addition to the depth of the foundations, they were also insulated with bitumen. (19), (20), (21). Figures 4. A, B shows raised from the ground by about 120 cm, with the walls reinforced with stones. Figure 5 shows Marble reinforcement of walls after reinforcement and insulation operations with raising the level of the foundations.

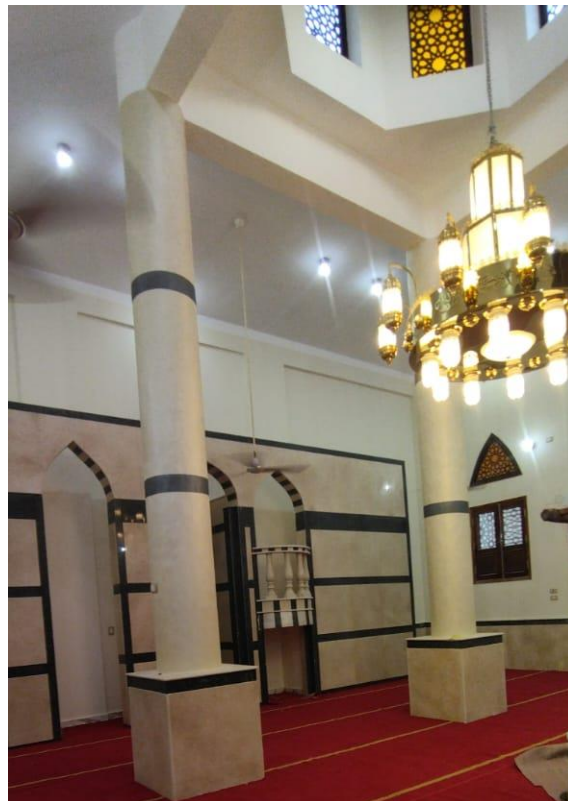
Figure 5; Marble reinforcement of walls after reinforcement and insulation operations with raising the level of the foundations.
