An analytical study of infrastructure failure and sandstone pylon collapse causes of Ramses II temple pylon (Ramesseum) in Luxor city

دراسة تحليلية لمسببات تدهم البنية التحتية وتصعد صرح معبد رمسيس الثاني (الرامسيوم) من الحجر الرملي بمدينة الأقصر

Key words: Ramses II temple pylon, construction technique, pylons collapse, Infrastructure failure, Seismic loads, structural.

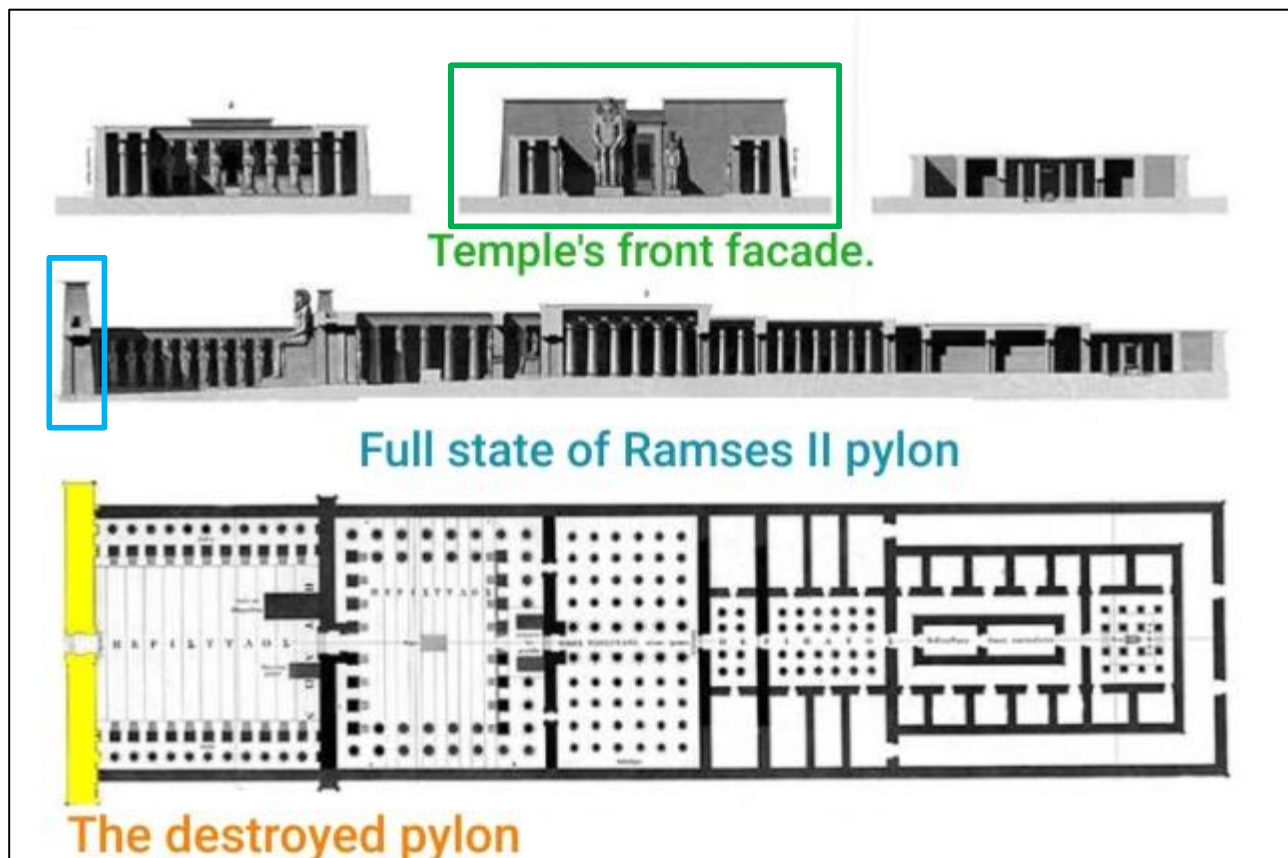
Fig. (1). A horizontal projection and front view showing the pylon and the temple in its complete state, a general map of the temple location, showing the current state of the temple and the demolished pylon, with an aerial view

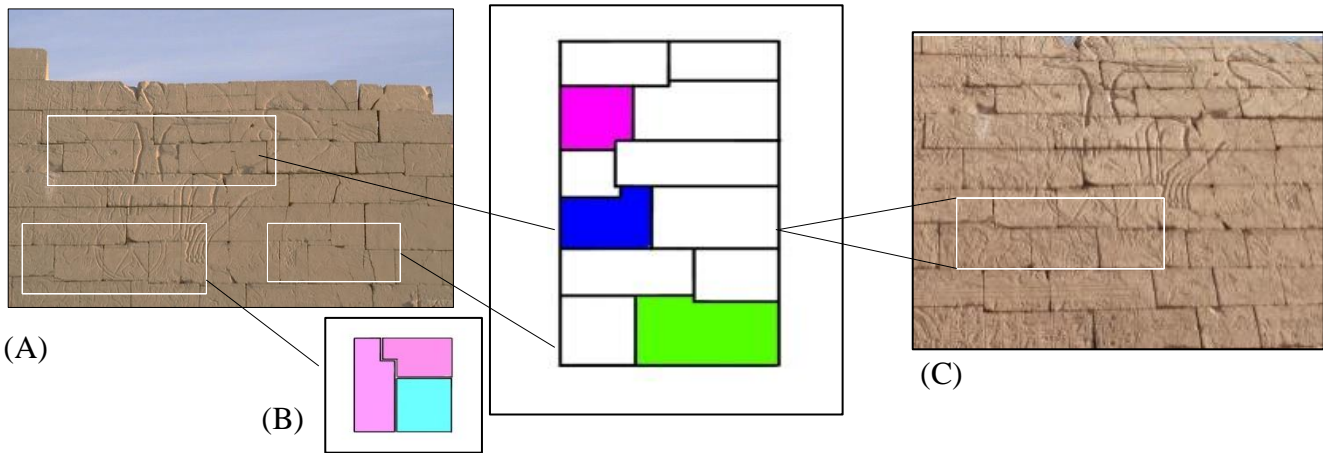
Fig. (2). (A) and (C) the ancient Egyptian method used partially in the pylon by separating part of the stone piece surface and keeping the other (interlock) to more connect and increase the strength of cohesion, (C) colored illustration to clarify this method that used in the pylon building

The foundation surface is leveled; leaving its rough outer vertical surface to be trimmed after the pylon is built, its blocks were connected with interlocking (Fig. 2), auxiliary mortar of lime, sand, and gypsum, their upper surfaces were marked with what is called the construction lines, and the foundations were joined together, the technique of stacking stone blocks by different systems were applied in arranging stones in all parts of the architectural elements, through flemish bond (Fig. 2) and dutch bond¹¹ (Fig. 3) header with stretcher this were in one architectural element, hence a row of stones 53 cm wide, topped by a row of stones 75 cm wide, and alternately two or three rows of less wide stones, then two or three rows of stones, this methodology was the most suitable way to employ and operate all stones, while making a connection between these stone blocks gradually over the surface of the stone, which gives the architectural elements strong bonding and cohesion between architectural elements¹².

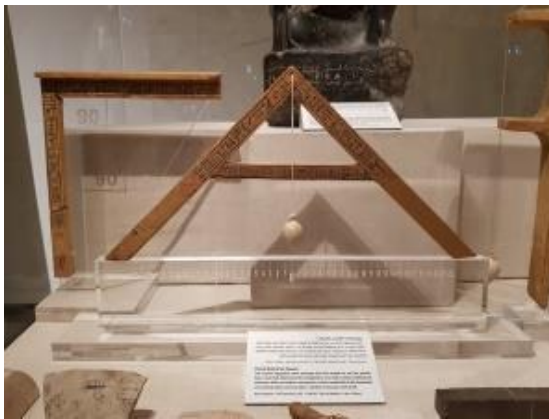
Fig: (5). (A) ancient Egyptian performance to measure stone and wall.(B),(C),(D) Stones stacking method showing the dove tail method for connecting the stone pieces opposite tangles method as an additional method to support and connect the stone pieces, connects stone each other of tower.

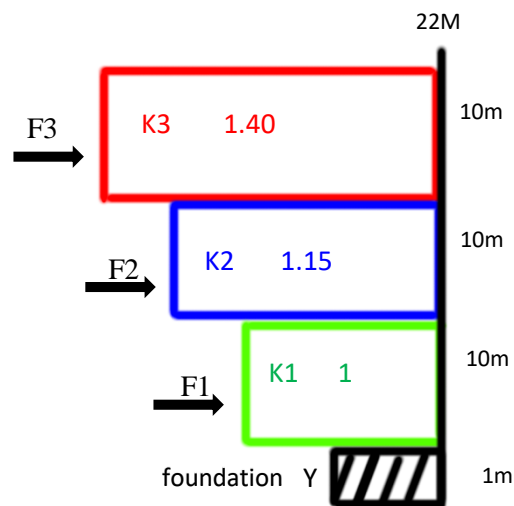
Fig. (7). Force of the wind loads.

Through the derivation process for wind loads, it was found that the force acting on the pylon by dividing high of the pylon into several levels (Fig.7), the total force above the foundation level is equal to 2570 kn, force from the foundation level is equal to 44550 kn, Table.5.

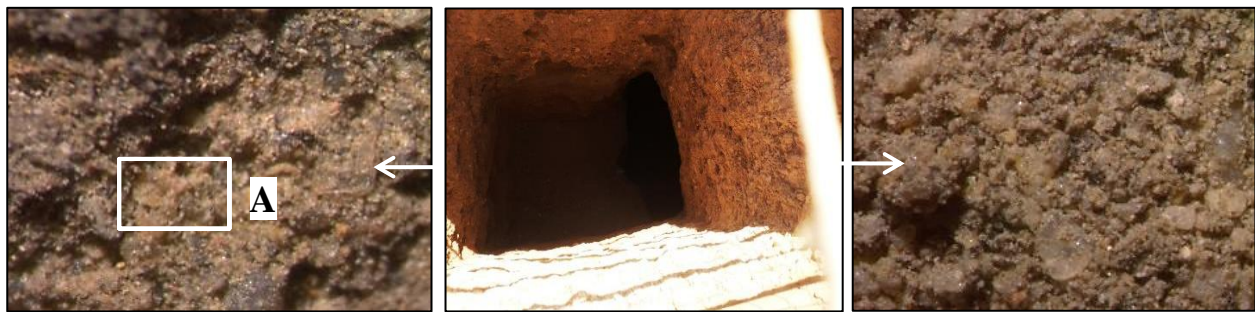
Fig. (14). the infrastructure soil of Ramses II pylon and the samples on which tests and were conducted.

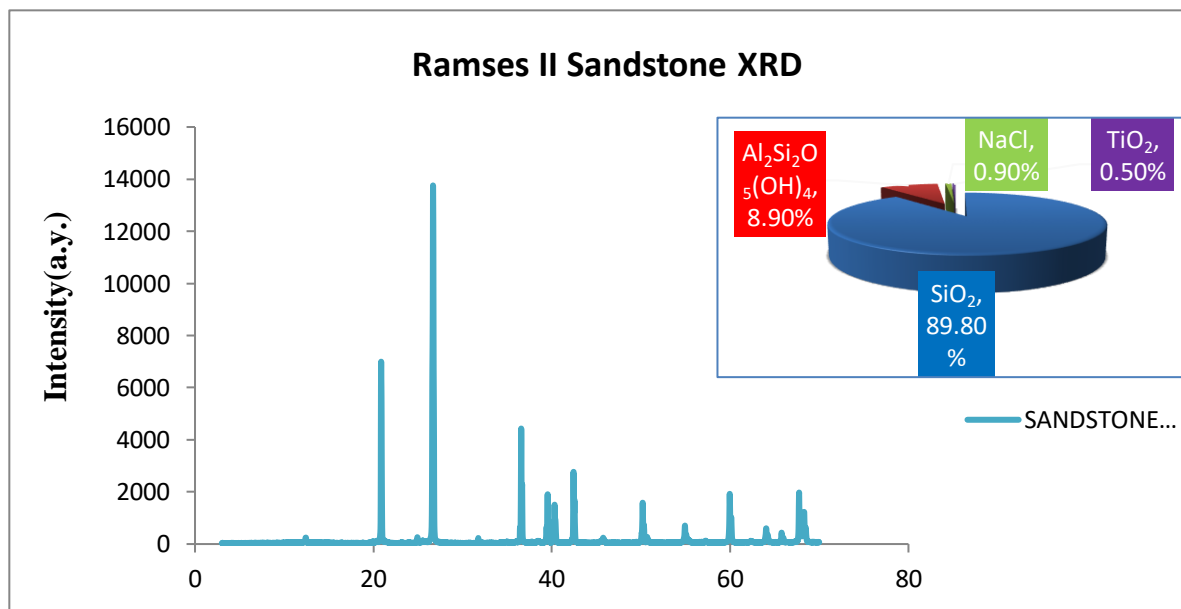
Fig. (16).X-Ray diffraction (XRD) analysis of sandstone sample

Conditions: radiation: $\text{CuK}\alpha 1$ generator current (MA): 25, wavelength alpha1 (A): 1.54060, wavelength alpha1 (B): 1.54060, intensity ration (Alpha1/ Alpha2): 0.500, receiving Slit: 0.2, diffract meter type: PW 1840, anode: Cu, generator tube tension (KV): 40, monochromator used: full scale of recorder (K counts/s): 20, time cons tant of recorder (s): 0.5 SS/FOM: $F(17)= 92.7 (0.0108, 17)$, and yet the results of the analysis by X-ray diffraction showed that the main component of the sample is quartz at a rate of 89.8%, with the presence of kaolinite as an impurity at a rate of 8.9%, as well as halite salt at a rate of 0.9%, and titanium oxide at a rate of 0.5%, the X-ray diffraction pattern Fig. (16). in the figure shows the indicated data side by side the table. (9).
