VOLUME 7, ISSUE 2, 2024, 101–119.  
DOI 10.21608/IJMSHR.2025.335148.1033

**THE ROLE OF CONSERVATION PROCESSES IN REVEALING AND  
DISPLAYING OF BLAZONS AND DECORATIVE PATTERNS ON LEAD-BRASS  
GRILLES IN THE MOSQUE OF AMIR QAJMAS AL-ISHAQI, CAIRO- EGYPT**

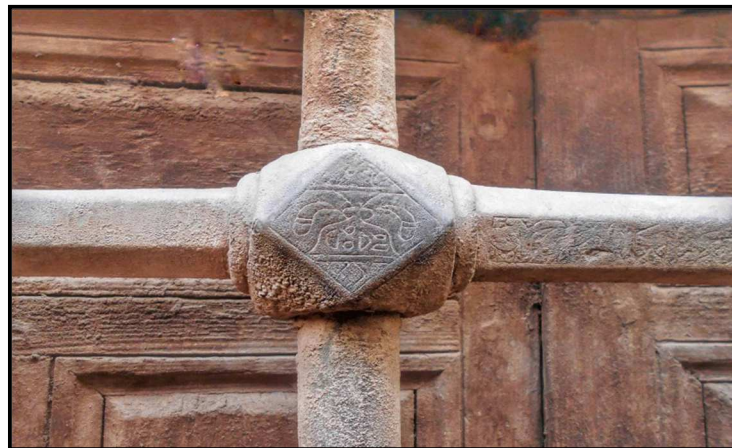
Dense layers of solid suspensions, dust, and corrosion compounds form on metal grilles, distorting their appearance and hiding their features and the various decorative and archaeological elements they may contain.<sup>1</sup> In the Mamluk era, an artistic phenomenon spread widely in Mamluk era buildings, whether in mosques, fountains etc., which is metal grilles.<sup>2</sup> They were made of bronze or brass alloy and sometimes iron. The main purpose of using metal grilles was to cover windows and provide protection, such as using them to protect doors inlaid with gold, such as the door of the mausoleum of Sultan Hassan Madrasa.<sup>3</sup> Metal grilles took different decorative forms to reduce the intensity of repetition in their use by creating cubes, small balls, or simplified polygons in the areas where the grilles intersect, which form a decorative aspect in addition to their structural function in strengthening those metal networks<sup>4</sup>. The metal grilles with ribbed sticks or stems that intersect in the form of beveled ribbed balls, which is the style used for the metal grilles in the mosque of Prince Qajmas Al-Ishaqi are made through the following steps, *Fig. (2)*.

**Fig. (2):** shows one of the metal grilles in the mosque of Prince Qajmas Al-Ishaqi, and the rank of Prince Qajmas Al-Ishaqi appears on it after the surface layers that were hiding it were removed by mechanical cleaning.

The beveled ribbed balls that carry the shape of the Prince Qajmas Al-Ishaqi blazon are prepared in the required size from brass using the casting method, and a hollow part is made on both sides that resembles a circular ring so that it fits the diameter of the ends of the vertical and horizontal sticks that will be used as metal grilles.<sup>5</sup> The horizontal and vertical ribbed sticks of appropriate lengths that carry casting style decorations are also prepared from brass alloy.<sup>6</sup> Traditional sand casting was used, and it was taken into consideration that the thickness or diameter of the horizontal and vertical sticks be less than the end diameter of the beveled ribbed balls.<sup>7</sup> The grilles network is fixed by inserting the ends of the horizontal and vertical sticks into the hollow end rings of the beveled ribbed balls that carry the blazons and riveting them. Thus, the metal

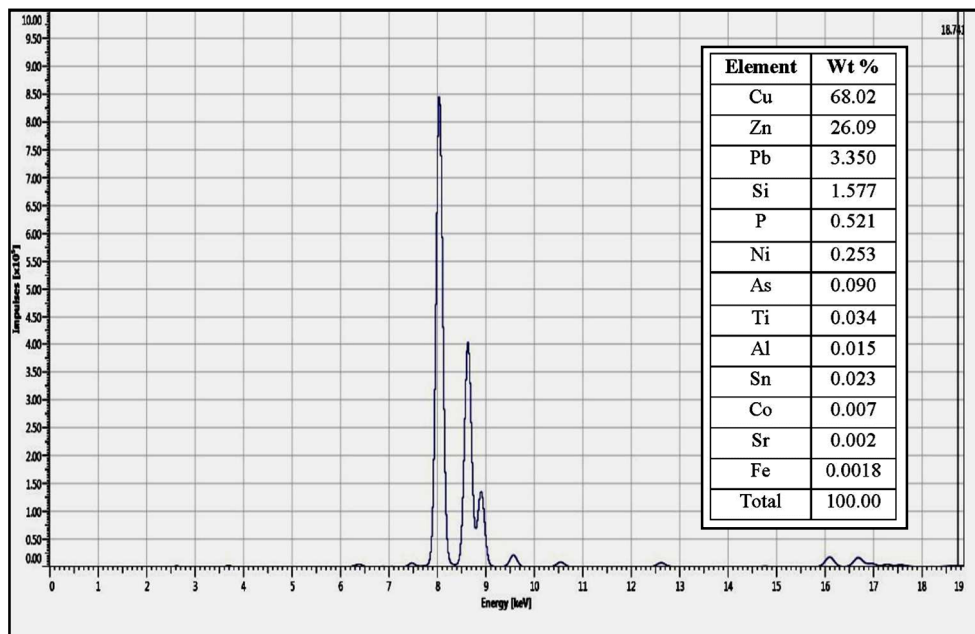
*Fig. (9): Shows EDX pattern of another sample from the grilles and the percentages of elements present in the sample.*

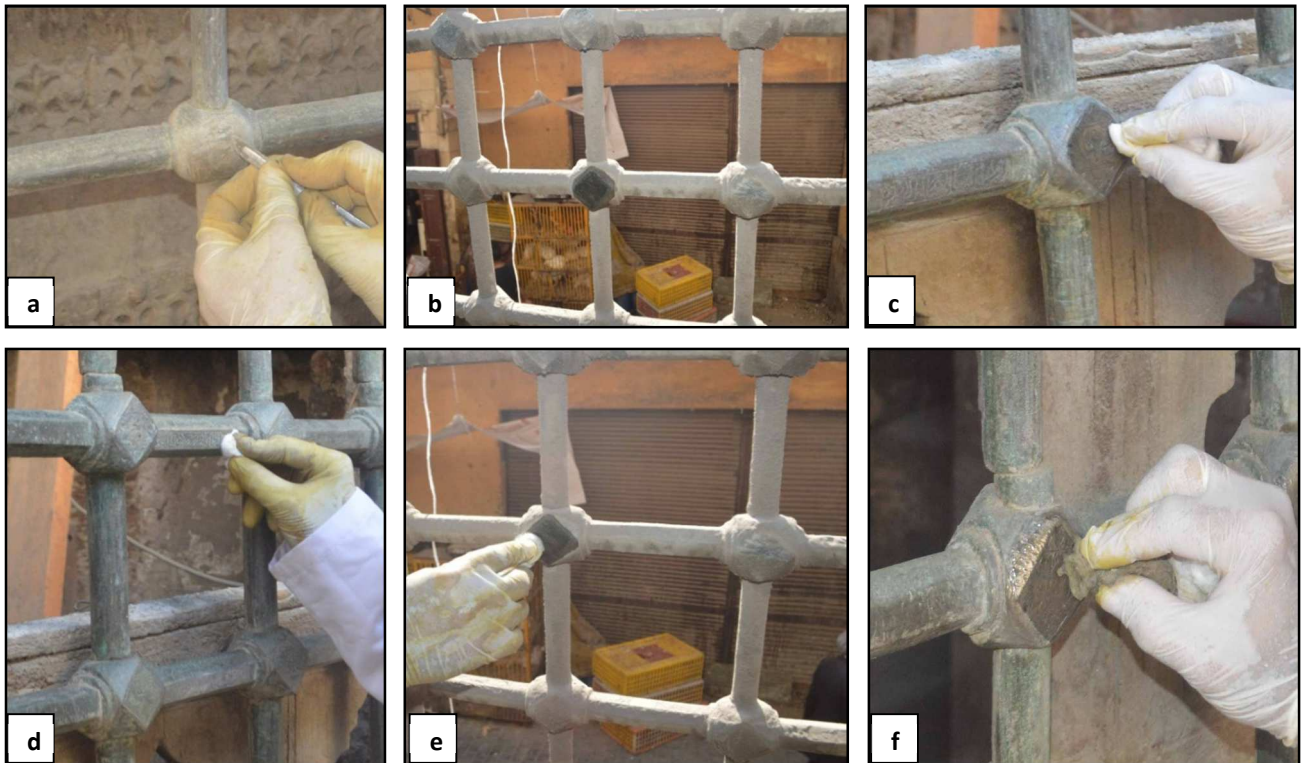
**Fig. (12), (a-f): Shows the treatment and conservation processes of the grilles of the fountain window of the Prince Qajmas Al-Ishaqi Mosque.**

The treatment and conservation processes of the grilles were carried out to treat it from deterioration, *Fig. (12), a-f*. It depends on the results of the examination and analysis.<sup>1</sup> The presence of thick layers of dust, suspended particles and corrosion compounds on the surfaces of the grilles concealed the decorations and blazons of Prince Qajmas Al-Ishaqi, the builder of the mosque underneath. In order to reveal and expose these decorations and blazons, treatment and conservation processes were carried out. Treatment processes began with mechanical cleaning using hand tools that included scalpels, metal needles and fine chisels.<sup>2</sup> The thick layers of suspended particles and calcifications were removed mechanically.<sup>3</sup> Since the decorations and the blazons were engraved in sunken engravings, sediments and calcifications were found in these sunken areas, which made it difficult to remove them completely with hand tools, therefore,<sup>4</sup> the use of mechanical cleaning was followed by chemical cleaning to complete the detection and exposure of the decorations and the blazons beneath the thick layers of corrosion and calcifications.<sup>5</sup>

Chemical cleaning of the surfaces of the grilles was carried out first using 5% sodium hexaphosphate solution to remove the dense scales and suspended particles on the surface.<sup>6</sup> Then the corrosion layers were removed using a Rochelle salt solution with rough and soft brushes to facilitate the removal of corrosion compounds, especially from between the decorative cavities and sunken blazon shapes of Prince Qajmas Al-Ishaqi executed using the casting

method.<sup>1</sup> Then chemical cleaning was carried out using a sodium sesquicarbonate solution, and the parts cleaned using chemical solutions were thoroughly rinsed with pure water<sup>2</sup>. The chloride compounds were removed using localized electrochemical reduction by placing zinc powder in these pits or holes with formic acid in a concentration of 5%. The released hydrogen reduces these compounds into soluble compounds. To preserve the grilles and protect them from being deteriorated again, a protective layer was applied to their surfaces using a solution of Paraloid B82 dissolved in toluene at a concentration of 3%.<sup>3</sup>

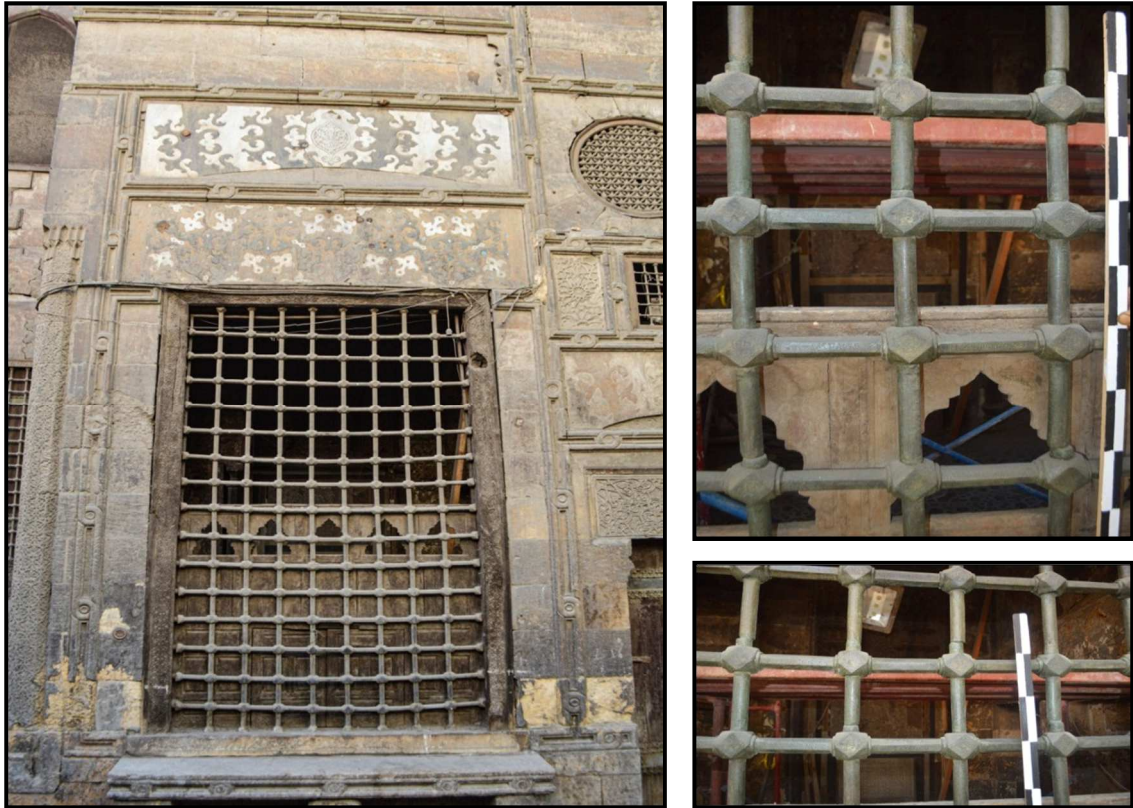
***Fig. (13): Shows the grilles of the Sabil window of the Prince Qajmas Al-Ishaqi Mosque after the treatment and conservation processes, and displaying the blazon of Prince Qajmas Al-Ishaqi on the surfaces of the grilles.***

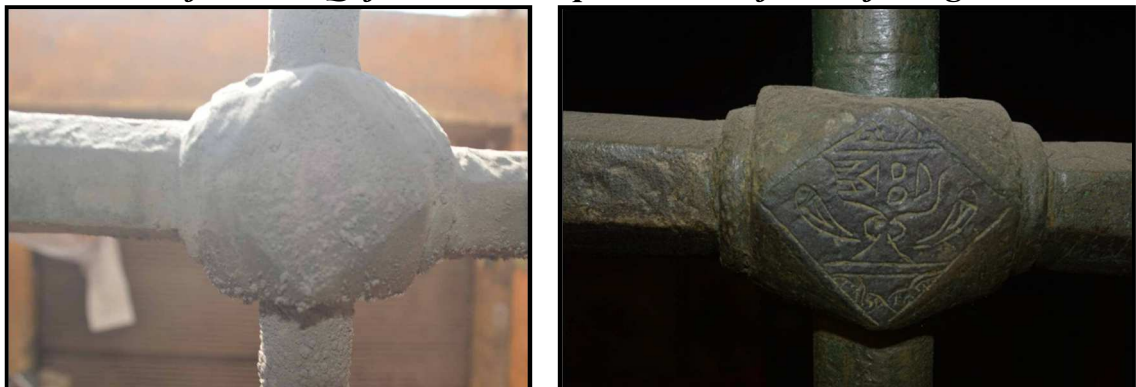
surfaces of the metal grilles. The blazon of Prince Qajmas al-Ishaqi is a circle divided into three sections, the widest of which is the middle section, called the shatb. The upper section is occupied by a drawing of the baujah sign, and the middle section occupies a cup with an inkwell, which is a writing tool, on its sides are two horns of gunpowder. The lower section contains a small cup <sup>1</sup>. *Figs. (14), (15).*

***Fig. (14): Shows the blazon of Prince Qajmas Al-Ishaqi on the surfaces of the grilles before and after treatment and conservation processes.***
