Danger of self-drilling self-tapping screws: case report

The Egyptian Orthopaedic Journal 2018, 53:381–383

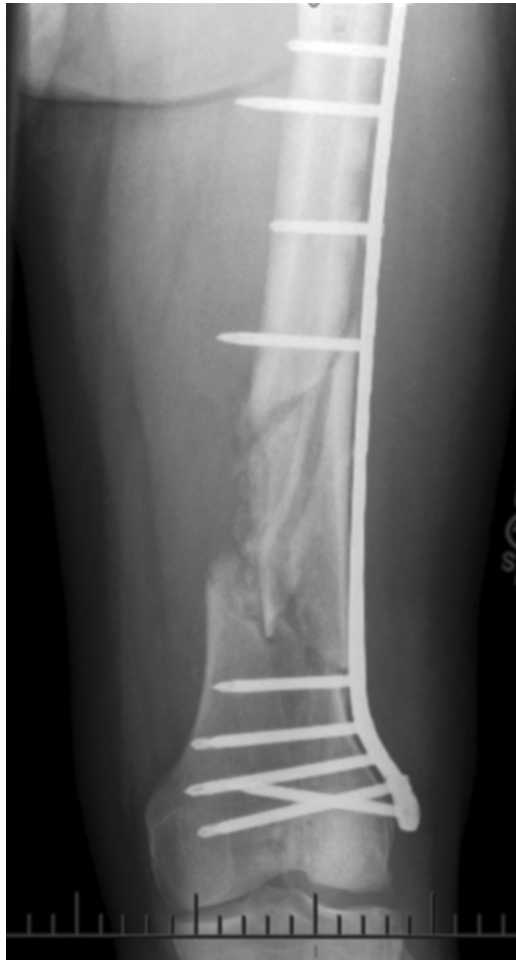
Figure 1

Early postoperative radiographs showing a locking construct used for an open comminuted femur fracture.

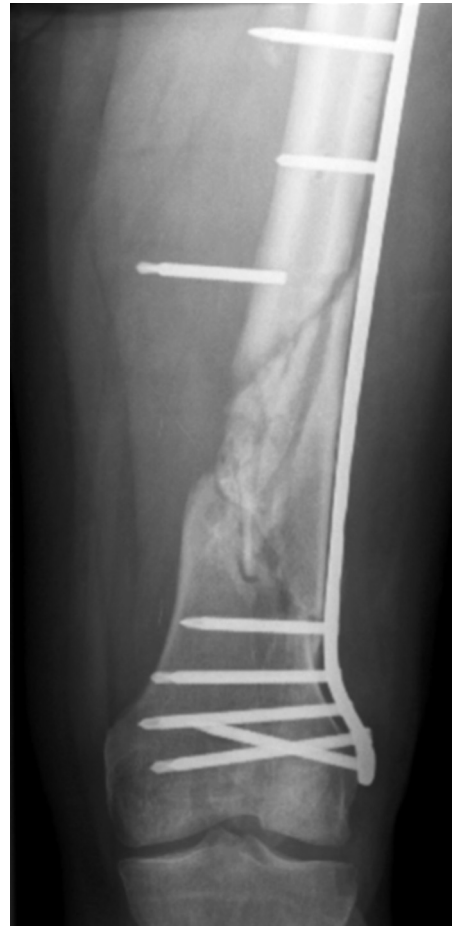
Figure 2

On further follow-up radiographs at 4 months postoperatively, there was (Fig. 2) hardware failure and migration of one of the locked screws medially, but the screw was still partially within the cortical bone. This screw was the first proximal fixation after the bridging portion of the comminution. There were no signs or laboratory results consistent with infection. The condition was discussed with the patient, and he was offered hardware removal. He was so happy with his clinical course that he was hesitant to have more surgery.

Four-month follow-up radiographs showing hardware failure.

The reported failures for the LISS plate have been soft tissue coverage issues, plate failure owing to unicortical screw cut-out, breakage of the plate, or failure to provide adequate support until osseous healing [5-7]. We report a case of screw breakage and migration from one such plate. Generic risks of hardware breakage and complications can include local migration or systemic embolization [8,9]. Obviously, migration of the self-drilling screws from a LISS femur fixation specifically could endanger vital structures. Failures of the plating technique itself have been reported. Screw migration has occurred after failure at the screw shaft region. The screw is minimal in cross-section at this point. This particular screw was also at the point of maximal stress for this fixation construct. The screw has

unicortical fixation, but this may have been on the far cortex only. The butterfly segment on the plate side of the bone may not have been solidly held by the screw, may have broken away from the screw with weight-bearing, or may have been stripped during insertion when the screw tip hit the far cortex. The resultant screw bone construct for this fixation point would have maximal stress at the screw neck where it exits the plate. The bone fragment needing solid fixation was maximally away from the plate. This would result in hardware failure at the screw neck. The length of the screw is dictated by inventory sizes in this system. The inventory is limited to cut down overhead costs. Diaphyseal screws therefore can sometimes be quite long when used in a bicortical fashion. In this particular case, the screw protruded into the soft tissue envelope. Potentially, friction or torque moment of the screw by the soft tissue may have resulted in progressive migration through the femoral cortex and along a straight path to the medial thigh. Any neurovascular structure along the path of the migrating screw is in danger. The movement through the soft tissue was also quite rapid and predictable in hindsight.

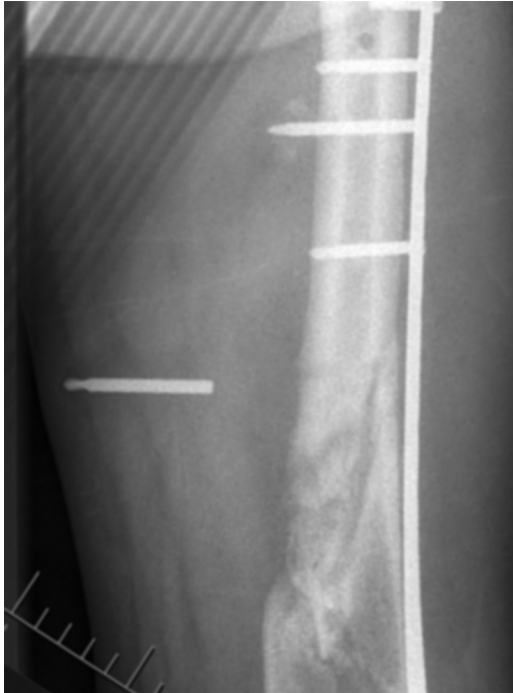
Figure 3

During follow-up at 4 weeks later, the patient complained of mid-femur pain at the skin level. He claimed that every time he flexed and extended his thigh, he felt a worsening stabbing pain in the medial thigh. Radiographs (Fig. 3) revealed more migration

had occurred to the medial thigh. The screw was palpable and was removed in the orthopedic clinic under local anesthesia.

Progressive migration has occurred. The screw is now palpable subcutaneously along the medial thigh. Potentially, neurovascular structures may be at risk from this migration.

With this locking plate system in particular, the first screw after a large bridge segment should be unicortical in the diaphyseal bone that is nearest the plate. In that case, if breakage does occur, there would be no migration, as there would be an intact femoral cortex at the tip of the screw. There would also be no soft tissue friction to cause screw motion owing to the medullary position of the broken screw. If screw

breakage does occur in a bicortical screw, careful radiographic and clinical examinations should be followed to ensure that migration does not occur.
