ADAPTIVE REUSE IN HISTORIC URBAN CONTEXTS: CONTEXTUAL AND VISUAL ASSESSMENT OF A BUILDING IN AL-HUSSEIN AREA

Doha Moustafa Amer¹, Prof. Dr. Iman Gawad², Assoc. Prof. Dr. Mohamed Abdel-Shakour³
Architecture Department, Faculty of Fine Arts Helwan University^(1,2,3)

-- Paper Extracted from Thesis --

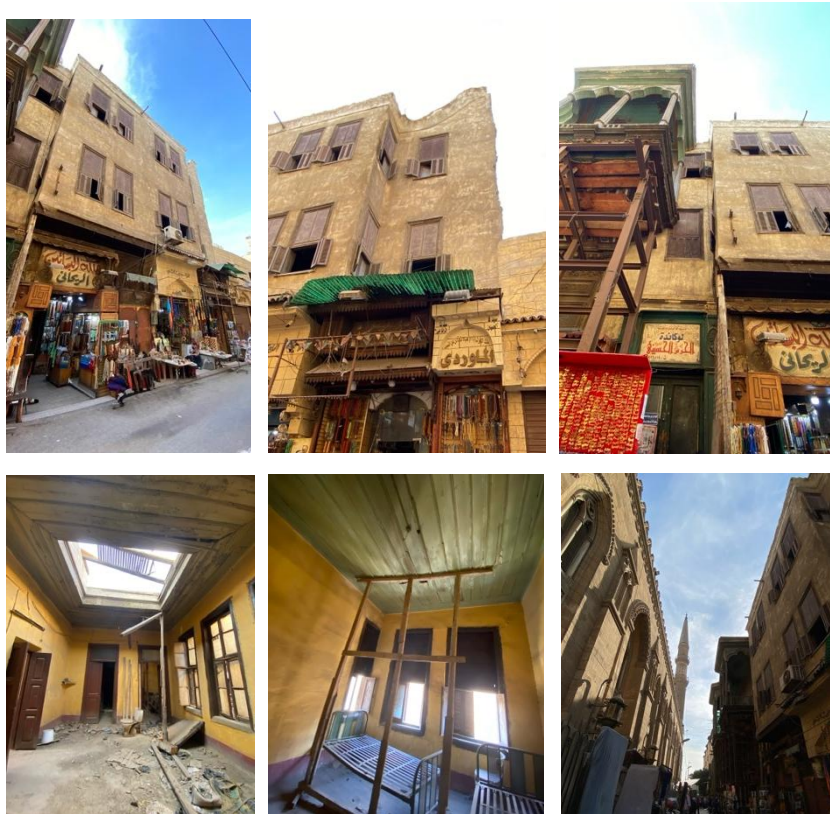
Historically, the structure was used as a local hostel (lokanda al-Haram al-Husseini) for pilgrims and visitors, thereby embodying the traditional culture of hospitality in the region. Today, however, it stands in a state of total neglect, devoid of any usable function or maintenance. Although the building is in a state of disrepair, it continues to be spatially and visually integrated into the surrounding urban fabric and has great potential for adaptive reuse given its prime location and proximity to major heritage attractions.

The exterior appearance and architectural design of the building still bear vestiges of its original purpose, but the circumstance that it stands close to one of Cairo's most revered and frequented religious landmarks highlights its significance in the larger context of urban regeneration and heritage-conscious redeveloping.

Figure (6) photos of the abandoned building – formally a hostel (lokanda el Haram el Hussein) in Gamaleya, Cairo. Source: photographs site visit by researcher.

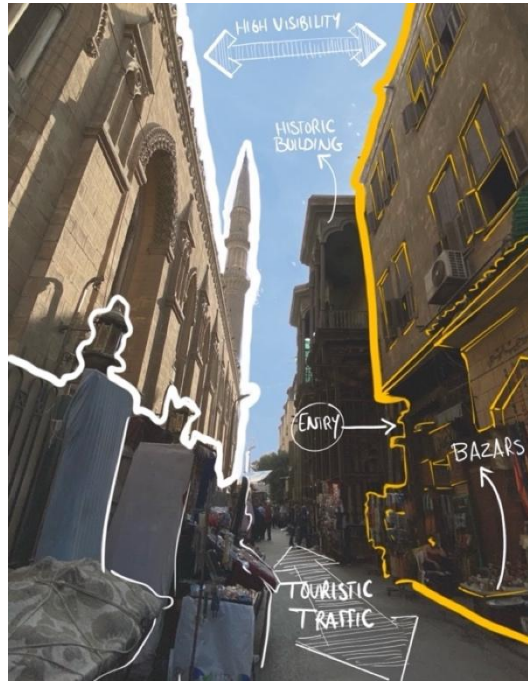
High Visibility Zone: The facility lies along a prominent pedestrian walkway that takes people to Al-Hussein Mosque, thereby making it very visible to residents and tourists who stroll through the historic bazaar.

- **Street-Level Integration:**
Situating in the middle of a commercial thoroughfare, the ground floor of the building is actively engaged with lively street life by having shops, establishing a permanent interface with the public.
- **Cultural Vibrancy:** The face that there is surrounding tourist traffic, active shopfront business, and public usage gives the building a life beyond its architecture infusing it with the daily rhythm of Old Cairo.

Figure (8) analysis of the case study building highlighted in yellow and its surroundings. source: photo and analysis by researcher

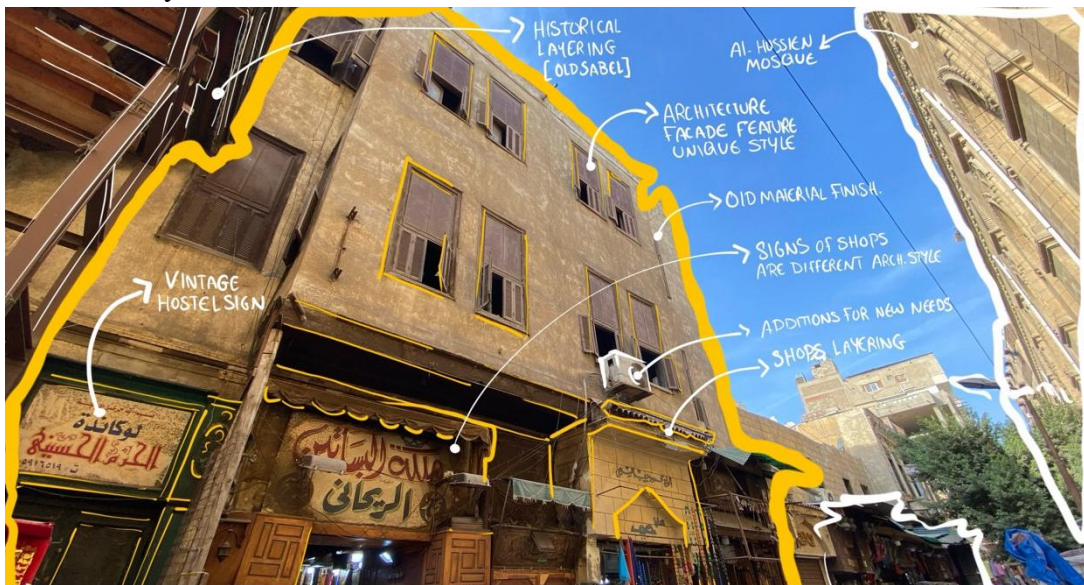
- The structure is situated directly adjacent to Al-Hussein Mosque, positioning it within a heritage area that is culturally sensitive and rendering its presence pivotal in defining the visual and spatial dynamics of the locale.
- Historic Traces: Although not a heritage-listed building, its old materials, vintage hostel signage, and layered façade reflect a sense of historical continuity and local identity.

Figure (9) analysis of the case study building relationship to heritage site. source: photo and analysis by researcher

- The building's simple form and weathered exterior are contrasted with the mosque yet are sympathetic to the context by scale and texture, contributing to the layered character of the district.

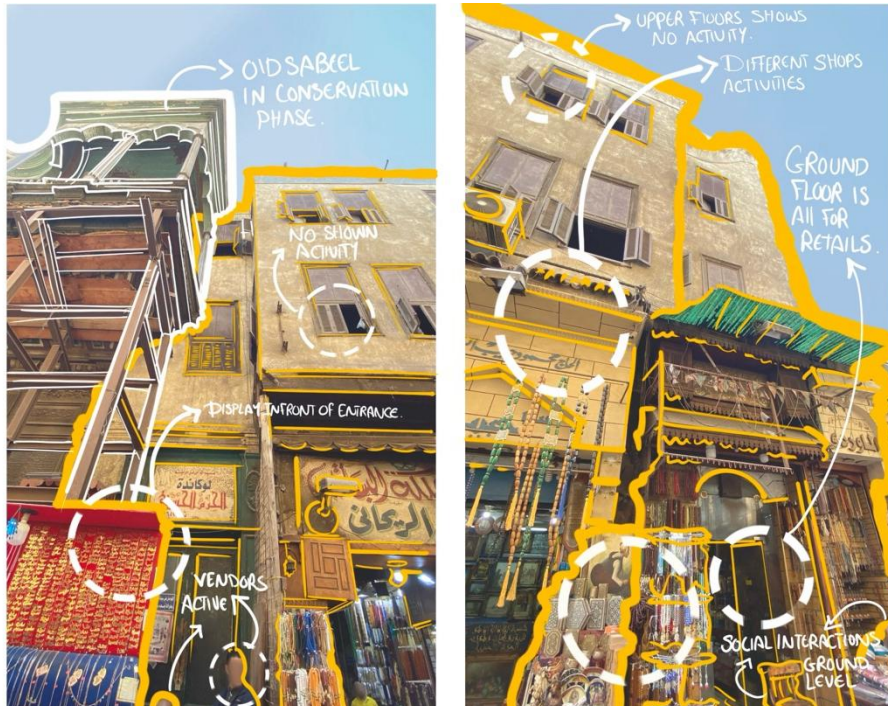
Figure (10) analysis of the case study building public activation. source: photo and analysis by researcher

- The building is located within a dense pedestrian zone, surrounded by continuous commercial and tourist activated, especially along the main street adjacent to Al-Hussein Mosque.
- The ground floor is incorporated within an active retail strip, with several existing store fronts that provide a robust public engagement at grade.
- The upper stories seem detached from street level activity, with no signage or points of access that would indicate active public use.

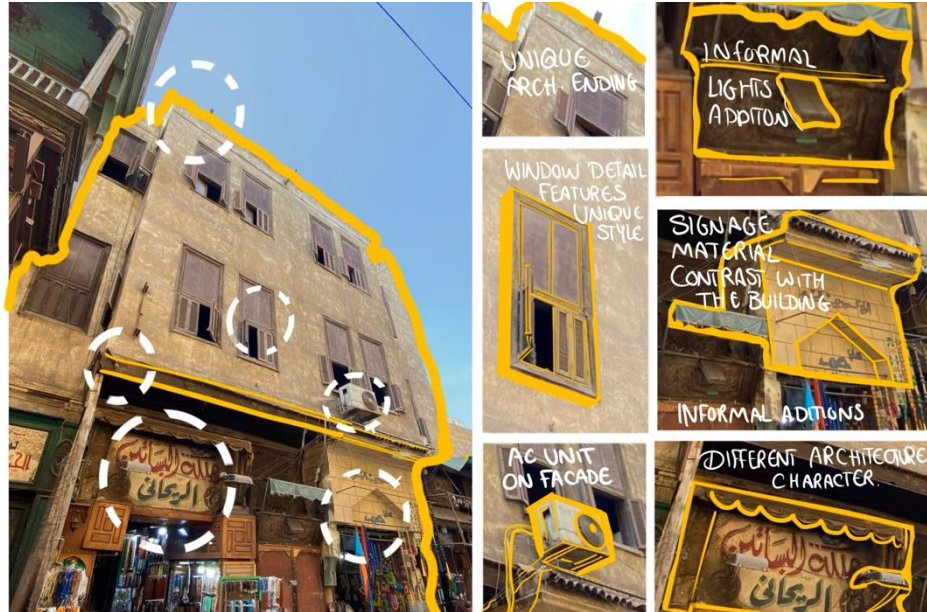
1. Facade and Architectural Features
2. The longitudinal rectangular windows set evenly across the higher levels have
3. wooden shutters, following a simple and modest vocabulary.
4. The repetition window pattern conforms to the initial purpose of the building as a hostel, providing repetition and symmetry appropriate for various similar rooms.
5. The ground floor is completely commercialized, and it has shops and bazaars whose displays spill over the building line, encroaching into the pedestrian space.
 - a. Every store has a unique sign design non-original additions by local users frequently trying to emulate Islamic motifs, albeit with diverse degrees of authenticity.

- b. Informal interventions can be observed, for example, a visible AC unit on the first floor and exposed cable trays that run across the facade.

Figure (11) analysis of the case study building façade, architectural features, exterior condition. source: photo and analysis by researcher

- The building's façade shows visible signs of surface decay, including blackened plaster, weathering, and material erosion.
- Lower portions of the outside are visually dominated by commercial aspects shop signs, metal shutters, and display structures.
- Informal changes disrupt the original architectural rhythm, e.g., projecting signage and inserted service elements.
- No evidence of recent repairs or maintenance is observed on the exterior of the building.
- Overall appearance expresses long exposure to environmental conditions and lack of regulatory oversight of facade interventions.

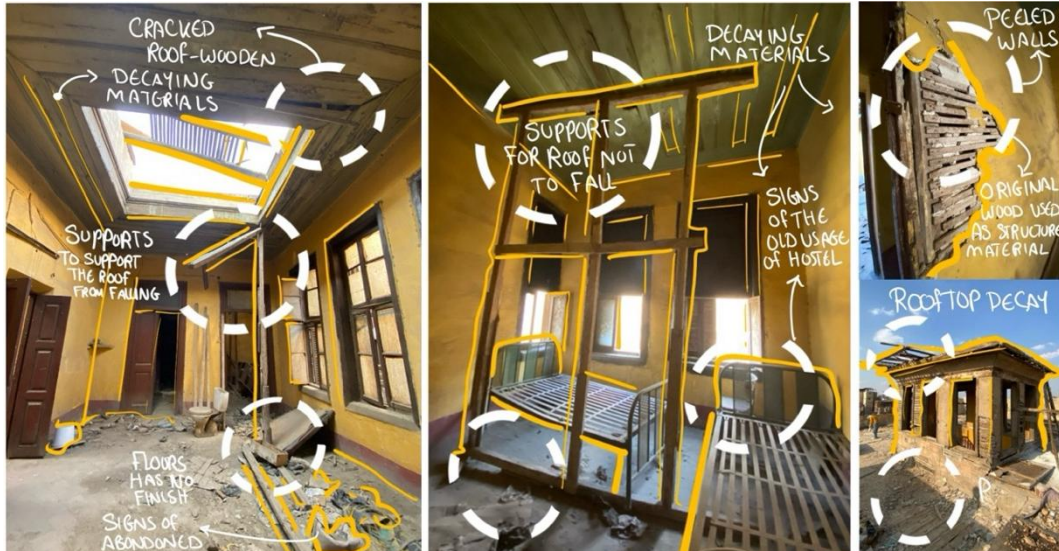
- interior spaces exhibit clear signs of deterioration, which include the buildup of dust, worn surfaces, and damaged wall finishes.
- Many sections of the ceiling show partial collapse or instability in structure, with temporary wooden supports installed to prevent further failure.
- The nonfunctioning or failure of light fixtures leads to dimly lit interiors, which exacerbate a feeling of neglect.
- the internal structure is still legible, with original room boundaries and corridors still present despite material destruction.

- Flooring in some areas shows traces of original tiles beneath layers of dust and debris, while others are heavily deteriorated.

Figure (11) analysis of the case study building internal condition and signs of use or abandonment. source: photo and analysis by researcher

- The front entrance is accessible but does not have any consistent pedestrian traffic or activity.
- Dust accumulation and visual inactivity near access points indicate extended non-use.
- There is no evidence of recent interior use or occupancy or recent maintenance.
- Windows appear dirty or smeared, limiting visual connection between inside and outside.
- The building gives a clear impression of vacancy, despite being physically open.

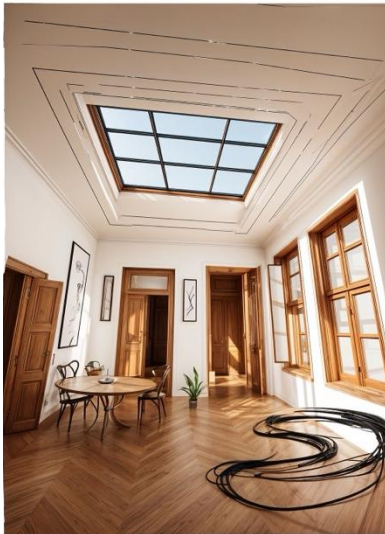
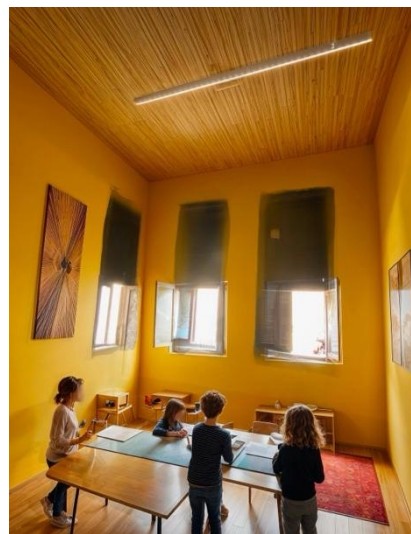
Figure (12) suggested adaptive re-use of the case study building in the main hall and creative workspace. source: photo and re-imagined by researcher

Given the location's Spatial location and its historic value, the reutilization of the higher levels as new workspaces, together with learning centers (e.g., lecture halls for cultural courses), seems to be the most suitable method of reutilization. Not only does this favor local craftsmen and professionals, but it also naturally relates the building functions to the preservation and sharing of Cairo's rich heritage.
