Behavior of Hybrid Reinforced Concrete Beams Under Influence of Seawater

Sherif S. Abd el Hamid¹, Amr A. Gamal El Din ¹, Ahmed F. Deifalla² and Tarik S. El-Salakawy¹

Abstract

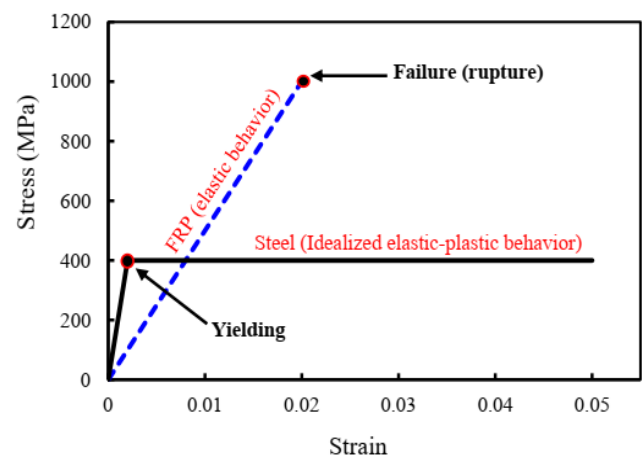
Fig. (3) Stress-strain relationship for GFRP and steel reinforcement [20].

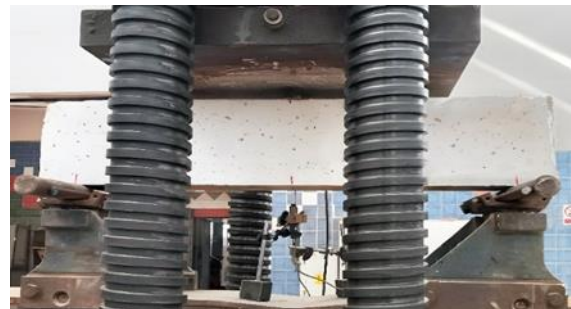
a) Test setup and apparatus

b) Loader parts

Fig. (8) Single Point-Loading of the bending test setup.

After completing the corrosion test, specimens were air-dried, and visual inspection and measurement of cracks due to corrosion were performed. After that, all beams were subjected to a single-point loading bending test using a vertical load at the middle of the span as shown in figure 8 (a, b) the beams were loaded by a hydraulic jack with a loading capacity of 500 tons, the load and retained displacement were recorded automatically using the data accusation system till failure. The load on the beam was measured using a load cell, along with two linear variable differential transformers LVDTs. LVDT(1) and LVDT(2) were positioned at the center of the test specimen to measure beam displacement under load. The maximum deflection of the middle cross-section was determined from these LVDTs measurements.

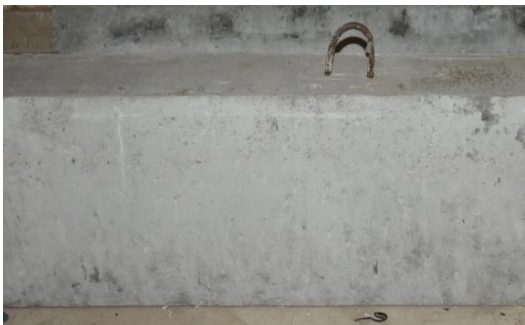
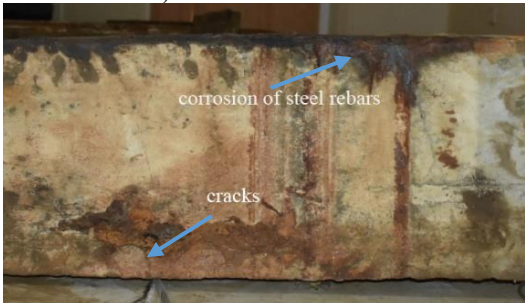
a) non-corroded beam

b) Corroded beam

Fig. (9) Visual inspection of beams after corrosion

All beams after the corrosion process were visually inspected, evaluating the damage to the submerged beams after the immersion period was ended. Fig. 9 (a, b) shows the status of the beams exposed to corrosion compared to beams exposed to air.

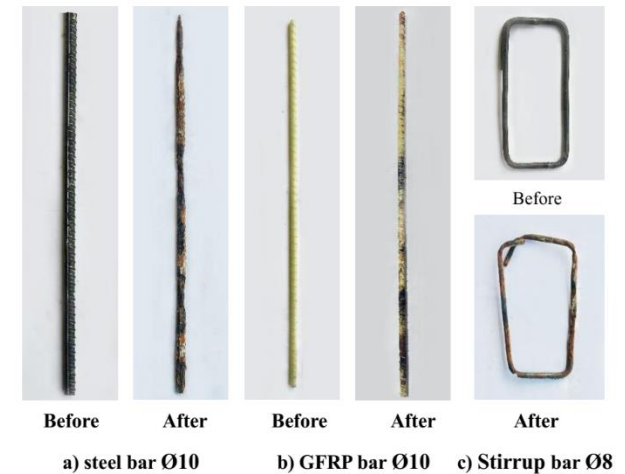
Fig. (11) Steel rebar Ø10 and GFRP bar Ø10 before and after the accelerated corrosion test.
Table (6) weight of the reinforcement cage (Kg) before and after the corrosion process.

The final internal inspection of the beams includes the following: First, the concrete cover is removed for corroded beams after flexural strength testing to evaluate the condition of the reinforcement visually after the corrosion process compared to non-corroded beams as shown in Fig. 11. Second, the weight of the reinforcement cage in Kg before and after the corrosion process was measured using a digital balance to calculate the weight loss ratio for each beam, as shown in Table 6. After that the actual diameter of the corroded bottom reinforcement was then measured using a digital calliper as shown in Fig. 12.

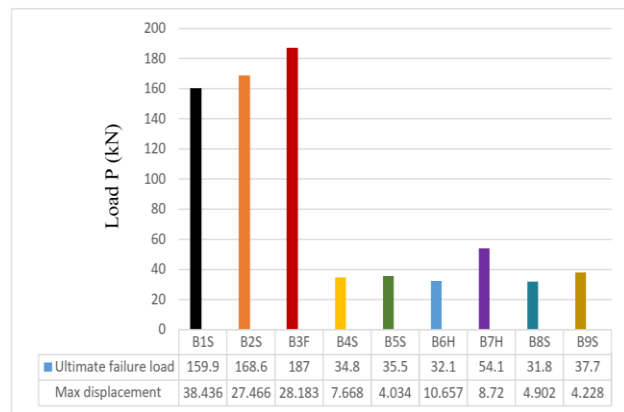
**Fig. (13)** Ultimate load failure and maximum displacement

The flexural behavior of the nine concrete beams was investigated by determining failure loads and ultimate displacements as seen in table 7. Three beams were exposed to air, and the other six underwent an accelerated corrosion test to compare the impact of corrosion on the flexural behavior of hybrid reinforced beams using steel rebar and GFRP bars. Figure 13 illustrates the ultimate failure load and maximum displacement for all beams, while Figure 14 shows the load and displacement curve relationship for each beam. Further explanation and analysis of the various groups is discussed in section 6.

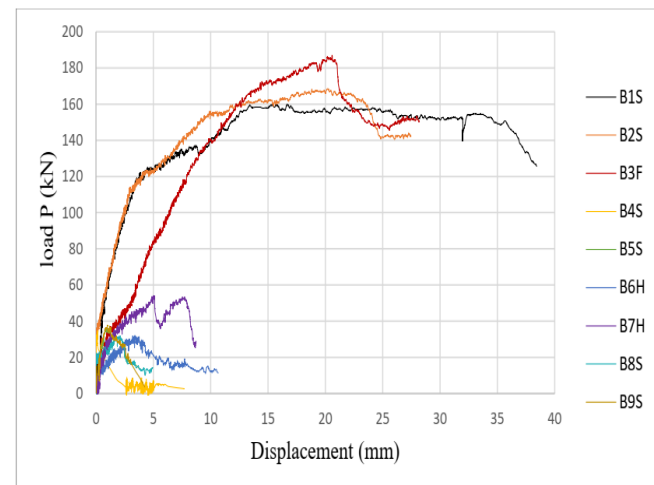
**Fig. (14)** Load and displacement curve for all specimens

The B2S beam shows 5.4% higher bearing strength than the B1S beam in bending strength resistance, despite both having the same reinforcement with a maximum displacement of 38.436 mm for B1S and 27,466 mm for B2S. The difference in ultimate failure strength was the existence of silica fume in the B2S. As for B3F the existence of silica fume, along with bottom reinforcement made of GFRP, led to a 16.9% enhancement in bending strength resistance compared to B1S. A maximum displacement for B3F is 28.183 mm, the failure mode cracks naturally propagate, where cracks typically form and spread along the beams tensile. bottom fibers in the midsection and propagate upwards.

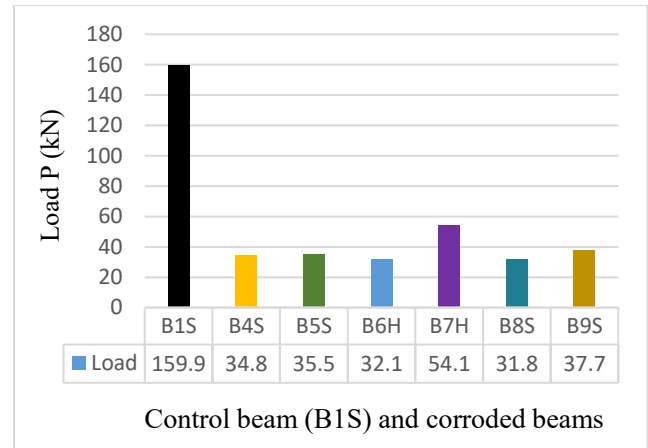
**Fig. (15)** Effect of corrosion on flexural strength test for corroded beams.

Submerged beams (B4S, B5S, B6H, B7H, B8S, and B9S) exhibited lower flexural resistance than the control beam B1S, as shown in figure (15). This reduction was attributed to decreased cross-section in steel rebar due to corrosion as shown in figure (12).

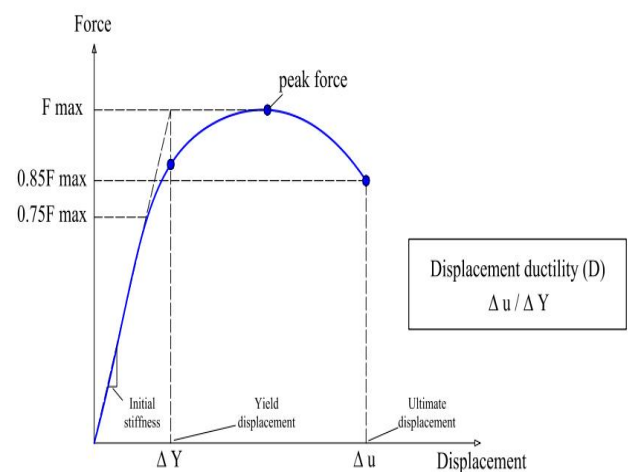
**Fig. (16)** Displacement ductility curve.

Cohn and Bartlett [26] proposed a more appropriate definition for a displacement ductility index. Based on their definition, the displacement ductility (D) index can be estimated as the ratio of the displacement corresponding to 85% of the maximum load on the post-peak portion of the curve to the displacement corresponding to the first yield displacement of a beam, Δy the displacement ductility index is the calculated displacement from the load-displacement curve by using the equation $(\Delta u \text{ at } 0.85p(\max)) / (\Delta y)$ as shown in Fig. 16. Table 8 shows the result of displacement ductility for all beams

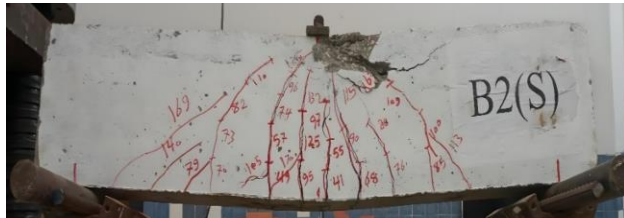
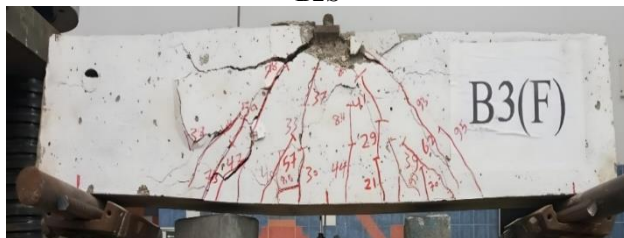
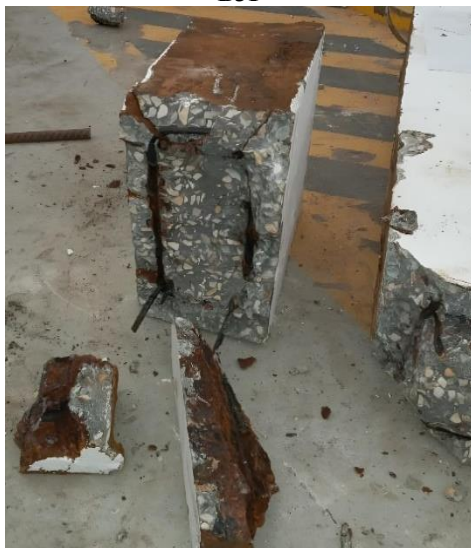
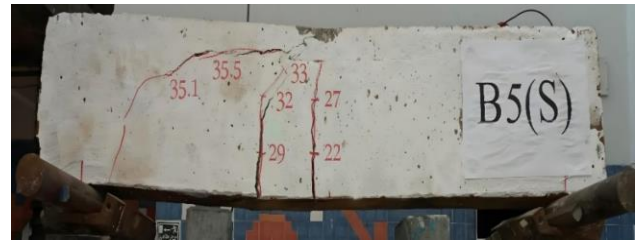
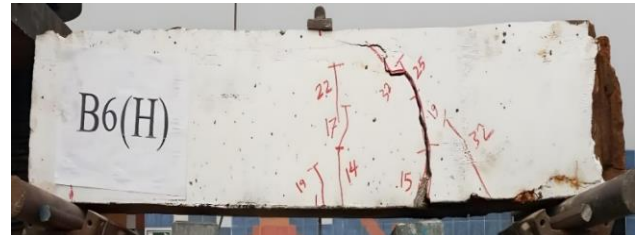
Fig. (17) Crack patterns on test specimens under flexural test of bottom reinforcement for the corroded beams.

This section discusses concrete test results for cubes and cylinders used in the concrete tests. and also present the findings of the flexural strength test and the failure mode, as illustrated in Fig. 17, for all beams exposed to and not exposed to corrosion, and discusses the effect of corrosion on the ductility of steel rebar, and the impact of corrosion on reducing the cross-section steel rebar.

The corrosion's effect on flexural strength tests for beams B4S and B5S, compared to beams B1S and B2S exposed to air, shows that B5S has a 2% better bending strength than B4S. B4S has a maximum displacement of 7.668 mm, while B5S has a maximum displacement of 4.034 mm. The bending strength test results for both beams highlight the impact of corrosion on ductility due to the deterioration of the main reinforcement and reduction in cross-sectional area. B4S experienced sudden failure due to stirrup corrosion near the shear zone, whereas B5S failure is due to flexure and shear.

Corrosion affected the flexural strength test results for beams B6H-B7H hybrid, showing that beam B7H resistance of flexure strength is better than B6H by 68.5% compared to B1S, due to the increased number of GFRP bars and the inclusion of silica fume in B7H. The beams B6H, and B7H have a maximum displacement of 10.657 mm and 8.72 mm respectively. The failure mode for both beams was a combination of shear and flexural due to the corrosion of stirrups and bottom reinforcement.

from corrosion. Upon inspection, corrosion was observed, indicating that this substance merely postpones corrosion rather than halting the chemical processes that lead to it. The B9S beam exhibited 18.5% higher resistance to bending force compared to the B8S beam, B8S should have a maximum displacement 4.902 mm and B9S should have a maximum displacement 4.228 mm. The failure mode in these beams is due to the stirrups' corrosion near the shear zone for B8S. AS for B9S failure mode is flexure and shear.
