## Study of the Structural Behavior of Bamboo Reinforced Concrete Slabs

**Abstract.** This research investigates the structural behavior of concrete slabs reinforced with bamboo as an alternative to conventional steel reinforcement. Bamboo, a renewable and eco-friendly material, offers potential benefits in terms of sustainability and weight reduction. Seven one-way concrete slabs with dimensions of  $1500 \times 550 \times 100$  mm were tested under flexural loading, with varying reinforcement configurations including 100% steel, 100% bamboo, and hybrid ratios. The experimental results revealed that while bamboo-reinforced slabs demonstrated reduced strength compared to steel-reinforced slabs, certain hybrid combinations showed acceptable structural performance. The findings indicate that bamboo can partially replace steel reinforcement in non-critical structural elements, offering an environmentally sustainable alternative. This study contributes to the development of green construction practices and supports further research into improving the mechanical and durability properties of bamboo as reinforcement in concrete structures.

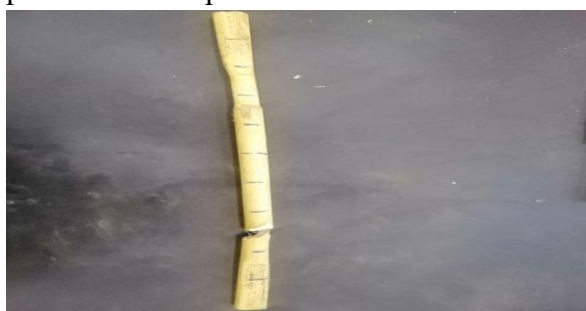
**Figure 3.** splitting and Grip Failure (sample-1)

The tensile tests were conducted for several samples of both bamboo specimens. Their failure pattern, ultimate and yield strength will be discussed in the following section. Tension tests were performed for specimens with different conditions of gripping.

Specimen No	Avg. Area (mm <sup>2</sup> )	Failure Load (KN)	Stress at Failure (MPa)	Strain	Failure type
1	19.5	9.419	483.03	0.002	Splitting and Grip Failure
2	15.51	3.396	219	0.0045	Splitting and Grip Failure
3	12	4.406	367	0.0027	Splitting and Grip Failure
4	9.5	2.505	260	0.0038	Splitting and Grip Failure
5	9.5	1.605	169	0.0059	Splitting and Grip Failure
6	12	5.147	428.916	0.0023	Splitting and Grip Failure

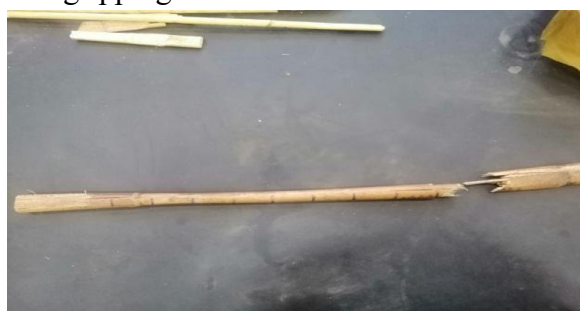
**Figure 4.** Splitting and Grip Failure (sample-2)

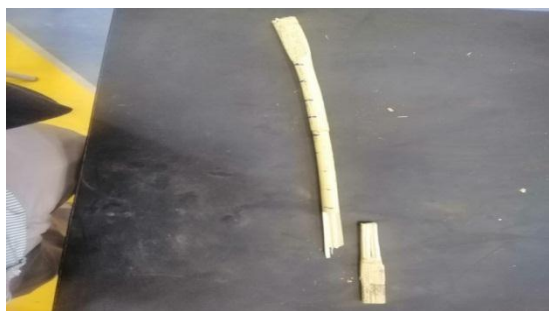
**Figure 5.** Splitting and Grip Failure (sample-3)

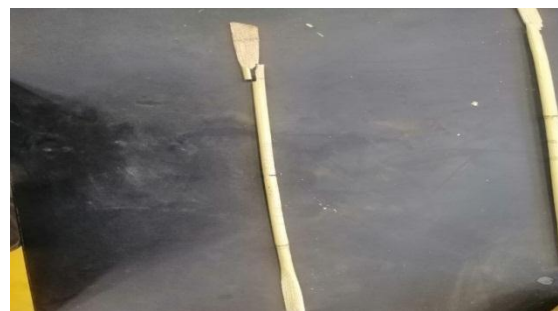
**Figure 6.** Splitting and Grip Failure (sample-4)

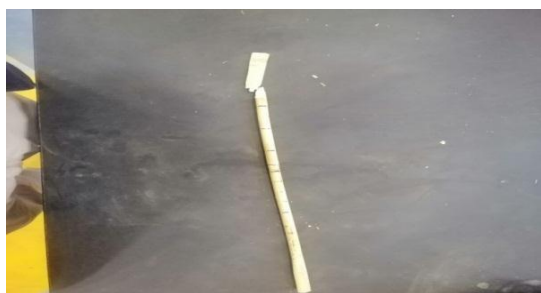
**Figure 7.** Splitting and Grip Failure (sample-4)

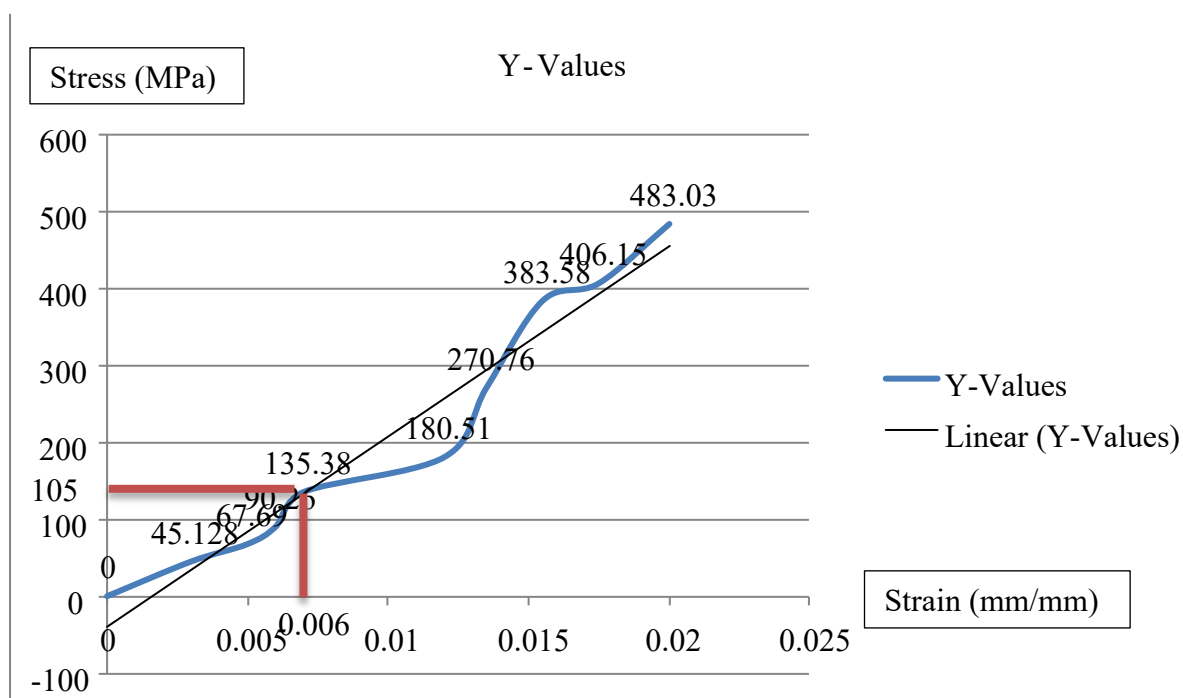
**Figure 8.** Stress - Strain Curve of Bamboo Samples -1.

From this curve, the yield strength has been calculated by offset method. The offset is the horizontal distance between the initial tangent line and any line running parallel to it. The value of the offset for a given material is usually expressed this way: Yield Strength, 0.1% Offset. Therefore, from this method, the yield strength  $f_y = 105$  MPa.

Load (KN)	Area(mm)	Stress (MPa)	Length (mm)	Elongation (mm)	Strain ( $\times 10^{-3}$ ) (mm/mm)
0	19.5	0	500	0	0
0.88	19.5	45.128	500	1.5	0.003
1.32	19.5	67.69	500	2.5	0.005
1.76	19.5	90.26	500	3	0.006
2.64	19.5	135.38	500	3.5	0.007
3.52	19.5	180.51	500	6	0.012
5.28	19.5	270.76	500	6.75	0.0135
7.48	19.5	383.58	500	7.75	0.0155
7.92	19.5	406.15	500	8.75	0.0175
9.419	19.5	483.03	500	10	0.02

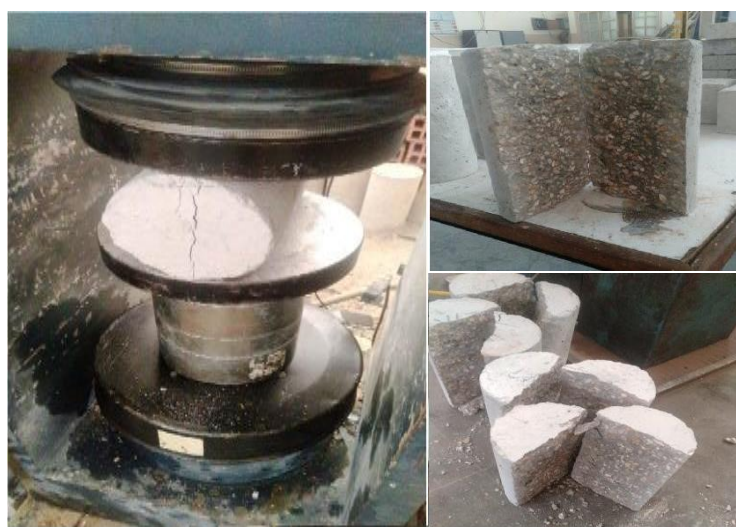
Three cylinders (150 mm Diameter & 300 mm height) were constructed, cured and tested after 28 days (the day of testing of the slabs). The results are shown in Table 3.4. Shown in figure 9.

**Figure 9.** Concrete Tensile Strength Tests Cylinder.

Specimen	Load (KN)	Concrete Tensile Strength (MPa)
1	181.3	1.28
2	206.5	1.46
3	199.1	1.41
Average		1.38

So, the Tensile strength of concrete is taken 1.38 MPa

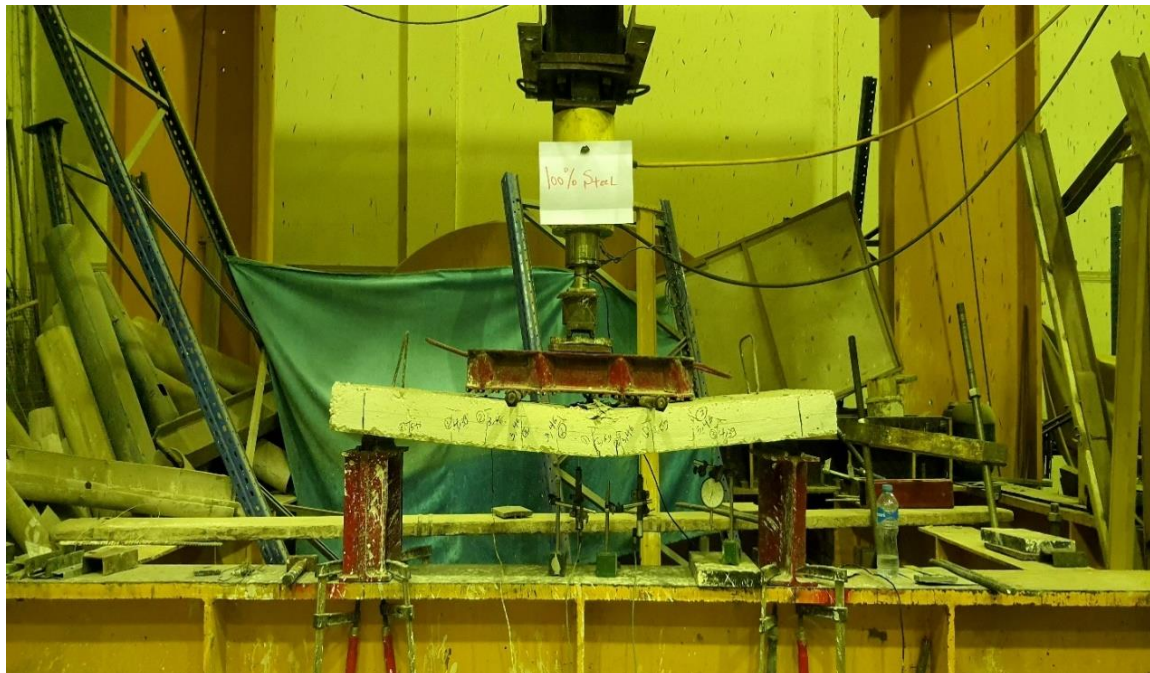
**Figure 11.** Failure mode for the SLAB 100% Steel (S100-B0) %.

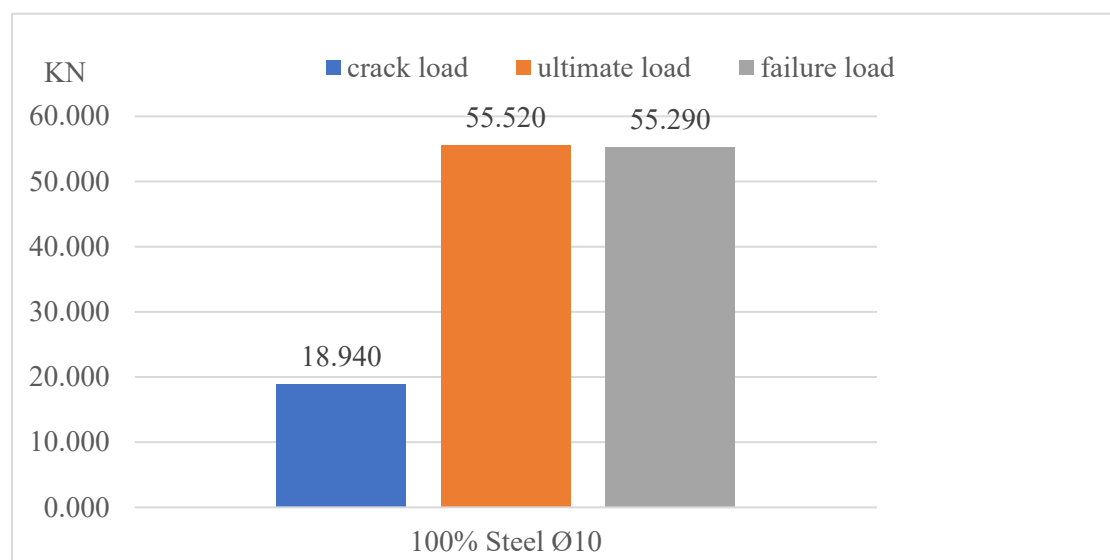
**Figure 12.** Comparison of the cracking, ultimate and failure loads for the Slab (S100-B0) %.

Specimen Code	Cracking Load (kN)	Ultimate Load (kN)	Failure Load (kN)
S100-B0	18.94	47.00	47.00
S80-B20	11.72	45.11	45.11
S60-B40	11.66	41.97	41.97
S40-B60	7.34	24.39	24.39
S40-B60 (12mm)	8.93	27.00	27.00
S20-B80	3.08	13.31	13.31
S0-B100	0.59	2.36	2.36

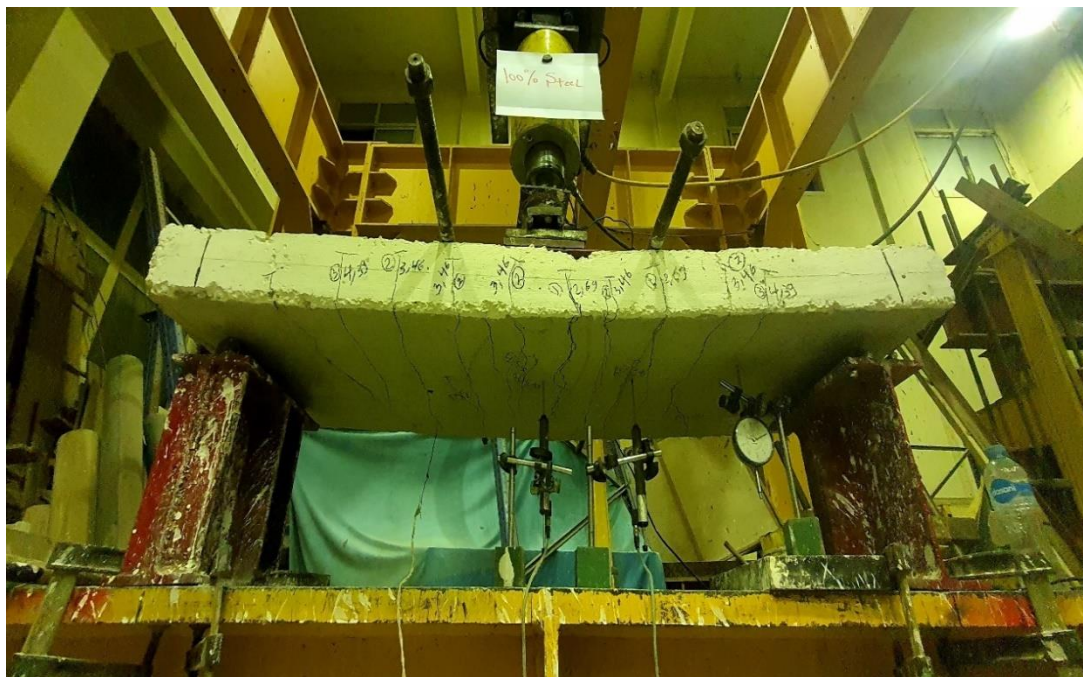
The first crack was observed in the mid-span at 18.940 KN. Upon increasing the load, more flexure cracks appeared in the bottom of the tension zone and expanded vertically upward. The cracks propagated at the maximum tension zone during the sequent loading stages up to failure shown in figure 13.

**Figure 13.** Final Crack patterns for 100% Steel Reinforced Slab (S100-B0) %.

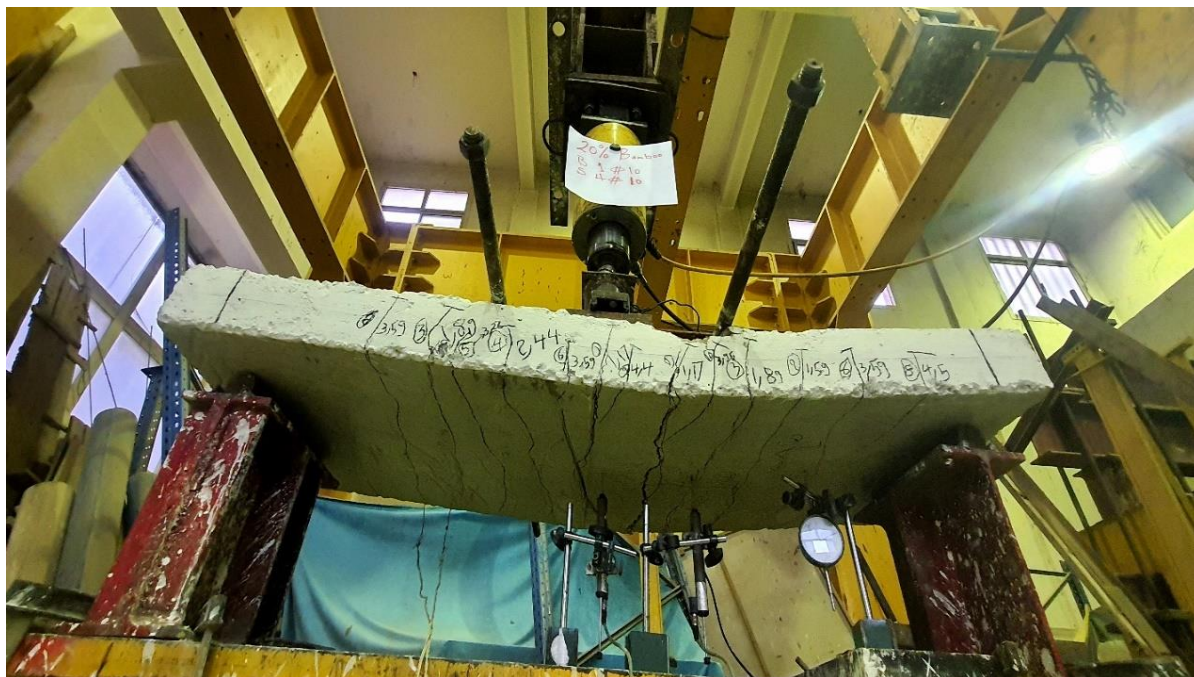
**Figure 1.** Failure mode for the Slab 20% Bamboo (S80-B20) %

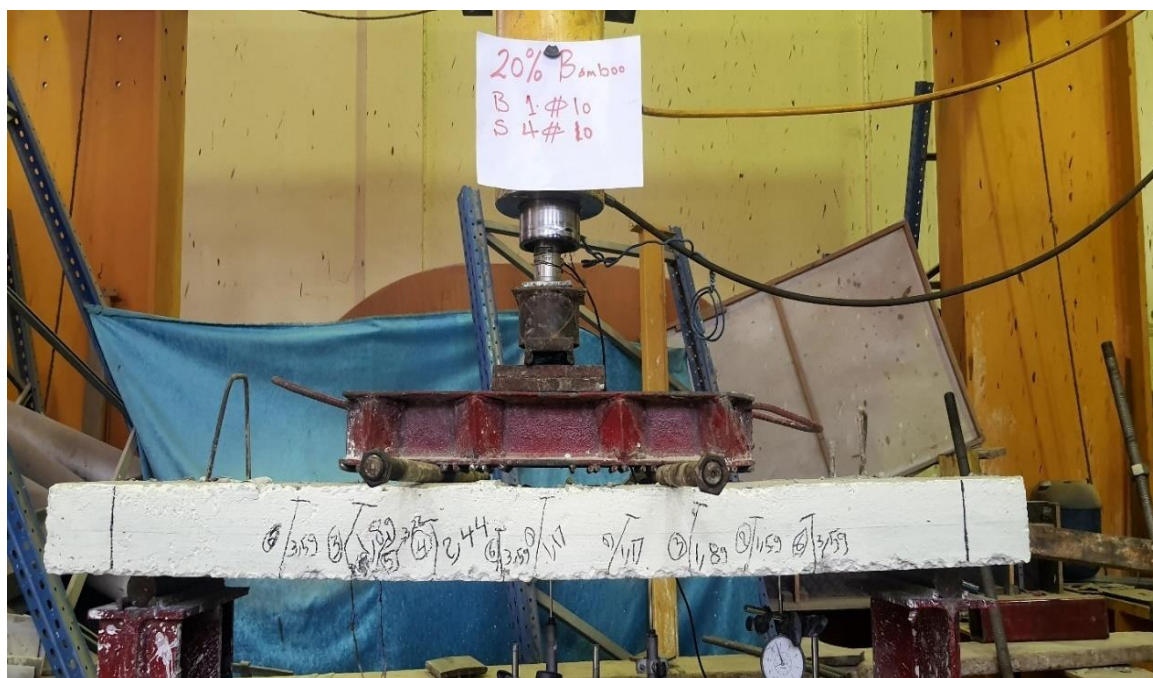
The first crack appeared due to the combined action of bending and shearing at 11.72 KN, which spread as shown in figure No (16). The second crack also appeared at a load of 15.92 KN, and it was distributed as in the picture. The third crack appeared with a load of 18.88 KN and. The fourth crack appeared at a load of 24.39 KN, the fifth crack appeared at a load of 32.26 KN. The sixth crack appeared at a load of 35.87 KN, and the seventh crack appeared at a load of 43.45 KN. The eighth crack appeared at a load of 45.11 KN. The failure of the concrete slab occurs when a load (45.110) KN. After that, the cracks widen and the load gradually decreases as a result of the collapse of the slab.

**Figure 16.** Final Crack patterns for 20% Bamboo Reinforced Slab (S80-B20) %.

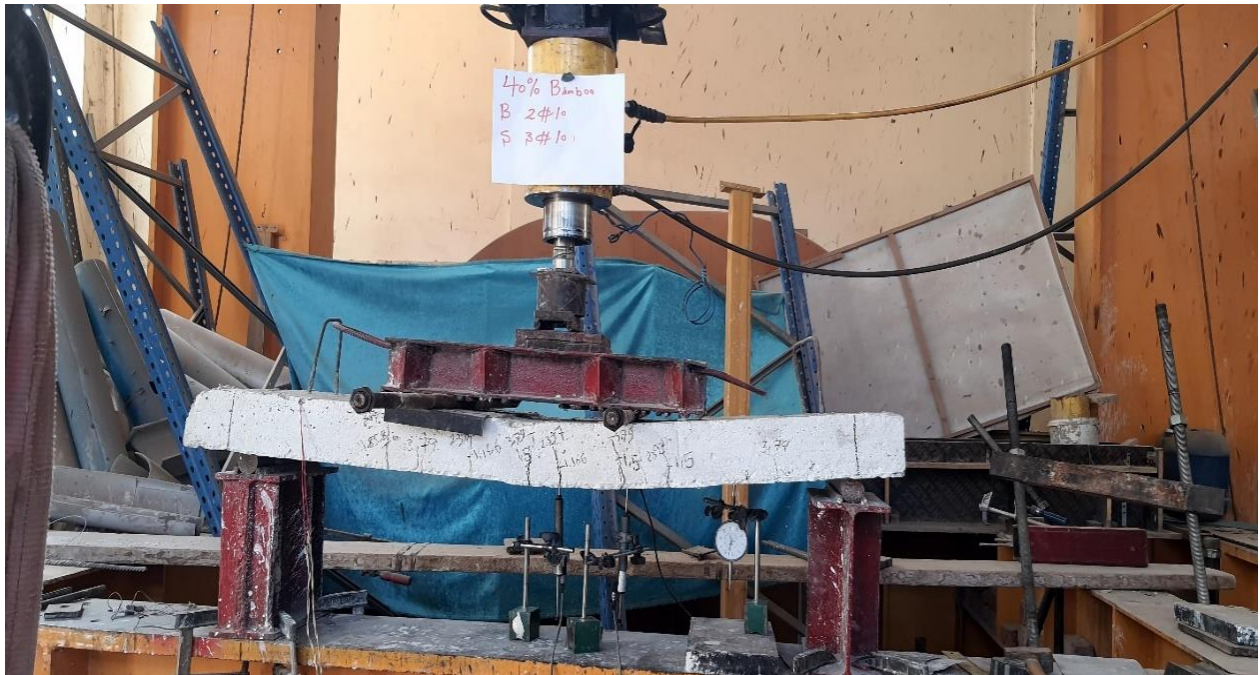
**Figure 17.** Failure mode for the slab 40% Bamboo (S60-B40) %.

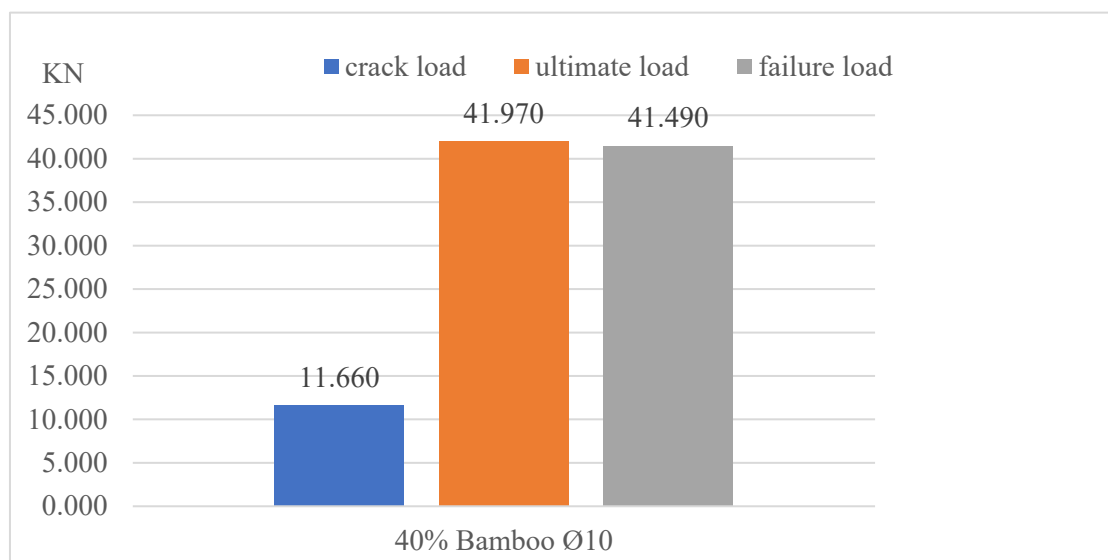
**Figure 18.** Comparison of the cracking, ultimate and failure loads for the slab (S60-B40) %.

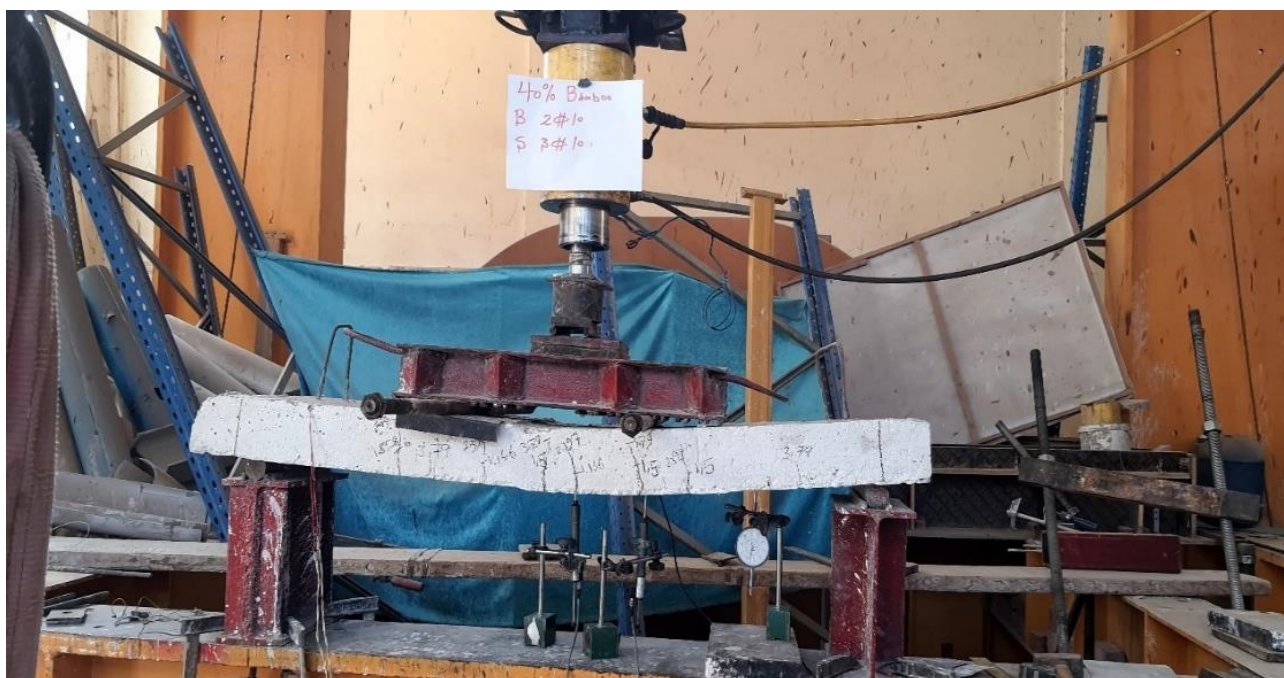
The first crack appeared due to the combined action of bending and shearing at 11.66 KN, which spread as shown in figure No (19). The second crack also appeared at a load of 15.09 KN, and it was distributed as in the picture. The third crack appeared with a load of 18.58 KN and. The fourth crack appeared at a load of 23.97KN, and the fifth crack appeared at a load of 37.88 KN. The failure of the concrete slab occurs when a load 41.97 KN. A widening of the cracks as the applied load increased, eventually leading to a major flexural crack. After that, the cracks widen and the load gradually decreases as a result of the collapse of the slab at the required load as shown in figure No (19).

**Figure 19.** Final Crack patterns for 40% Bamboo Reinforced Slab (S60-B40) %.

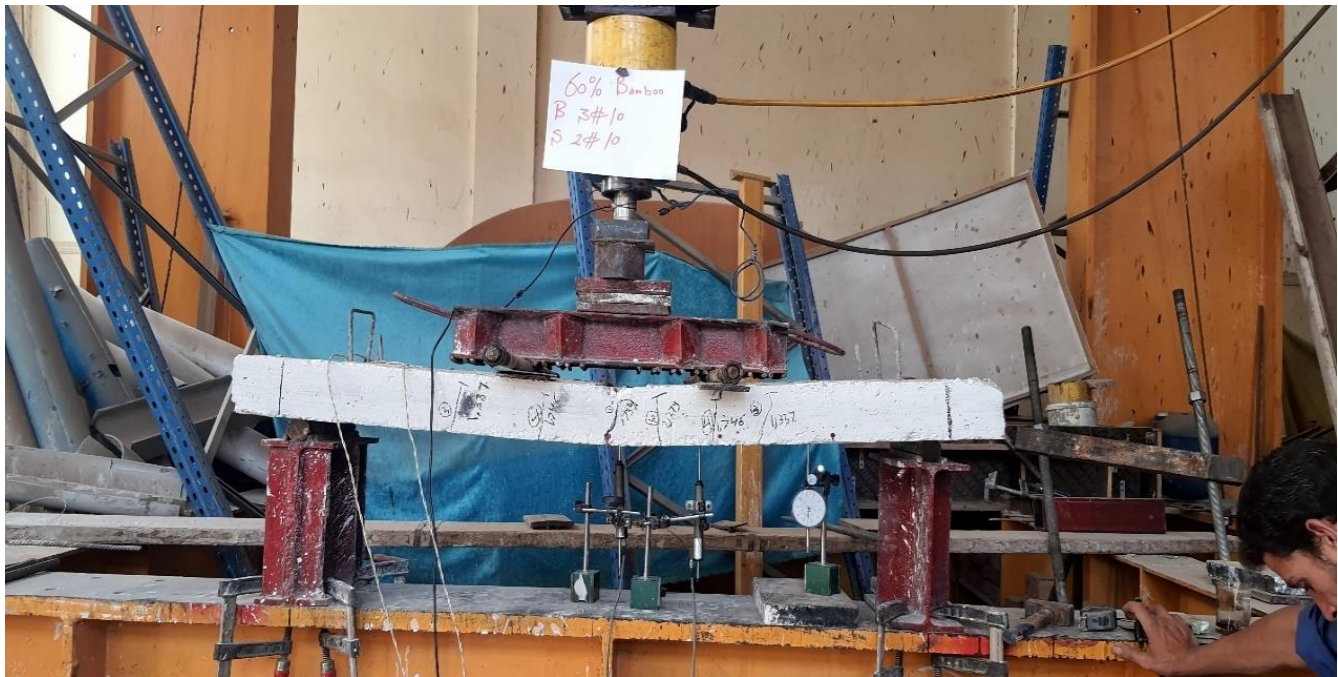
**Figure 20.** Failure mode for the slab 60% Bamboo (S40-B60) %.

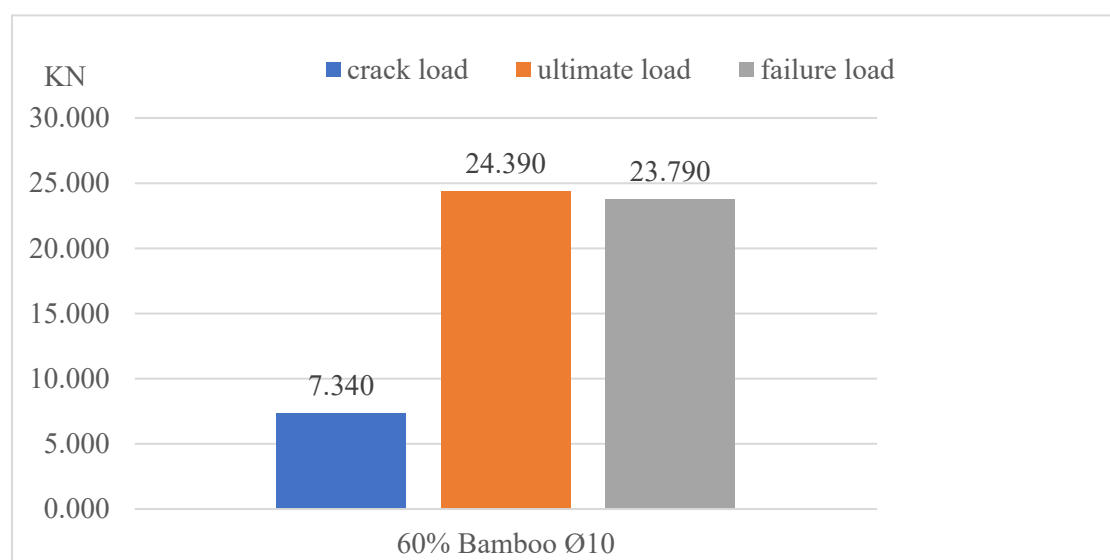
**Figure 21.** Comparison of the cracking, ultimate and failure loads for the slab (S40-B60) %.

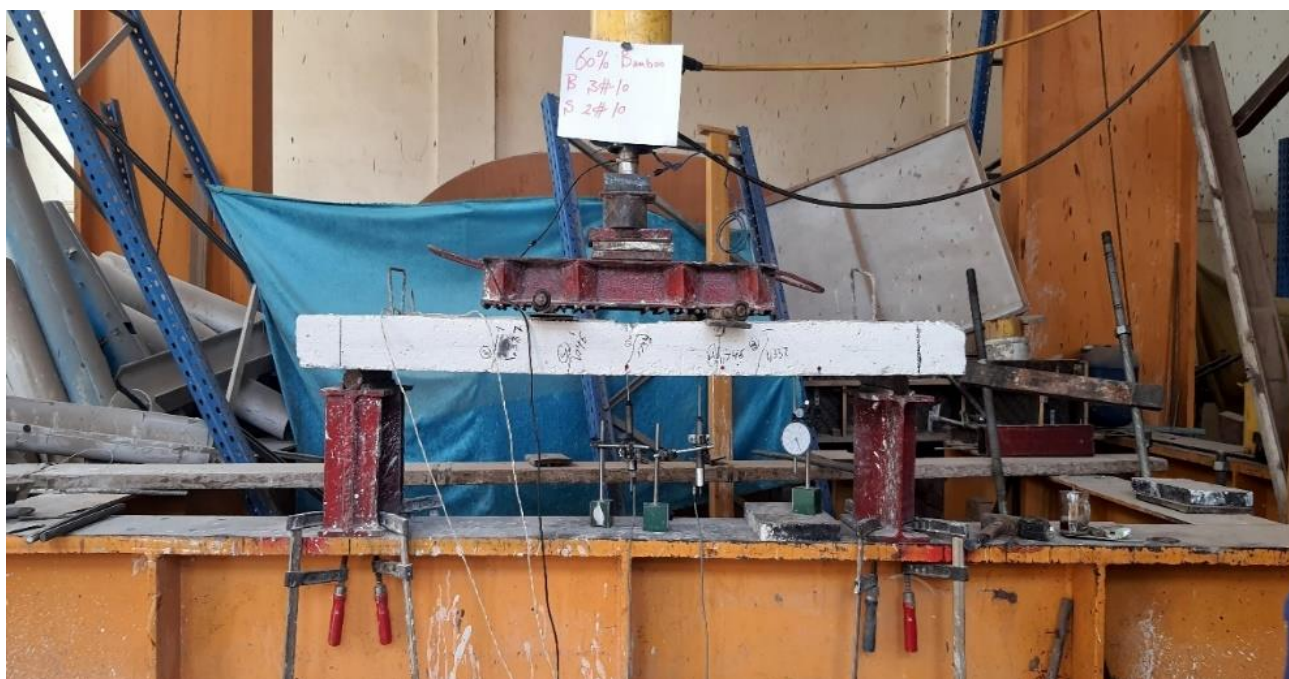
The first crack appeared due to the combined action of bending and shearing at 7.34 KN, which spread as shown in figure No (22). The second crack also appeared at a load of 11.6 KN, it was distributed as in the picture. The third crack appeared with a load of 13.37 KN, the fourth crack appeared at a load of 17.46 KN, and the fifth crack appeared at a load of 19.53 KN. The failure of the concrete slab occurs when a load 24.39 KN. A widening of the cracks as the applied load increased, eventually leading to a major flexural crack. After that, the cracks widen and the load gradually decreases as a result of the collapse of the slab at the required load as shown in figure No (22).

**Figure 22.** Final Crack patterns for 60% Bamboo Reinforced Slab (S40-B60) %.

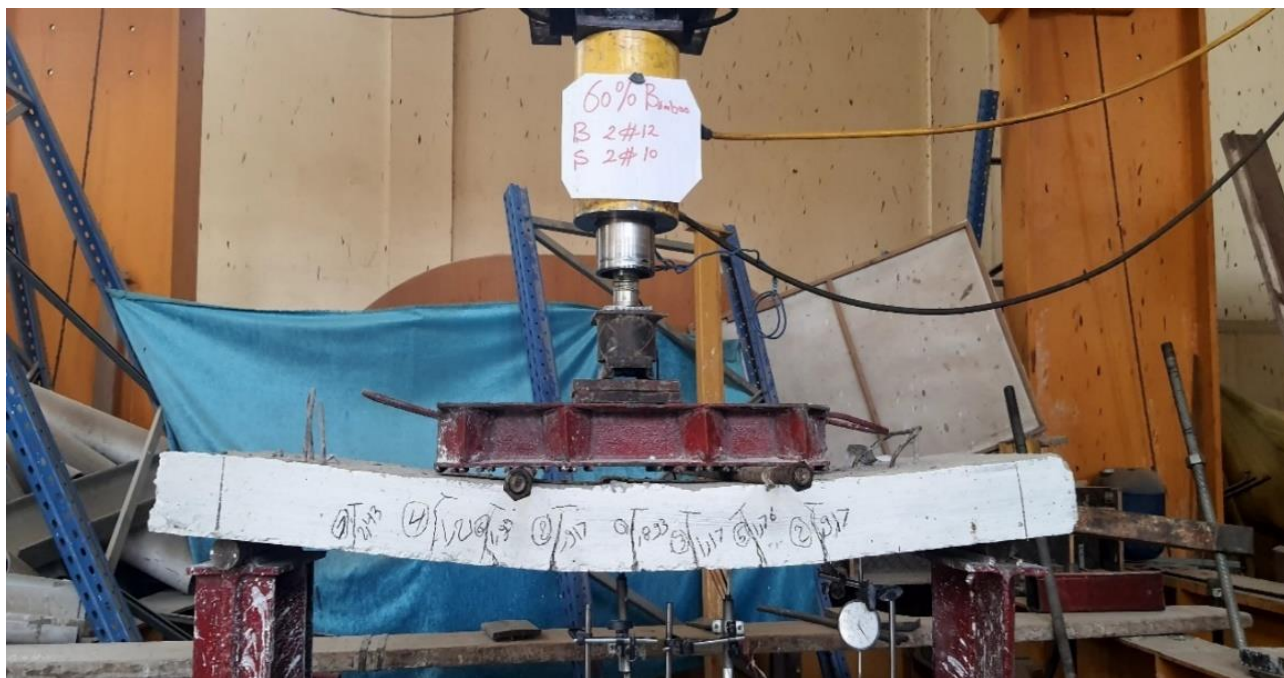
**Figure 23.** Failure mode for slab Reinforced (S40-B60 12mm) %.

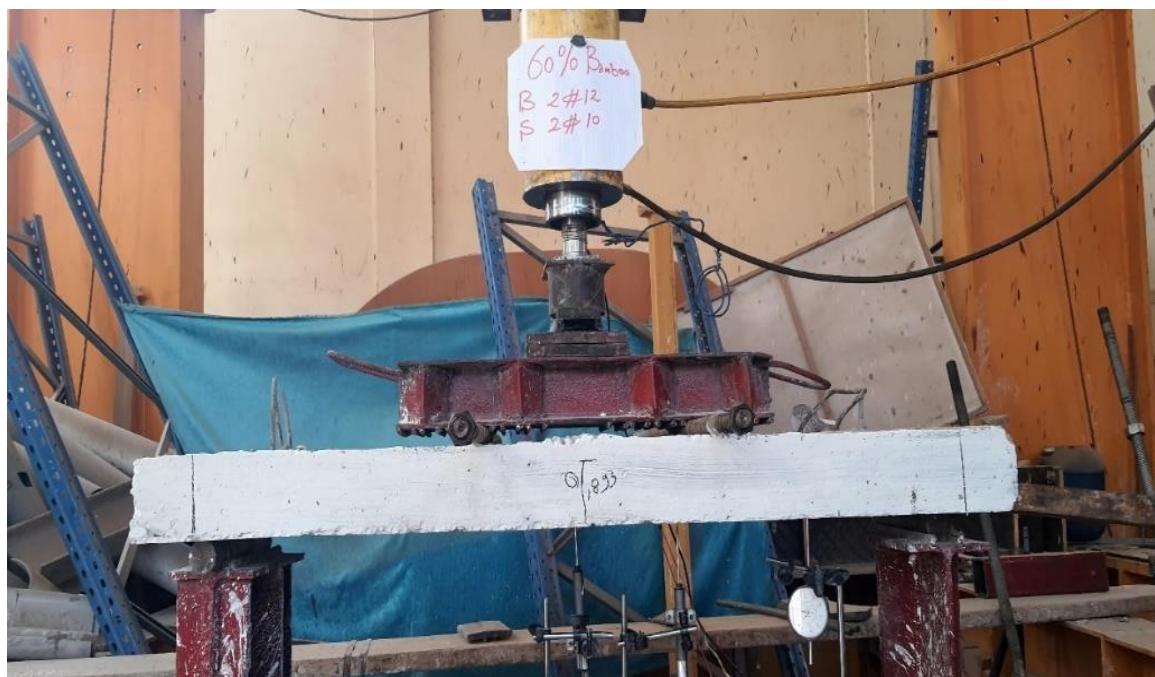
The first crack was observed in the mid-span at 8.93 KN. Upon increasing the load, more flexure cracks appeared in the bottom of the tension zone and expanded vertically upward. The cracks propagated at the maximum tension zone during the sequent loading stages up to failure shown in figure 25.

**Figure 25.** Final Crack patterns for 60% Bamboo Reinforced Slab (S40-B60 12mm) %.

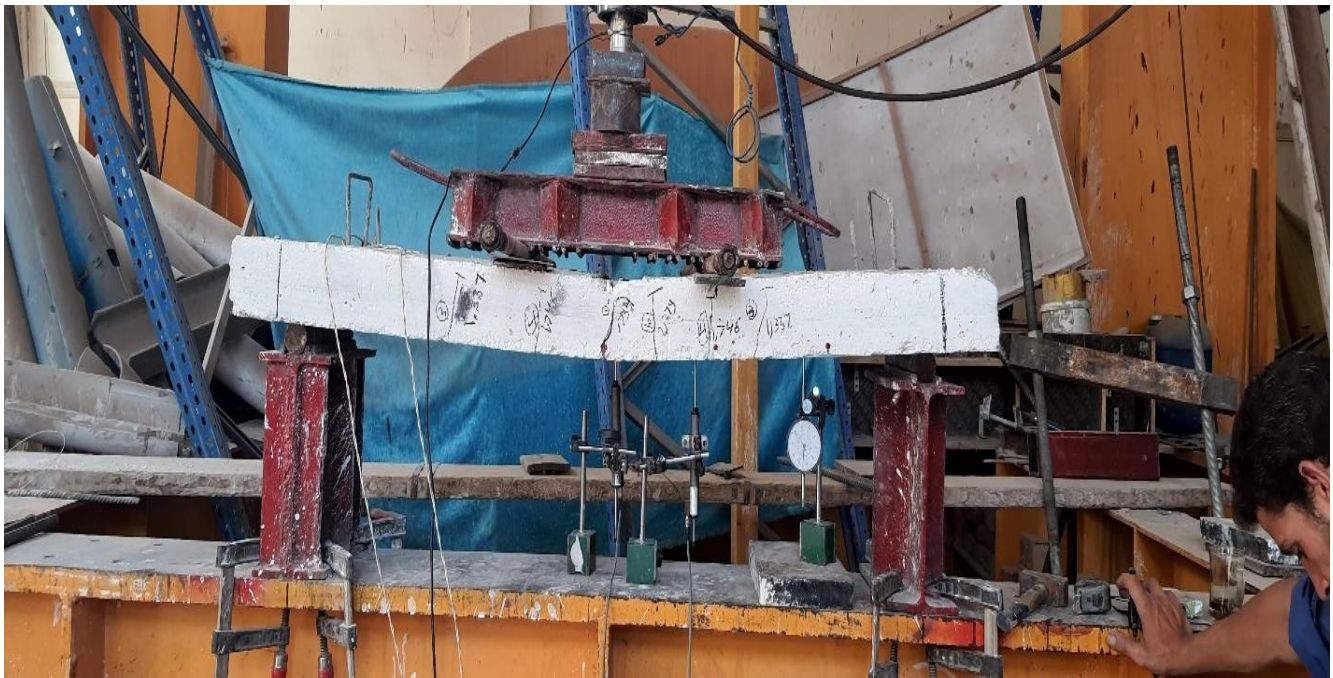
**Figure 26.** Failure mode for the slab 80% Bamboo (S20-B80) %.

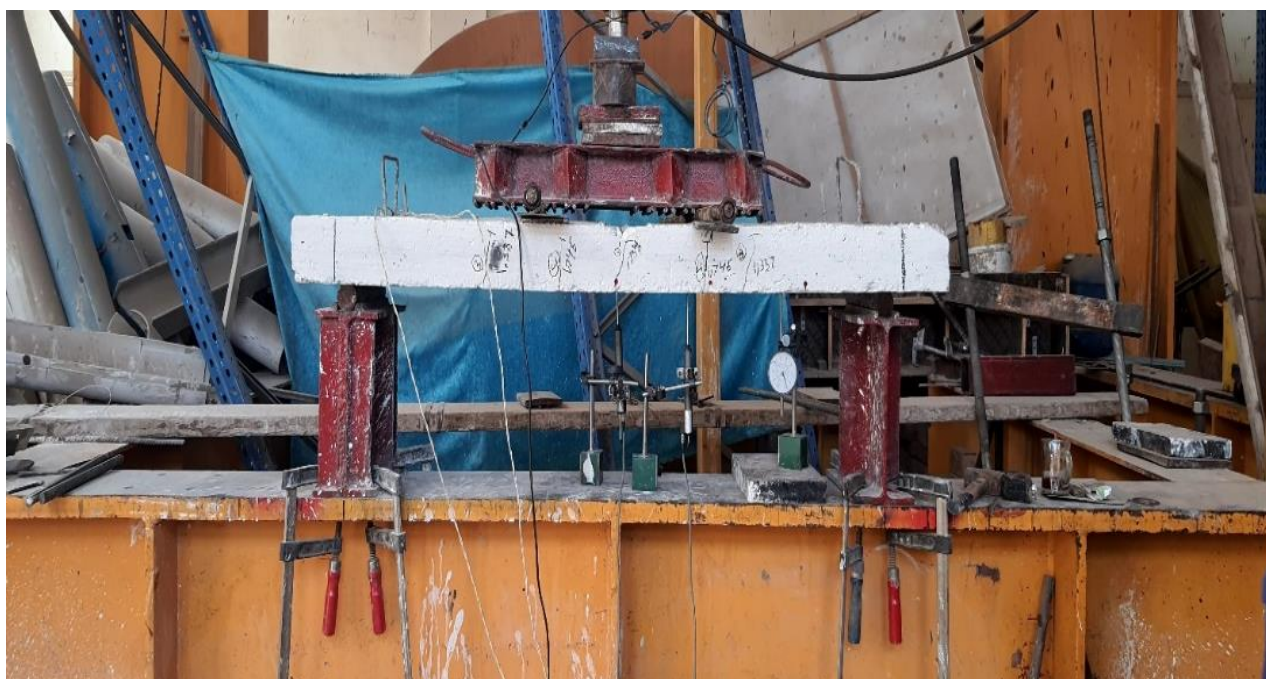
The first crack appeared due to the combined action of bending and shearing at 3.075 KN, which spread as shown in figure No (28). The second crack also appeared at a load of 4.080 KN, it was distributed as in the picture. The third crack appeared with a load of 5.205 K, the fourth crack appeared at a load of 3.300 KN, and the fifth crack appeared at a load of 8.345 KN. The failure of the concrete slab occurs when a load 13.315 KN. A widening of the cracks as the applied load increased, eventually leading to a major flexural crack. After that, the cracks widen and the load gradually decreases as a result of the collapse of the slab at the required load as shown in figure No (28).

**Figure 28** Final Crack patterns for 80% Bamboo Reinforced Slab (S20-B80) %.

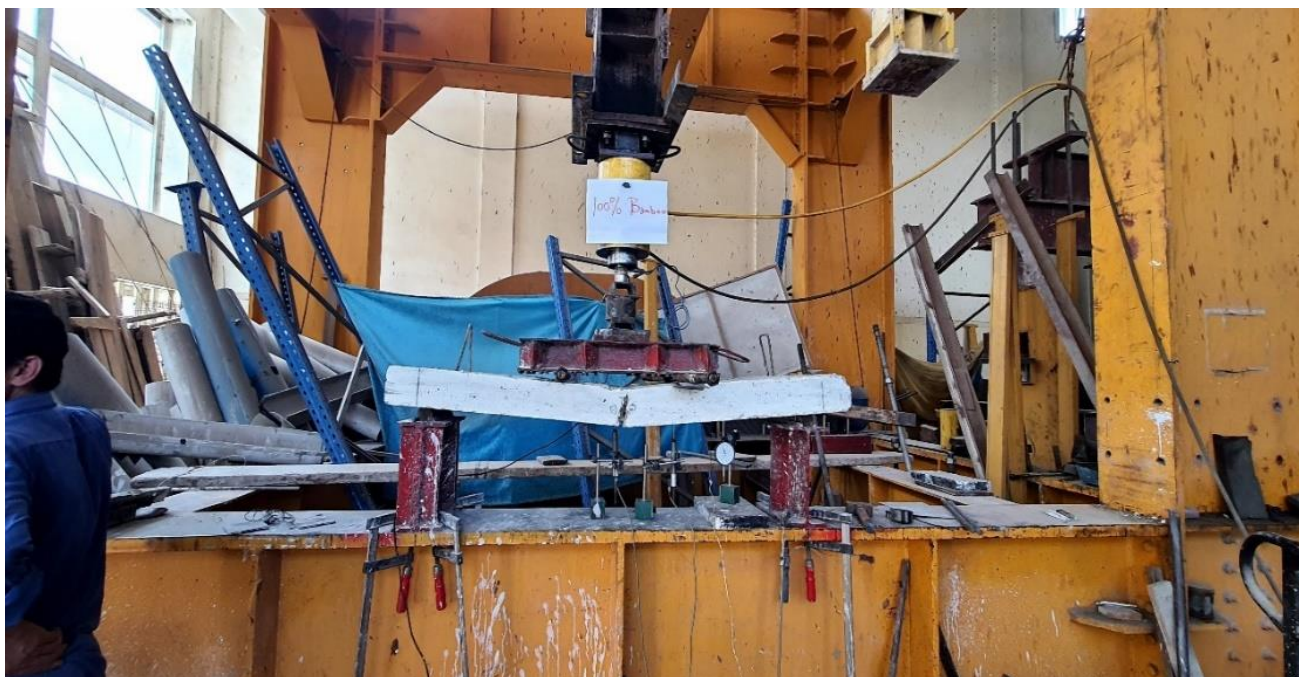
**Figure 29.** Failure mode for the slab 100% Bamboo (S0-B100) %.

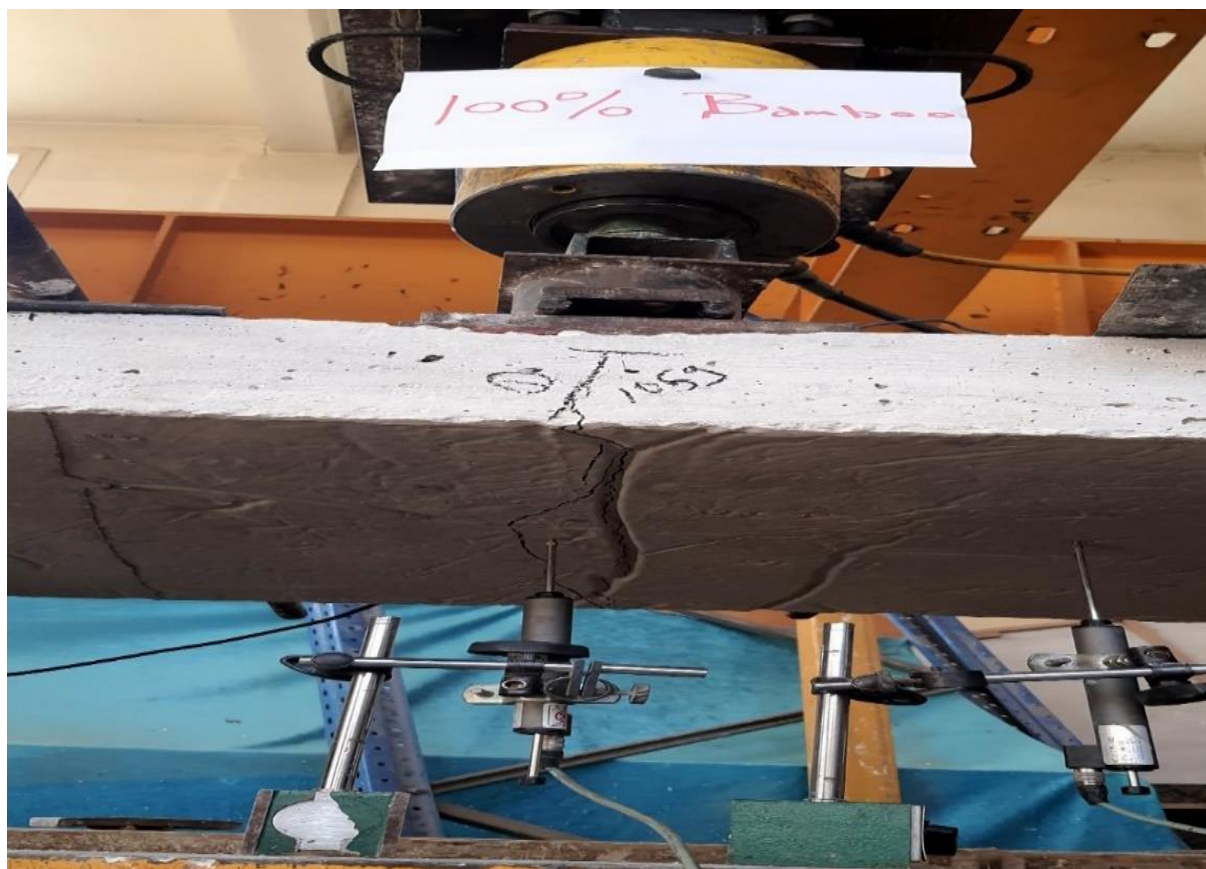
The crack appeared due to the combined action of bending and shearing at 0.590 kN, the failure of the concrete slab occurs when a load 2.360 kN. After that, the crack widens and the load gradually decreases as a result of the collapse of the slab at the required load as shown in figure No (31).

**Figure 31.** Final Crack patterns for 100% Bamboo Reinforced Slab (S0-B100) %.
