Study the effect of hybrid steel on concrete column mixed with sea water under axial Load

Waleed Mohamed Fouad Tawhed¹, Amal Hassanin Ibrahim¹, Magdy Mahmoud Mohamed Genidi¹, Ahmed Mohamed Rabie^{1,*}

¹Civil Engineering Department, Faculty of Engineering Mataria, Helwan University

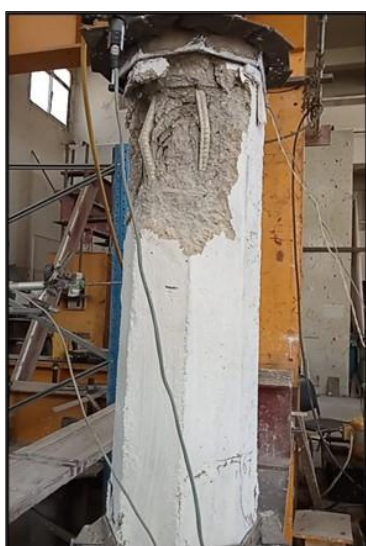
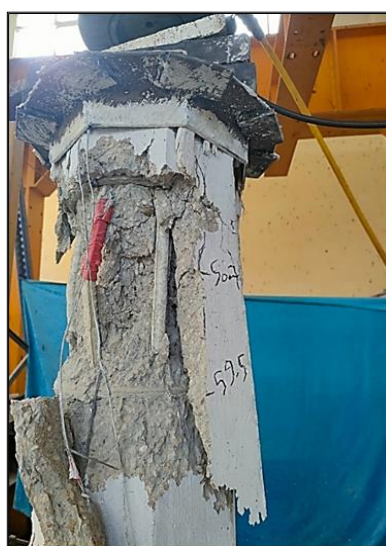
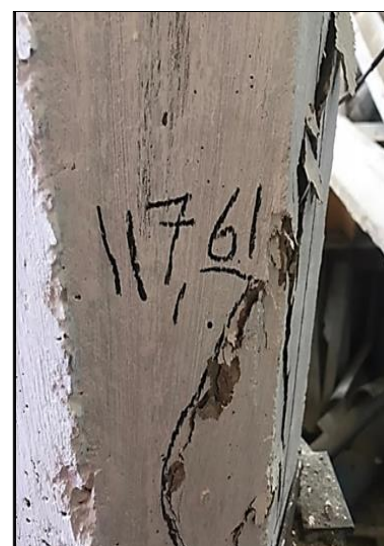
The first crack appeared either at the Top of the Column zone, and some finer cracks appeared in the bottom, all tested column failed after the propagation of cracks downwards to the loading region, and location of cracks was almost exclusively at Top zones photo 1,2, and 3 depicts the cracking pattern of specimen C1, C3, C6

Photo1: C1

Photo2: C3

Photo3: C6

Group	Column No	Mode of failure	Cracking Load (KN)	P failure (KN)	At Failure	
					Axial Displacement (MM)	P Crack /P failure
Group 1	C1	Crushing	670	887	10.29	0.75
	C3	Crushing	648	717	37.7	0.90
	C6	Crushing	743	1176	37.9	0.63

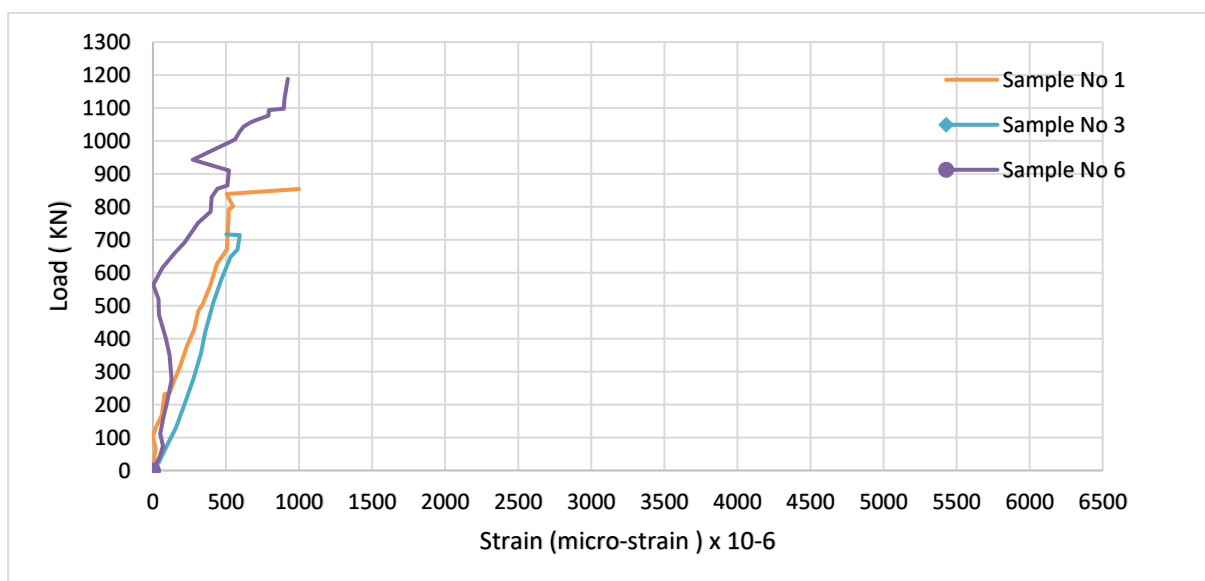
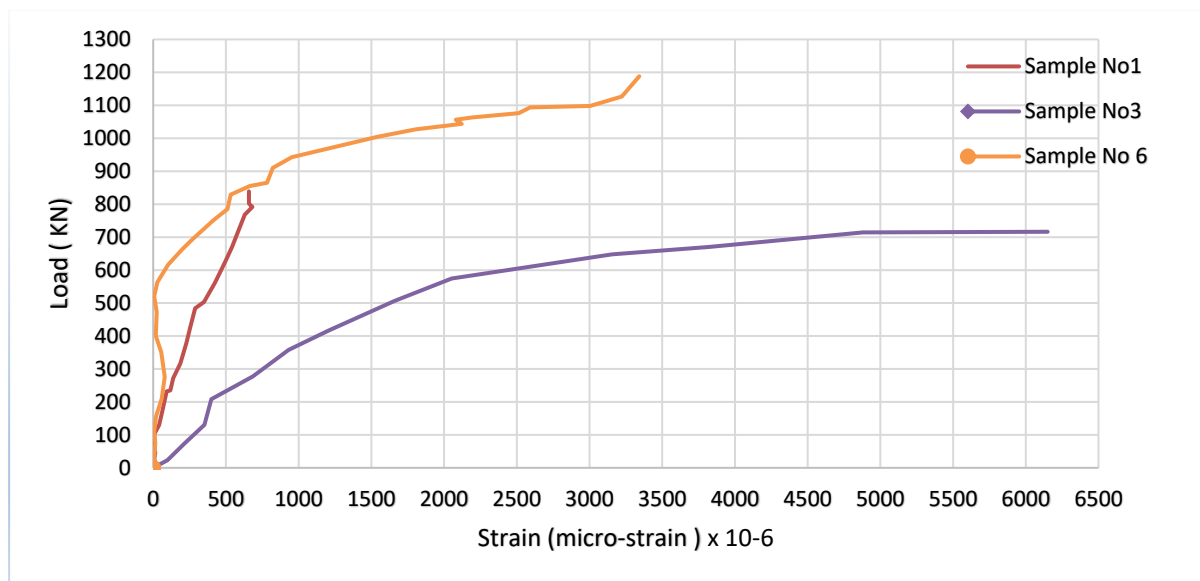
The mid and upper quarter sections of the primary reinforcing steel bars housed the strain gauges. Observe that (S1-sf 16%-(50%Cf. 50%Cs)), (S3-sf 16%-(100%Cf. 0%Cs)), and (S6-sf 16%-(0%Cf 100%Cs)) are the results. For all three specimens, the relationship was linear; however, only specimen

number six remained linear until the failure load was reached. We note that the maximum strain in the upper quarter of the RFT bar is 923, corresponding to (S6-sf 16%-(0%Cf.100%Cs)). We note that the maximum strain is 6150, which is based on the strain curves depicted in Figure 5-6

(S3-sf 16%-(100%Cf. 0%Cs)).

Fig 5: Strain for Mid part of the RFT bar

Fig 6: Strain for upper quarter part of the RFT bar

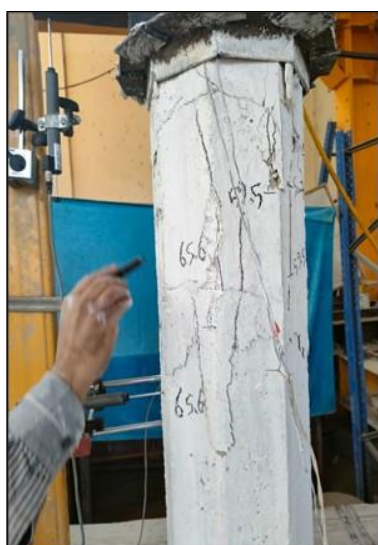
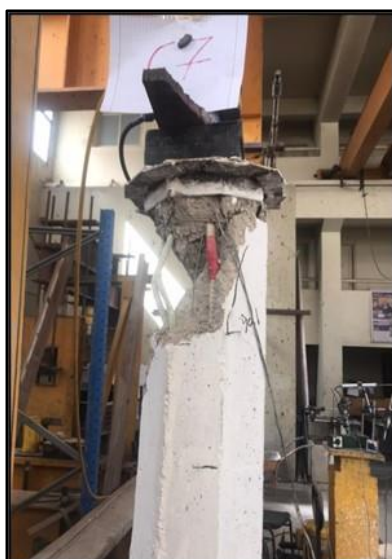
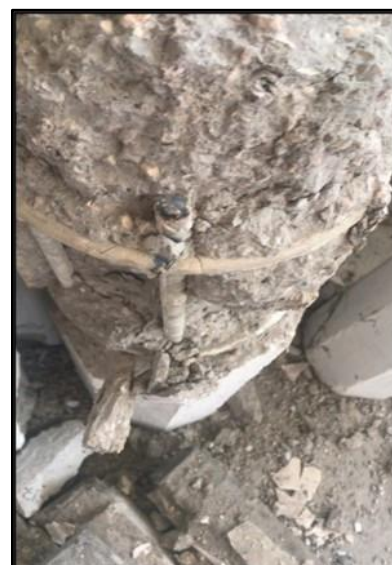
All tested columns failed after the cracks spread downward to the loading region, with the majority of the cracks appearing at the top zones of the column. The first crack was either at the top of the column zone, and some finer cracks also appeared at the bottom. The tested columns in group 2's cracking patterns are displayed in photo 4,5,and 6 following failure. The first crack developed in column (S2-sf 33%-(50%Cf. 50%Cs).) with volume fraction (V_f) = 33% at a load of roughly 667 kN. As the load increased, more cracks started to show up through the upper quarter of the column, and at a load of roughly 770 kN, the column gave way. S7-sf 33%-(100%Cf. 0%Cs).) is a column that contains

the first crack developed at a load of roughly 390 kN, volume fraction (V_f) = 33%. More cracks started to show up as the load increased, passing the upper quarter of the column, and the column

finally failed at a load of roughly 900 KN. Column (0%Cf.100%Cs).-S9-sf 33%- The first crack developed at a load of roughly 570 KN, containing volume fraction (V_f) = 33%. As the load was increased, more cracks started to show through the column's upper quarter, and at a load of roughly 867 KN, the column broke. Concentrated loads caused cracking, with the major propagating through the top zone in the loading area, and these failure crack patterns were almost identical for the three tested columns (C2, C7, and C9).

Photo 4 :C2

Photo 5: C7

Photo 6: C9

Group	Column No	Mode of failure	Cracking Load (KN)	P failure	At Failure	
					Axial Displacement (MM)	P Crack /P failure
Group 2	C2	Crushing	667	770	10.85	0.86
	C7	Crushing	390	900	9.05	0.36

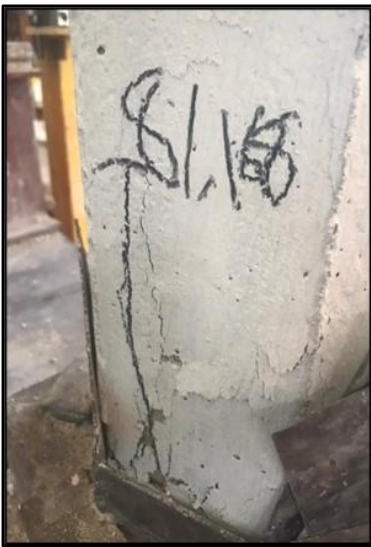
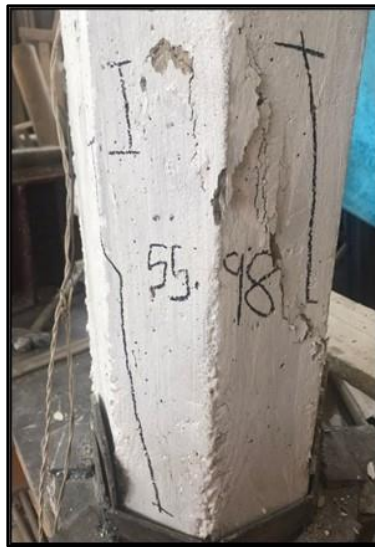
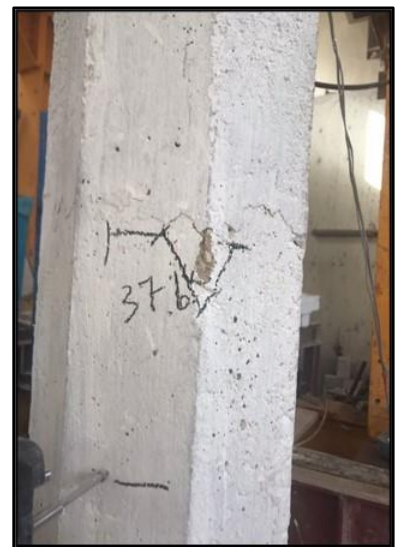
All tested columns failed after the cracks spread downward to the loading region, with the majority of the cracks appearing at the top zones of the column. The first crack was either at the top of the column zone, and some finer cracks also appeared at the bottom. The tested columns in group 3's cracking patterns are displayed in Photo 7, 8, and 9 following failures. The S8-sf 50%-(100%Cf. 0%Cs) Column At a load of roughly 673 KN, the first crack emerged, containing volume fraction (V_f) = 50%. More cracks started to show up as the load increased; passing the upper quarter of the column, and the column finally broke at a load of roughly 832 KN.

containing volume fraction (V_f) = 50%, the first crack emerged at a load of roughly 560 KN (S11-sf 50%-(0%Cf. 100%Cs)). More cracks started to show up as the load increased, passing the upper quarter of the column, and the column finally failed at a load of roughly 895 KN. 50%-(50%Cf. 50%Cs) in S12-sf At a load of roughly 375 KN, the first crack developed, containing volume fraction (V_f) = 50%. More cracks started to show up as the load increased; passing the upper quarter of the column, and the column finally broke at a load of roughly 719 KN. The three tested columns (C8, C11, and C12) had failure crack patterns that were almost identical in that concentrated loads led to cracking, with the majority propagating through the loading area experiments' top zone for the tested specimens in Group 3.

Photo 7: C8

Photo 8: C11

Photo 9: C1

Group	Column No	Mode of failure	(KN)	P failure	At Failure	
					Axial Displacement (MM)	P Crack/P failure
Group 3	C8	Crushing	673	832	35.75	0.80
	C11	Crushing	560	895	29.46	0.62
	C12	Crushing	375	719	34.85	0.52

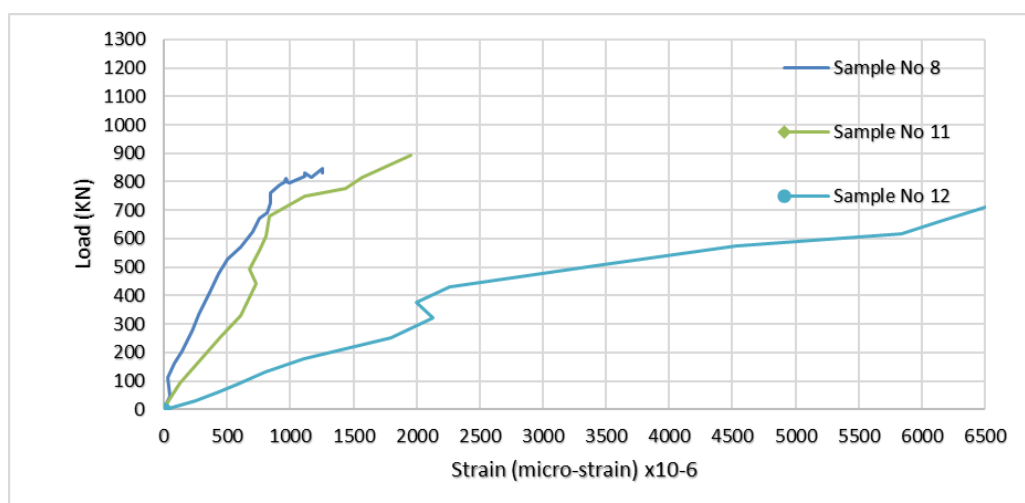
The mid-height column's strain gauges were fastened to the primary steel bars that provided reinforcement. (S8-sf 50%-(100%Cf. 0%Cs)), (S11-sf 50%-(0%Cf.100%Cs)), and (S12-sf 50%-(50%Cf.50%Cs)) are the findings that indicate this. With regard to the three specimens, the relationship was linear. The maximum strain in the upper quarter of the RFT bar, as we can see, is 6135, which is based on (S12-sf 50%-(50%Cf.50%Cs)). We note that the maximum strain is 3201, which is based on the strain curves depicted in Figures 9–10 (S8–sf 50%–(100%Cf. 0%Cs)).

**Fig 9:** Strain for upper quarter part of the RFT bar

**Fig 10:** Strain for Mid part of the RFT bar

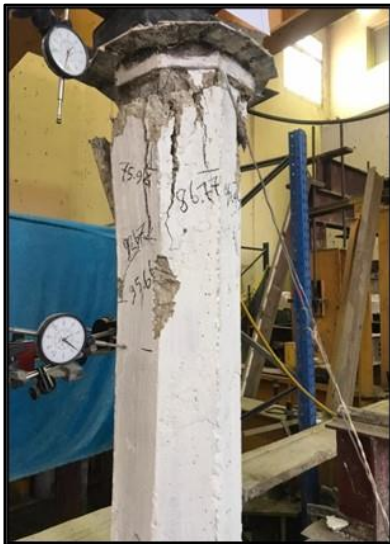
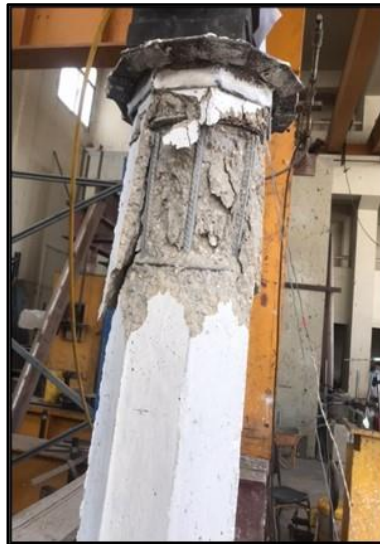
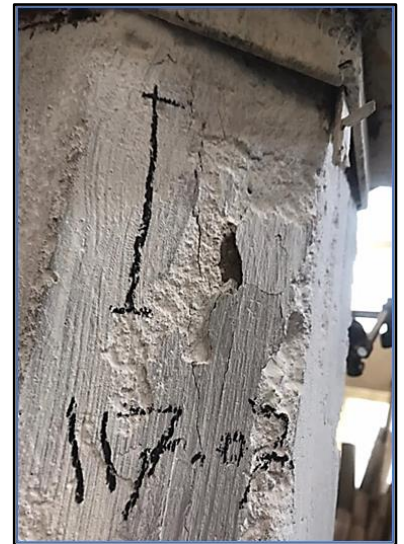
All tested columns failed after the cracks spread downward to the loading region, with the majority of the cracks appearing at the top zones of the column. The first crack was either at the top of the column zone, and some finer cracks also appeared at the bottom. The tested columns in group 4's cracking patterns are displayed in Photo 10,11, and 12 following failures. The S4-sf 0%-(50%Cf. 50%Cs) Column At a load of roughly 791 KN, the first crack emerged, containing volume fraction (V_f) = 0%. As the load was increased, more cracks started to show through the column's upper quarter, and at a load of roughly 965 KN, the column failed.

Containing volume fraction (V_f) = 0%, the first crack (S5-sf 0%-(0%Cf. 100%Cs).) Emerged at a load of roughly 854 KN. More cracks started to show up as the load increased, passing the upper quarter of the column, and the column finally broke at a load of roughly 1211 KN. (0%-(100%Cf. 0%Cs)-S10-sf.) At a load of roughly 759 KN, the first crack emerged, containing volume fraction (V_f) = 50%. More cracks started to show up as the load increased; passing the upper quarter of the column, and the column finally broke at a load of roughly 956 KN. The three tested columns (C4, C5, and C10) had failure crack patterns that were almost identical in that concentrated loads led to cracking, with the majority propagating through the loading area experiments' top zone for the tested specimens in Group 4.

Photo 10: C10

Photo 11: C4

Photo 12: C5

Group	Column No	Mode of failure	Cracking Load (KN)	P failure	At Failure	P Crack/P failure
					Axial Displacement (MM)	
Group 4	Sample 4	Crushing	791	965	35.75	Sample 4
	Sample 5	Crushing	854	1211.3	29.46	Sample 5
	Sample 10	Crushing	759	956	34.85	Sample 10

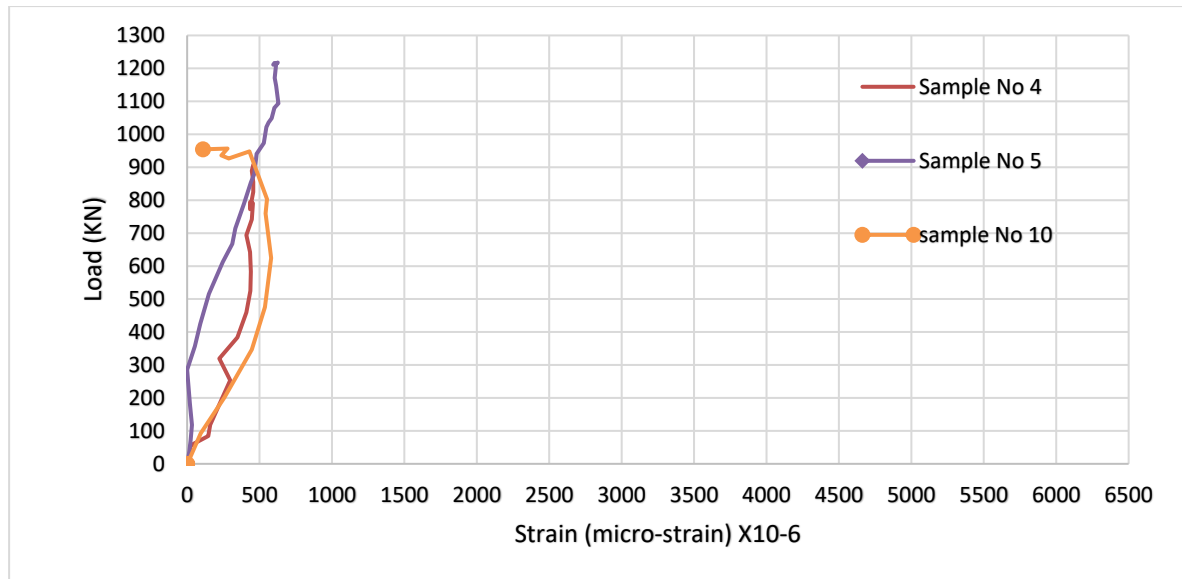
The mid-height column's strain gauges were fastened to the primary steel bars that provided reinforcement. (S4-sf 0%-(50%Cf. 50%Cs)), (S5-sf 0%-(0%Cf.100%Cs)), and (S10-sf 0%-(100%Cf.0%Cs)) are the findings that indicate this. With regard to the three specimens, the relationship was linear. We note that the maximum strain in the upper quarter of the RFT bar is 1278, corresponding to (S10-sf 0%-(100%Cf.0%Cs)). We note that the maximum strain is 630, which is based on the strain curves depicted in Figures 11–12 (S5-sf 0%-(0%Cf.100%Cs)).

**Fig 11:** Strain for upper quarter part of the RFT bar

Fig 12: Strain for Mid part of the RFT bar
