Spatial Analysis of Hydrological Characteristics and Their Impact on the Stability of the Nile River Banks in the Area Extending from Matai to Al-Fashn

This study investigates the spatial analysis of hydrological characteristics and their influence on the stability of the Nile River banks in the reach between Matai and Al-Fashn. An integrated analytical framework was adopted, beginning with a long-term assessment of channel dynamics and morphological changes over the past seven decades. Remote sensing and Geographic Information Systems (GIS) techniques were employed to monitor these transformations with high precision, enabling the detection of temporal and spatial changes in channel development, meander evolution, island shifts, and variations in water surface area. Such changes are interpreted as direct responses to hydrological, structural, and climatic drivers and are considered early indicators of bank instability. The findings revealed that hydrological parameters—including discharge, flow velocity, water levels, and suspended sediment load—represent critical determinants of riverbank risk, particularly when combined with soil properties. Hydro-mechanical analysis demonstrat

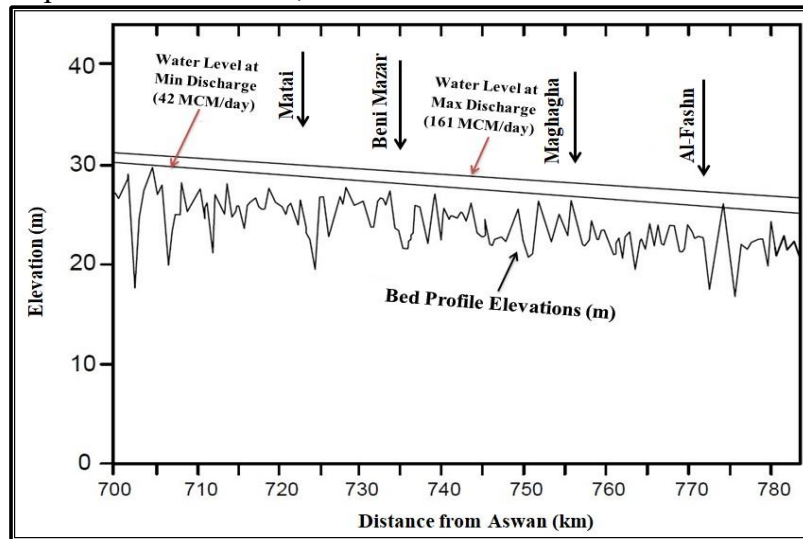
Figure 8. Variation in Bed Elevation along the Nile River Channel from Matai to Al-Fashn

and hydraulic energy distribution, as observed near kilometer marker 757.5 km north of the Aswan Reservoir (Figure 8). Table 4 further reveals substantial topographic variability along the river bed between Matai and Al-Fashn. During maximum discharge conditions, water depths range from 1.81 to 10.52 m, with an average of 5.36 m. Under minimum discharge, depths vary from 0.48 to 9.47 m, averaging 4.18 m. The channel's longitudinal gradient is relatively steep—approximately 10 cm/km, significantly higher than the gradient measured in the Assiut–Cairo reach, which averages 7.5 cm/km (El-Husseiny, 1988, p. 8). The ruggedness and steep gradient of the river bed are attributed to a combination of hydromorphological factors, primarily the variation in erosion and sedimentation rates along the channel, particularly at meander bends. Additionally, the attachment of river islands to one of the banks redirects water flow toward the main channel, increasing current velocity and prompting the river to reshape itself through enhanced lateral and vertical erosion in pursuit of a new state of equilibrium. Human interventions—such as the infilling of secondary channels—also play a role by forcing water into the main channel, thus

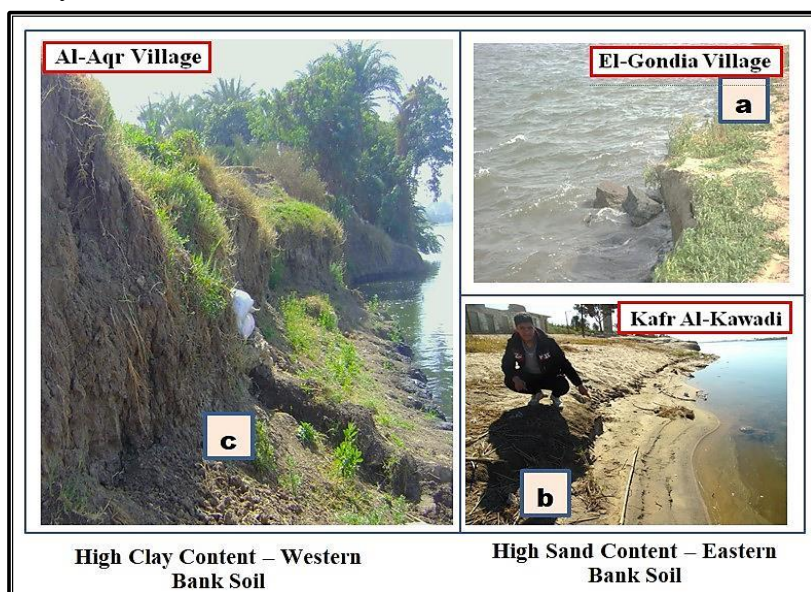
Figure 16. Variation in erosion rates on both river banks due to differences in bank soil composition

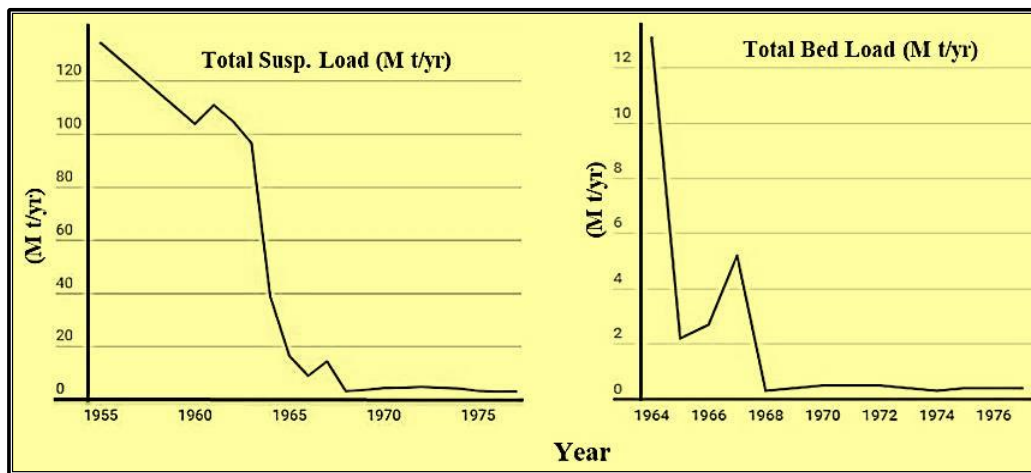
Figure 17. Sharp decline in average suspended and bed load annually behind Assiut Barrages after the construction of the High Dam.

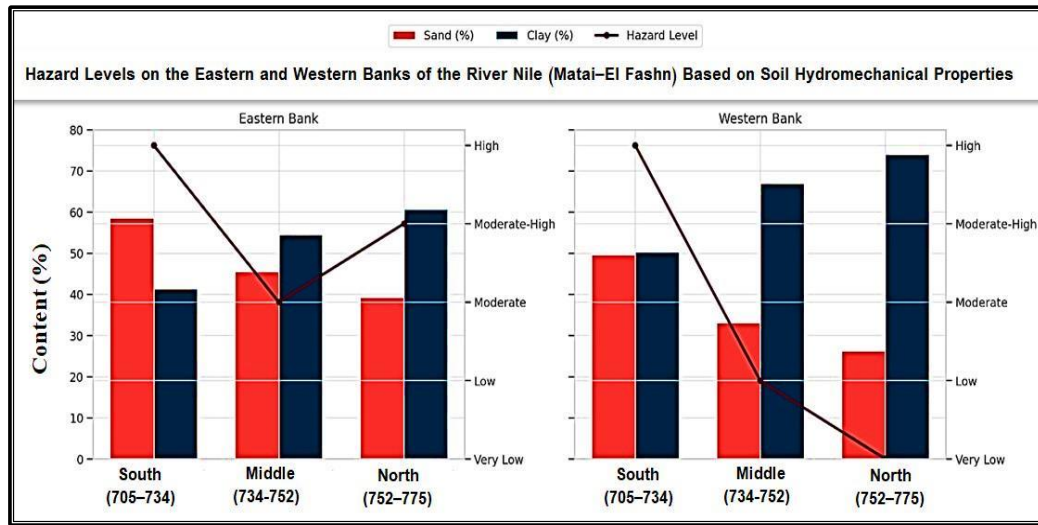
Figure 18. Hazard Levels on the Eastern and Western Banks of the River Nile (Matai–El Fashn) Based on Soil Hydromechanical Properties

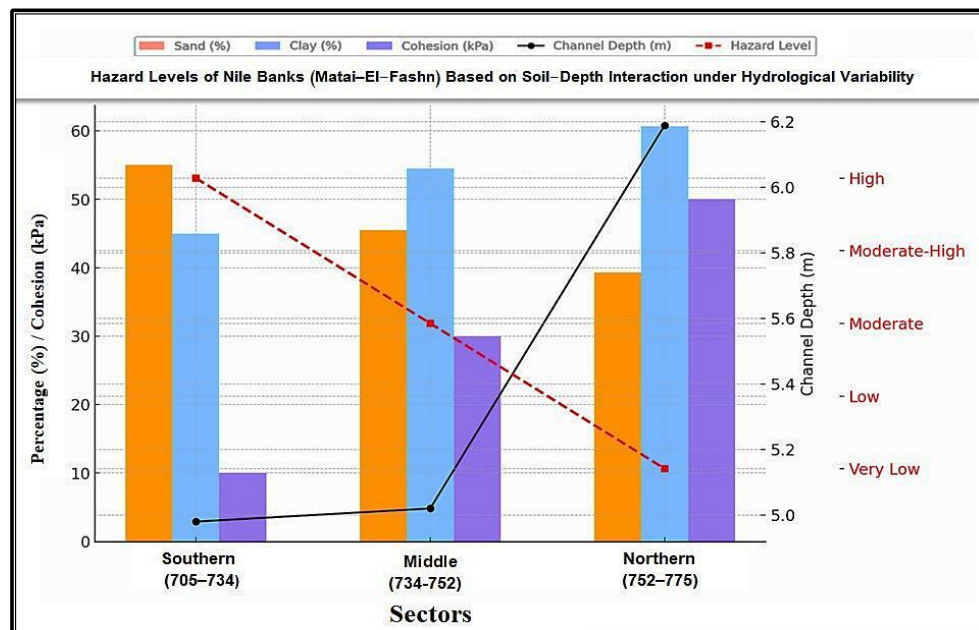
Figure 20. Hazard Levels of the Nile River Banks (Matai–Al-Fashn) Based on Channel Depth and the Hydromechanical Properties of Bank Soils under the Influence of Discharge Fluctuations

Based on these conditions, the river banks in this sector are classified as moderate to low risk (Table 18; Figure 20), due to the relative balance between adequate cohesion levels, stable moisture content, and moderate channel depth. Nonetheless, sustained hydraulic pressures or recurring hydrological fluctuations could compromise the stability of certain structurally weak zones, especially those with steep slopes or insufficient vegetation (Figure 21).

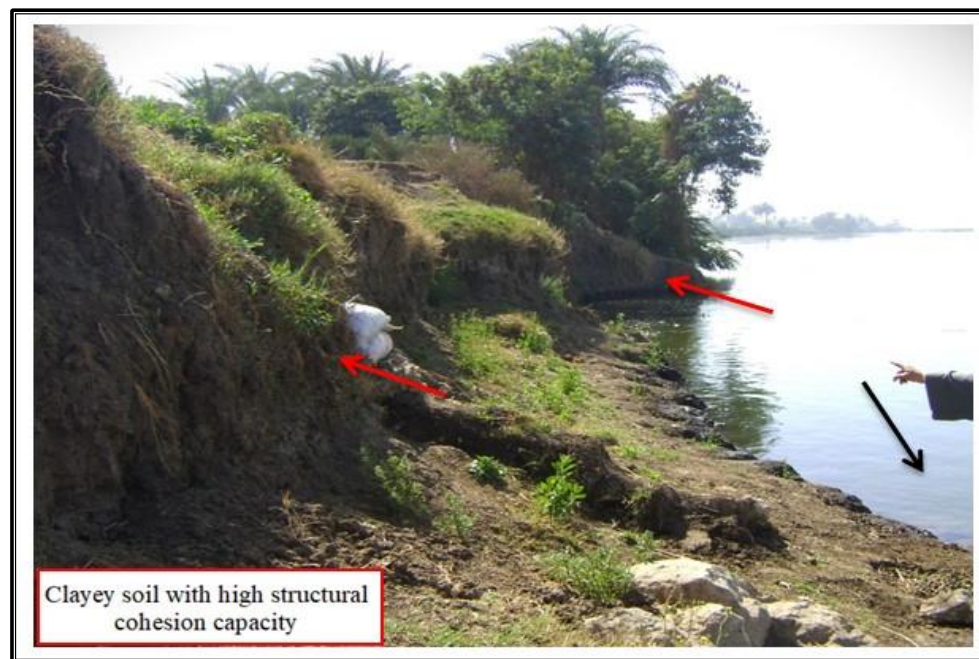
Figure 22. Retention of Structural Cohesion in Clayey River bank Soil during Low Discharge due to Fine Particle Size and Strong Molecular Bonding (Eastern Bank – West of Al-Aqr Village)

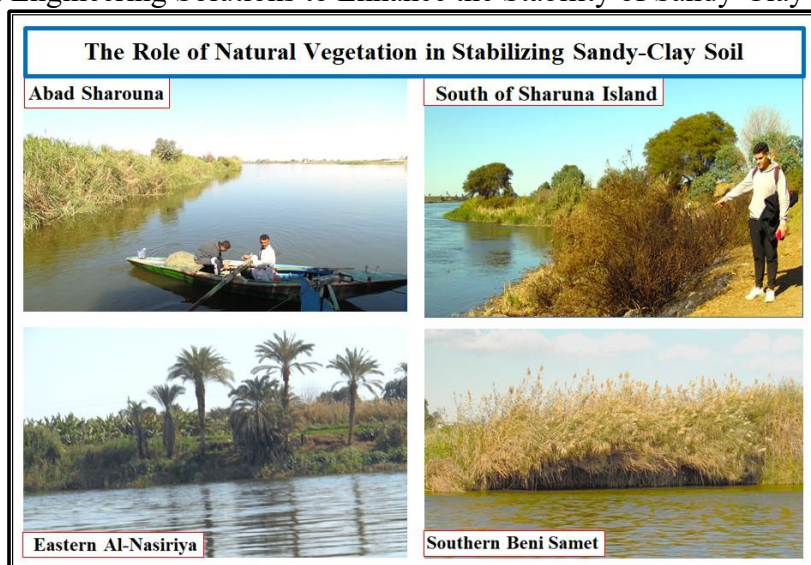
Figure 25. Farmers plant dense vegetation on sandy-clay river banks to improve soil cohesion and contribute to bank stability
