## DIGITAL DOCUMENTATION OF URBAN HERITAGE IN CAIRO: A STUDY OF BAB AL-BARQIYYA AND ITS APPLICATION IN MODERN REHABILITATION PRACTICES

R. B. Afify " Digital Documentation Of Urban Heritage In Cairo: A Study of Bab Al-Barqiyya And Its Application In Modern Rehabilitation Practices", Journal of Al-Azhar University Engineering Sector, vol. 20(77), pp. 1305-1323, 2025.

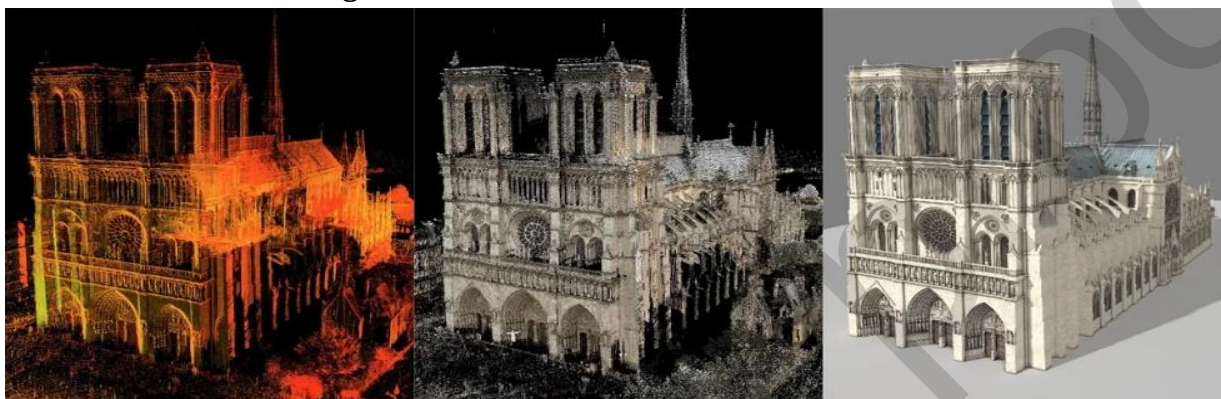
**Fig. 4: LiDAR scanning played used in documenting and planning the restoration of Notre-Dame Cathedral, [13]**

For example, LiDAR scanning used in documenting and planning the restoration of Notre-Dame Cathedral as shown in **Fig. 4**.

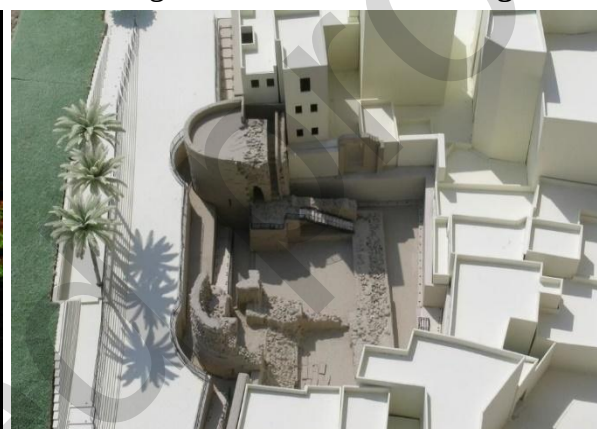
**Fig. 12: 3D Model of Bab Al-Barqiyya**

- a) Photogrammetry: Used to generate accurate 3D visualizations of the gate's architectural form from photographs and provided a spatial basis for identifying deformation, missing stones, and areas of erosion [18].
- b) Point Cloud Analysis: Image-based point clouds were generated to analyze surface conditions and it provided high-precision data for stone-by-stone mapping, especially for irregular surfaces [19], as shown in **Fig.11**.
- c) Digital Visualization: Rendered visualizations and models were shared with the public and stakeholders to enhance public engagement with the heritage site [20], as shown in **Fig. 12**.

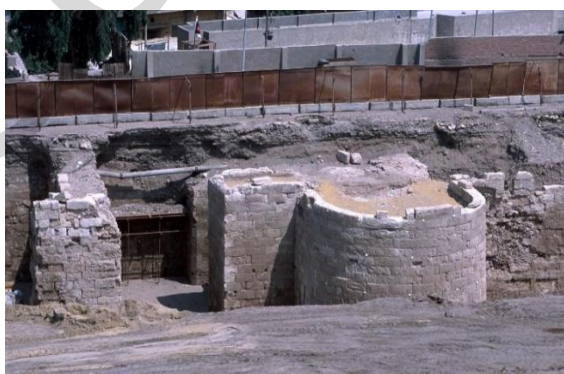
**Fig. 13: loss of stone details before restoration**

- a) Material Condition Assessment
  - High-resolution photogrammetry was employed to capture detailed surface textures and stone conditions. This allowed conservation experts to identify erosion patterns, surface decay, and loss of stone details without physically interfering with the structure. Furthermore, the digital imagery enabled visual comparison between pre-restoration and post-restoration states, enhancing monitoring and planning [11], as shown in **Fig. 13 & Fig. 14**.

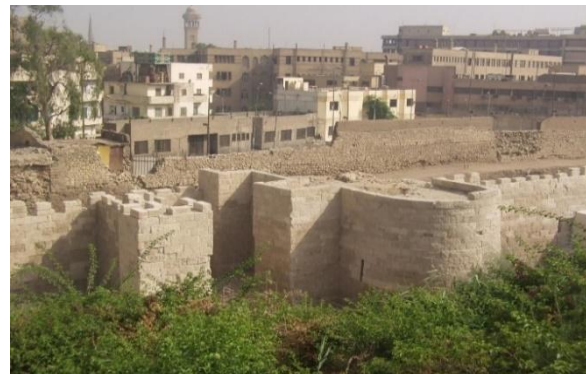
**Fig. 14: the wall after restoration**

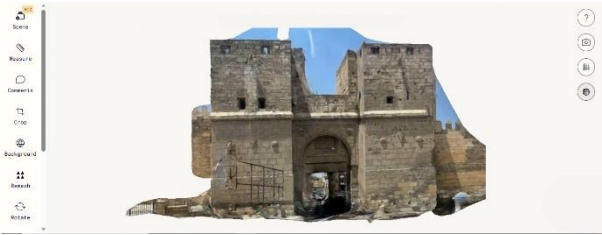
Fig. 19: photogrammetry from Polycam

The photogrammetric model of Bab al-Nasr, was generated using Polycam, a mobile-based 3D scanning application that employs Structure-from-Motion (SfM) and Multi-View Stereo (MVS) algorithms. High-resolution images were captured around the monument using a smartphone camera under consistent lighting conditions to ensure optimal texture mapping and geometric accuracy. These overlapping images were processed directly within the app, where feature matching and triangulation techniques were applied to reconstruct the 3D geometry of the gate, as shown in **Fig. 19**. The result was a textured mesh model as shown in **Fig. 20**, exported in .glb format, representing the architectural features and façade of the gate. Although some geometric distortions were present primarily due to limited access to higher and lateral viewpoints, the model successfully documented key elements such as the arched entrance, stone reliefs, and battlements.
