## Preliminary architectural Study on the Small Chapel of Hathor at Kom Ombo<sup>1</sup>

Aurélie Terrier

Swiss Federal Institute of Technology in Lausanne (EPFL) – SNSF

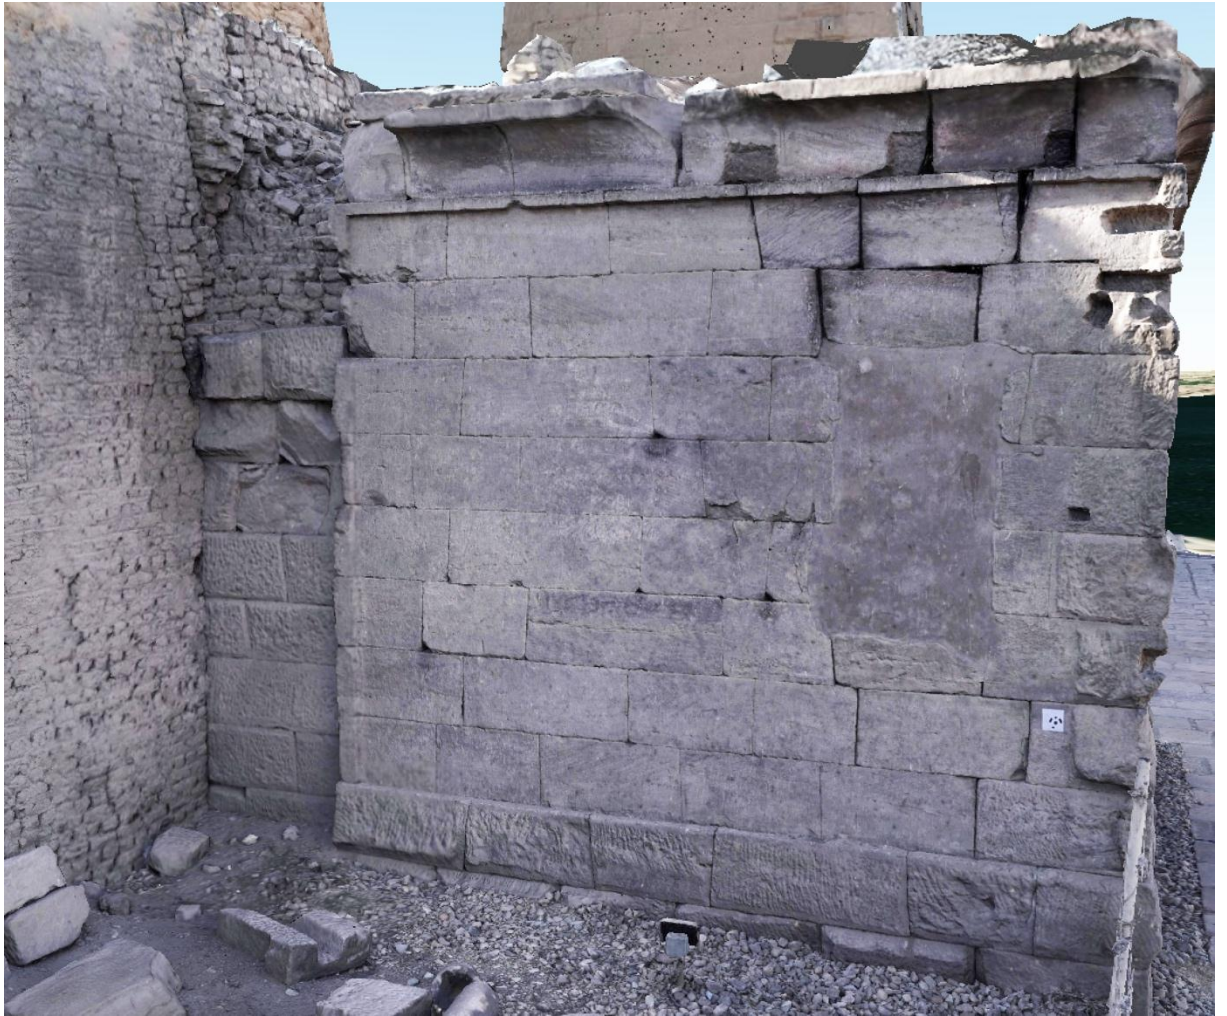
**Pl. 2**

Pl. 2 Photograph of the eastern façade of the chapel (A. Terrier)

The latest interventions observable in the chapel's structures are quite late and were carried out after the site was abandoned as a sanctuary (Pls. 2 and 9). A door was cut in the north wall and a window in the east wall. Furthermore, the longitudinal and slightly curved opening made above the entrance door of the chapel, as well as in the brick elevation above the reconstructed door of the southern chamber suggests the construction of a new area topped by a barrel-vault oriented east-west, occupying a large part of the platform. On the exterior faces of the north and west walls, several sockets can also be observed, indicating the construction of additional spaces.

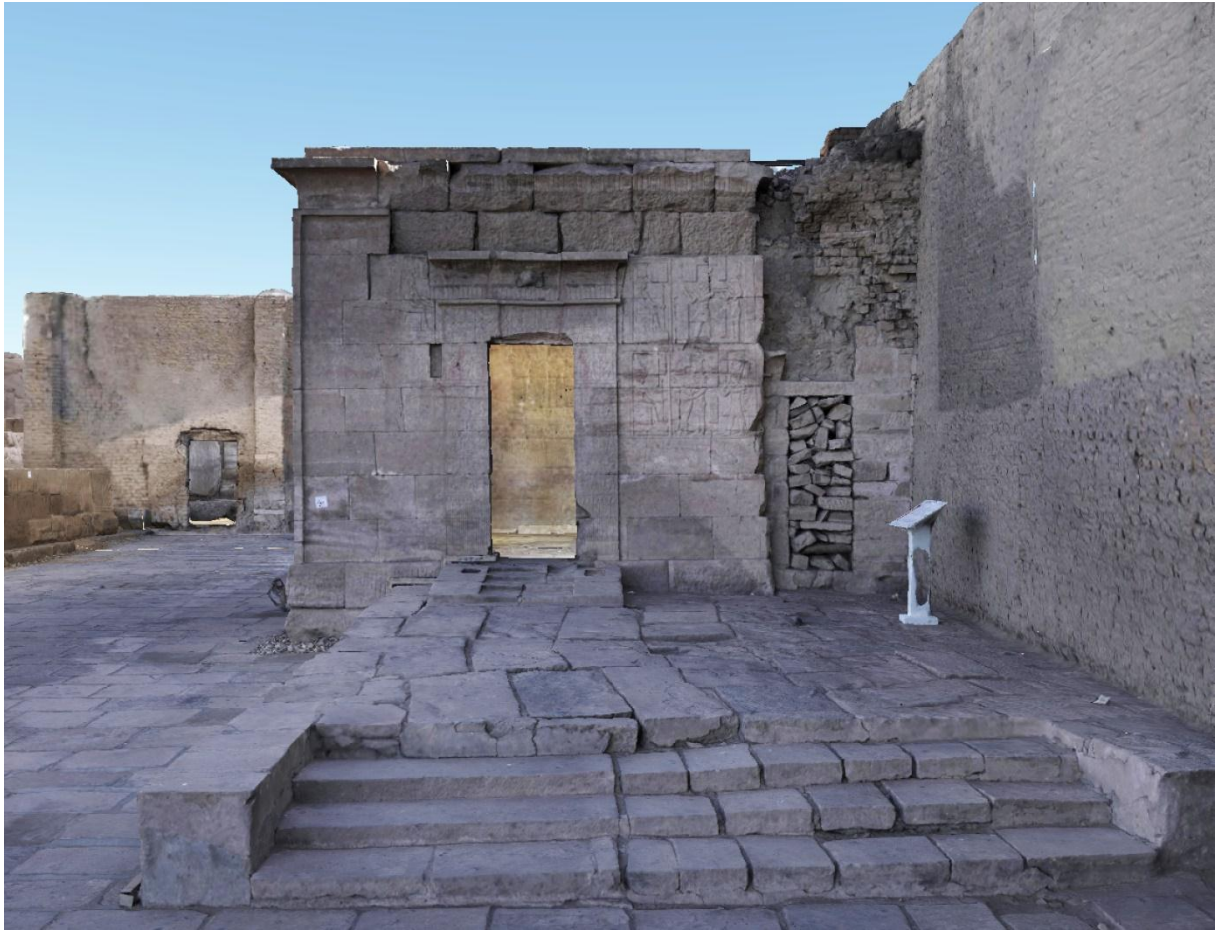
Pl. 3 Photograph of the western façade of the chapel (A. Terrier)

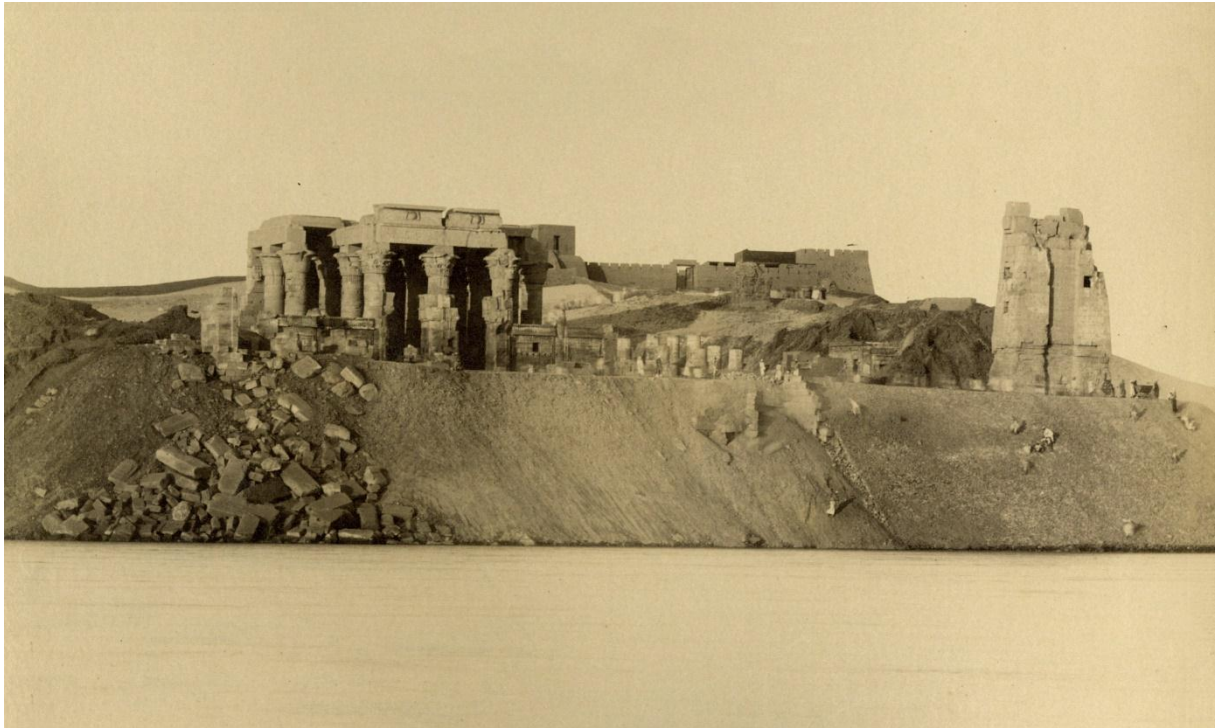
**Pl. 4**

Pl. 4 Photograph of the Temple of Kom Ombo taken from the Nile by A. Beato (Archivio Museo Egizio INV21\_007)

A photograph taken from the Nile in the late 19th century by Antonio Beato shows the construction of the embankment undertaken by de Morgan to halt the erosion of the riverbank (Pl. 4). In this image, the western and southwestern sections of the sanctuary are in the process of being cleared, and the Chapel of Hathor remains partially buried beneath the debris<sup>4</sup>.

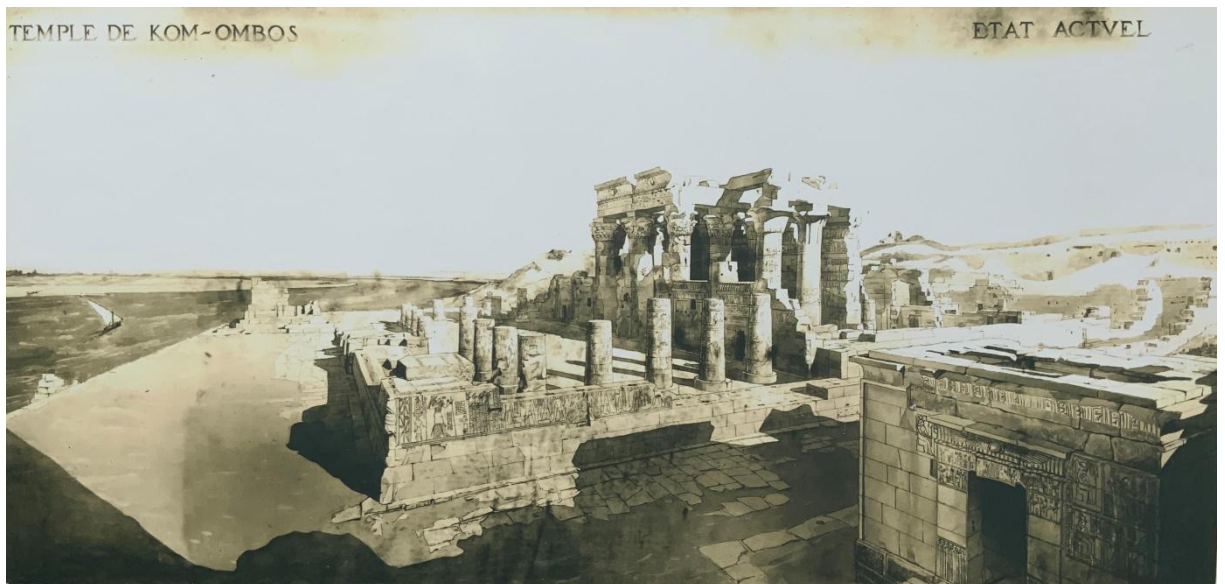
**Pl. 5**

Pl. 5 Perspective view of the Temple of Kom Ombo from the south, by É. André (reproduction of a sepia drawing, 1898, Nancy, Private Collection).

In André's sepia-toned reconstruction of a southwest view of the sanctuary, the chapel appears in the foreground, offering several noteworthy details (Pl. 5). First, the southern room appears to lack a dedicated entrance. The eastern return of the cornice and torus is clearly visible, indicating that no tall structure was attached to this side of the chapel and thus invalidating the theory of a double sanctuary. In addition, several slabs between the northern chapel wall and the southern wall of the main temple courtyard appear to frame the chapel within a quadrangular structure. These paving stones can also be discerned in a photograph showing André and Munier standing in front of the chapel (Pl. 6). It is certain that the wall de Morgan built to enclose the sanctuary was already in place when André conducted his survey, although the corridor adjacent to it still appears to have been accessible.

As mentioned above, André drew a quadrangular structure to the north of the chapel, which appears to be at the same level as the floor south of the courtyard (Pl. 5). We know that he was meticulous in his surveys, and this drawing is as precise as a photograph could be<sup>1</sup>. The stone slabs discovered by the excavation team in 2017 could therefore correspond to those partially visible in the trench north of the platform. Unfortunately, the trench was too narrow to draw any firm conclusions<sup>2</sup>.

<sup>1</sup> Research conducted on the archives of Émile André has shown that he applied his architectural training to produce his drawings. The illustration presented in Pl. 5 is not a simple observational sketch but a constructed perspective, meaning that precise measurements were taken to accurately represent all the structures.

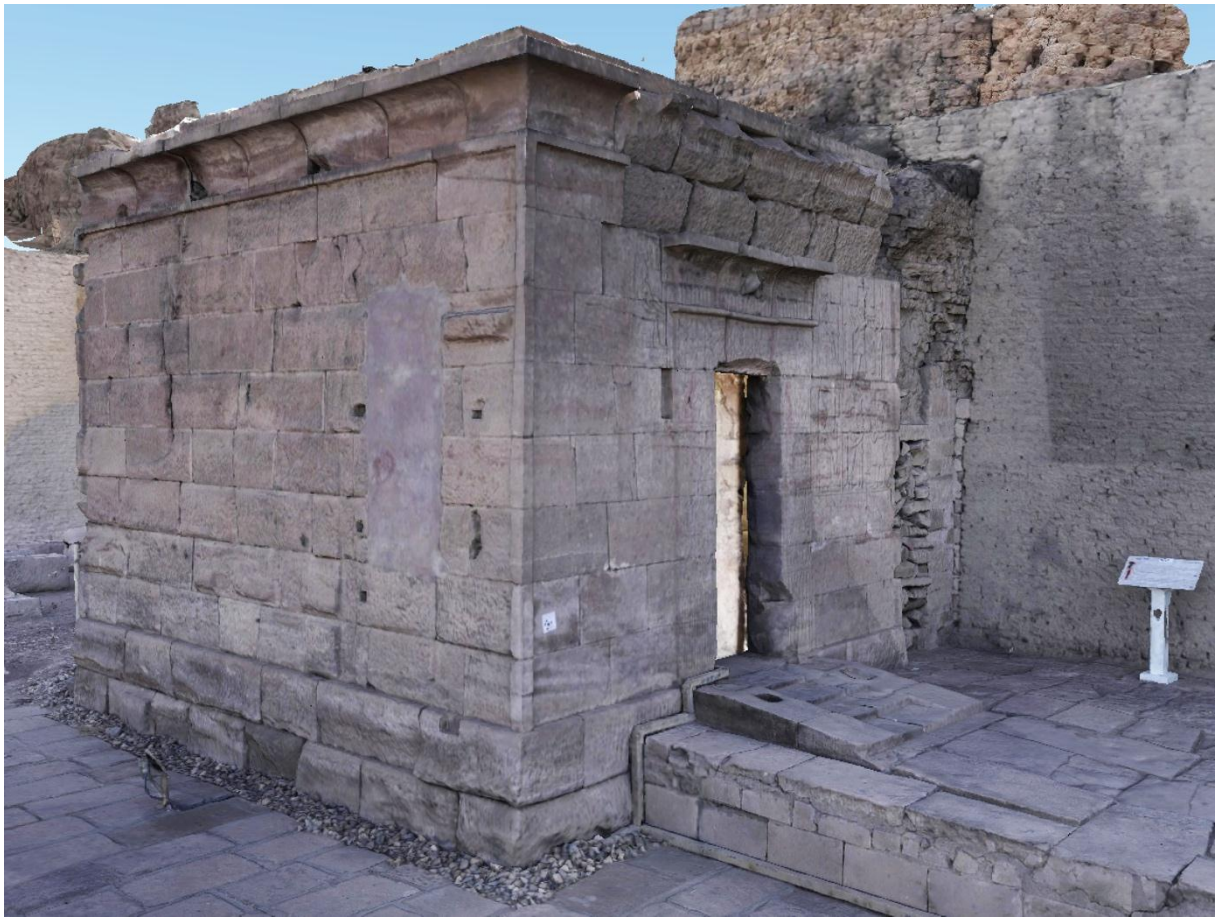
**Pl. 9**

Pl. 9 Photo of the north face of the chapel (A. Terrier)

However, one question remains unanswered. On the north façade of the Hathor chapel, at the level of the 8th course, the block that forms the north-west corner has what appears to be the starting point of a door lintel (Pl. 9). Were there two adjoining chambers to the north and south when the Chapel of Hathor was built? If so, the reassembly of the south door lintel is not at the right level. Unfortunately, there are still too many questions to put forward a valid hypothesis for the reconstruction. We will have to wait until we are in a position to observe the interior of the south room.
