## **PERFORMANCE OF STRAW BALE WALLS AS A NATURAL BUILDING MATERIAL**

**Ashour, T.**

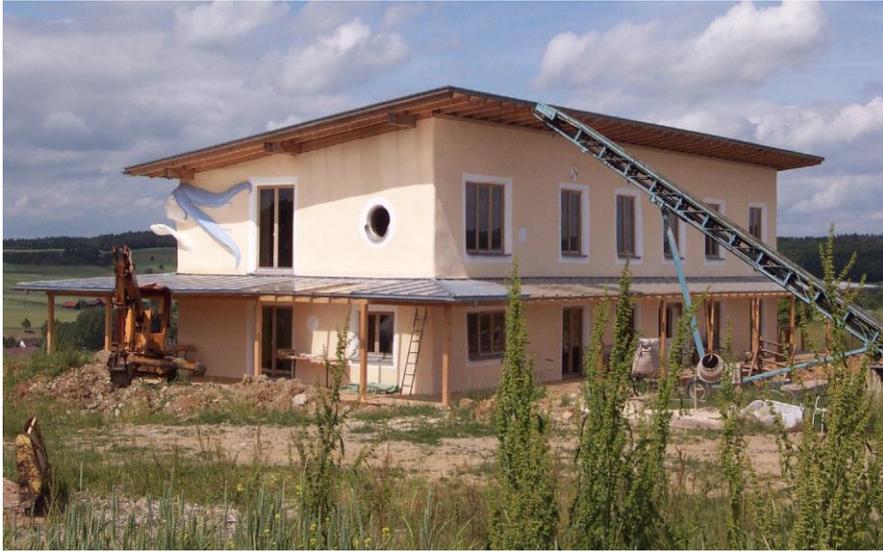
**Fig.1.** House for case study

In addition to the mechanical behavior of straw bales, it is very important to evaluate temperature and relative humidity inside the wall under natural conditions. A straw bale house in Germany was chosen for our investigations. The orientation of the straw bales inside the wall was horizontal. The house consisted of two floors as shown in Fig. 1. The wall thickness is about 50 cm. The wall consists of calcium stucco as outside plaster (1 cm), outside plaster (2 cm), straw bale wall (45 cm) and inside plaster (2 cm).

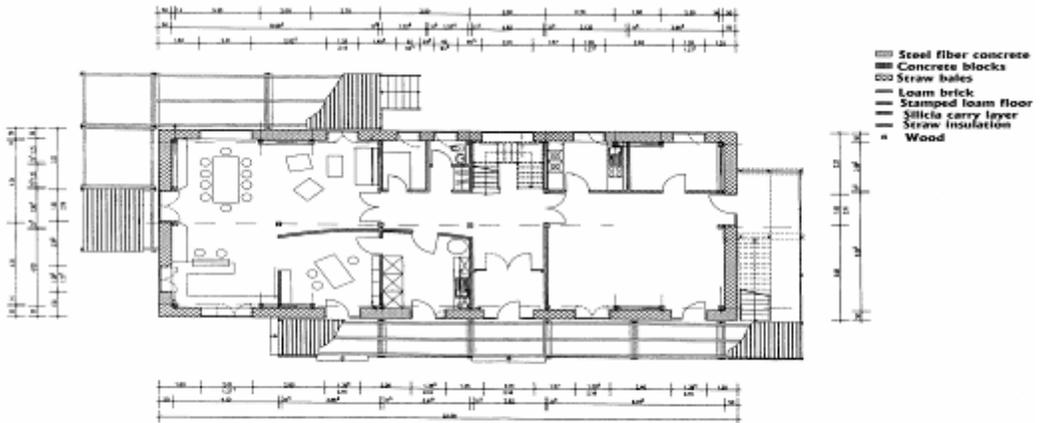
**Fig.2.** Plan view for the ground floor of the house.

The house includes different rooms such as bathroom, bedroom, living room, kitchen and others as shown in Fig.2.

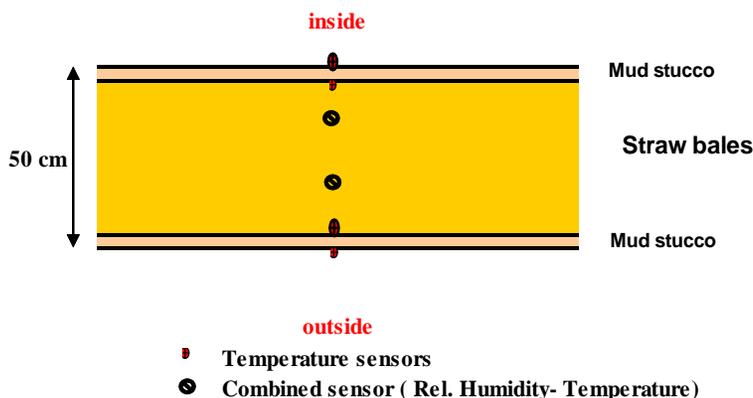
**Fig.3.** Sensors positions inside the wall

In-situ measurements are important to evaluate the performance of straw walls under natural conditions. The in-situ testing included the temperature and relative humidity inside the straw bale walls. The sensors for measuring the thermal and humidity behavior were installed at different locations in the wall. The commercial temperature and relative humidity sensors of the type of Negative Temperature Coefficient (NTC) were used for this investigation. The capacitive humidity sensors contain a glass substrate with a humidity-sensitive polymer layer between two metal electrodes. The measuring signal is proportional to the relative humidity and is independent of the atmospheric pressure. The probe pipe is made of aluminum with a diameter of 12 mm. The device covers a wide measurement range, from 5% to 98% for relative humidity and from -20 to +80 °C for temperature. Plastering is very important for the durability of straw bale constructions. The wall consisted of three layers such as outside plaster, straw wall and inside plaster. So the sensors should be covering all positions. The temperature sensors were installed on the plaster surface and inside the wall. The sensors were placed in the different positions such as outside temperature, outside plaster surface, between outside plaster and straw wall, 10cm from outside, 20 cm from outside, between straw wall and inside plaster and inside plaster surface as shown in Fig. 3.

The temperature and relative humidity properties were measured in the ground floor and the sensors locations were depend the wall layers. The sensors position for the ground floor was at south east wall and 1.4 m above the floor.

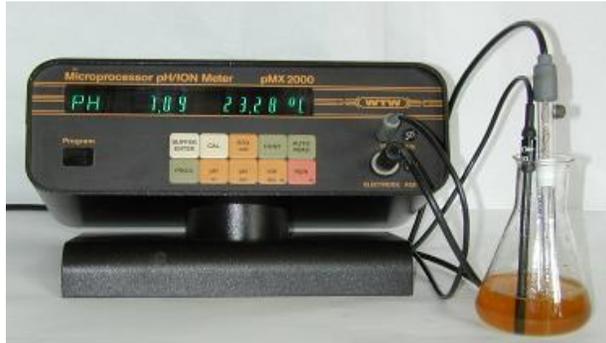
**Fig.4.** Instrument for measuring the pH value of Straw

Straw is an organic building material. The environmental, physical and chemical properties of straw inside the bales are of importance for the durability of straw buildings. The environmental condition includes temperature, relative humidity, Oxygen and pH. When the condition inside the bale is optimal for micro-organisms, the growth of these micro-organisms will be enhanced. The growth of micro-organisms leads to straw deterioration and has negative effect on the durability of straw building. Beside temperature and humidity, the pH value, i.e. an acidity or alkalinity environment, is important for the growth of micro-organisms. A total of 16 samples were used to measure the pH values, with 4 replicates for straw from the house under studying. To make an extraction for measuring the pH, the straw was dried at 105 °C for 24 hours and 5 grams from dried straw were mixed with 45 gram of distilled water with the ratio of 1: 9 between straw and water. The straw was mixed with water for 30 minutes, and then the pH measuring was started. The pH value was measured every 60 minutes over a period of 5 hours (Fig.4).

The average of pH value of straw inside the bales was about 7.29. This means that the condition inside the bales is alkaline. This pH value is typical for straw material. Beside the moisture content, the pH values inside the bales are important for the microbial activity. Fungi and microorganisms may activate inside the bales and cause deterioration of the bales and decrease the building life. Further research in this area is needed in the future.

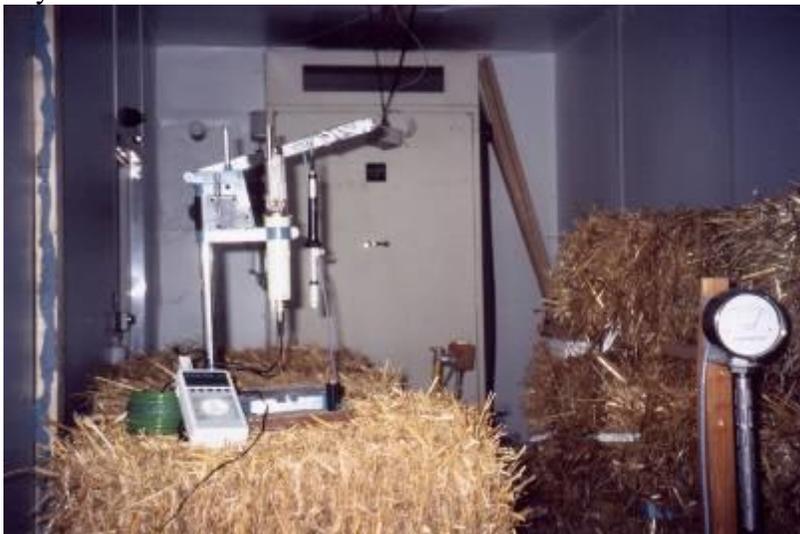
**Fig.5.** Bales inside the climate chamber under compensation test condition

The tests were carried out to measure the temperature and relative humidity in straw bales. The measurements were made when equilibrium was reached between the straw bale and the ambience. A compensation for temperature and relative humidity was carried out according to DIN (1991). A total of 10 bales were used for this test. A dual sensor was placed in the centre of each bale. The tests were carried out in a climate chamber with 23 °C and 78 % relative humidity (Fig. 5). The test was performed under high relative humidity to study the temperature and humidity transfer from environment to straw bale.

The test was terminated when the temperature and relative humidity inside the bales became equal to the temperature and relative humidity in the climate chamber.

The thermal stability of bales was investigated by placing the bales in a climate chamber with controlled atmosphere at 23°C and 78% relative humidity. Ten straw bales were used for testing. The sensors were placed in the center of the bales to record temperature and relative humidity. The measurements were continued until a stability condition was achieved. Readings of the temperature and relative humidity were taken every 5 minutes. In general some 450 hours were needed.

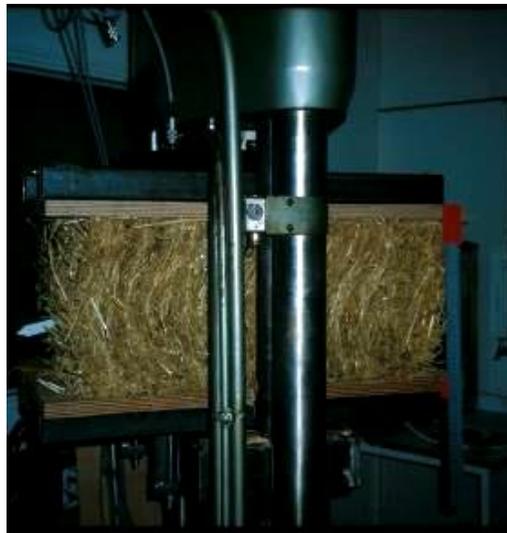
**Fig.6.** Straw bale in compression test

The mechanical properties were investigated by compression tests according to DIN (1984). The tests were carried out on a total of 10 straw bales from the building. The straw bales were tested in horizontal and vertical orientations. For the case of horizontal orientation the dimension of the bales was about 61 cm long 43 cm wide and 36 cm high. For the case of vertical orientation the dimension was about 61 cm long 36 cm wide and 43 cm high.

A vertical load of about 2 kN was first applied to the bale. Afterwards, the vertical load was increased in increment by 1 kN to reach the maximum load of about 10 kN. The loading piston was then stopped after each increment and the bale dimensions were measured as shown in Fig.6. At the end of each test the bales were dried to measure the moisture content of the bales. The stress, horizontal strain, vertical strain and the deformation modulus were evaluated (according to Kozachenko et al., 1998).

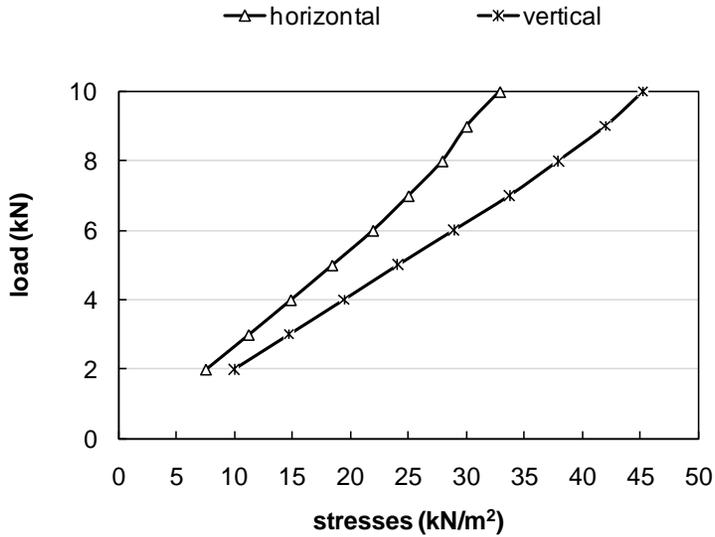
**Fig.7.** Stress in straw bales

Fig.7 shows the relationship between the applied load and the stress for horizontally and vertically oriented straw bales. The cross-sectional area was about 0.204 m<sup>2</sup> in vertical direction and 0.276 m<sup>2</sup> in horizontal direction. The applied load started with 2 kN and increased in increments to reach 10 kN at the end of test. The figure shows that the stress increases with increasing load for both vertically and horizontally oriented bales. At the beginning (2 kN load), the average stress was about 9.95 kN/m<sup>2</sup> for the vertical orientation. This was higher than that of the horizontally oriented bales of 7.6 kN/m<sup>2</sup>. While at 10 kN load, the same trend can be observed, the average stress was about 45.2 kN/m<sup>2</sup> at vertical orientation while it was 32.9 kN/m<sup>2</sup> for the horizontal orientation bales. The difference in stresses for the vertical and horizontal orientations was due to the different cross-sectional areas.

The overall average stress ( $28.4 \pm 12.3$  kN/m<sup>2</sup>) for vertical orientation was higher than that of horizontal orientations ( $21.1 \pm 8.7$  kN/m<sup>2</sup>). This may be due to the fact that the bales of horizontal orientation have larger cross-section area compared to that of bales of vertical orientation. Also, the direction of the straw stems in the vertical orientation is different from that in the horizontal orientation.

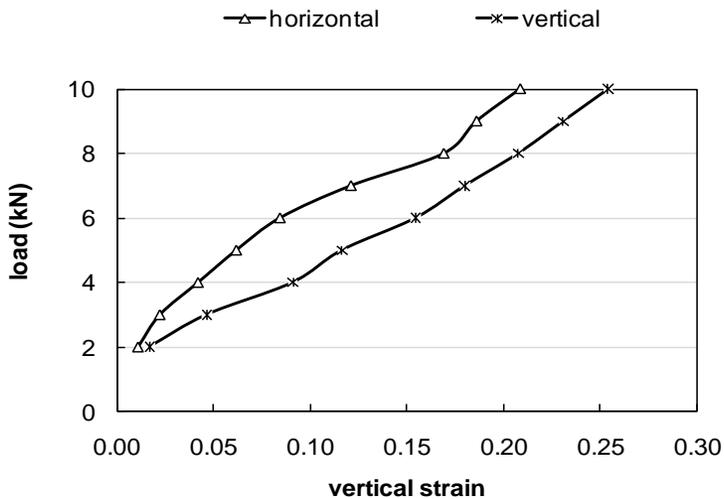
**Fig.8.** Vertical strain of straw bales under compression test

The strain is defined as the displacement of the bale divided by the original height of the bale. The vertical and horizontal deflections were measured for two different orientations (vertical and horizontal). Fig.8 shows the relation between load and vertical strain for vertically and horizontally oriented straw bales. For small load up to about 2 kN there is only very small strain in the bales.

For vertically orientated bales, the maximum strain was about 0.25 and the minimum strain was about 0.017. It is clearly that the resistance to deflection increases with applied load. For horizontally oriented bales, the vertical strain ranged from 0.011 to 0.208. From the results we can see that the vertical strain ranged from 0.017 – 0.254 at loads from 2 – 10 kN for the vertically oriented bales while it ranged from 0.011 – 0.208 for the horizontally oriented straw bales.

The vertical strain values increased with increasing load for both vertical and horizontal orientations. It is also clear that the vertical strain values for vertical orientation were higher than those for horizontal orientation.

It is worthily to be noticed from Fig. 8 and Fig.9 that, the vertical strain is higher than the horizontal strain for both vertically and horizontally oriented bales.

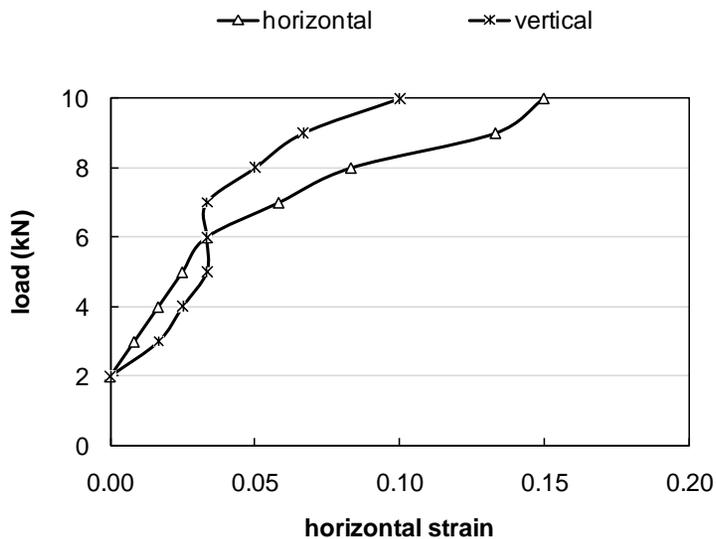
**Fig.9.** Horizontal strain for straw bales under compression test

Fig.9 shows the relationship between the horizontal strain and load of vertically and horizontally oriented straw bales. By increasing the load, horizontal strain was observed where it reached to a minimum of 0.10 at 10 kN for vertical oriented bales and 0.15 for horizontal oriented bales.

The average horizontal strain for the horizontal oriented bales is larger than that of vertical oriented bales. The average horizontal strain ranged from  $0.04 \pm 0.03$  for the vertical oriented bales which it ranged from  $0.06 \pm 0.05$  for the horizontally oriented bales.

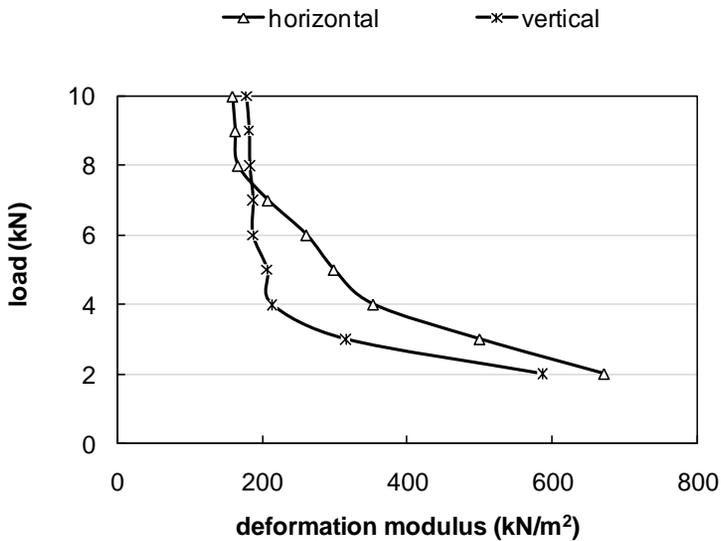
**Fig.10.** Deformation modulus during compression test.

Fig.10 shows the relationship between the deformation modulus and the applied load for the straw bales at different orientations. The deformation modulus is calculated as the ratio between stress increment and strain increment. It can be seen that the deformation modulus decreases with increasing load for both bale orientations. The stress-strain behaviour of straw bales is nonlinear. Under increasing load the deformation modulus decreases to reach a value of about 200 kPa for both bale orientations.

It can be seen that the deformation modulus decreased gradually with increasing load. At the load of about 4 kN the deformation modulus reached 213 kPa and remained unchanged for the vertically oriented bales. While for the horizontally oriented bale the deformation modulus reached a constant modulus of about 165 kPa at the load of about 8 kN. This decrease of deformation modulus was attributed to the initial compression of the voids among the straw fibres. The constant modulus at higher load represented the resistance of well compressed straw bales. The reduction of the deformation modulus does not mean that the

resistance against deflection decreases. The resistance still increases nonlinearly. These experimental results agree well with those reported in Ashour 2003; Bou-Ali 1993 and Watts et al., 1995).

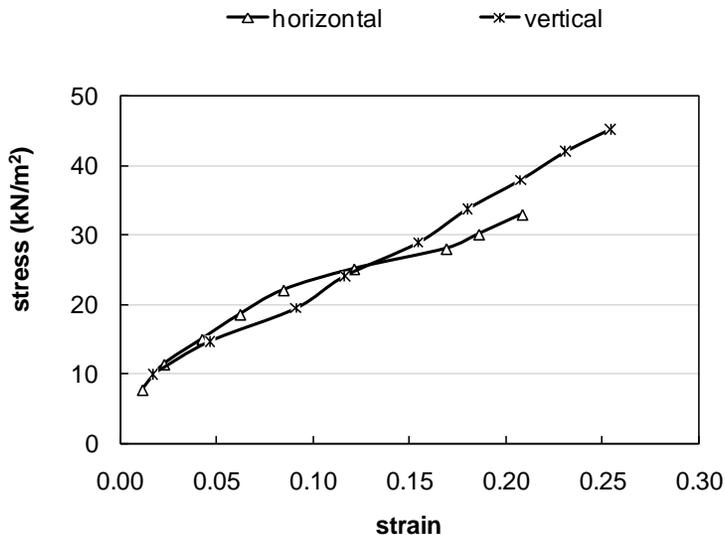
**Fig.11.** Stress-Strain relationship for straw bales during compression test

Fig.11 shows the stress-strain curves for vertically and horizontally orientated straw bales. The nonlinear behavior can be clearly observed. It is worth to mention that all bales showed highly resilient behavior, i.e. the deformation was recovered after the load was removed. However, the recovery of deformation after load removal took several minutes. The time required for a complete recovery of deformation varied between 10 and 13 minutes for both vertically and horizontally oriented bales.

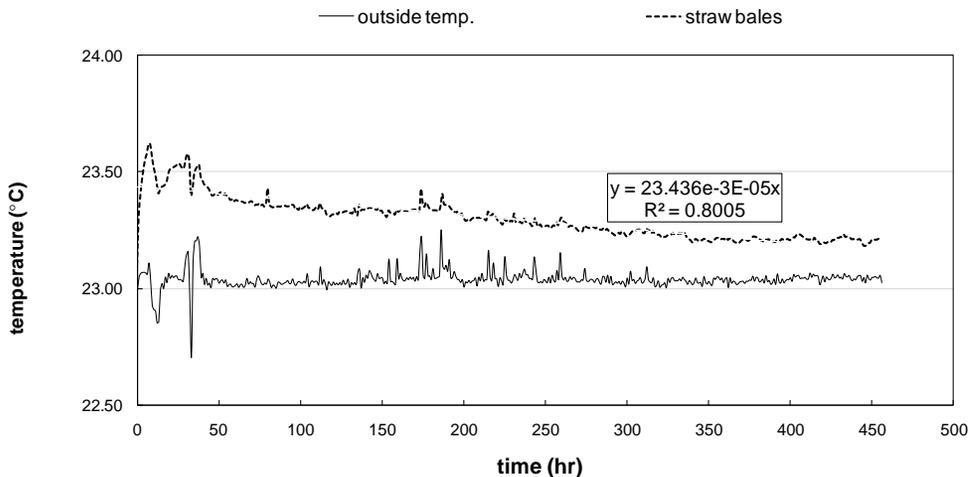
**Fig.12.** Temperature evolution of straw bale

Fig.12 shows the temperature of straw bales from the house of case study with time together with the ambient temperature of about 23 °C. The tests were carried out on straw bales with an average density of about 102.6 kg/m<sup>3</sup>. Starting from an initial temperature of about 23.1 °C, the temperature in bale showed an initial sharp increase to about 23.6 °C followed by a gradual decrease to about 23.21 °C at 450 hr. The difference between the surrounding temperature and bale temperature decreased with time. However a small difference between the ambient temperature and the temperature in bale remained after 450 hours. This is ascribed to the insulation function of the straw material. A closer examination of the data showed that temperature decreased with time according to an exponential equation with the correlation of about 80.05%.

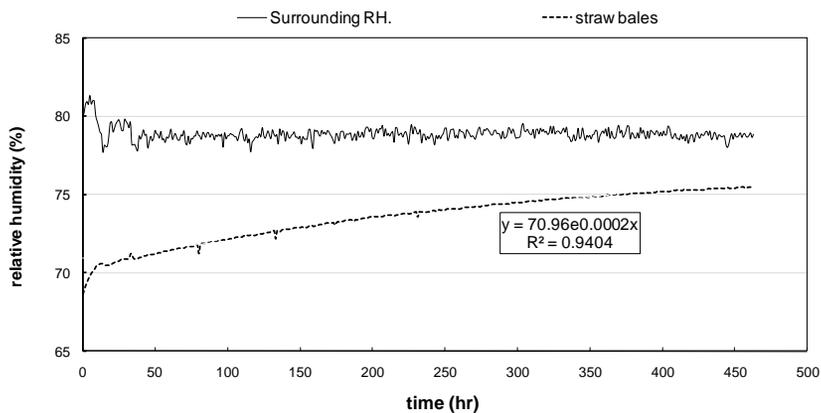
**Fig.13.** Evolution of relative humidity inside the bale

Fig.13 shows the relative humidity of straw bales from the straw house under study with time together with the surrounding relative humidity of about 78%. The test was started with an initial relative humidity of about 68.65 % in bale. After an initial step increase the relative humidity increased gradually with time to reach 76.4% after 450 hours. The difference between the surrounding relative humidity and the relative

humidity in bale decreased with time. At 400 hours this difference was about 3.44%. At the end of test (after 450 hour), this difference was only about 2.55%.

It is interesting to observe that the temperature and relative humidity in bale differed from the outside condition even after 450 hours. Our results showed that relative humidity increased with time according to an exponential equation with the correlation of 94.04%. The results showed the excellent insulation function of straw materials against the outside relative humidity. This could be owed to the low moisture content of straw. Therefore, it took very long time to reach equilibrium with the outside conditions.

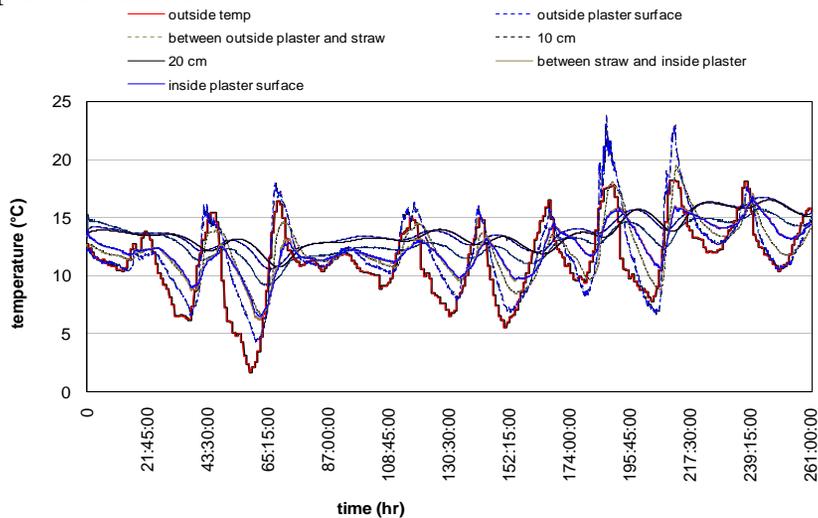
**Fig.14.** Temperature evolution across straw wall of the ground floor.

The temperature was recorded at different locations, at outside temperature, on outside plaster surface, in straw wall at 10 cm from outside, 20 cm from outside and on the inside plaster surface. Fig.14 shows the temperature evolution inside the wall at different locations of the straw bale wall of the ground floor. It is shown that the temperature gradient increased from outside (low temperature) towards the inner side of wall. Moreover, the extreme outside temperature peaks were smoothed out by the straw wall.

Table 2 shows the average temperature at different locations and times inside the straw bale wall. At the beginning, the average temperatures were 12.7, 12.1, 12.5, 13.73, 13.43, 13.5 and 13.7 °C for outside temperature, outside plaster surface, between outside plaster and straw bale, 10 cm in straw, 20 cm, in straw, between straw and inside plaster and inside plaster surface, respectively.

After 24 hours, the temperature increased towards the wall interior, where the temperature difference between the outside temperature and the different location are 0.04, 0.19, 2.11, 2.04, 0.62 and 0.26 °C for outside temperature, outside plaster surface, between outside plaster and straw bale, 10 cm in straw, 20 cm, in straw, between straw and inside plaster and inside plaster surface, respectively.

After 96 hours, the temperature percentages between the ambient temperature and the wall interior were 12.18, 16, 29.1, 29.7, 11.25 and 19.9 % for outside plaster surface, between outside plaster and straw bale, 10 cm in straw, 20 cm, in straw, between straw and inside plaster and inside plaster surface, respectively.

It is interesting to observe that the percentage inside straw is higher than the outside plaster. While it was 29,1% and 29.7% for 10 and 20 cm inside straw. This may be due to the fact that the outside plaster is influenced by outside conditions and its lower thermal insulation in comparison with straw.

At the end of test (261 hours), the temperature percentages between the outside temperature and the other side of the wall bales were 5.83, 6.59, 20.86, 19.68, 9.46 and 111.99 % for outside plaster surface, between outside plaster and straw bale, 10 cm in straw, 20 cm, in straw, between straw and inside plaster and inside plaster surface, respectively.

Table 1 and Fig.14 showed also that the temperature inside the straw wall was stable despite the large difference of outside temperature between day and night. The results also revealed that straw wall smoothed out the extreme temperature peaks outside and provide better living conditions.

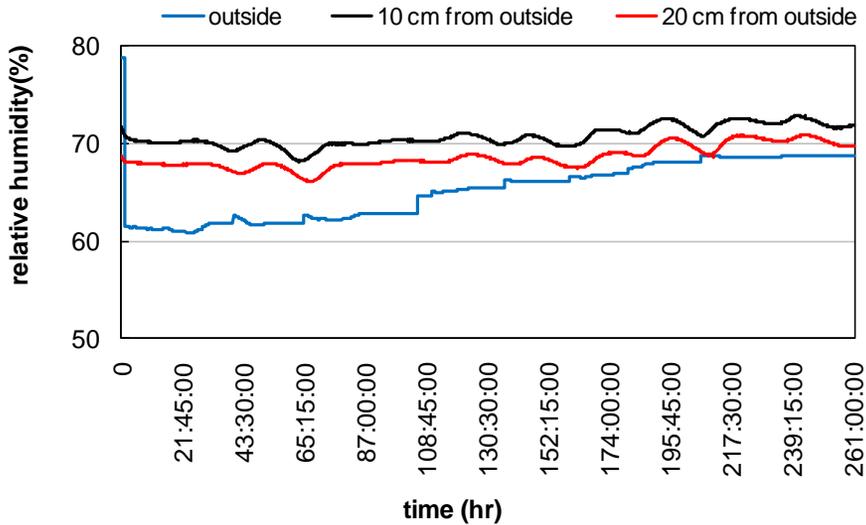
**Fig.15.** Relative humidity distribution inside the wall for the ground floor

Relative humidity is a very important factor especially for straw bale buildings. Relative humidity values were recorded at different locations, i.e. outside house and inside the wall (at 10 cm and 20 cm from external surface). Fig.15 shows the relative humidity evolution inside the wall at different locations. The average values are given in Table 2. At the beginning, the average relative humidity values were 78.77, 71.76 and 68.82 % for outside relative humidity 10 cm in straw, and 20 cm, in straw, respectively.

After 24 hours, the relative humidity difference between the outside relative humidity and the different location are 8.67 and 6.36 % for 10 and 20 cm, respectively.

After 96 hours, the relative humidity percentages between the surrounding relative humidity and the other side of the wall bales were 11.86 and 8.29 % for 10 and 20 cm, respectively.

After 261 hours, the relative humidity percentages between the outside relative humidity and the other side of the wall bales were 5.74 and 2.63 % for 10 and 20 cm, respectively.

Table 2 and Fig. 15 show also that the relative humidity behavior inside the straw wall is stable although there are large variations outside between day and night. At the beginning of the test the relative humidity inside the straw bale wall was higher than those outside. This means that the moisture migration through the straw bale wall was very slowly.
