## Repairing Capability of Friction Stir Welded Defected SAF 2205 Duplex Stainless Steels Groove Joints Using Fusion Welding Processes

### ABSTRACT

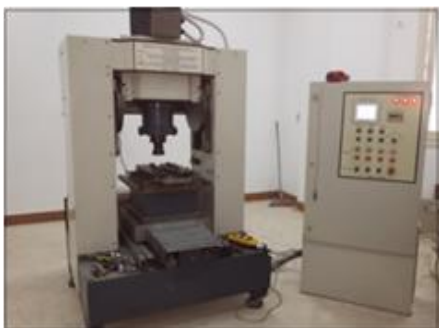
Fig. 1, Friction Stir Welding Machine

The FSW welding was carried out using the FSW machine model (EG-FSW-M1) shown in Fig. 1, at the friction stir welding and processing lab that belongs to Faculty of Petroleum and Mining Engineering, Suez University. The tool was controlled vertically, but the work piece was controlled horizontally. WC tool specially designed for this work, the probe of conical shape, 12/5 mm diameters, with a length of 5.5 mm, and a shoulder of 20 mm diameter shown in Fig. 2. The FSW applied with constant rotational speed at 300 rpm, travel speed at 25mm/min, tilt angle of 3°, and down load of 20KN [17]. The joints were prepared as V groove geometry without root opening, and 2 mm root face, for both joints and 40° groove angle for specimen 1 and 60° with 1 mm raised face at shoulder land for specimen 2 shown in Fig. 3

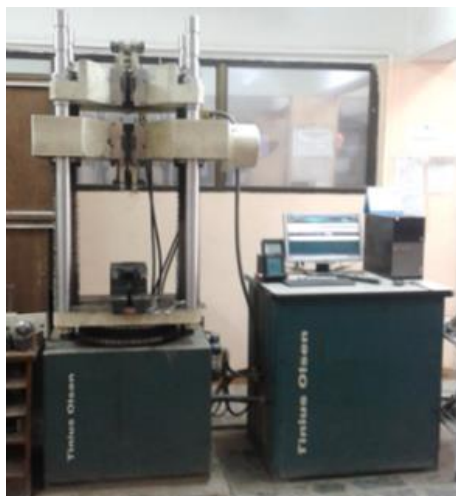
Fig. 5. Tensile / Bend test machine

Tensile test was conducted using the universal testing machine (Tinius Olsen) shown in Fig. 5, which located at PETROJET central workshop - Cairo, 600 KN capacity with a speed of 0.05 mm/Sec, according to ASME IX and ASTM E8 [18,19]. To evaluate the tensile properties of the repaired joints, large transverse flat tensile specimens with a gauge length of 50 mm and a width of 12.5 mm were machined perpendicular to the welding direction. Tensile tests were carried out at room temperature, the failure load and failure location were recorded for each specimen, where the failure load was the averaged of two specimens for each welding condition shown in Fig. 4a.

Three-point bend tests were applied using a universal testing machine (Tinius Olsen) shown in Fig. 5, which located at PETROJET central workshop – Cairo, with a crosshead speed of 0.5 mm/min according to ASME IX [18]. The cap and root-bead reinforcements were removed flush with the surfaces to be smooth, the specimen dimensions were 200 x 19 x 6.5 mm as shown in Fig. 4b, the test was carried out at room temperature, the test load was 59 KN, the specimens were bent in a U-shaped, the weld root surface becomes the convex surface, and visually examined for cracks or any other imperfection.

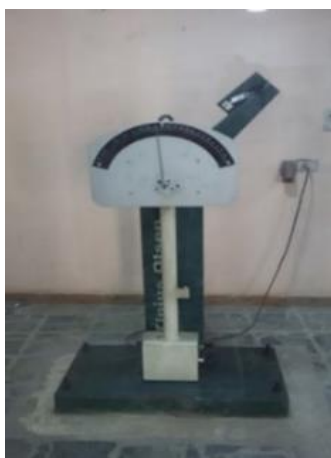
Fig. 6. Impact test machine

Impact test was carried out using a specially designed testing machine (Tinius Olsen) Model IT 542, it has an available energy of 542 J, and located at the PETROJET central workshop laboratory, Cairo shown in Fig. 6, according to ASME IIIV, and

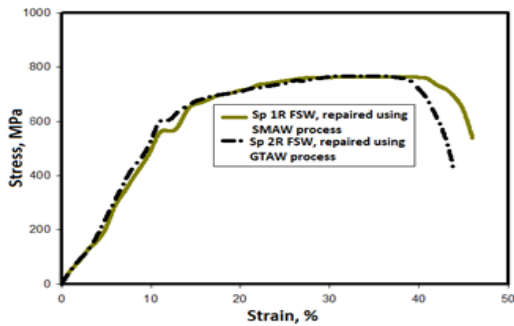
Fig. 11, Stress strain diagrams, for Specimen 1R repaired by SMAW, and Specimen 2R repaired by GTAW

For joint Sp1R, which repaired using SMAW, the average values were; yield stress 565 MPa, ultimate tensile stress 765 MPa, and 40% elongation, which are more than the minimum requirements of base metal, and the fracture occurred at base metal. For joint Sp2R, which repaired by GTAW, the average values were; yield stress 590 MPa, ultimate tensile stress 768 MPa, and 38% elongation, which are more than the minimum requirements of base metal, shown in Fig. 11, with ductile fracture appearance for both two joints, these results better than that obtained by Mourad et al [10]. In addition, stress, strain and young's modulus can be calculated for specimens 1R and 2R, as shown below;

The test data for specimens 1R and 2R from Fig.11 as shown in Table 3

Specimen	Area (mm <sup>2</sup> )	F <sub>y</sub> (KN)	F <sub>u</sub> (KN)	Offset
1R	79.55	44.9	60.85	0.27%
2R	73.15	43.1	56.2	0.26%

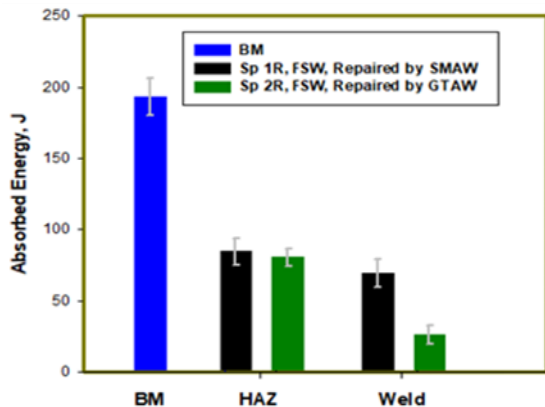
Fig. 13, Bar chart with error bars for Impact test at  $-40^{\circ}\text{C}$  of BM, joint Sp1R repaired by SMAW, and joint Sp2R repaired by GTAW.

The impact energies of weld metal centerline and HAZ, as shown in Fig. 13, show that, the average toughness at -40°C, for weld metal and HAZ of Sp1R which, repaired by SMAW, were 80 and 85 J respectively, these results are accepted according to ASTM A923 [27], and agree with the results of Aristotile et al [11]. On the other hand, for joint Sp2R which, repaired by GTAW, were 27, 70 J respectively, these results are accepted for HAZ, not accepted for weld metal according to ASTM A923 [27], and not agree with the results of Aristotile et al [11]. Moreover, it was noted that, for joint Sp1R not only strength was improved but the toughness was improved as well, for joint Sp2R the strength was

improved but the toughness was not improved.

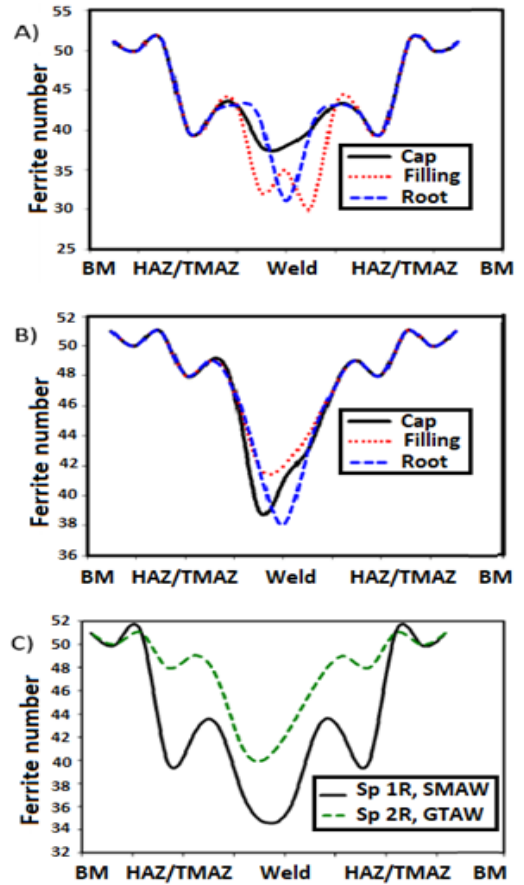
Fig. 16, Ferrite number diagram for, a) Sp1R joint, b) Sp2R joint, c) Comparison between joints Sp1R, and Sp2R.

Ferrite content profiles for the joints Sp1R, and Sp2R, show that, the average ferrite/austenite content for joint Sp1R at weld metal and HAZ were 39/61, and 41/59 respectively shown in Fig.16A, and for joint Sp2R at weld metal and HAZ were 43/57, and 48/52 respectively shown in Fig. 16B. From Fig. 16C, It can also be noted that ferrite volume fraction at HAZ is higher than that of the weld region and that is agree with Paulraj et al [7]. It is significantly noted that, FN for Sp2R is higher than FN for Sp1R, and that is confirm the microstructure evaluations across HAZ and FZ of these joints shown in Figs. 14 and 15, it is attributed to exposing the joint welded using GTAW process to lower heat input and higher cooling rate during weld than that of the joint welded by SMAW process, where, the ferrite is more than the austenite at the higher temperatures in DSS, and the time to reformation of austenite in is less than that for joints welded by SMAW process [7,15]. In general, it is observed that, the ferrite level at DSS weld metal is within the range of 30-70% and agree with Robert et al [5].

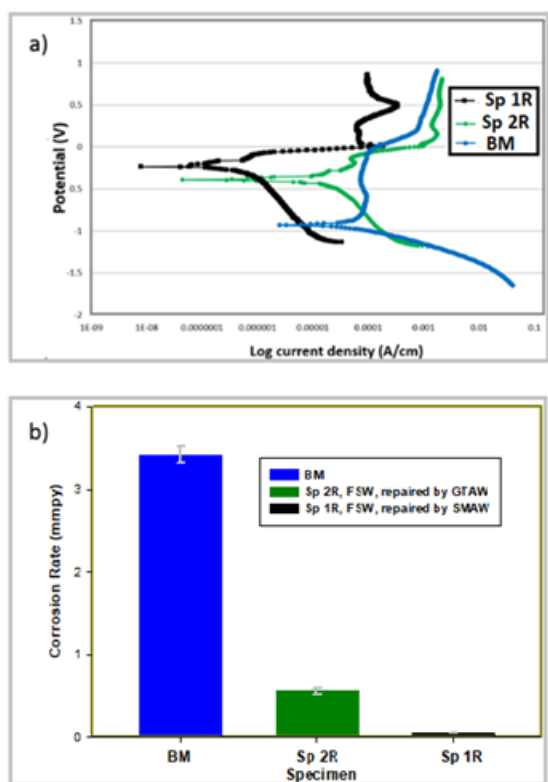
Fig. 17, a) Comparison between Tafel (potentiodynamic) polarization curves for DSS specimens of DSS SAF 2205 BM, joint Sp1R, and joint Sp2R, b) Bar chart with error bars for the average corrosion rates of same specimens

The average corrosion rates of SAF 2205 DSS base metal, joint Sp1R and joint Sp2R were 3.4522, 0.02098, 0.59187 mmpy respectively, these results are accepted according to ASTM A923 [27]. In addition, it was noted that the corrosion resistance for SP1R is better than Sp2R and the both as a whole nobler than BM shown in Fig. 17, that is due to the formation of almost austenite free areas with ferrite coarse grains, which resulted in a lower cooling rate of the joints welded using GTAW [7,15]. The required phase ratio changed during fusion welding processes and encourages the formation of more ferrite in the welding metal as a result of the re-melting and solidification of the material, so that is agree with Robert et al [5].
