INVESTIGATION OF THE CORROSION PROBLEM IN THE PIPELINE OF ENRICHED ALUMINA RECYCLE TO ALUMINIUM CELL

In this work, the failure of pipeline used for recycling the enriched alumina to self-baked (Soderberg) cells is investigated; the study includes also the deterioration of pipeline that recycling the enriched alumina to pre-baked cells and that recycling fresh alumina. Systematic measurements for the loss in the pipeline –wall thickness with the time are carried out. The gaseous emissions from the cells and the characteristics of enriched alumina are analyzed. Based on the analyses and visual inspections, a corrosive- wear sequence was identified, for the failure of pipeline of Soderberg system. The scales formed on the pipe inner wall are easily destroyed by the alumina impact due to the weak adherence of such scales. This resulted in the exposure of the fresh steel surface to the highly corrosive environment that prevails inside the pipeline, which accelerates the corrosion of the metal. For the pipeline recycling enriched alumina of pre-baked system, hard and dense layers were formed, which were strictly adherent to substrate. The loss in the pipeline wall thickness of the fresh

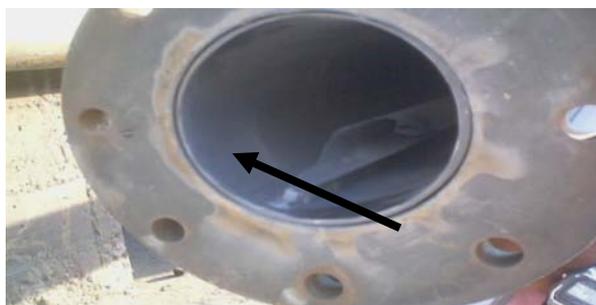
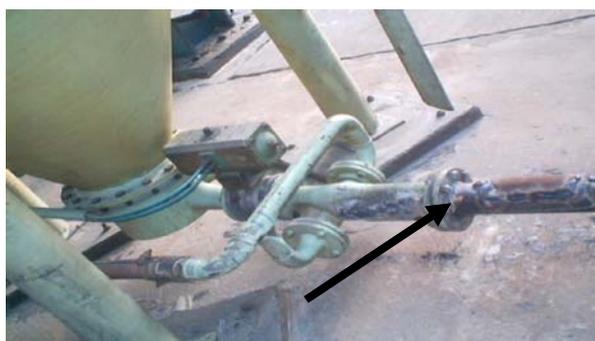
(a)

(b)

Fig. 1: Photographs of the erosion –corrosion in the pipeline of Soderberg cells; a- inlet of the pipeline, b- failure of the inner pipe

1. The failure of pipeline recycling enriched alumina to Soderberg cells was due to erosion-corrosion. However, the dominant process was the effect of corrosion on erosion.

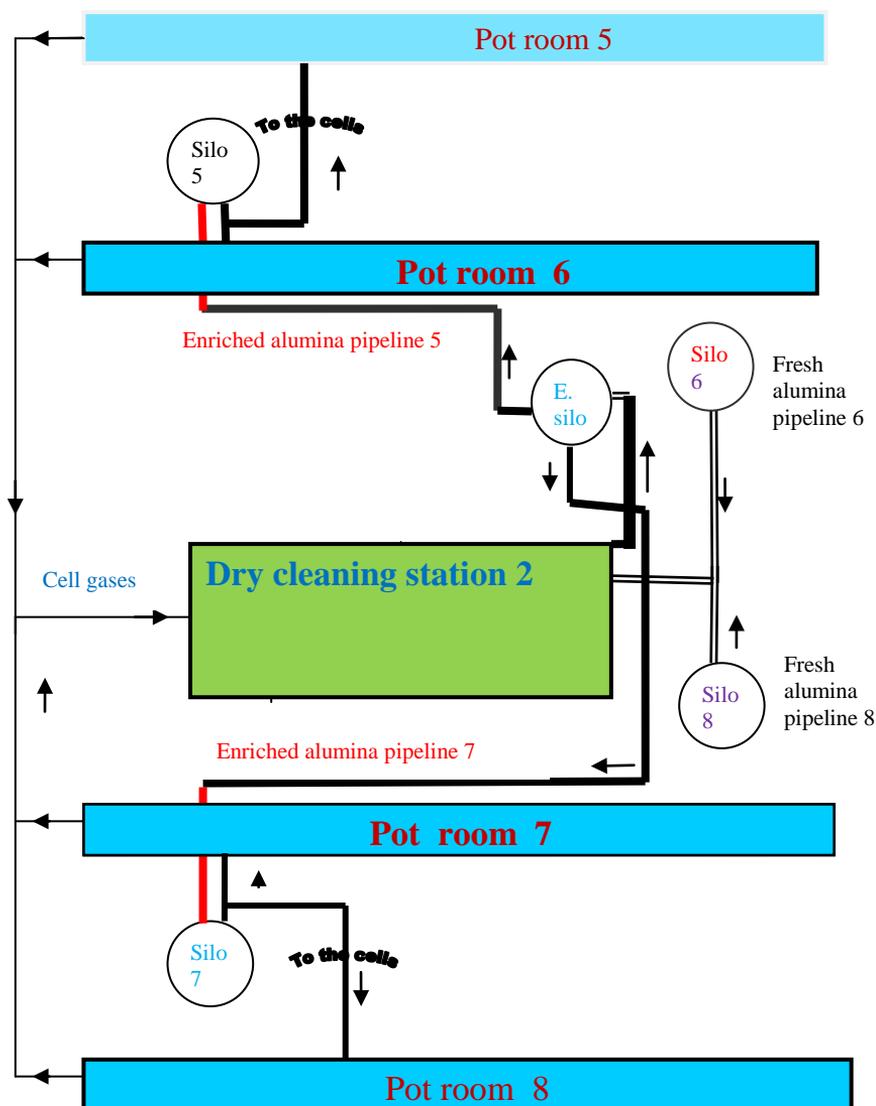
Fig.2: Schematic diagram for the Soderberg pipeline system

Associated with the EGYPTALUM pot lines there are gas treatment centers (GTC'S) that is positioned between the pot rooms to receive emissions from the pots. The GTC'S have the primary role of recycling the fluoride and dust captured from the pots. The emissions are treated in the GTC to extract the fluoride, using alumina as a scrubbing agent. The fluorinated alumina is then directed into the pots. Figure 2 shows the schematic of the pipeline network with the necessary storage bins and silos for one of GTC'S. The pipelines 5, 7 and 6, 8 are used for carrying enriched alumina and fresh alumina respectively. The pipeline material is carbon steel. The chemical analysis of the carbon steel is carried out by an optical emission spectrometry "ARL 3560" and is given in Table 1. The pipeline has an inside diameter of 127mm and thickness of 6mm. The pipeline length is 300m, in which 260m is horizontal and 40m is vertical. The pipeline consists of connecting tubes of 6m long. The tube is seamless with flanged connections. In this study, the failure analysis is concerned with the horizontal pipeline. The air required for conveying the particulate material within the pipeline is jetting from small tube 20mm diameter incorporated within the pipeline. The air velocity is measured by a pitot-tube meter which is already erected in the pipeline construction. The loss in thickness of the inner side of the pipe wall is investigated for pipelines 6,11,5 and 7. Pipeline 6 transports fresh alumina. Pipelines 11, 5 and 7 deals with enriched alumina. Pipeline 11 belongs to the prebaked system while pipelines 5 and 7 belong to the Soderberg system. The pipe wall thickness is measured by a

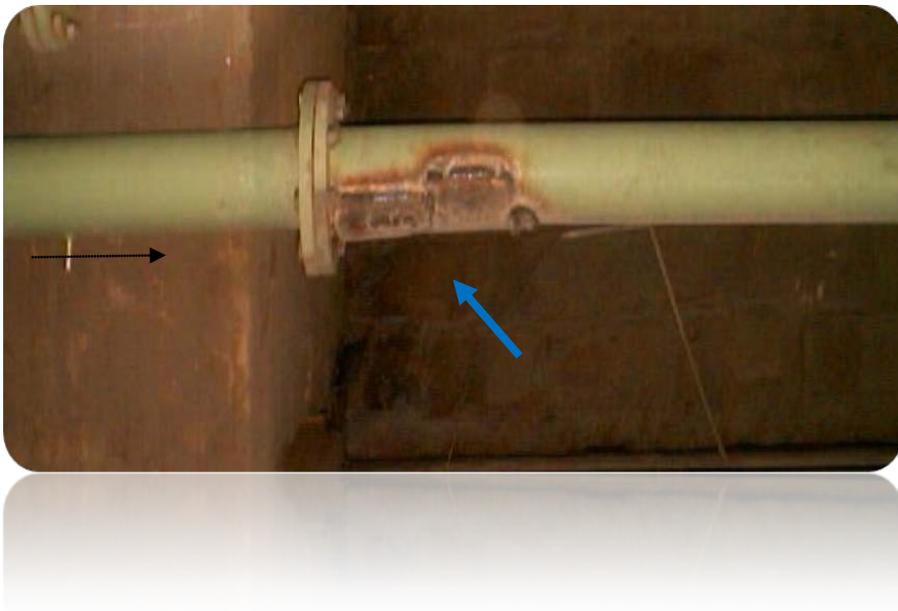
The loss in the thickness of the inner side wall of horizontal pipelines is measured at three points. Two points (1&2) at the ends of the horizontal diameter. The third one (3) at the bottom end of the vertical diameter. These measurements are repeated along the pipeline at a span of 60 cm. Tables 2 and 3 show typical measurements for the loss in thickness along the circumferential and longitudinal tube wall, respectively. The data reported in Table 2 belong to pipeline 5 and those at Table 3 belong to pipeline 7. From Table 2, it seems that the largest loss in the thickness is at the bottom (point 3). Therefore, the loss in the thickness at the bottom will be taken into consideration in analyzing the failure for different pipelines. Figure 3 and Table 3 show that the most deteriorated region is beside the flange.

Fig. 3: Photograph of the more deteriorated locations

Length apart from flange, cm	60	120	180	240	300	360	420	480	540
Average loss, mm/year	2.07	1.85	1.91	1.87	1.84	1.99	1.92	1.85	1.91

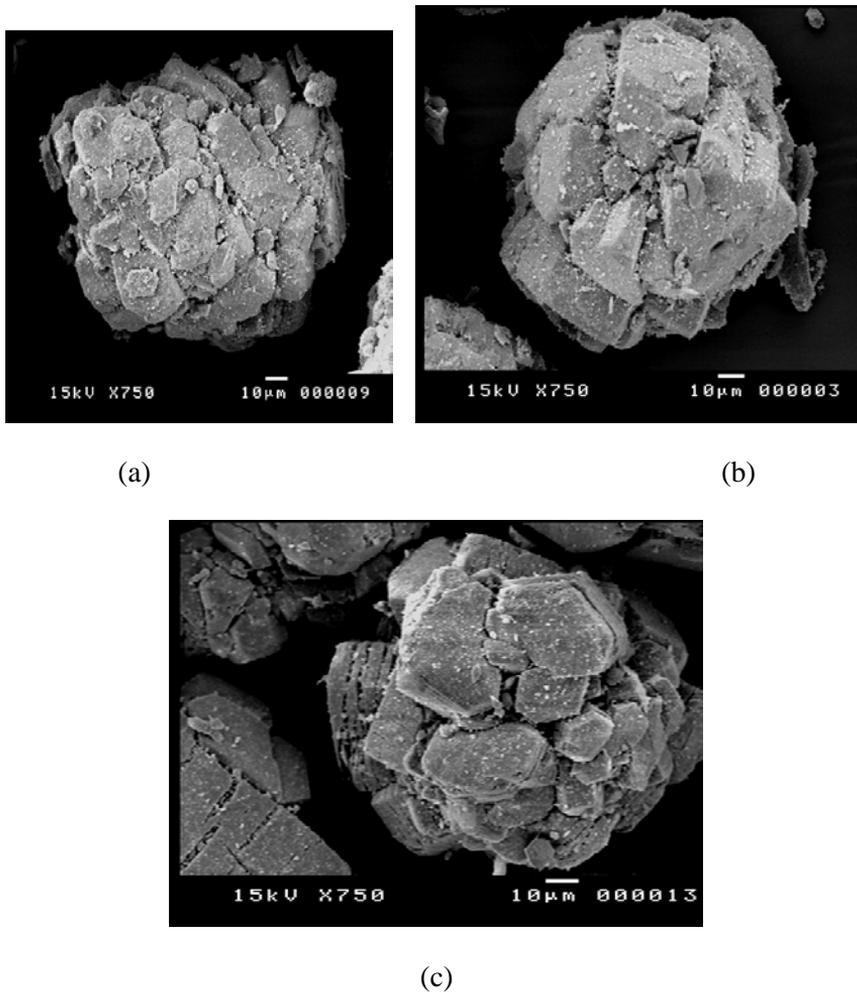
SEM photographs of the fresh alumina and the enriched alumina used in the pre-baked and Soderberg are shown in Fig.4. It is difficult to identify any change in the structure among the different alumina samples

Fig.4: SEM photographs of the enriched alumina used in the Soderberg system (a), enriched alumina used in pre-baked system (b) and fresh alumina (c)

The fresh alumina (Al₂O₃) has white color. However as result of passing the emission gases in the bed of fresh alumina for cleaning, the alumina has discolored. The worst discolor was for the enriched alumina used in the Soderberg system. The color changed from white to cinnamon.
