ANALYTICAL STUDY AND TREATMENTS OF THE DECAYED MURAL PAINTINGS AT ATHRIBIS IN SHEIKH HAMAD TEMPLE, SOHAG GOVERNORATE, EGYPT

This article focuses on the identification of the building materials used at Athribis temple – Sohag and their most common degradation factors, and then assessing the most appropriate consolidants for the decayed wall paintings at the temple. The building materials were studied through XRD, SEM-EDX, FTIR spectroscopy and light optical microscope to identify chemical decompositions and physical failures. Soluble salts were detected in the building materials. White pigment is calcium carbonate, yellow pigment goethite, red pigment hematite, blue pigment Egyptian blue, green pigment Egyptian green, the paint medium is animal glue. Conservation treatments were achieved using Ethanol + PLM.I for injecting detached plasters, Sturgeon glue 1.5% as a filler for cracks, Syton x30 for pre-consolidation, EDTA poultices for cleaning, EDTA for salt extraction, Cidal 50 L50 as a biocide and Klucel G as a final consolidant.

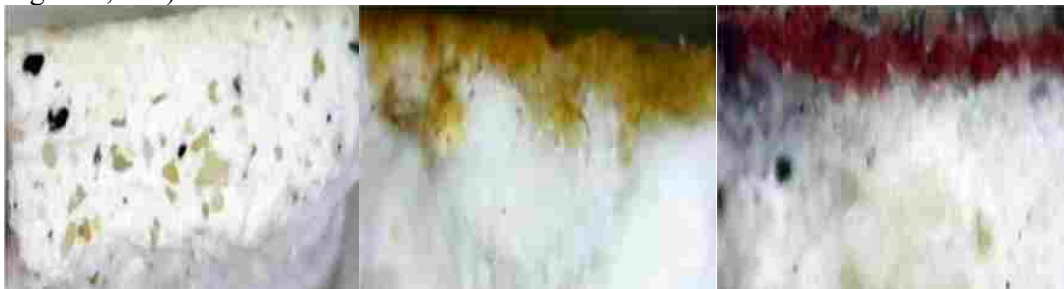
Most of the pigments were applied directly on the limestone surface after adding a thin layer of whitewash, the latter containing quartz particles in a small amount. All pigments were fine grounded and pulverised as they have a high covering power, homogeneity and interference with the whitewash layer is also observed (Figure 3 to Figure 7,x 50)

Fig. 2: Thin layer applied to the white pigment from Athribis temple.

Fig. 3: Thin layer applied of the yellow pigment from Athribis temple.

Fig. 4: Thin layer applied of the red pigment from Athribis temple.

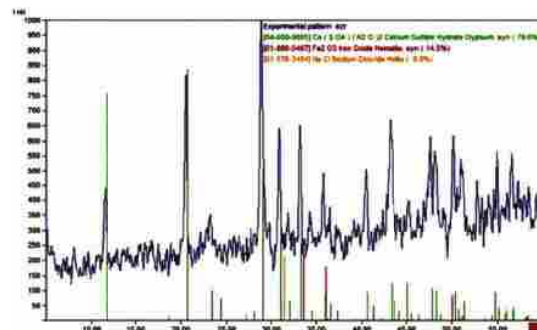
According to XRD analyses, the first sample is a hard limestone as it is a pure calcite 100% (CaCO_3) (Figure 8). The second sample white pigment is a calcium carbonate pigment made of 84.8% calcite (CaCO_3) and 15.2% quartz (SiO_2) (Figure 9). The yellow pigmented plaster sample contains 73.2% CaCO_3 , 13.9% goethite $\text{FeO}(\text{OH})$ and 12.9% hematite (Fe_2O_3) (Figure 10). The red pigmented sample contains 79.5 % gypsum ($\text{CaSO}_4 \cdot 2\text{H}_2\text{O}$), 14.5% hematite (Fe_2O_3) and 6% halite (NaCl) (Figure 11). The blue pigmented sample is a pure Egyptian blue as it is composed of 100% cuprorivaite $\text{CaCu}_2\text{Si}_2\text{O}_7$ (Figure 12). The green pigmented plaster sample contains 75.7 % of Egyptian green (Wollastonite CaSiO_3) complemented with 24.3% of calcium carbonate (CaCO_3) (Figure 13).

Fig. 11 XRD pattern of the red pigment sample from Athribis temple.

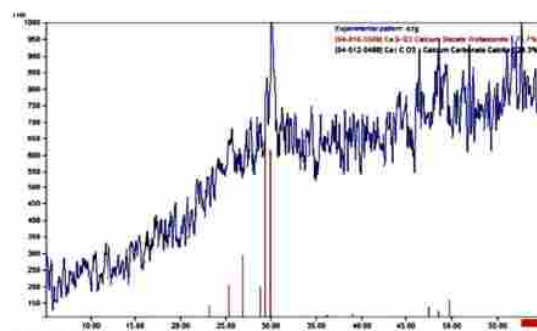
Fig. 13 XRD pattern of the green pigment sample from Athribis temple.

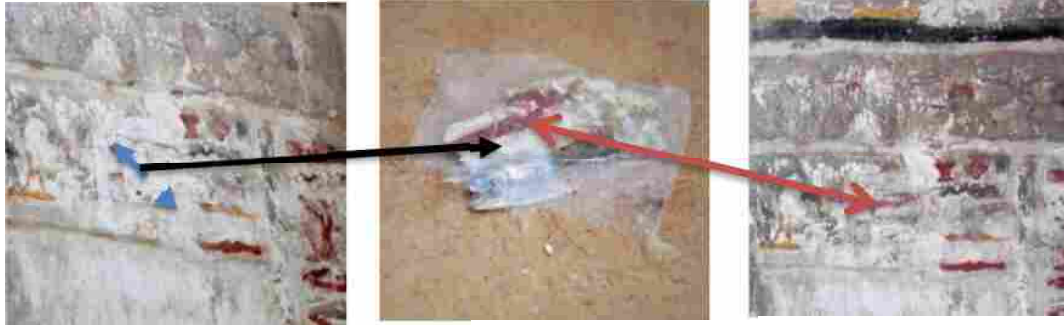
Fig. 22 Detachment part in the mural painting

Fig. 23 The Detachment part on Japanese Paper

Fig. 24 Replace the separated part in its place

The temple's mural paintings are in a bad condition. Its pre-consolidation process is fundamental. The stability of the fragile separated parts must be enhanced before initiating restoration processes. The physicochemical similarity between the treated material and it's consolidated is an important aspect in the consolidation process¹⁷. Syton x30¹⁸ (Ethyl Silicate protect against corrosion especially underground and industrial atmosphere¹⁹, Table 2), it used dissolved in water 4% to re attach the detached pigment layers (Figure 22,23,24,25), table 2. Cracks were injected and

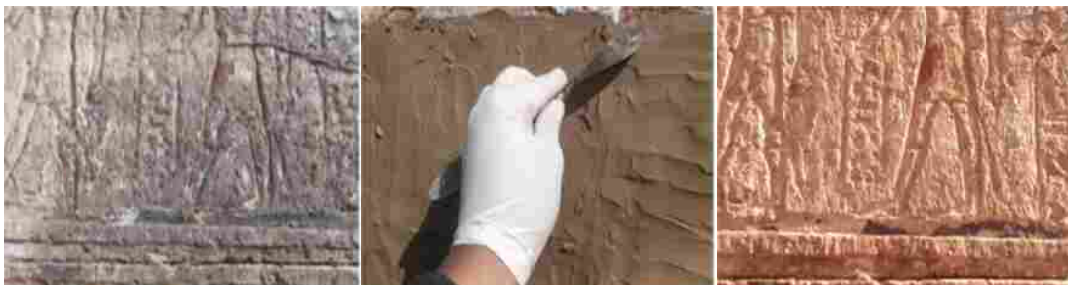
Fig.28 Scene before applying the poultice.

Fig. 29 Scene during the application.

Fig. 30 Scene after cleaning.

Mechanical cleaning has been done by brushes of different size, by metallic spatulas sometimes, by scalpels, and by air blower to clear the surface accumulation and to remove dust and sand from the mural painting (Figure 27). EDITA poultice (Tetra Sodium Salt Ethylene Diamine Tetra Acetic Acid) was used conjointly for this purpose (Figure 28, 29, 30), in order to overcome different spots and calcifications^{25,26,27,28,29}. Micro emulsions are also used as they are transparent and stable materials³⁰.

Poultices of distilled water were used to remove the halite salts, in addition to cotton poultices filled with EDTA solution. This enabled the extraction of insoluble salts such as carbonate and sulphate³¹.
