# STEEL RAILWAY BRIDGES IN EGYPT

## ABSTRACT

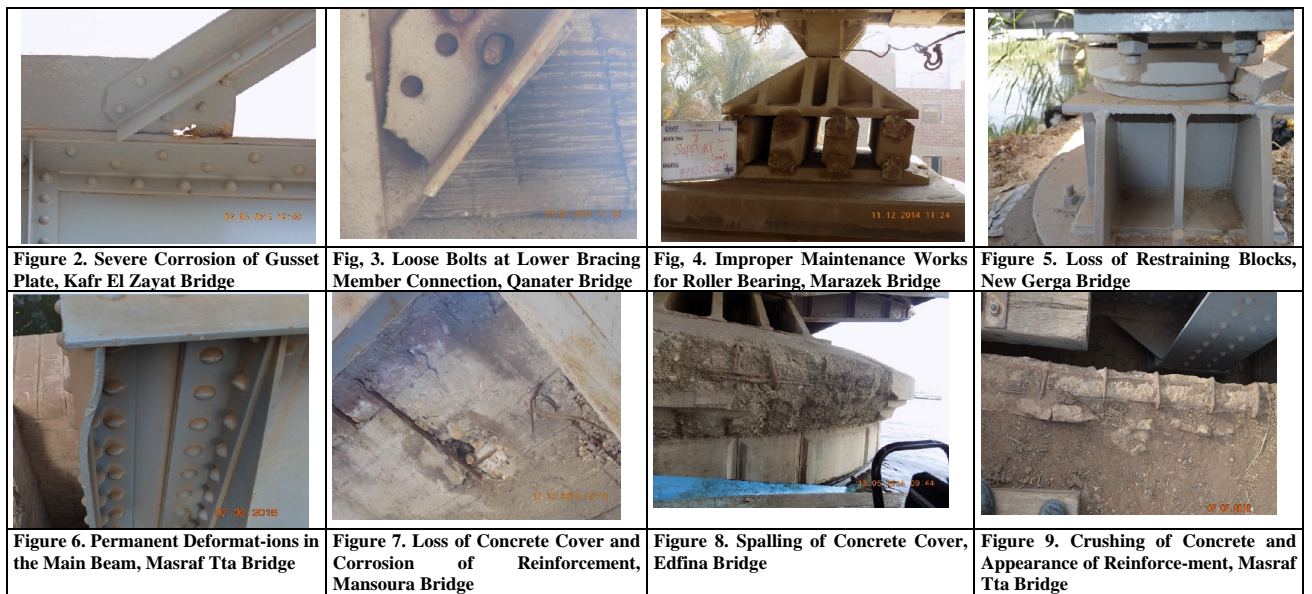
poor condition of concrete, in addition to inadequate lighting or drainage facilities. Figures 2 through 9 show the main defects observed during the visual inspection phase. Observations from the visual inspection phase were recorded and used to determine the suitable repair procedures. Consequently, FE models were developed based on the as-built drawings and the visual inspection observations. Static and dynamic tests were performed to validate the built models. Hence, models are used to analyze the bridge performance under the increased axle loads. In addition, fatigue assessment study was performed considering the records provided by Egyptian National Railways (ENR).

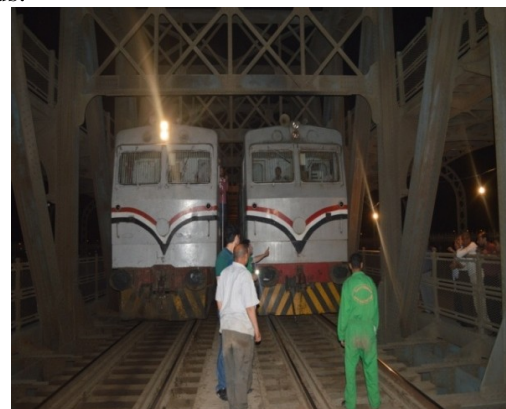
Figure 10. Static Load Test, Imbaba Bridge

Static and dynamic load tests were carried out during the assessment campaign to determine the response of the studied bridges. Test locomotives were positioned such that the resulting straining actions do not exceed 85% of the ultimate load. Deflections and strains were measured at key locations and compared to the results extracted from finite element models. In addition, modes and frequencies were deduced from test results and used to verify the analytical models. Test results were used to validate the finite element models. In addition, results were compared to the previous load test results performed throughout the bridge service life to pinpoint any deterioration in performance. Figures (10 and 11) show sample of performed tests.

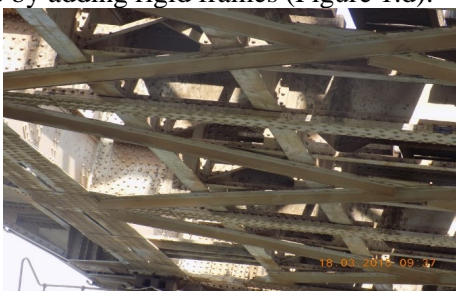
Figure 13. Replacement of Lower Bracing Members, Mansoura Bridge

The different inspected bridges showed signs of previous repair works during their service lives. This would include periodic repair works in addition to major rehabilitation of the bridge following structural assessment or accidents. It was observed that in many cases, the original lower plate bracing system was replaced with steel angles (Figure 13). In addition, stringer and cross girder bracing were added to the original structural system (Figure 14). Most of these modifications were implemented upon assessing the bridge condition 70 years after its construction upon considering the increased axle loads during checking of the different members. In Qanater Bridge, increased vibrations were observed along with train passages which lead to unsatisfactory behavior and discomfort to users. Hence, a study was performed in 2004 and recommendations included increasing the lateral stiffness of the bridge by adding rigid frames (Figure 1.d).

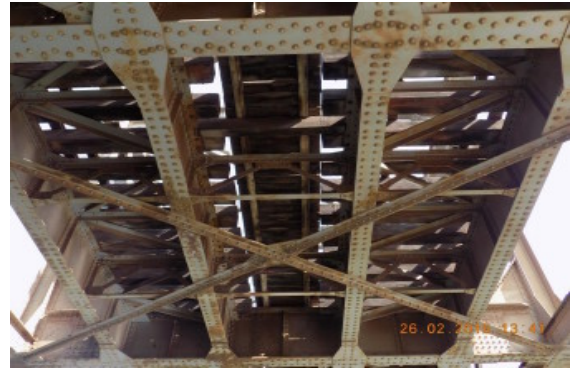
Figure 14. Addition of Stringer Bracing, Banha Bridge

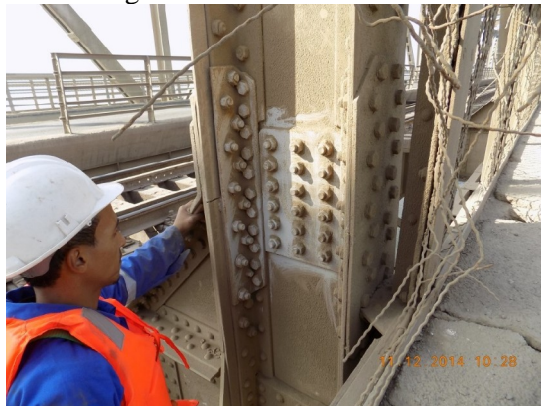
satisfactory manner even under the extreme cases. In 2002, a train derailment caused immediate loss of several main truss members of Marazek Bridge. However, due to the redundancy of the bridge, the bridge did not suffer from sudden or successive failure. Figure 15 shows the replaced truss vertical member and cross girder. Such accidents stress the importance of providing bridge designs that can safely provide alternate load paths to prevent or minimize large human losses.

Figure 15. Replacement of Vertical Truss member after Train Derailment Accident, Marazek Bridge

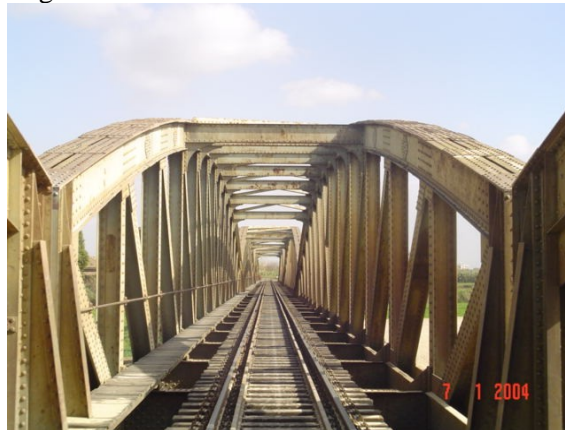
One of the bridges that was determined to perform below the accepted levels was the Qanater Bridge. Upon visual inspection, the Qanater Bridge was found to have suffered from deterioration and heavy rust for the different members and connections. The total length of the bridge is 490 m (seven equal bays) and it serves a single track railway line. The main bridge system is two riveted truss bridges with variable depth (3.5 m at edges and 7.8 m in the middle). Floor beams consist of longitudinal secondary beams (stringers) supported on transverse secondary beams (cross girders) spaced at 5.3 m supporting the open timber floor system. In addition, lower and upper bracing systems are employed; however, it was observed that the upper bracing system is only present at the middle part of the bridge (Figure 16). The bridge was built in 1907 and has gone through major rehabilitation procedures along its service life. Repair works included: adding stringer bracing, changing the lower bracing sections with larger angles, adding cross girder bracing, adding cross frames at the end bays (Figure 1.d), strengthening of cross beams, removing and replacing of rusted parts from the main truss members, and lubricating of bearings. However, the bridge performance was found unsatisfactory after several phases of repair

Figure 16. Qanater Bridge Condition before Strengthening Applications

and it was recommended to replace the existing bridge with a new one.
