Compatibility between Canals Lining Methods and Sites Conditions

Case Study: Al-Khofoog Canal, El-Minia

Tarek Sayed Abu-zeid

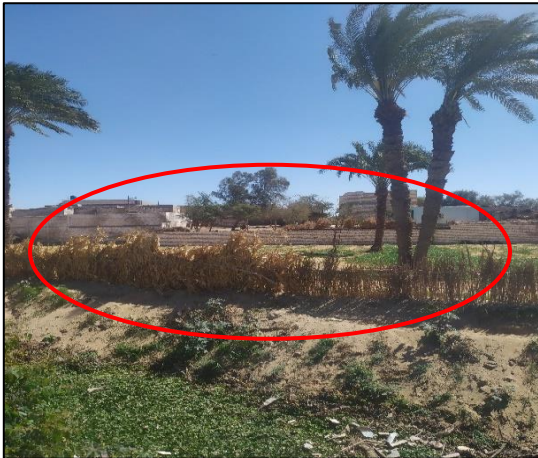
Photo (4): Buildings and lands near the canal

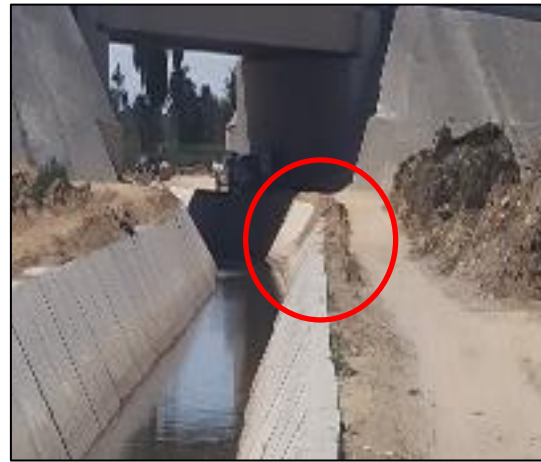
There were some failures in the bed slabs due to the large amounts of seepage water into the canal cross-section. It was also noticed that there was sliding and failure in some of the side-lined slabs, as well as some failures of the canal slopes in places that have not been lined, as shown in photos (5) and (6).

Photo (5): Sliding in some lined slabs

- The large amounts of seepage water from the surrounding high lands into Al-Khafoog canal cross sections causes many failures and sliding of the implemented parts of the proposed lining type (50 cm. rubble covered with 12 cm. plain concrete), for these reasons, this type of lining is refused.

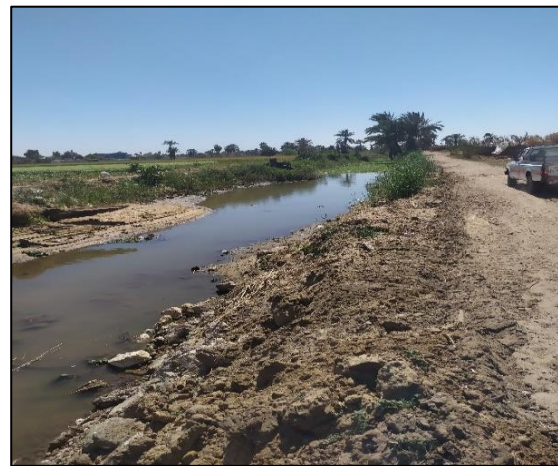
Photo (6): Failure of canal side slopes

The soil, according to the samples taken from the site, is very fine soil with a small internal failure angle, so a slope of 3:2 may be not suitable with its nature and it would be better if the side slopes in such soils were 2:1 to ensure more stability of slopes and avoid such failures.

- Proposed internal side slopes of Al-Khafoog canal cross-section under implementation (3:2) is unsuitable for the existing type of soil in the field and must be changed to be (2:1) which is more suitable and compatible with the soil type for more stability of slopes.
