STRENGTHENING OF INTERIOR SLAB COLUMN CONNECTIONS VIA POST INSTALLED STEEL SHEAR BOLTS

H. El-Esnawi

Civil Engineering Dept., Faculty of Engineering, Al-Azhar University, Egypt

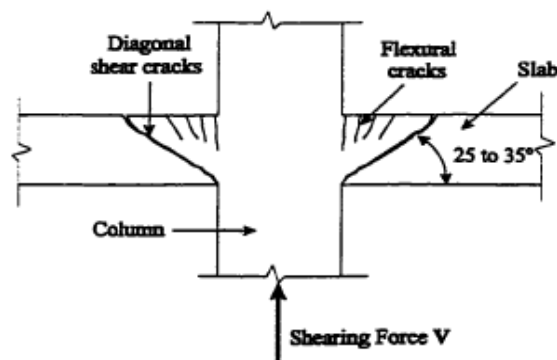
Figure (1) Slab flexural and shear cracks in the column vicinity

Flat slabs are subjected to the risk of brittle punching failure at the slab column connection. Figure (1) shows an elevation view of an interior slab column connection transferring shear force V caused by gravity loads. Flexural cracks appear on top of the slab. In addition, a diagonal shear crack develops within the slab thickness. Once shear strength of the slab column connection is reached, the diagonal shear cracks cross the full slab thickness forming a trenched cone or pyramid. This punching failure is risky since it occurs suddenly in a brittle manner. Modern building codes require a building to be designed in a way that a local failure shall not lead to a progressive collapse of the entire structure, but flat plates does not fulfill this basic requirement because it has a very limited rotational capacity at the columns. Punching will occur when the rotational capacity is exceeded. A punching failure may probably lead to subsequent punching at the adjacent columns due to large slab rotations, and the risk of a progressive collapse is imminent. In order to overcome the major disadvantage of flat slabs, previous researchers investigated the efficiency of several strengthening techniques. The use of shear studs in the column vicinity is one of the famous strengthening techniques. Figure (2) shows shear stud reinforcement in a slab column connection. Another method for ductility enhancement is the use of bent bars and stirrups in the column vicinity as shown in figure (3). Broms provided a detailing for ductility using a combination of bent bars and stirrups. Strengthening of slab column connections can be done also after slab construction. Strengthening is needed due to a design or/and construction mistake, or due to changing the function of the building. Fiber reinforced polymers can be used as a transverse reinforcement in slab column connections. Increasing the flexural reinforcement ratio has a significant effect on increasing the punching shear capacity of slab-column connections. It also increases the post-cracking stiffness and decreases the ductility of the connections Rizk et al. 2011

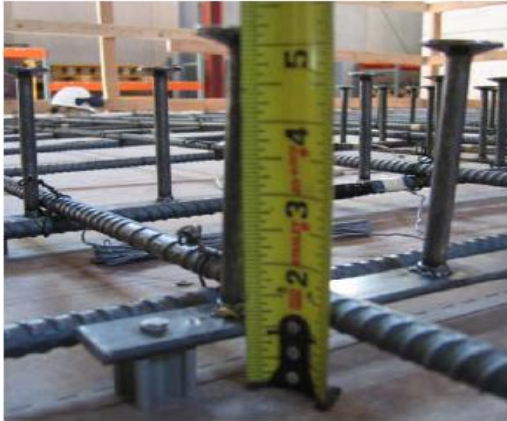
Figure (2) Headed shear studs in a slab column connection

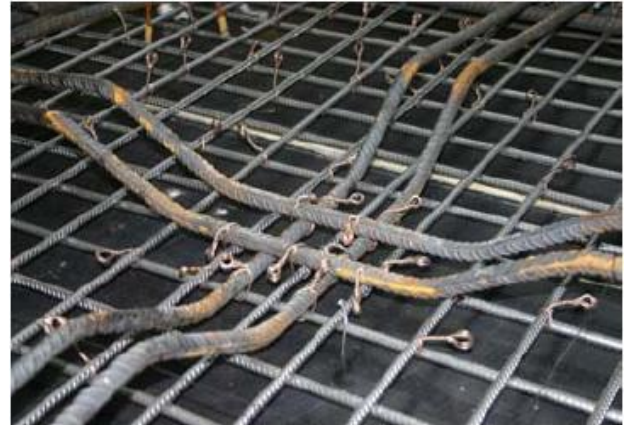
Figure (3) Bent up bars for ductility enhancement.

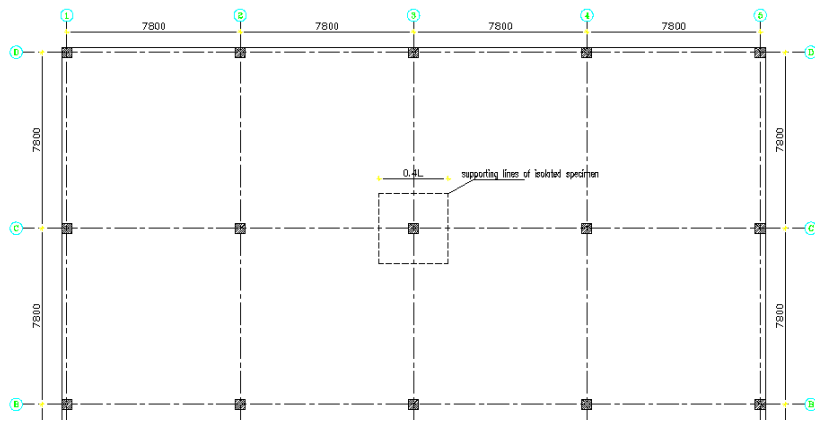
Figure (4) Plan view of prototype structure

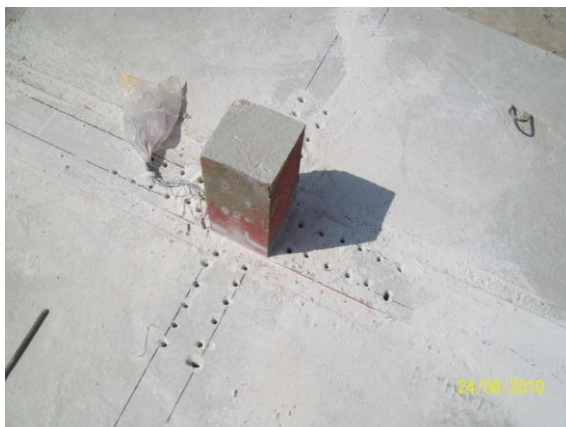
Figure (5) Slab specimen after holes drilling process

The strengthened test specimens was provided with high strength steel shear bolts of a diameter 12 mm, the grade of shear bolts was 8.8. They were installed in the concrete slab of the specimens after drilling 12.5 mm diameter holes through the slab. Figure (5) shows a slab specimen with drilled holes. However, after completing the drilling process, steel shear bolts were installed in the concrete slab through the drilled holes. The bolts were then tightened against the slab by a standard torque wrench. The tightening torque was kept constant for all specimens with a value of (70 N.M). Figure (6) shows a strengthened slab after the installation process of shear bolts.

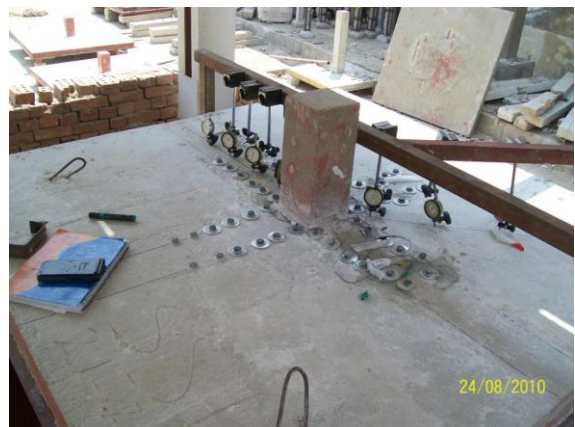
Figure (6) Slab specimen after the installation process of shear bolts

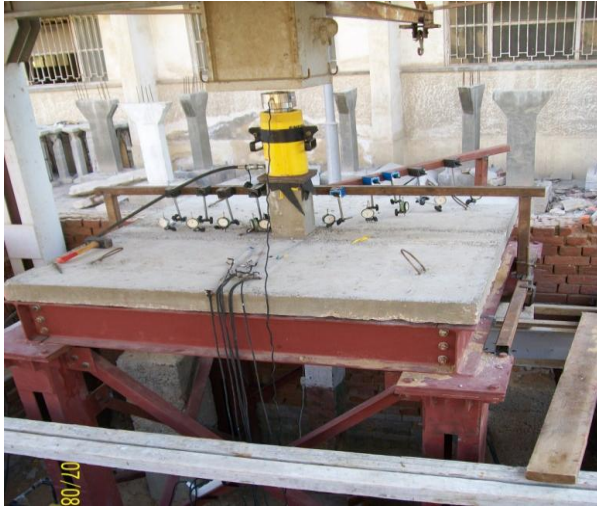
Figure (7) Test setup

The layout and dimensions of the testing frame is shown in figure (8). Data acquisition system has been used to monitor and record the load magnitude and the strains in the flexural reinforcement, as well as concrete strain. Displacements are measured using dial gauges. Figure (7) shows the test setup. Six strain gauges are installed on the tensile reinforcement of every tested specimen. The capacity of the loading actuator is 1000 KN, and the capacity of the load cell is 800 KN. Subsequently, vertical load is applied through the column stub by the load actuator. Load was applied by increments of (25 KN) up to failure load. After every loading increment, loading was held to allow for crack monitoring and record of deflection values.

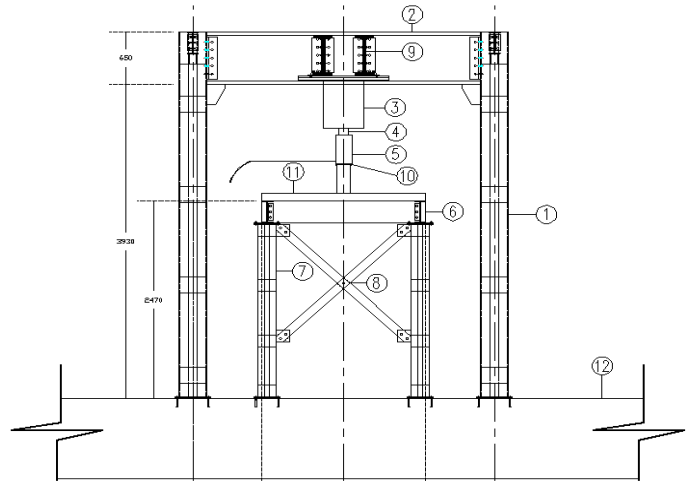
Figure (8) Elevation view of the testing frame

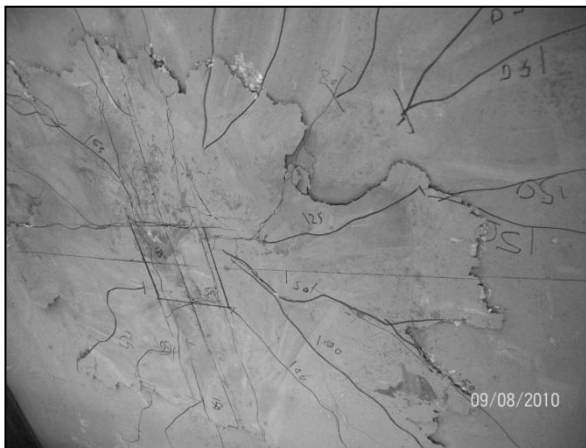
a) Specimen (NS1)

Figure (9), crack patterns of the tested specimens

Crack patterns of the tested specimens after failure are shown in figure (9). For specimen (NS1), the first circumferential crack occurred at the column face, this crack was observed at 50 kN load. With increase of the applied load, the radial cracks extended further towards the slab supports while circumferential cracks formed semi-closed rectangles around the column faces. At a load level of 191 kN, the column stub with a portion of the slab penetrated the slab. A trenched cone is formed due to the punching of the column through the slab. The trenched cone base extended to a distance of 80 mm from the column face at the bottom side of the slab. Nevertheless, splitting of the concrete cover has been observed outside the region of the trenched cone indicating false dimensions of the trenched cone for specimen (NS1), i.e. the dimensions of the trenched cone appeared larger because of splitting of the concrete cover outside the region of the trenched cone. Crack patterns of specimen (NS2) and (NS3) were similar to those of specimen (NS1). At a load level of 235 kN for specimen (NS2) and load level 305 kN for specimen (NS3), the column stud punched through the slab and a typical trenched cone is formed.

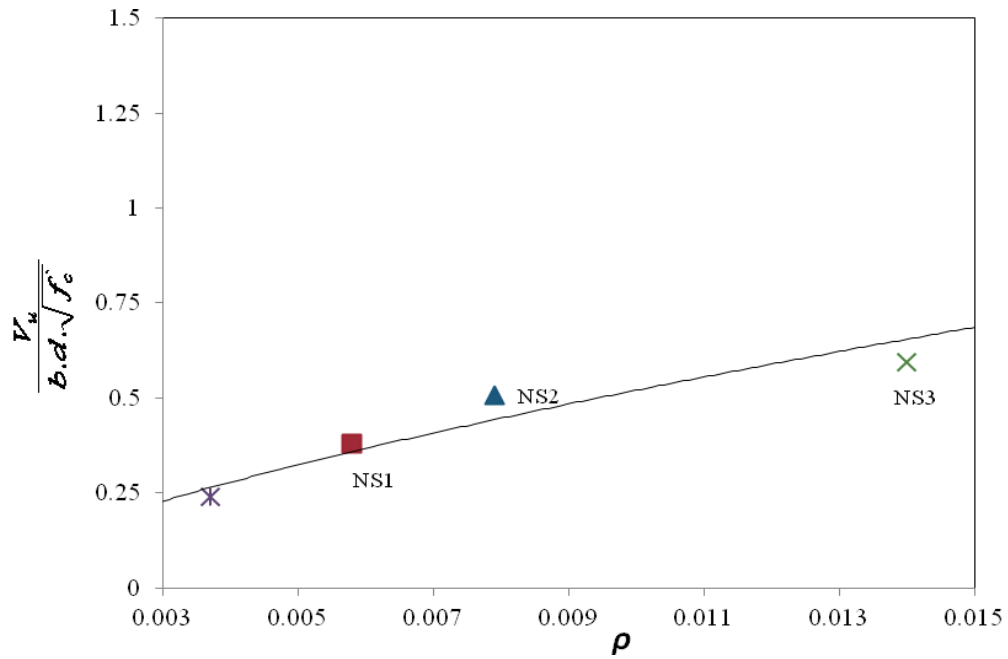
Figure (10), effect of reinforcement ratio on the punching shear strength of slabs

Figure (10) shows the relation between the punching shear strength and the tensile reinforcement ratio for the first un-strengthened group. However, a significant increase in the ultimate punching load is observed with the increase of the tensile reinforcement ratio. Table (2) shows also similar relation for the strengthened slabs.

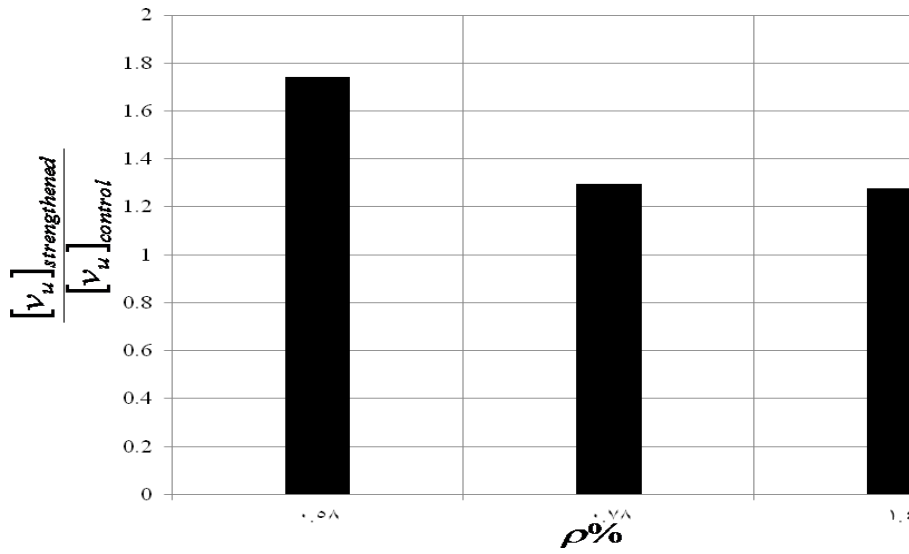
Figure (11), effect of shear bolts on punching shear strength for different ratios of flexural steel reinforcement

Figure (11) shows the effect of shear bolts on the punching shear strength of slab column connections for different reinforcement steel ratios. The percentage of increase in punching shear strength varied from 28% to about 55% depending on the ratio of flexural steel reinforcement.

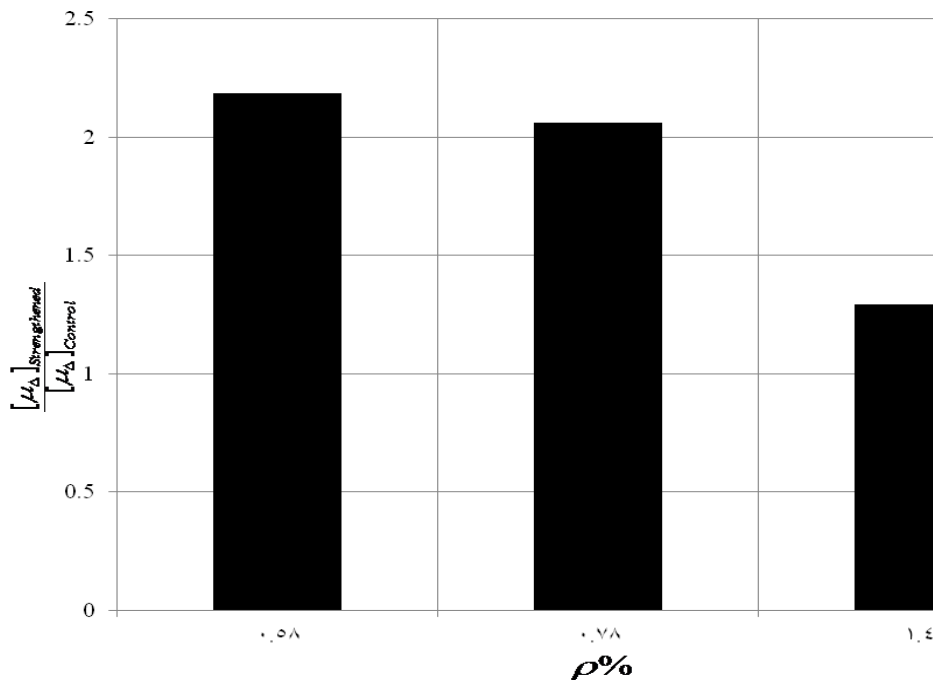
Figure (12), the ratio of increase in the displacement ductility factor due to installation of shear bolts

Figure (12) shows the ratio of increase in the displacement ductility factor due to installation of shear bolts for different reinforcement ratios. The percentage of increase in displacement ductility factor varied from 30% to about 118% depending on the ratio of flexural steel reinforcement.
