Mechanical and corrosion behaviour of conventional and high-speed remote scanner laser welding for duplex stainless steel: A comparative study

To cite this article: Mahmoud Abu El Khier *et al* 2019 *IOP Conf. Ser.: Mater. Sci. Eng.* **610** 012021

Mahmoud Abu El Khier¹, Ahmed M El-Aziz¹, Horest Exner²

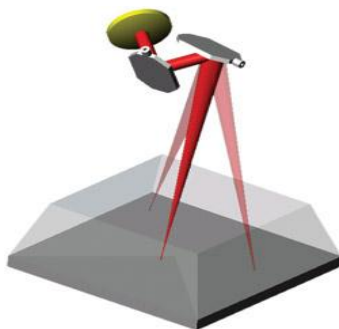
Figure 1 Working area of the laser scanner system, (Courtesy of Trumpf Laser technique)

Remote scanner laser welding which is a high-speed system works as multiplier of laser stitch to make weld combined with very short un countable welding times like Tungsten Inert Gas (TIG). To get good remote welding system, the presence of high performance laser with power in excess of 3 Kw in addition to high beam quality is a must. This which makes the direction of auto-motive industry to use this type of welding in order to increase the productivity, strength and new designs to be implemented [5,6]. In the auto-motive industry the laser technology was implemented to increase the productivity, strength of constructions and new designs [8,9]. First applications with long welds on the vehicle body are currently trailed by replacement of resistive spot welds by short laser welded fastens with the benefit of shorter preparing times. [12,13].

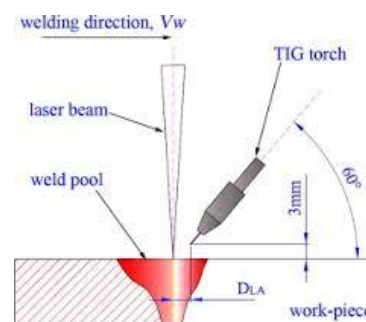
Figure 2 Key hole penetration between Laser and TIG weld

Keyhole welding or deep penetration welding is a procedure in which the laser beam penetrates partially or completely through a specimen forming a keyhole; so as the laser beam progresses, molten metal fills in behind the hole to form the weld bead; which results in a homogenous weld. At the point when high laser beam power densities are accomplished, deep- penetration fusion welding is cultivated by a keyhole energy transfer mechanism. Laser beam welding gives Weldament less Heat affected zone(HAZ) and less distortion in contrasting with traditional tungsten inert gas (TIG) welding which gives an important solution for welding critical joints, and for the circumstances where quality and purity welds are required it creates a high-virtue weld contrasted, which is pivotal in huge number of applications. The cost of TIG welding is very moderate and affordable. However, the process has a low deposition rate and whenever performed inappropriately, continuations, inclusions, overheating of specimen can make products to become defective [13].

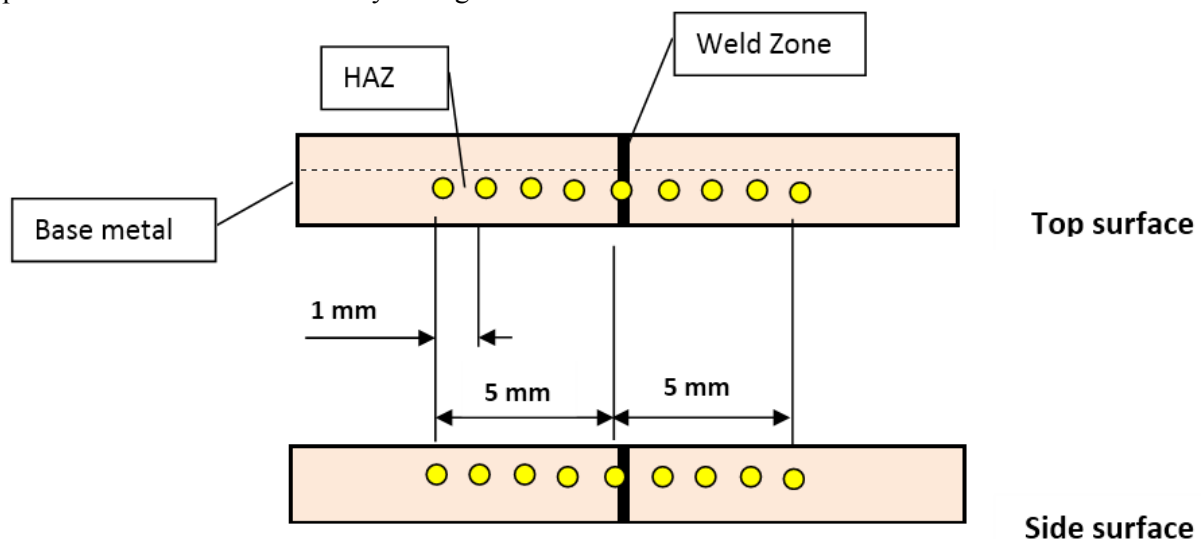
Figure 3 Schematic for specimen shown Base metal-HAZ-Weld zone

The Vickers micro hardness was used to attain the hardness of the specimens across line path according to (ASTM E384-99)[14] standard done through the top and side surfaces of the specimen of the laser-welded specimens and the TIG welded specimens as shown in fig.3 The load applied was 300 g and the loading time was 15 s by equipment Buehler Micromet 5100 series. All the specimens were ground to provide a smooth surface for the test. In order to get the precise results; the sample has been handled around the weld line from extreme left to the extreme right passing by the weld line; as well as the heat affected zone HAZ, measurements are also taken from the top and the surface of the specimen as shown schematically on Figure 3

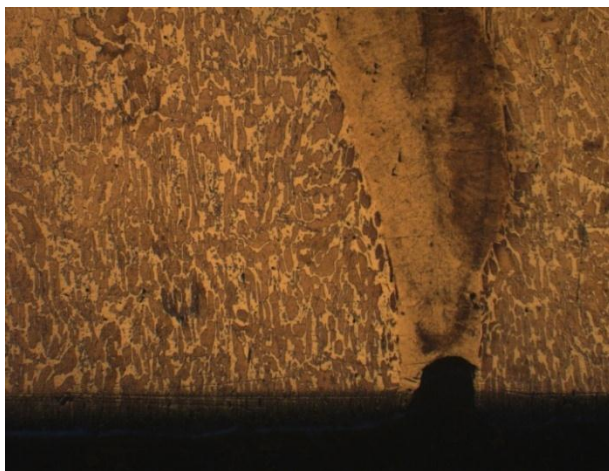
Figure 4-1.4462 8mm thickness Laser weld in complete penetration defect

Observing that there are different types of defects were happening due to welding as shown in fig.4 and fig.5 for laser welded and TIG welded specimens respectively. The most common defect observed is incomplete penetration and under fill of the weld bead that happen to the laser welded specimen this might be from reflection of the incoming laser off the surface of the stainless steel same for the TIG happened due to the filler rod melting. In order to decrease these defects; then decrease the reflectivity of the laser off the surface of the material. It can be obtained by coating of the surface to absorb and decrease the surface reflection. It has also seen in fig.6,7 in the TIG sample; the inclusions happened on the surface due to the slag of the sample when trying to avoid forming pockets to trap the slag. [21] Figures 8,9 present the difference in the HAZ and the base metal for the elongated grains.

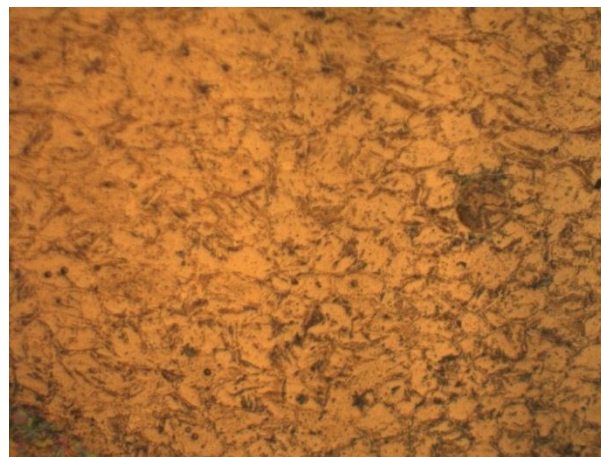
Figure 5- 1.4462 8mm thickness TIG weld inclusion defect

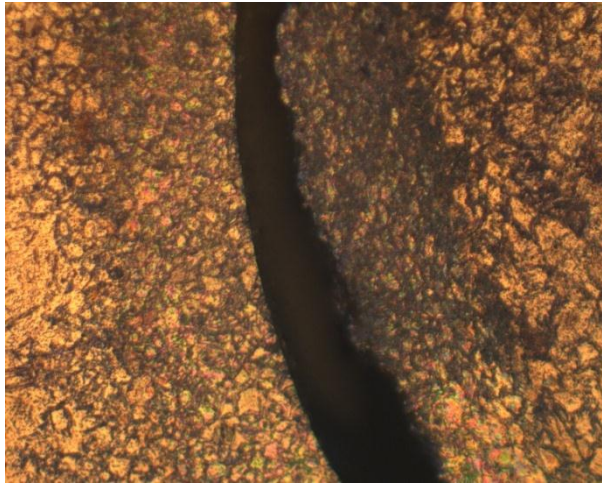
Figure 6-1.4462 8mm thickness TIG weld under fill

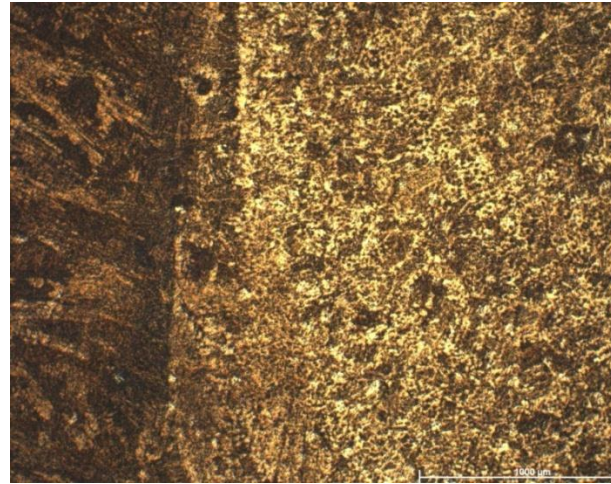
Figure 7- 1.4462 Tig weld line difference in grain size

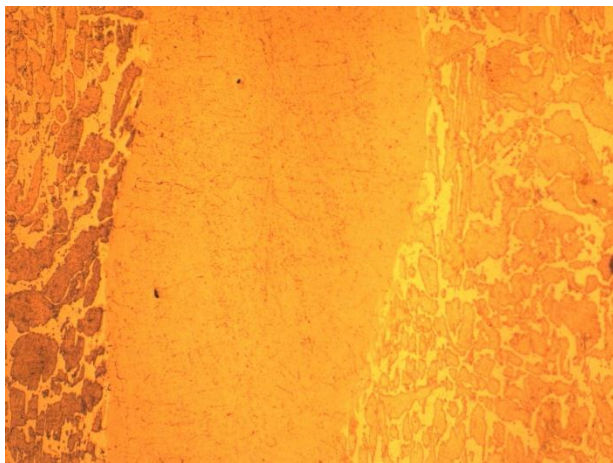
Figure 8-1.4462 difference of grains at different zones

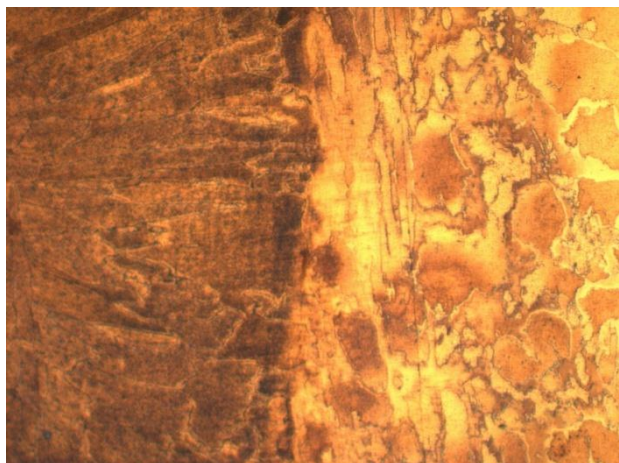
Figure 9- 1.4462 Laser weld around the weld line

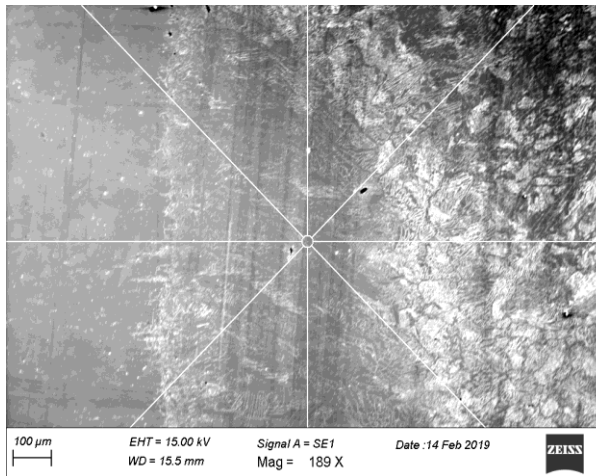
Figure 10- 3 1.4462 D.S.S Tig weld zone

Clearly from scanning electron microscope The grain size of this material was very clear in fig.10 due to the use of detector large-field detector (LFD) using TESCAN-Mira3 to show the phases. In figure 11,12 by using EVO-MA15 the help of magnification we can see its very small and may be this explains why the hardness at this region will be very high. these black spots are carbides but after making the EDX and comparing between the HAZ and base metal or even though change in percentage of the iron or chromium so this means that there is no precipitation and the heat generated from the remote scanner welding just make Recrystallization of the grains. In D.S.S there is two phases δ ferrite and γ austenite both are seen clearly. The dark regions are the ferrite where the light ones are the austenite

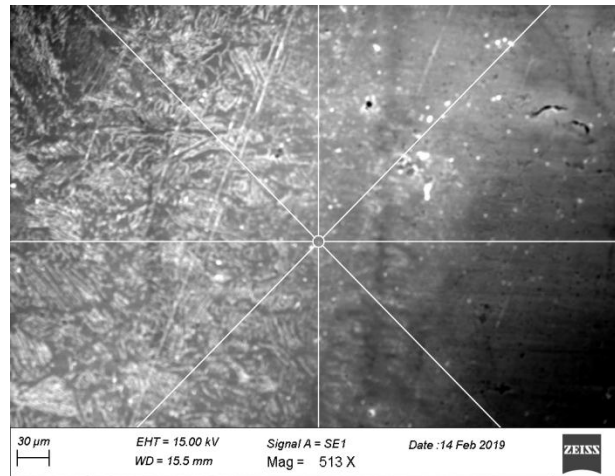
Figure 11- 1.4462 D.S.S Tig weld HAZ

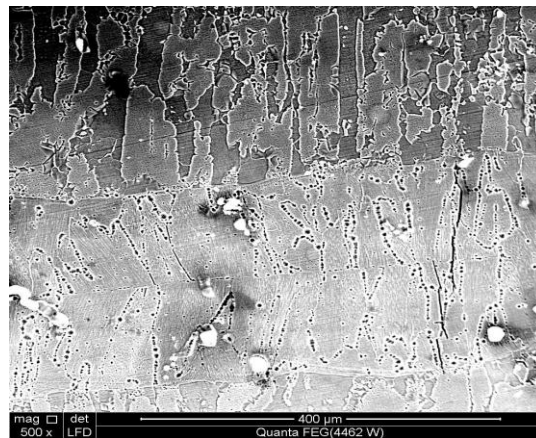
Figure12- 1.4462 D.S.S laser weld zone

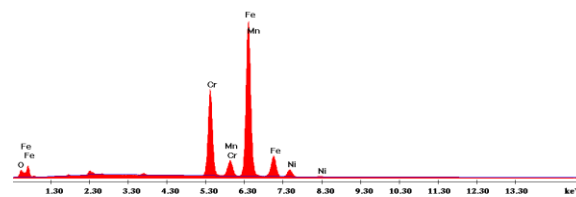
Figure 13 EDX of 1.4462 laser weld in HAZ

Table3. is more cleared by figure13 representing the Energy-dispersive X-ray (EDX) inside the HAZ

Element	Wt%	At%	k-ratio	Z	A	F
O K	2.88	9.24	0.0123	1.1408	0.3723	1.0040
Cr k	22.89	22.63	2.2640	0.8911	0.9858	1.1801
Mn k	2.14	2.00	0.0209	0.9750	0.9962	1.0056
Fe k	67.49	62.11	0.6315	0.--9955	0.9334	1.0070
Ni k	4.60	4.02	0.0381	1.0156	0.8156	1.000
Total	100.00	100.00

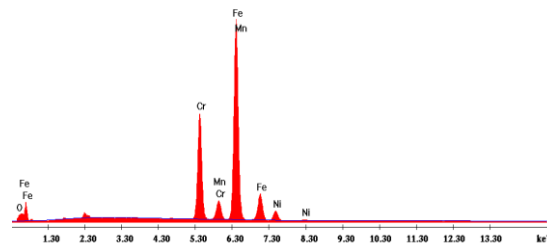
Figure 14 EDX of 1.4462 laser weld Out HAZ

Table 4. is more cleared by figure14 representing the Energy-dispersive X-ray (EDX) away from the HAZ

Element	Wt%	At%	k-ratio	Z	A	F
O K	2.37	7.71	0.0101	1.1417	0.3707	1.0041
Cr k	22.94	22.94	0.2647	0.9919	0.9854	1.1806
Mn k	1.99	1.88	0.0195	0.9758	0.9959	1.0059
Fe k	67.80	63.13	0.6349	0.9963	0.9330	1.0074
Ni k	4.90	4.34	0.0406	1.0164	0.8151	1.0000
Total	100.00	100.00

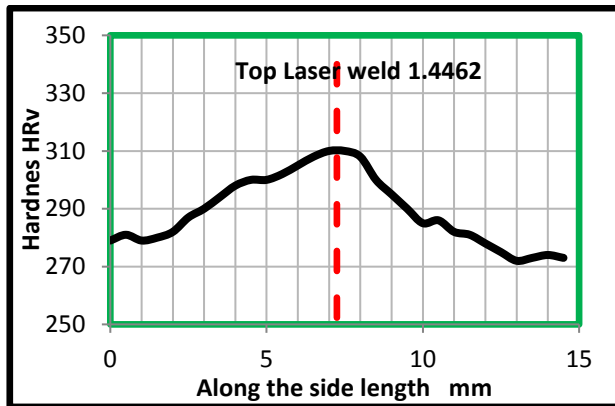
Figure 15-1.4462 D.S.S top surface Laser weld hardness test

Hardness test is a general path pattern where the hardness increases towards the weld line zone until it is at its most extreme at the centre of weld, as shown in top surface figures 15 and 16 and for side surface figures 17 and 18. The phenomena may be illuminated by a reason behind welded duplex stainless steel 1.4462. The fundamental reason might be a direct result of the grain refinement and the development of smaller grains as in the small grain, no dislocation can travel more than one unit of distance not like the grain growth area. This type of strengthening is known as Hall-Patch strengthening, which implies more grain boundaries. These grain boundaries give more strength to the material which causes an increase of the hardness. For Duplex stainless steel 1.4462 (318LN) the hardness for the welded specimens were much higher than the unwelded. There is a great increase in the TIG weld over the laser weld compared to the unwelded. Since, a very large increase in the ferrite is observed, where the primary phase becomes the ferrite phase, so a very large increase in the hardness is observed reaching as much as 54% more than the original hardness as seen in Figure 19. Comparison with literature results for the unwelded sample which is 293 HV close to the result in figure 19. It is 318 HV for TIG weld compared to the 310 for laser welded sample which indicates the more over the unwelded sample.

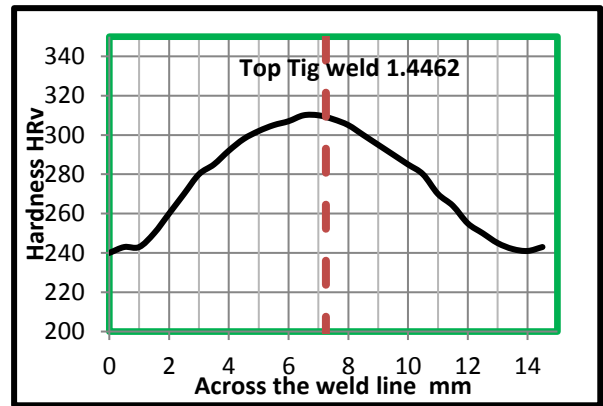
Figure 16-1.4462 Top surface D.S.S TIG weld hardness chart

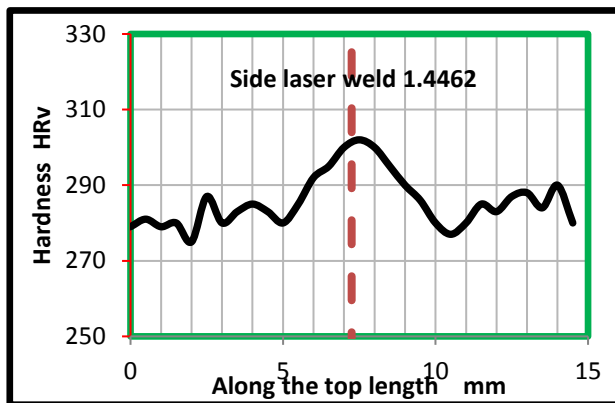
Figure 17 1.4462 D.S.S side surface laser weld hardness test

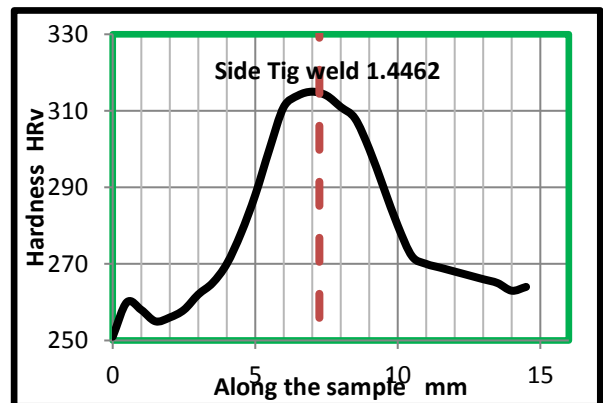
Figure 18 1.4462 D.S.S Side surface TIG weld hardness chart

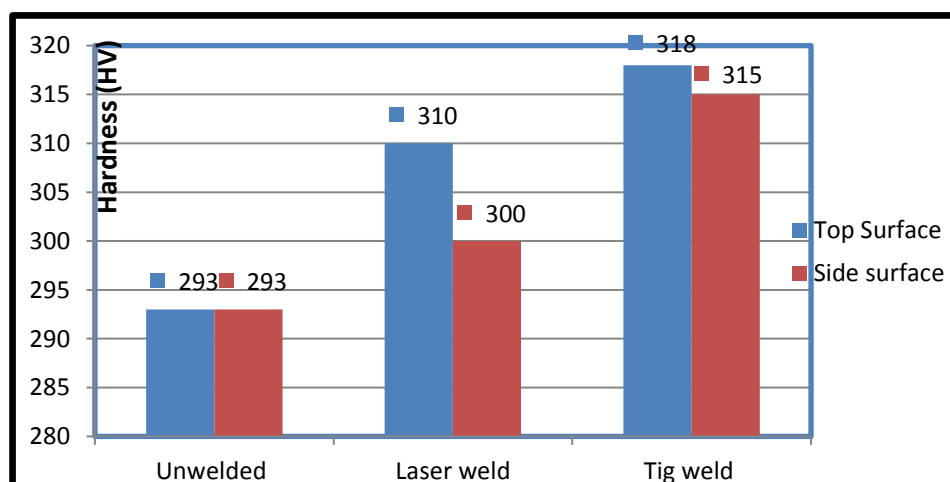
Figure 19- 1.4462 Micro hardness Histogram comparisons

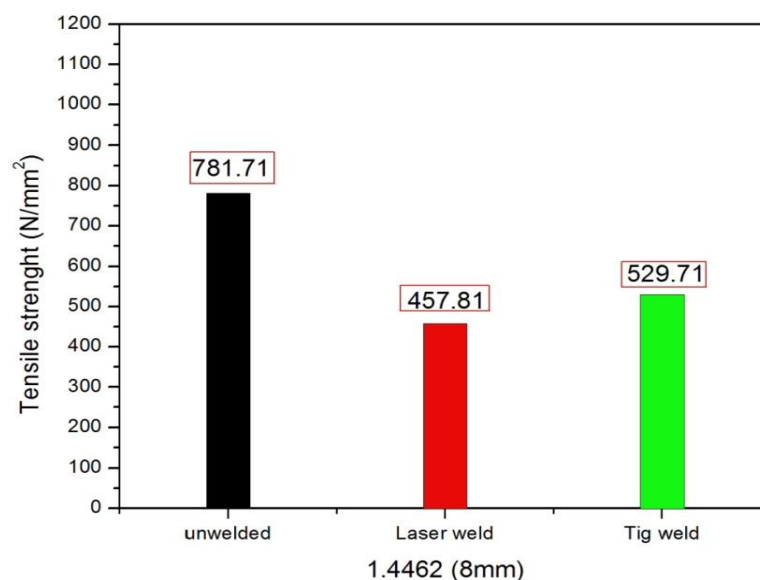
Figure 20 1.4462 D.S.S Tensile strength comparison of the unwelded, laser, and TIG joints

Tensile strength testing was carried out for laser and TIG welding 8mm thickness for comparison unwelded base metal was used. observed that the weld done to the specimens done well compared to the original unwelded specimen that the tensile strength range from (650 to 800 N/mm²) according to literature review fig.20 After several tests observed that the main reason about failing was some of the weld defects found in the weld zone that contain pores and cracks would weaken the material and can be affected by corrosion resulted in failure of the specimen below suspected breaking part. The incomplete penetration debilitates the material totally as the welding zone turns out to be not exactly the original measure. Compared to micro hardness measurement its assure that in the Laser weld its hardened which cause the failure at lower strength than TIG weld and the base metal. Through visual investigation of the tested specimens, the materials that performed best were the materials that had the least imperfections. In this manner, to choose which materials had the more exact welding conditions, we observe which specimens had the most elevated average ultimate strength.

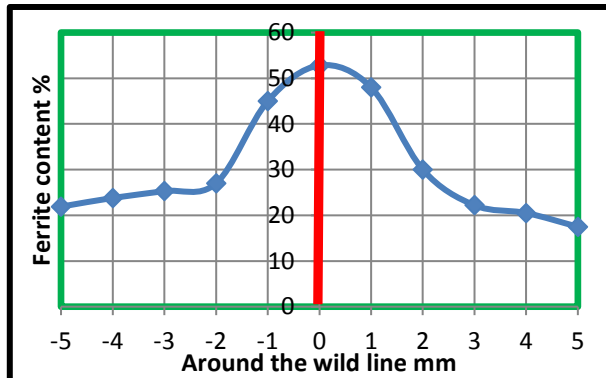
Figure 21-Ferrite%1.4462(318LN) D.S.S Laser weld

Ferrite testing is accurate way to measure delta ferrite content in duplex stainless steels. test conducted by FERITSCOPE FMP30. For Duplex Stainless Steel 1.4462, shown during the probe passing through the specimen that the Ferrite % increasing along moving from the base metal to the heat affected zone followed by the maximum in the weld zone which has lower corrosion resistant that will be confirmed later in corrosion study happened due to the precipitate in the HAZ as found in figures (21 and 22) for top surfaces, figure (23 and 24) for side surfaces; Production welds shall be checked on the surface (top-side) along the weld with a calibrated ferrite gauge and shall not exceed 60% ferrite. According to literature: Ferrite content shall be within the following ranges:

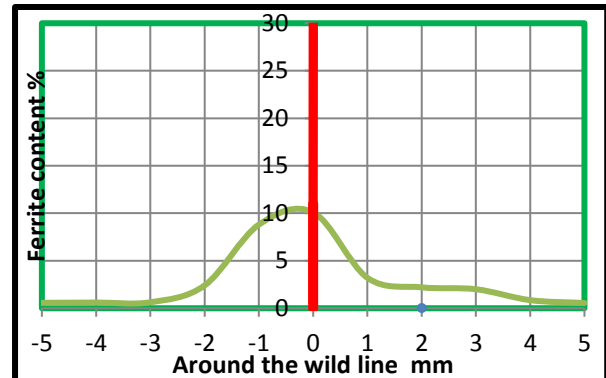
Figure 22-Ferrite % 1.4462 (318 LN) Tig weld

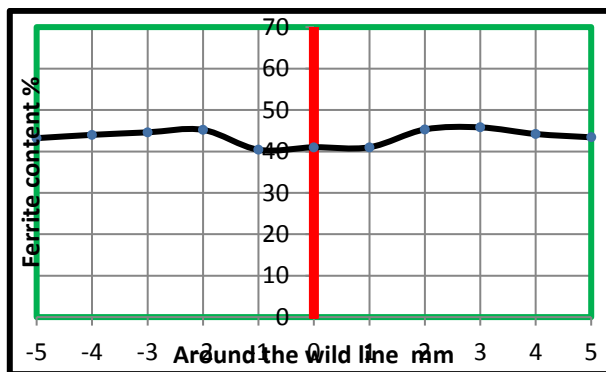
Figure 23-Ferrite % 1.4462(318LN) DS.S Laser weld

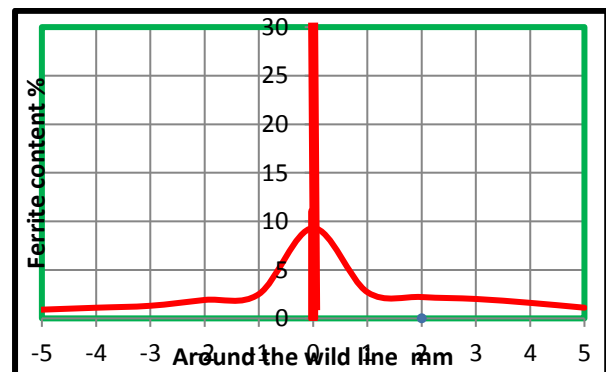
Figure 24-Ferrite % 1.4462 (318 LN) TIG weld

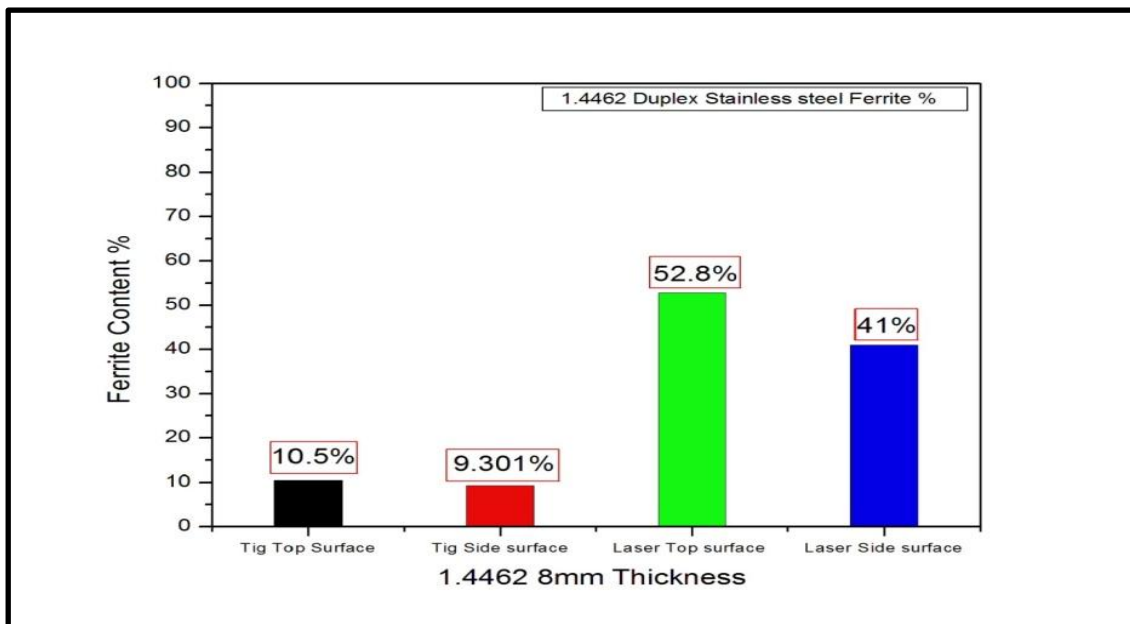
Figure 25- 1.4462 D.S.S Ferrite content % comparison histogram

For TIG weld its is subjected that the base metal composition might be conducted nearly to austenitic stainless steel but in the weld metal due to the filler id duplex that's illustration for the low ferrite content % compared to the Laser shown in fig.25

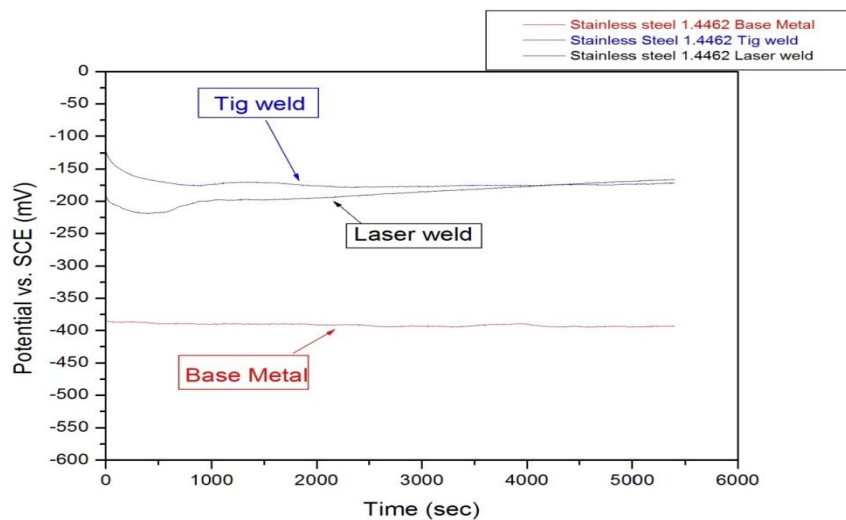
Figure 26- 1.4462 (318LN) D.S.S OCP

In the above fig.26 in D.S.S 1.4462 the laser welded has a higher OCP values than the TIG welded and the Base metal (unwelded). Which illustrates that the welded material (Laser-Tig) has a higher passivity than the unwelded material in environment of 3.5% NaCl. At 4500sec (75mins) the laser -172.12mV compared to TIG which is -162.12mV the base metal (unwelded) is -392.92mV. As going from Laser welded specimen followed by the TIG welded specimen which indicates that the less negative potential direction is indication towards corrosion value happens due to the formation of carbides around the grain. The increase of potential from TIG weld to Laser weld then the base metal may conclude TIG re-passivation more corrosion resistant than Laser weld [27].

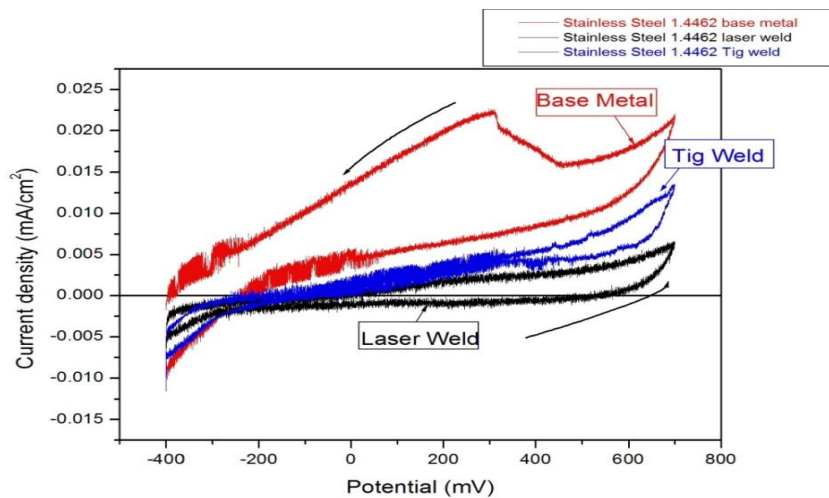
Figure 27 1.4462 D.S.S PCV

After conducting the Potential cyclic voltammetry for scan rate 2mV/sec from -400mV to 700mV[28] it was seen from fig.27 for the laser weld is more pitting resistant comparing it to the corrosion rate of Tig 8.917 $\mu\text{m}/\text{Y}$ to the Laser welded 5.615 $\mu\text{m}/\text{Y}$ from table5.
