Sealing Ability and Dislodgement Resistance of Three Materials for the Repair of Furcation Perforation (*In-vitro* Study)

Ali Ismail El-Tahan¹, Hossam Mohamed Tewfik², Alaaeldin Hussien Diab³, Amr Ahmed Bayoumi⁴

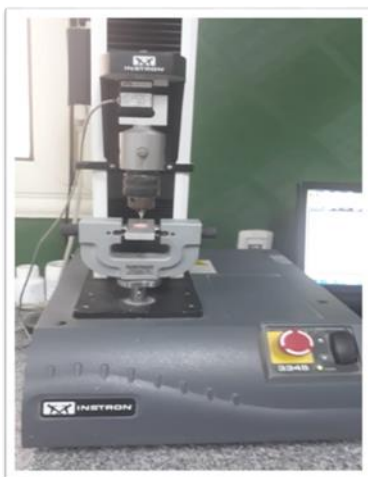
Figure 3: Universal testing machine (Instron).

upward. Metal stylus of different diameters (0.8, 1, 1.5 ,2) mm equivalent to the diameters of the repair materials was mounted on a universal testing machine. The samples were positioned on a metal slap with a central hole to allow the plunger with a diameter of 1.2 mm to move freely, at a constant vertical downward pressure at a speed of 1 mm/min. The plunger tip was positioned to contact the test material touching only the filling material without stressing the surrounding dentin, in a coronal-apical direction. The test was completed until total bond failure. The highest force applied to materials at the time of dislodgement was recorded in megapascal (MPa), as described by Tomer.*et al.*¹⁵ (**Figure 3,4**). Bond strength was calculated from the following equation as illustrated:¹⁶ **Bond strength= $F/\pi dh$** , (**F**) is the compressive force applied to the specimen, (**d**) is the diameter of the plunger, (**h**) is the thickness of the specimen, (**π**) is constant (3.14). All Samples were examined

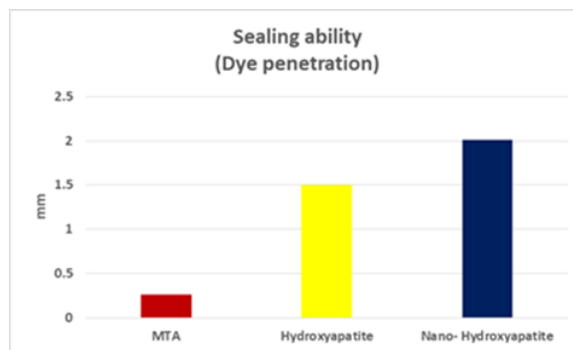
Figure 5: Bar Chart Representing Sealing Ability for Different Groups.

Sealing ability (Dye penetration): (Table 1, figs 5-8)

Comparing the dye penetration values for the three experimental groups showed that the least dye penetration was seen within the samples repaired by MTA ($0.26 \text{ mm} \pm 0.09 \text{ mm}$). The highest dye penetration was recorded with the samples repaired by nanohydroxyapatite ($2.01 \text{ mm} \pm 0.3 \text{ mm}$). Samples repaired by hydroxyapatite showed intermediate dye penetration value ($1.50 \text{ mm} \pm 0.34 \text{ mm}$). Statistically, the dye penetration values for the three tested materials were significantly different at $P < 0.001$.

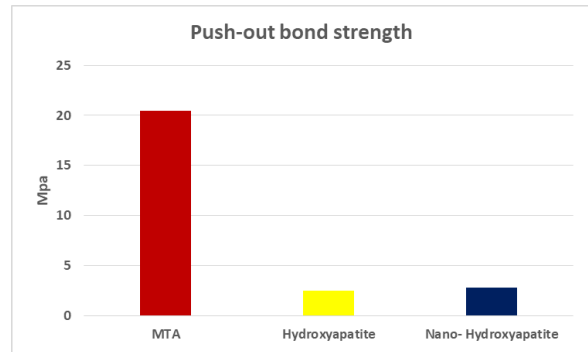
Figure 9: Bar Chart Representing Push-out Bond Strength for Different Group.

Push-out Bond Strength: (Table 2, figs 9-12)

Comparing the values of push-out bond strength for the three experimental groups showed that the least push-out bond strength was seen within the samples repaired by hydroxyapatite ($2.54 \text{ MPa} \pm 1.01 \text{ MPa}$). The highest push-out bond strength was recorded with samples repaired by MTA ($20.46 \text{ MPa} \pm 4.37 \text{ MPa}$). Samples repaired by

nanohydroxyapatite showed intermediate push-out bond strength ($2.81 \text{ MPa} \pm 0.65 \text{ MPa}$). Statistically, the bond strength values of samples repaired by MTA was significantly higher than the samples repaired by hydroxyapatite and nanohydroxyapatite. On the other hand, the bond strength values for the samples repaired by hydroxyapatite and nanohydroxyapatite were not significantly different at $P < 0.001$.

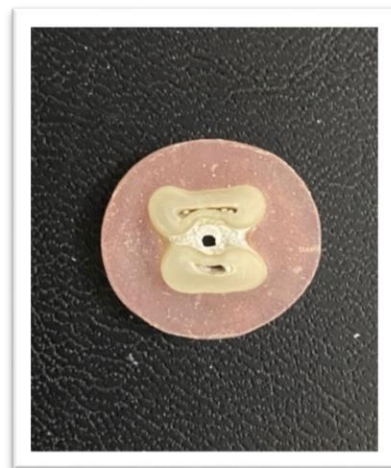
Figure 10: Push-out sample of MTA showing the cohesive failure.

-In MTA group, 9 samples out of 10 showed a cohesive failure.

Analyzing the mode of failure, it was found that 90% of samples of MTA showed a Cohesive bond failure. Only 10% (one sample) showed adhesive bond failure. This result reflects the perfect sealing properties of this material. This came in agreement with

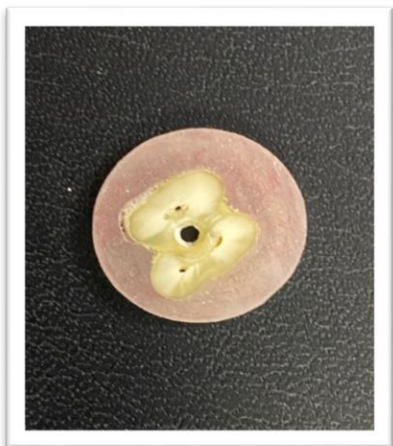
Figure 11: Push-out sample of Hydroxyapatite showing the adhesive Failure

-In Hydroxyapatite group 7 samples out of 10 showed adhesive failure.

Samples of Hydroxyapatite and Nanohydroxyapatite showed lower bond strength. This low resistance to dislodgment reflects bad sealing qualities. These results were further explained by the mode of failure, where 60-70 % of the samples repaired showed adhesive failure. Those bond failures of those two materials revealed that their compressive strength is considerably low to withstand any force applied.
