## Diagnosis of construction stone state as a step in the conservation plan for Cairo Citadel Aqueduct

**Key words:** Cairo Citadel Aqueduct, Biomicroite limestone, deterioration aspects, investigation and analysis.

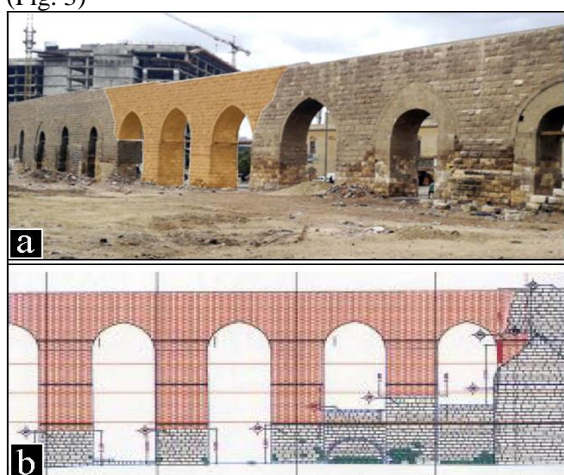
**Fig. 3 a. The current condition of the Cairo citadel aqueduct, (b) sketch shows some newly completed arches**

There is a 2.2 kilometres wall between the waterwheel structure at the mouth of the Gulf and the citadel walls, and the thickness of the wall itself ranges from 2.5 to 3 m, and the rest of the space is filled with broken stone, mortar and some bricks (El Brambly, 2008: 5, 25-26). The land, along with other arches, was completely blocked, there are some dilapidated parts in the body of the Cairo Citadel Aqueduct, and there are only the foundations of the pillars, as a result of traffic accidents through the collision of its contracts with heavy transport vehicles, and other parts have been completely removed to establish a road network, and the metro line - the Helwan Railway- (Attia, and Hassan, 2002: 6). This first occurred after the wall was finished under Sultan Ghouri rule. all its arches were built as pointed stone arches Al-Wasiya Sabil and the current Salah Salem Street, but there were several restoration works on the wall that led to a change in its shape (El Brambly, 2008: 6) (El-Kasaby and Farag, 2015). (Fig. 3)
