***REHABILITATION OF BEAMS MADE OF
ALUMINUM POWDER AND PUMICE STONE
AFTER FIRE USING DIFFERENT TECHNIQUES***

ASGE Vol. 03 (04), pp. 214-226, 2019

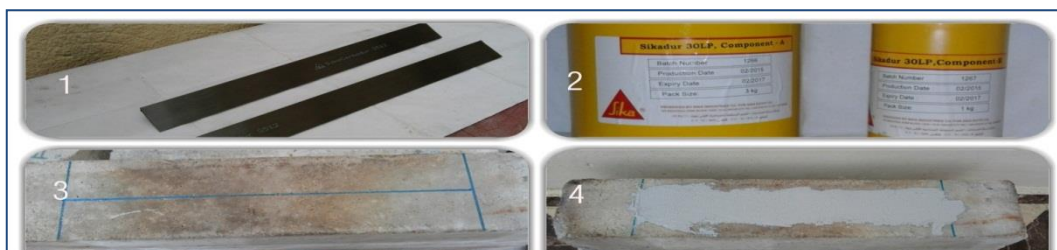
Fig. 1: Steps of rehabilitation of beams using CFRP

The rehabilitation of the reinforced concrete beams made of lightweight concrete after the fire was by using three different methods; the first method was using CFRP strips with width 50 mm and thickness 1.2 mm, where preparation of concrete surfaces was before putting a layer of the epoxy matrix on the bottom of beams. After that, the strips of carbon fiber were put on epoxy matrix, then the second layer of epoxy matrix was put on fiber strips. The second method was using steel plates with width of 100 mm, thickness of 4 mm and the steel plates were installed for covering 100% of effective span of beam. The steel plates have been affixed using expansion bolts which were inserted into the holes with depth 80 mm. The last method was using concrete jacket, where the holes were created with diameter of 10 mm and depth of 70 mm on each side of the beams to insert the stirrups with diameter of 8 mm inside beams, two bars with diameter of 10 mm were added as main steel of reinforced concrete jacket. The stirrups were glued into the holes by using Kimapoxy 165 after cleaning the holes with an air blower, then sprinkling the addibond 65 on the top surface of beams to improve the bond between old and new concrete. Finally, the new concrete layer was cast. Figs. 1 to 3 show steps of rehabilitation of the reinforced concrete beams. The flexural behavior of produced beams after the fire and rehabilitation by different techniques was studied at 800°C for a period 2 h, where the beams were with a cross-section of 150×150 mm and 1000 mm length. The main reinforcement was high-strength reinforcing steel with diameter 10 mm. The details of reinforcement and loading of beams are displayed in Fig. 4.

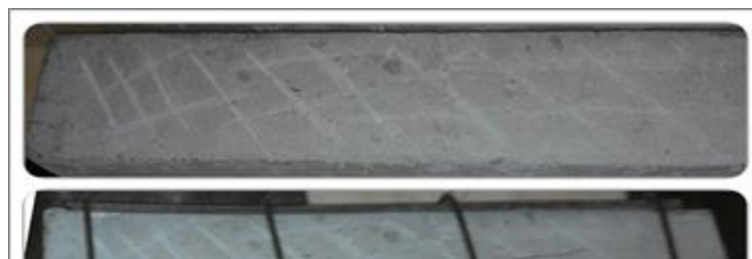
Fig. 3: Rehabilitation of beams using concrete jacket

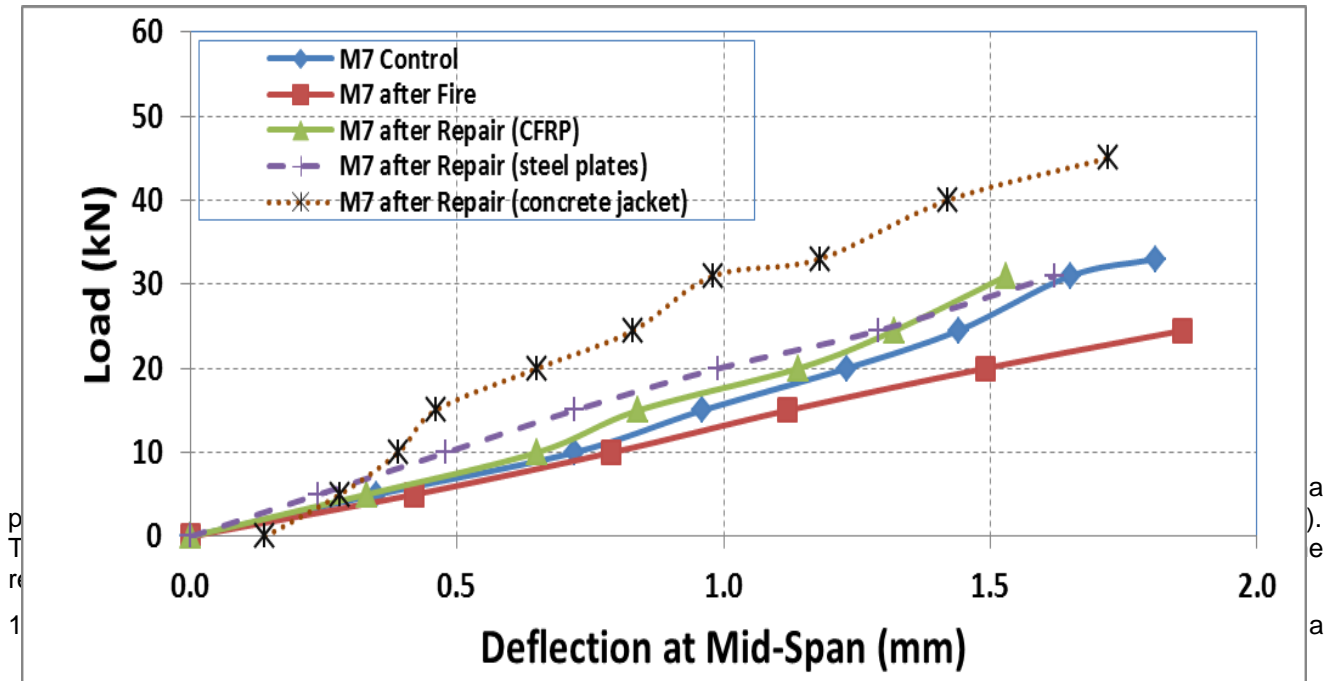
Fig. 9: Load-deflection curve of beams (M7) after fire and repair

2. The loss of load capacity in flexure decreased by about 19.6%, while the deflection values at mid-span decreased by about 15.4%, when the beams were repaired using CFRP strips after fire exposure with the same previous conditions, this because of the mechanical properties of CFRP.
3. The loss of load capacity in flexure decreased by about 21.21%, while the deflection values at mid-span decreased by about 10.49% when the beams were repaired using steel plates after fire exposure with the same previous conditions, as a result of resistance of steel plates to flexural behavior.
4. The load capacity in flexure increased by about 54.5%, while the deflection values at mid-span decreased by about 4.97% when the beams were repaired using concrete jacket after fire exposure with the same previous conditions, this may be due to the increase in the cross-section of beam and steel reinforcement.

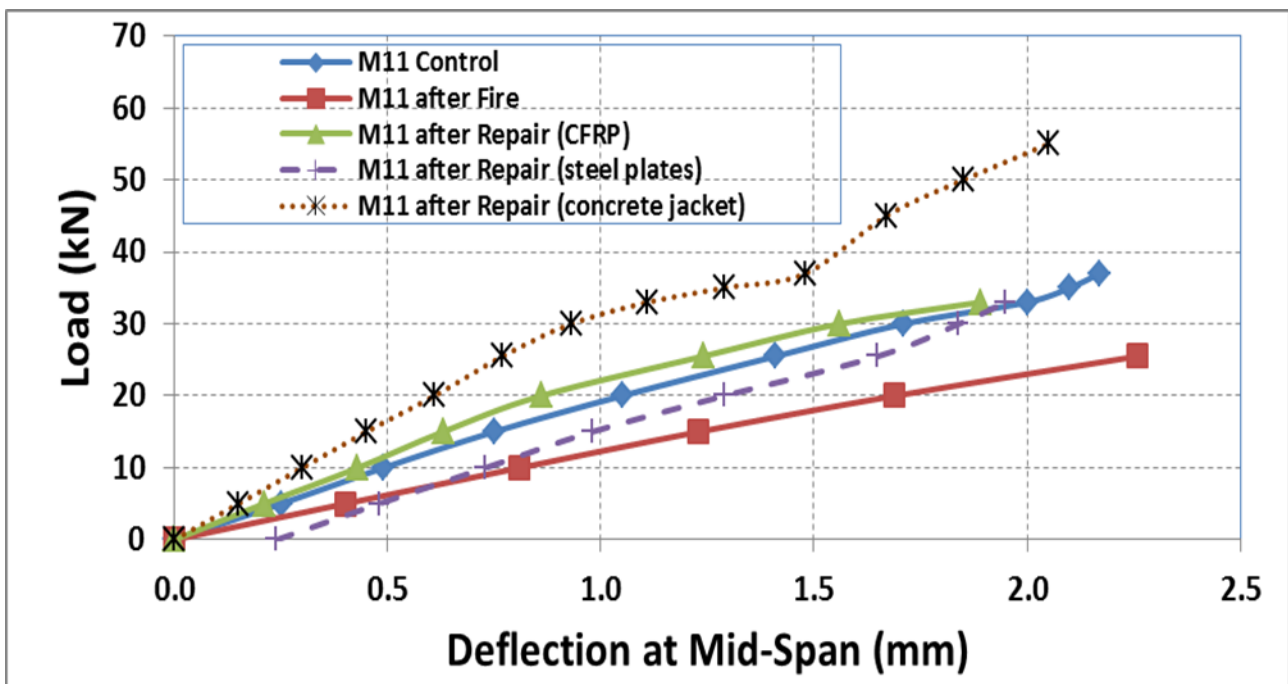
Fig. 11: Load-deflection curve of beams (M11) after fire and repair

The structural behavior of beams made of mixture (M11) was studied after exposure to fire of 800°C for a period 2h and rehabilitation of the beams by three techniques (CFRP strips, steel plates and concrete jacket). The load-deflection behavior of beams is shown in Fig. 11. and crack pattern is shown in Fig. 12. Based on the results it can be noticed that:

1. The load capacity in flexure decreased by about 31% when the beams were exposed to fire of 800°C for a period 2h, while the deflection values at mid-span increased by about 4.1%.

- The loss rate of load capacity in flexure decreased by about 20.3%, while the deflection values at mid-span decreased by about 12.9%, when the beams were repaired using CFRP strips after fire exposure with the same previous conditions, this is attributed to the mechanical properties of CFRP.

- The loss of load capacity in flexure decreased by about 34.7%, while the deflection values at mid-span decreased by about 10.13% when the beams were repaired using steel plates after fire exposure with the same previous conditions, as a result of resistance of steel plates to flexural behavior.

- The load capacity in flexure increased by about 48.6%, while the deflection values at mid-span decreased by about 5.53% when the beams were repaired using concrete jacket after fire exposure with the same previous conditions, this is attributed to the increase of both a cross-section of beam and steel reinforcement.

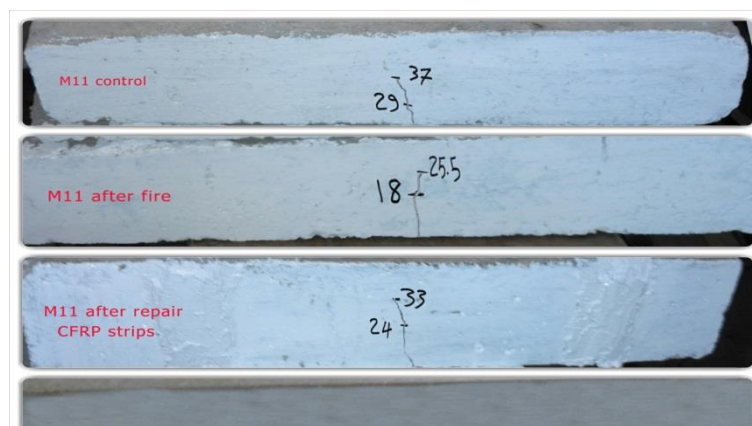
Fig. 12: Crack pattern of beams (M11)
