BEHAVIOR OF STRENGTHENED RC BEAMS USING DIFFERENT TECHNIQUES UNDER FATIGUE LOADING

T.F.EI-SHAFIEY¹, E.E.ETMAN², M.HUSSEIN³ AND M.M.EI-BOSIELY⁴

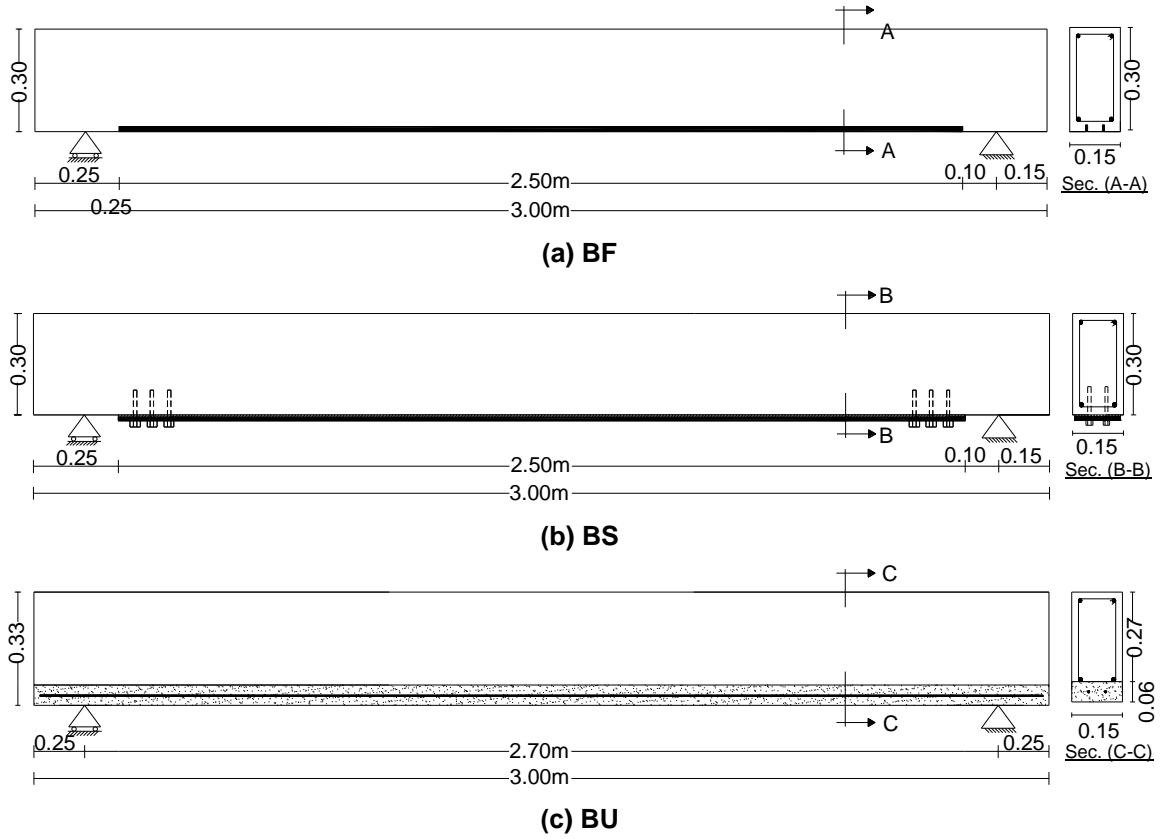
Fig. 2: strengthening schemes for the different techniques

Fig. 2 shows the used different strengthening techniques. Three different techniques (NSM CFRP, E.B. steel plate with end anchors and applying UHP-SHCC layer) are used for strengthening. Regarding to the different tensile strength of the used strengthening materials, the area of each strengthening material was deliberately chosen to obtain the same force gained at the tension side of the beam, to have the same criteria on the comparative study. Two carbon fiber strips with a cross section of 1.2 x 10 mm, a steel plate with cross section of 1.3x135 mm and a layer of UHP-SHCC with cross section of 60x150 mm were selected for the comparative study.

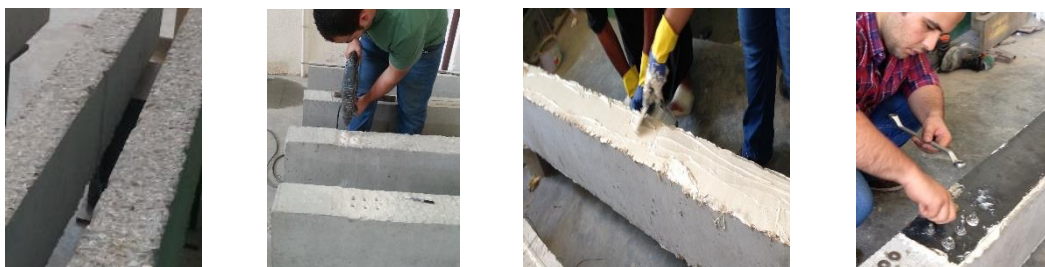
Fig. 4 E.B. steel plate with end anchors application process

As shown in Fig. 3, the strengthening steps of NSM CFRP technique. After marking the layout the grooves were formed in the tensioned side of the beams by making two saw cuts and finishing off with a manual hummer to chisel any remaining concrete between cut paths, finally clean the groove and eliminate any residual dust with compressed air. According to ACI 440.2R-08 [18], grooves with size 6 x 20 mm² were cut for strips with a cross section of 1.2 x 10 mm². Epoxy resin was used to install the strips in the concrete a grooves. For externally bonded steel plate technique, Fig. 4 shows the main steps of the technique. The first step was surface preparation to clean the surface by removal of all possible surface contaminations, then drilling holes for anchors. Slightly larger clearance holes of 12mm diameter were provided for tolerances in fabrication and drilling of holes in the substrate and steel plates. Six bolts at each end of diameter 10mm, grade 8.8 are fastened in drilled holes. Number of bolts and spacing between centers of them are designed according to the Egyptian code of practice for steel construction and bridges (ASD code) [19] to avoid failure due to shear of bolts or bearing of the steel plate. A layer of high performance Epoxy adhesive with 1mm thickness is applied to the substrate concrete. Finally, the steel plate is placed on the layer, and hammered down slightly to remove air voids between the plate and the adhesive layer. Then the bolts are tightened sufficiently to ensure that sufficient contact is achieved between the different parts.

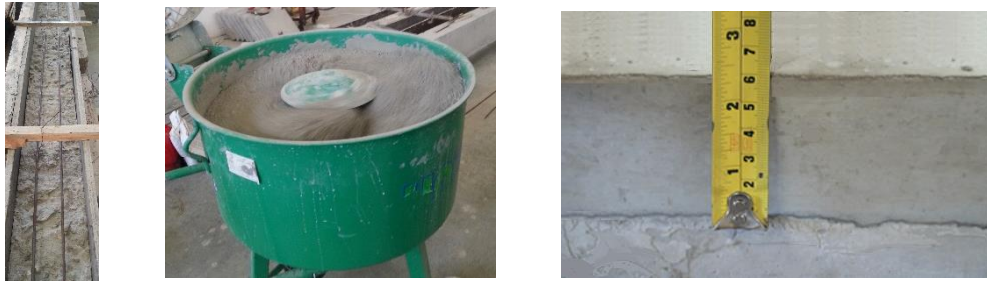
Fig. 5: Applying UHP-SHCC layer process

Applying of (UHP-SHCC) Layer technique was conducted through three main steps as shown in Fig. 5 The first step is surface preparation for the reason as mentioned before. Mixing the ingredients layer and installing the layer. The strengthening layer was bonded to the concrete beam surface, using the epoxy adhesive. After casting of all strengthening layer, curing is done by cover all specimens with wet burlap.

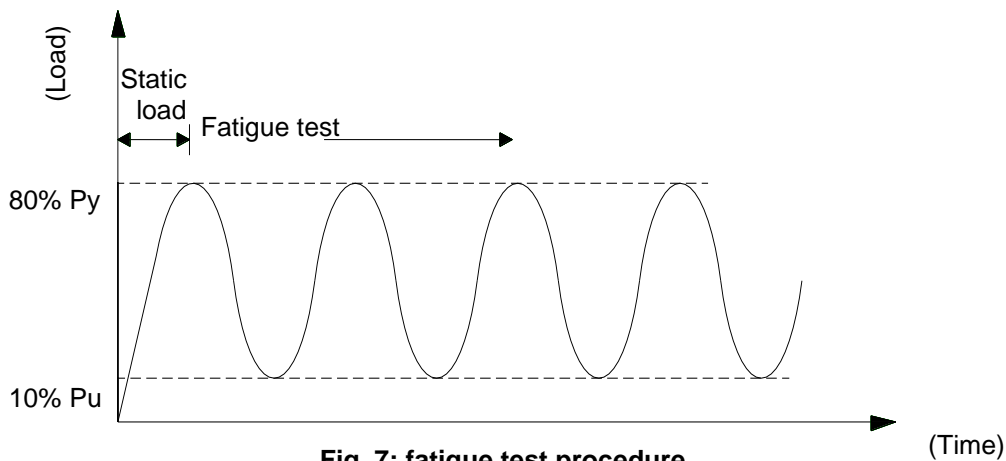
Fig. 7: fatigue test procedure

reached in real life applications. The load range was evaluated from static load test (paper static). The fatigue loading was applied for 180,000 cycles then the fatigue loading was stopped, and the load was released gradually for a rest period of about 10 h to count for the practical circumstances. At the end of the rest period, the beam was reloaded with the same sequence of loading for 360,000 cycles then the fatigue loading was stopped again for the next rest period, finally the beam was reloaded till fatigue failure. Based on field data and assuming that a linear relationship exists between vehicle speed and load frequency, the typical loading frequency of a truck varies between 0.159 and 8.724 Hz for a speed between 2 km/h and 110 km/h Lin JH [21]. Thus, a loading frequency which was implemented in this study since it would reasonably represent the actual vehicular loading frequency experienced in practice. Fatigue loads were applied using a sinusoidal variation between minimum and maximum values. A summary of fatigue loading limits is shown in table (3).

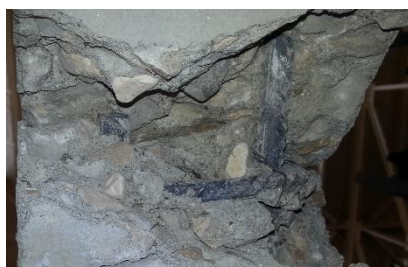
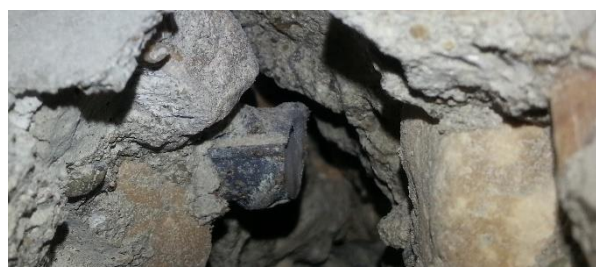
Fig. 12: Fatigue failure due to a rupture in the reinforcing steel bar

The failure modes of all beams are shown in Figs. 7–10. All beams failed suddenly due to fatigue failure of the tension steel reinforcement due to cyclic fatigue loading. This mode of failure was expected since the stress range in the tension steel reinforcement was high enough to cause a fatigue failure in the steel. No indications of imminent failure were observed as the failure was brittle. Fatigue failure of the reinforcing bar was accompanied by a sudden propagation of the flexural cracks and crushing of concrete in compression. It is also noted a sudden increase in deflection and a significant drop in the beam stiffness followed the failure of the bars. The control specimen beam (BC), (BS), (BU), (BF) survived 783,571, 762,964, 720,865, and 730,746 cycles respectively. For beam BS a typically cracks formed at the substrate in the anchors region of the steel plate during the last stage of loading. Thus when a steel reinforcement had fractured, a fatigue fracture of the concrete

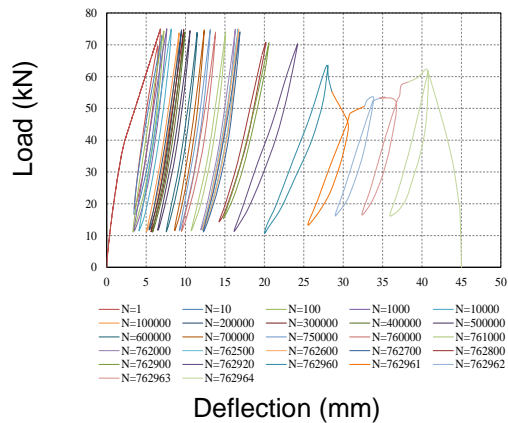
Fig. 13: Load-deflection relationship for BC

The unstrengthened concrete control beam, (BC), survived 783,571 cycles of fatigue loading under the specified live load with stiffness and displacement degradation. This can be seen in Figure (13), the rupture of one of the reinforcing bars became apparent after cycle 782,100. At this point, the stiffness of the beam changed significantly and an increase in mid-span deflection was evident. The width of the crack increased significantly near mid-span due to the energy release associated with a fatigue rupture and the greater beam deformations. The test was continued until cycle 783,571. The fatigue test was terminated automatically following the reinforcing steel fracture due to the displacement control input detector. For beams BS, BU and BF it was observed that the slope of the hysteresis curves (secant stiffness) degrades after rupture of the reinforcing bars and the failure occurred at cycles 762,964 ,720,865 and 730,746 respectively. In general, the load deflection behavior under cyclic fatigue load seems to vary according to the strengthening technique. This may be manifested by description the load deflection hysteresis loops of all beams as shown in

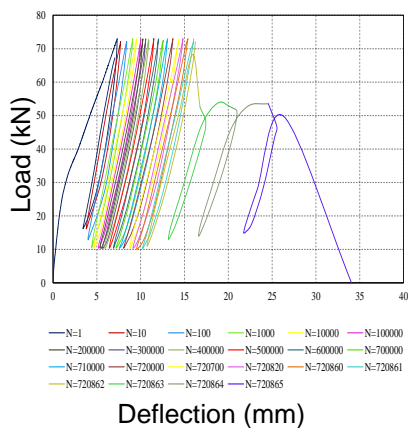
Fig. 15: Load-deflection relationship for BU

An important figure that must be generated to evaluate the structural performance under fatigue loading is the load-deflection hysteresis loops. For Figures (13-14-15-16), which show typical cyclic behavior for the unstrengthened and strengthened beams. Under fatigue loading, all beams demonstrated an increase in their midspan deflections in the early stages of their life during approximately the first 10 thousand cycles. The measured deflection of the beam remained relatively constant with an increasing number of cycles until approximately 95% of the life of the beam was attained. At this point, the rate of deflection increased sharply during last

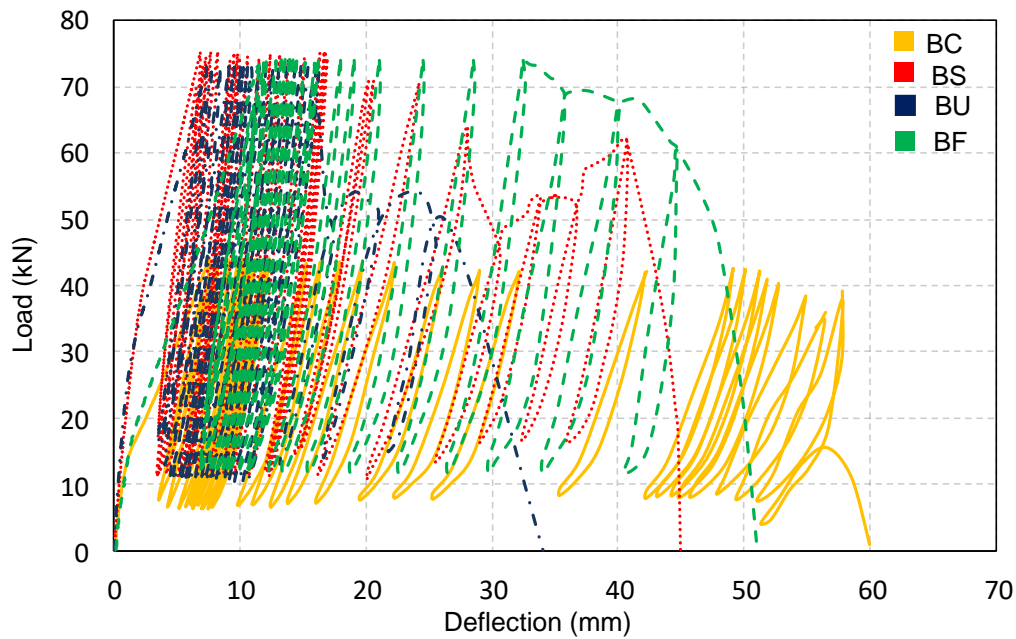
Fig. 17: load-deflection relationship

Figure 17.

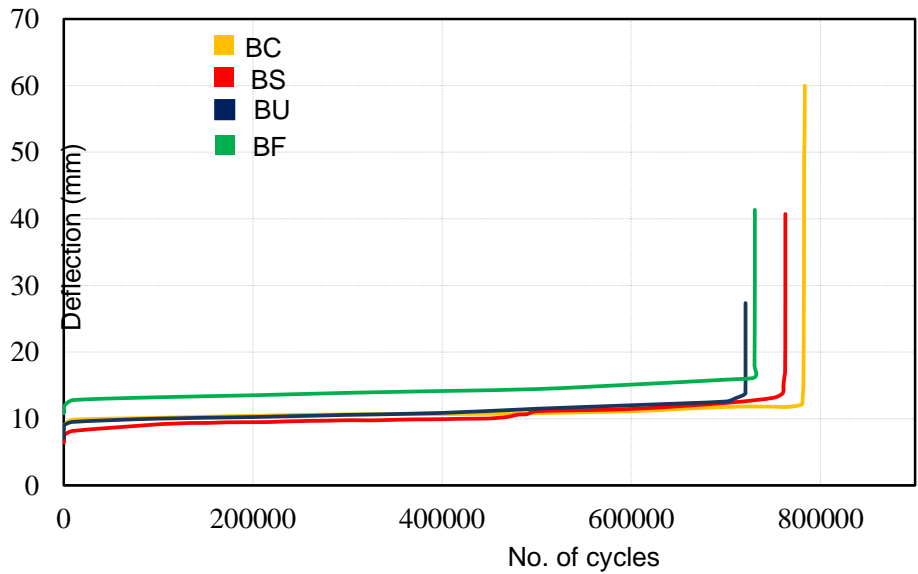
Fig. 18: Variation of mid-span deflection during fatigue loading.

For each beam, the deflection was recorded until failure occurred. In Fig. 18. It can be seen that in all beams there was an initial increase of the mid span deflection, followed by a stable region where the deflection remained relatively constant through many cycles, followed by an abrupt increase of deflection just before failure. There is a more gradual increase in the deflections as the beam approaches its fatigue life. This may be caused by a greater number of cracks resulting from increased cycling. Moreover Strengthened beams exhibit a deflection versus number of cycles behavior similar to that of the control beam, as the strengthening techniques had a limited effect on the rate of increase of deflection during the stabilization stage of the beams. Both unstrengthened and strengthened beams encountered similar rates of increase in their mid span deflections under fatigue loads during the stabilized period. However, the percentage deflection increase, at the end of fatigue loading, was almost the same for strengthened beams (BS) and (BF). For beam (BU) the percentage deflection increase, at the end of fatigue loading was lower than other strengthened beams. Also the percentage deflection increase at the end of fatigue loading of the strengthened beams was lower than that of un-strengthened beam. This indicates the efficiency of the strengthening system in lowering the damage accumulation. It is worth mentioned that the the fatigue life of the additional reinforcement used in the strengthening layer for beam (BU) is lower than the fatigue life of the main reinforcement. When the additional reinforcement was fractured after 694,000 cycles, the load deflection behavior under fatigue load seems to vary according to the different beam. The number of cycles and the fatigue life of the control and strengthened beams are shown is Fig. (19) and (20) respectively.

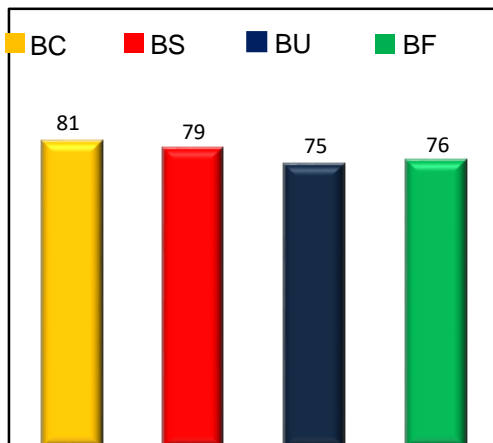
Fig. 19: Number of cycles

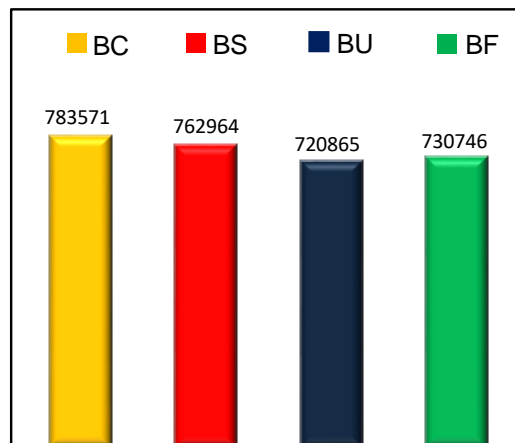
Fig. 20: fatigue life

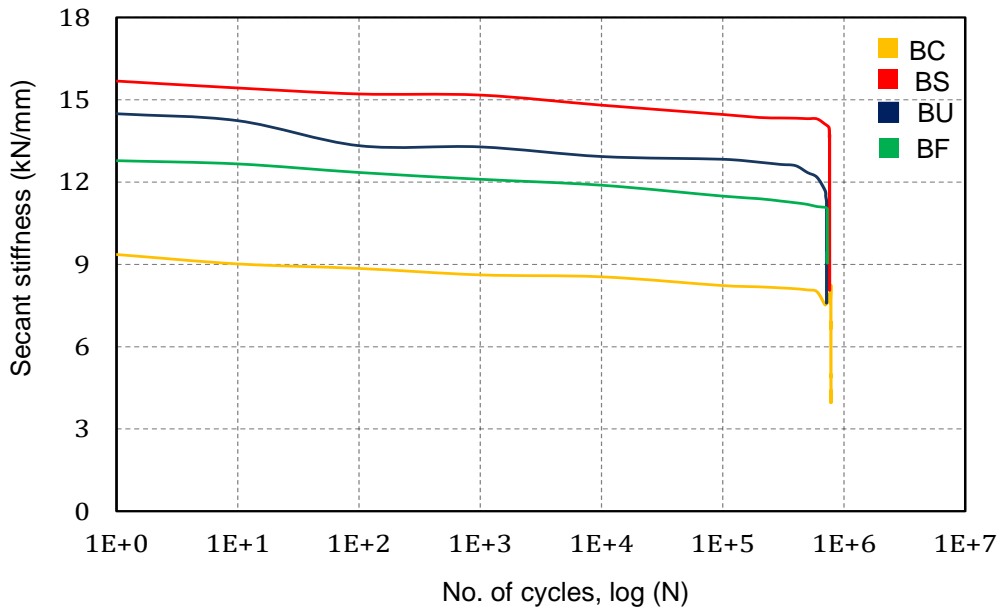
Fig. 21: Relation between secant stiffness and number of cycles

In order to provide a quantitative measure to the stiffness degradation in the beams, the stiffness after each fatigue loading cycle was calculated. The method of calculations involved recording the load and deflection for each specimen after the specified cycle, then the secant stiffness was calculated. Stiffness gets reduced when the beam is subjected to fatigue loading. This reduction in stiffness is due to the following reasons: during fatigue loading, the materials, viz. concrete and steel, are subjected to loading and unloading processes. This will cause initiation of micro-cracks inside the beam and will sometimes lead to the low fatigue limit of the materials. This, in turn, increases the deformations of the beam, thus resulting in increasing the damage level of the beam, which lead to reduction in the stiffness. Hence, it is necessary to evaluate degradation of stiffness in the beam subjected to fatigue loading. The degree of damage in beams can be measured from the degradation in stiffness at different cycles. In order to determine the degradation of stiffness, the values of the secant stiffness obtained for each cycle (Shannag et al, 2005) [25]. The stiffness is computed by taking the slope of the load versus mid-span deflection curves. To compare the reduction in stiffness up to the end of fatigue life with respect to the 1st cycle, the normalized stiffness curves are plotted in Fig. 21 for all beams show a deterioration in stiffness that would have

signified immediate failure. In all tested beams most of the stiffness degradation took place in the initial 500 cycles after which the trends were stabilized with respect to the increase in number of cycles until an abrupt stiffness degradation happen during the fatigue failure of the reinforcement. The stiffness of beams (BC), (BS), (BU) and (BF) decreased by 35%, 40%, 44% and 29%, respectively, at the end of the fatigue loading. It is noticed that beam (BF) has a lowest stiffness degradation compared to beam (BS) and (BU).
