**The Anti-Bacterial Lime Mortar Used in the Restoration of
Ancient Limestone Buildings by Adding Heavy Metal Oxide**

**Lecturer, Department of Architecture - OHI –
Giza- Egypt**

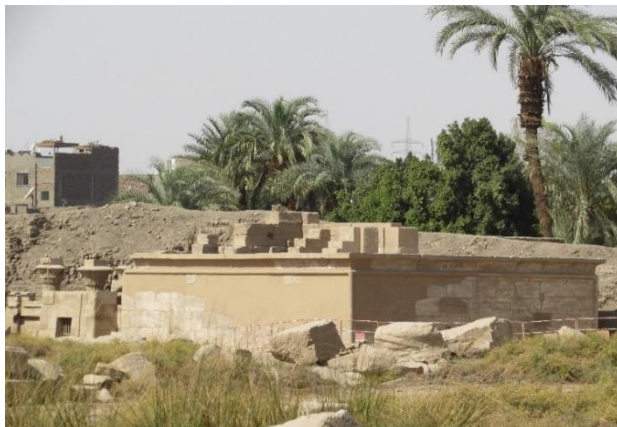
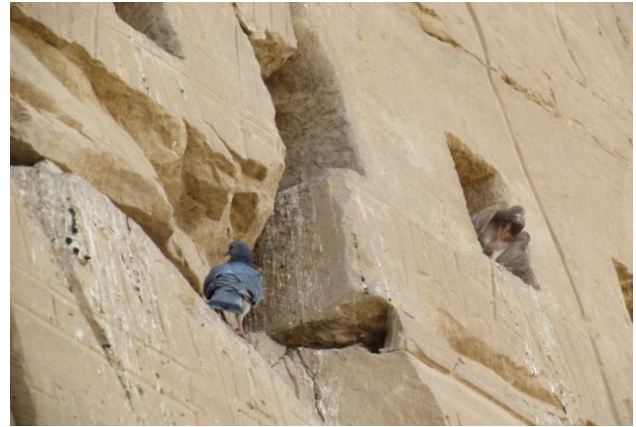
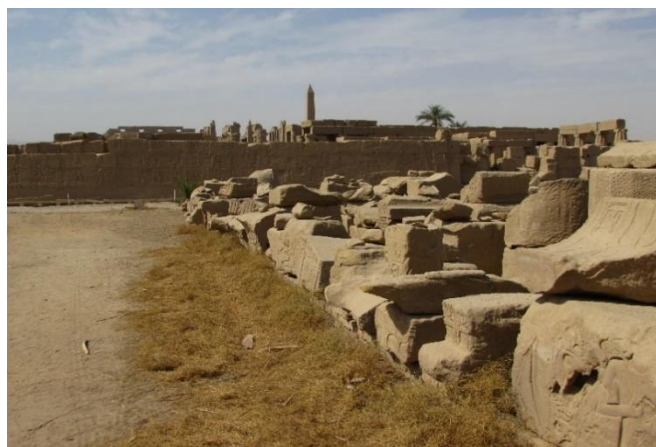
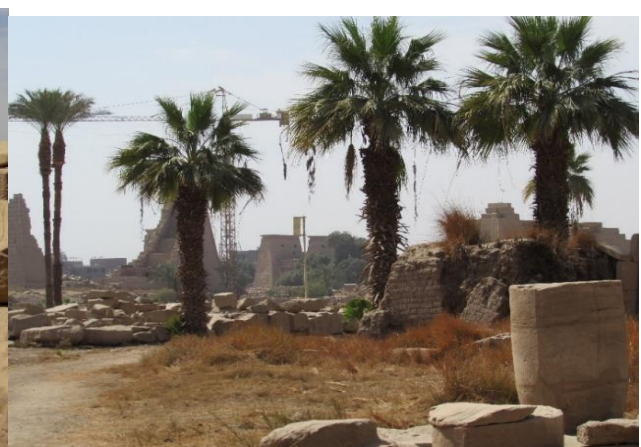
Figure (3): The effect of plant growth on limestone & sandstone

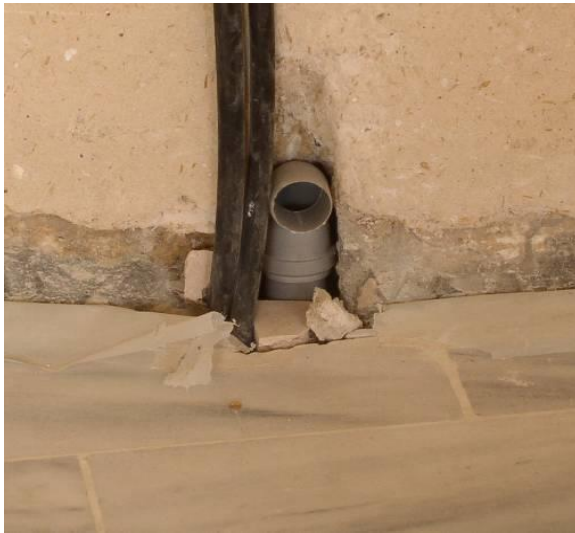
Figure (4): Soil dysfunction and ventilation to prevent groundwater movement due to poetic property.

- 1- Groundwater: Soil dysfunction and ventilation to prevent groundwater movement due to poetic property.
- 2- Rain moisture insulation: Rainwater-prone surfaces are insulated using bitumen and making trails to drain rain.

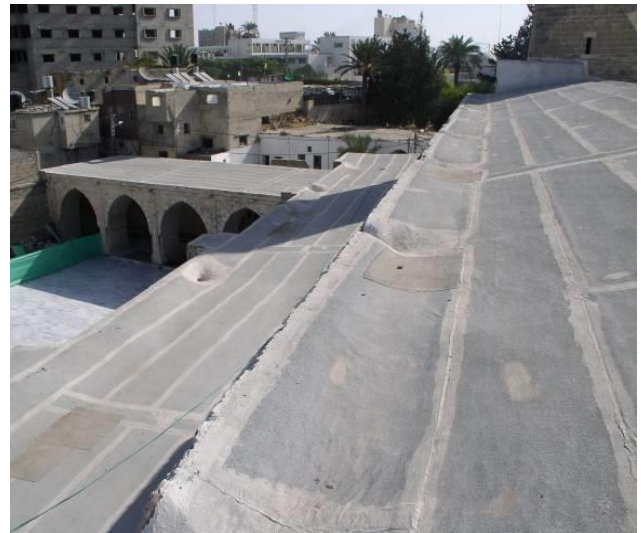
Figure (5): Rainwater-prone surfaces are insulated using bitumen and making trails to drain rain.

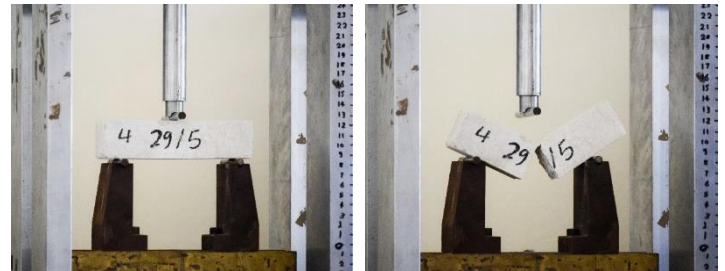
(a) (b)
Figure (14): Flexural strengths tests of mortar samples according to EN ;(a) Flexural strength test setup, and (b)) Flexural strength test failure

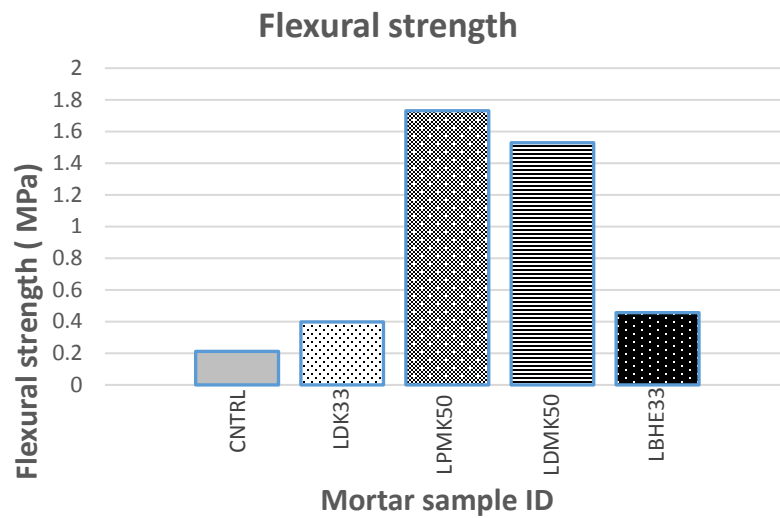
Figure (15): Flexural strength test result for 5 mixes
