## **The Reasons of Using the Original Stone for Repair and Conservation of Ancient Egyptian Buildings in The light of Discovery of Some Ancient Quarries which are inferred to be used as Stone Sourcing and The Reason of Using Other Alternatives**

**Abdou El-Derby\***

### **Abstract**

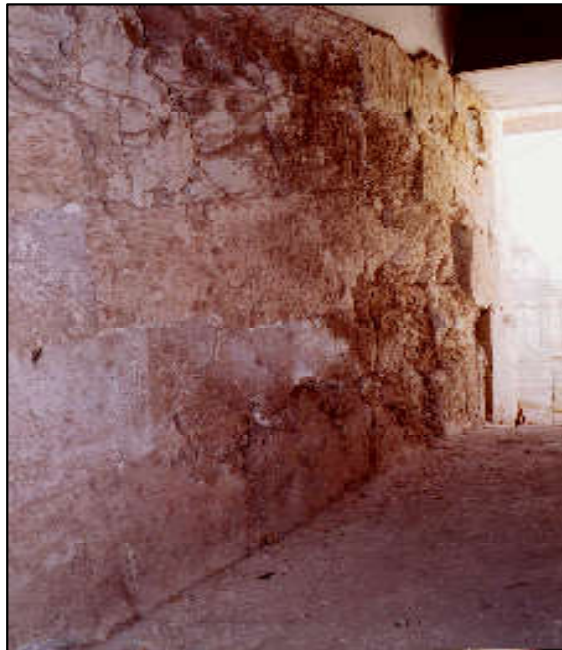
**Fig.4** Display an example of loss and absence of archaeological stone building structural, functional and esthetical role in addition to loss of inscriptions , drawings and paintings (documentary and esthetical function ) in the funeral passage Osireion at Abydos because of raising of ground water tables and continuous salt crystallizing , so we have to remove deterioration and damage causes and sources before replacement with original local limestone

- a. An example of loss and absence of archaeological stone building structural, functional and esthetical role in addition to loss of inscriptions , drawings and paintings (documentary and esthetical function ) in the funeral passage Osireion at Abydos because of raising of ground water tables and continuous salt crystallizing , so we have to stop deterioration and damage causes and sources before replacement with original local limestone (**fig.4**) .

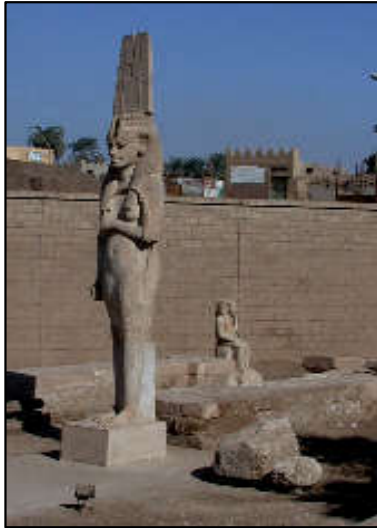
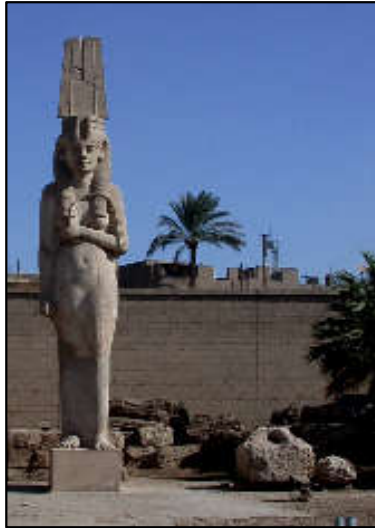
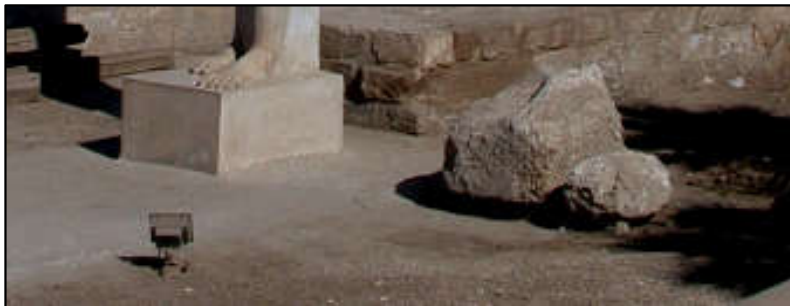
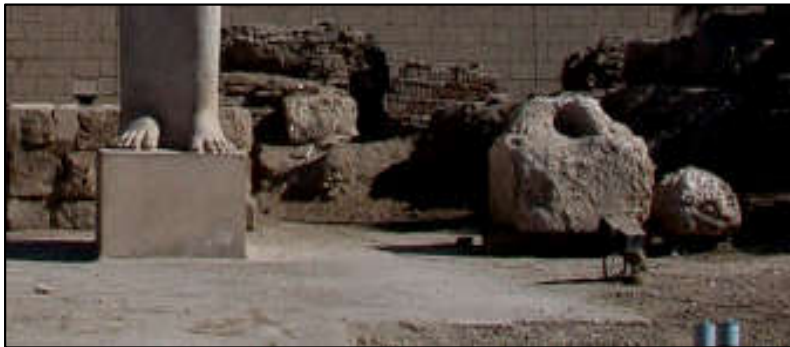
**Figs .6-9 display** the base of colossal statue of Merit Amun in Akhamim as an example of the decayed stone which lost its structural and functional role but it still retains its archaeological and documentary values , so the base was replaced with a stronger alternative with keeping the archaeological base in the site beside the statue because it still has a connection with the past .

In some cases the decayed stone lost its structural and functional role but it still retains its archaeological and documentary values such as the base of colossal statue of Merit Amun in Akhamim where it lost its structural and functional role and it did not ordain any more to bear the dead load (weight) of the hefty statue , so the base was replaced with a stronger alternative with keeping the archaeological base in the site beside the statue because it still has a connection with the past (**figs .6-9**) .

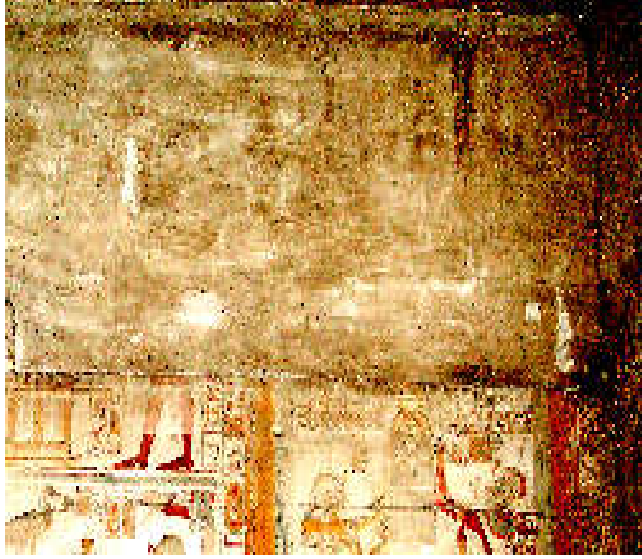
**Figs .10-11**  
Display examples of emergency for partial reconstruction with the original stone from the local quarry for preventive conservation where the seven chapels of the temple of Seti I at Abydos had lost their ceilings and big parts of their upper walls , so the partial reconstruction restored esthetical role and provided a preventive conservation from weathering particularly inscriptions and pigments .

- c. An example of emergency for partial reconstruction with the original stone from the local quarry for preventive conservation (from weathering and the majority of environmental deterioration causes and factors where the seven chapels of the temple of Seti I at Abydos had lost their ceilings and big parts of their upper walls , so the partial reconstruction **restored esthetical** role and provided a preventive conservation from weathering particularly inscriptions and pigments (**figs .10-11**)

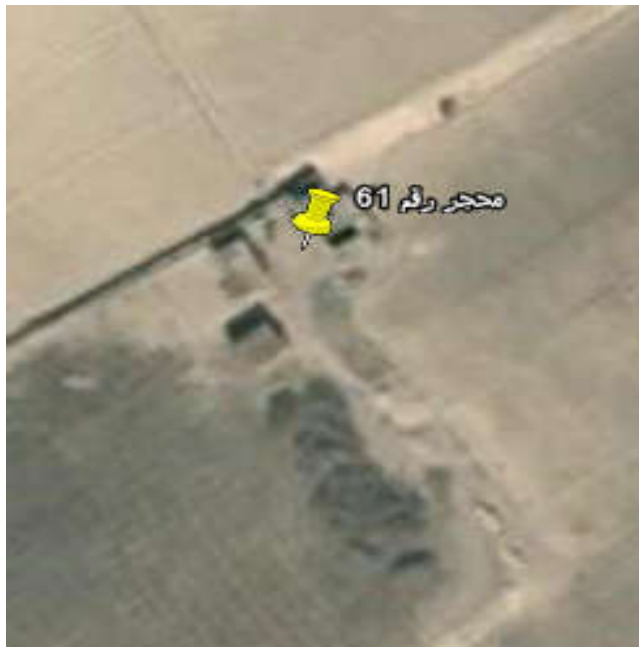
**Fig12** displays an aerial view photo (by Google Earth) of surroundings of the first quarry which was published by James A. Harrell under serial number (61) from north to south among documented and published ancient limestone quarries and was ascertained and verified by the researcher , the yellow position mark and the red arrow indicate the quarry , which is girdled with Man-made agricultural activities and growth , thereupon it is subject to ravage

same terrain and latitude of eleven of these quarries in the north west of Abydos (Harrell et.al. 1996 , p.23) <sup>(13)</sup> the first is published by James A. Harrell under serial number (61) from north to south from north to south among documented and published ancient limestone quarries <sup>(14)</sup> and was ascertained and verified by the researcher (it is open quarry) (**figs.12-13**) , now it is girdled with Man-made agricultural activities and growth , thereupon it is subject to ravage , and the second is published under serial number (62) , was ascertained and verified by the researcher and it is manifested that is false and the published position ( 26 ° 11.75 ' N , 31 ° 51 .95 ' E ) or ( 26 ° 12.15 ' N , 31 ° 52 .35 ' E ) is unsuitable to quarrying (**fig.14**) .

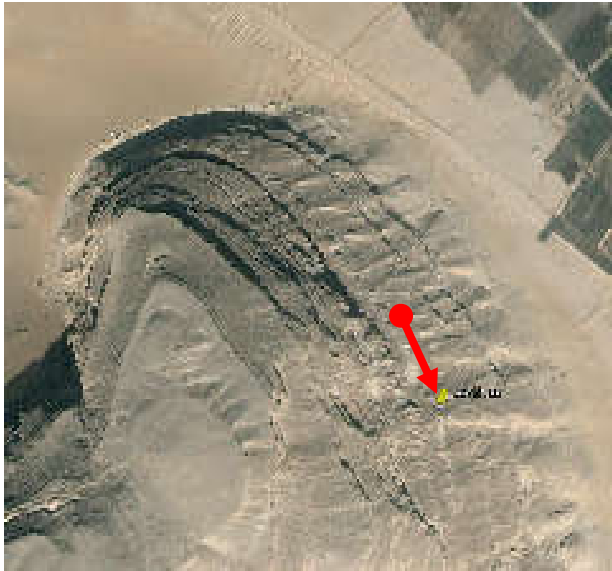
**Fig.13** displays an detailed zoom in aerial view photo (by Google Earth) of the upper figure , the yellow position mark and the red arrow indicate the quarry

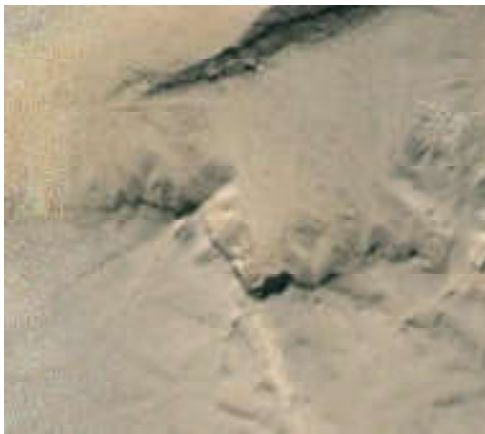
**Fig. 15** displays an aerial view photo (by Google Earth) display the first discovered quarry (I) (covered quarry) (  $26^{\circ} 11.58' . 40 N$  ,  $31^{\circ} 52.08' . 58 E$  ) (Height : 289 m. ) the position of its entrance (arrow) , its approximate dimensions are  $84.5 \times 23.35 \times 3.5$  meters

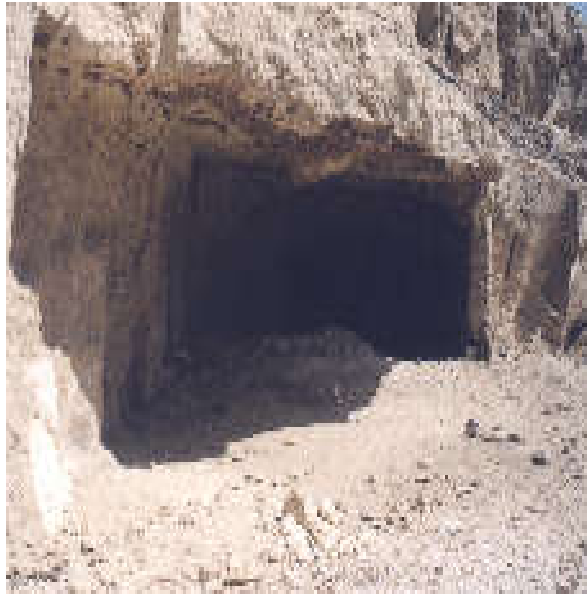
**Fig. 17** Display the entrance the first discovered quarry (I) (covered quarry) , its position of its entrance locates at (  $26^{\circ} 11.58' . 40$  N ,  $31^{\circ} 52 .08' . 58$  E ) (Height : 289 m. ) .

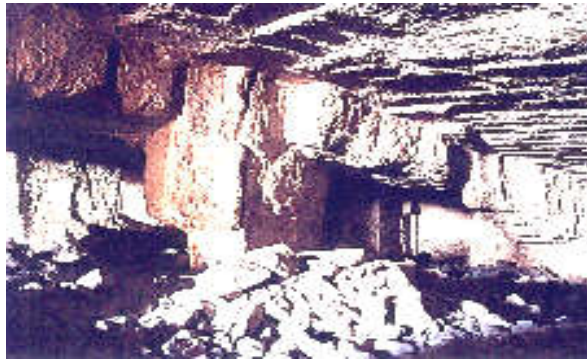
**Fig. 18** display the interior of the quarry (I) where we note the ancient separation trenches remains and marks

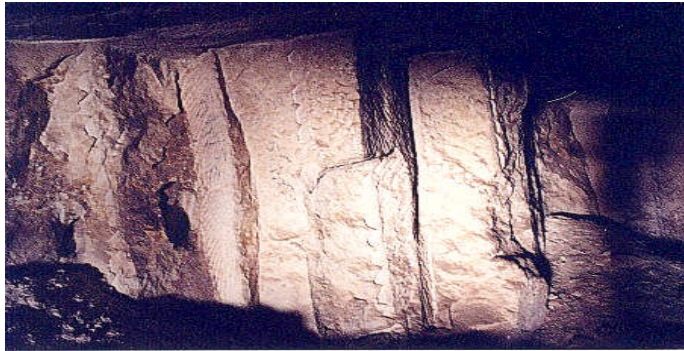
**Fig. 20** Display the inside of the first discovered quarry (I) (covered quarry) where ancient separation trenches remains and marks are noted

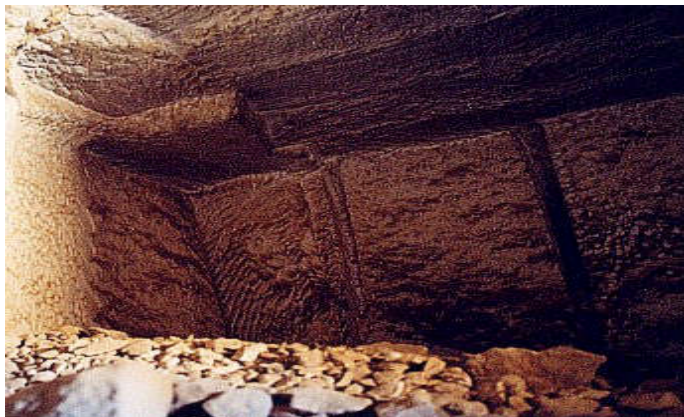
**Fig. 22** Display the interior of the first discovered quarry (I) where very regular, closely set longish lines , all hewn from the same direction characterize the Ramesside period until the end of Pharaonic times , are noted and this concurs also with a numerous of archaeological buildings in Abydos the adjacent district , and this indicates this had been used during more than one period

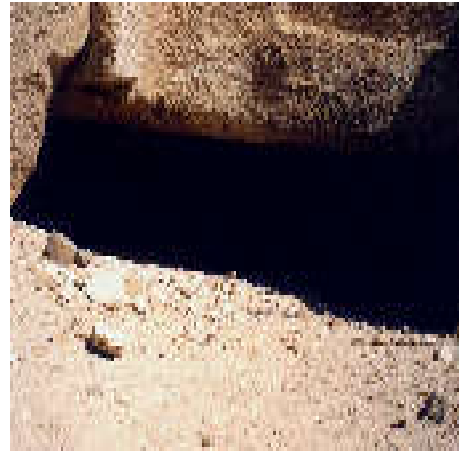
**Fig. 24** Display the entrance the second discovered quarry (II) (covered quarry) , its position of its entrance locates at : (  $26^{\circ} 12.04' . 57 N$  ,  $31^{\circ} 52 .17' .96 E$  (Height : 277 m. ) its width is about 20 meters .

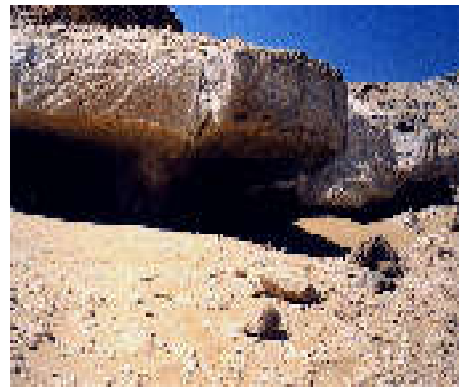
**Fig. 26** Display the entrance the third discovered quarry (III) (covered quarry) , its position of its entrance locates at : (  $26^{\circ} 11.32' . 32 N$  ,  $31^{\circ} 52 .17' .00 E$  ) (Height : 141 m. ) .

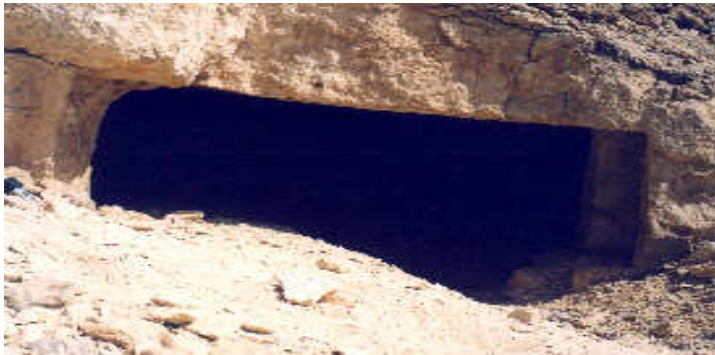
**Fig. 27** Display zoom out panoramic view of the fourth discovered quarry (IV) (covered quarry) the red arrow indicate the quarry, its position of its entrance locates at : (  $26^{\circ} 11.56' N$ ,  $31^{\circ} 51.99' E$  ) .

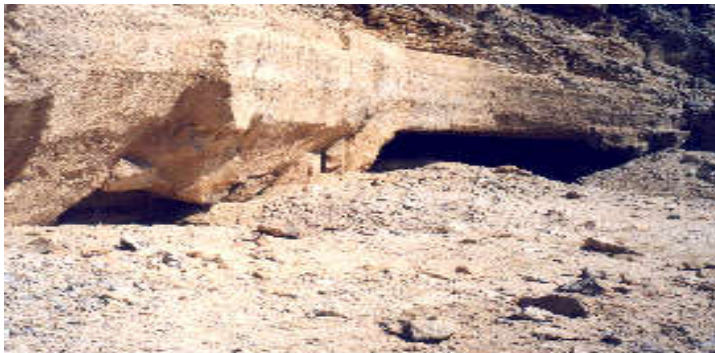
**Fig.28** Display the entrance the fourth discovered quarry (IV) (covered quarry) , its position of its entrance locates at : (  $26^{\circ} 11.56' N$ ,  $31^{\circ} 51.99' E$  ) .

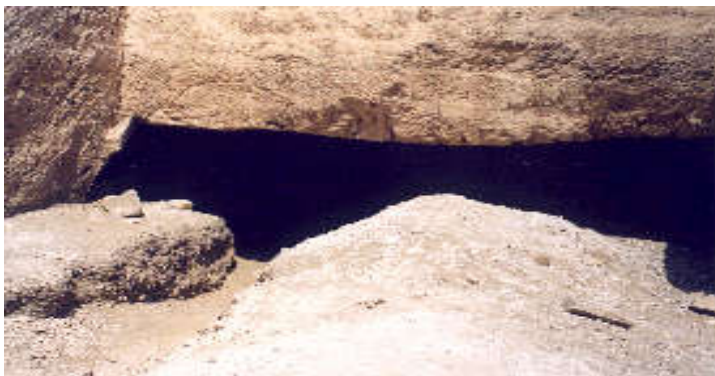
**Fig. 29** Display the entrance the fifth discovered covered quarry (V) , its position of its entrance locates at :  $26^{\circ} 11.64' N$ ,  $31^{\circ} 52.00' E$  ) .

**V.**26 ° 11.64 ' N , 31 ° 52 .00 ' E ) (covered) (**fig. 29**) .

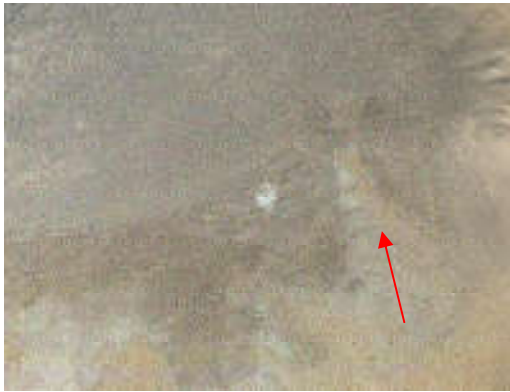
**Fig.30** Display the entrance the sixth discovered covered quarry (VI) , its position of its entrance locates at : (  $26^{\circ} 11.65' N$ ,  $31^{\circ} 51.99' E$  ) .

**VI.**( 26 ° 11. 65 ' N , 31 ° 51 .99 ' E ) (covered) (**fig. 30**).

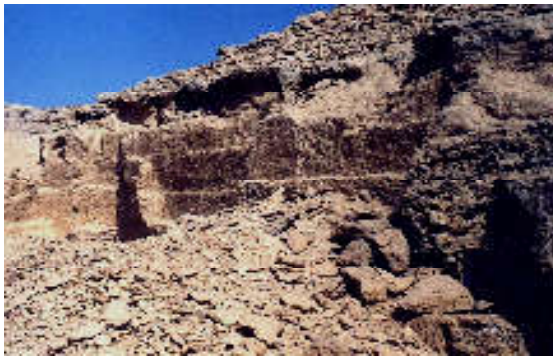
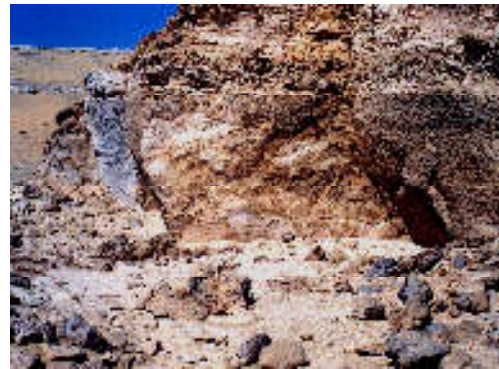
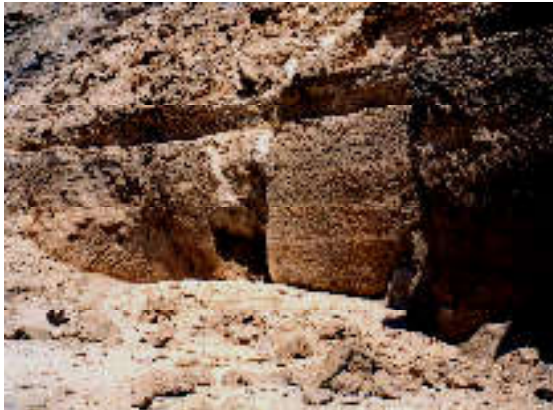
**Figs.33, 34 , 35** from left to right and from up to down display of , the eighth (VIII) , the ninth (IX) and the tenth (X) open quarries ,

**VIII.**( 26 ° 11.63 ' N , 31 ° 52 .02 ' E ) (open) (**fig. 33**).

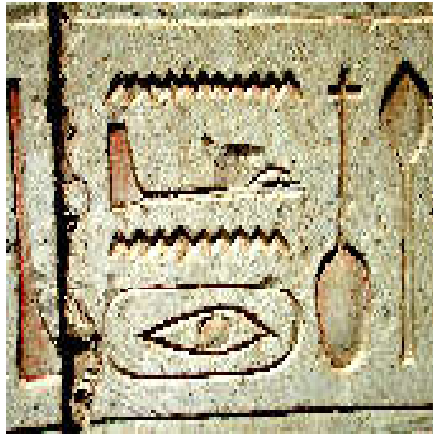
**Fig. 42** displays Oolitic structure in remains of the north tower of the first pylon of Seti I temple at Abydos similar to in the adjacent calcareous lower Eocene plateau

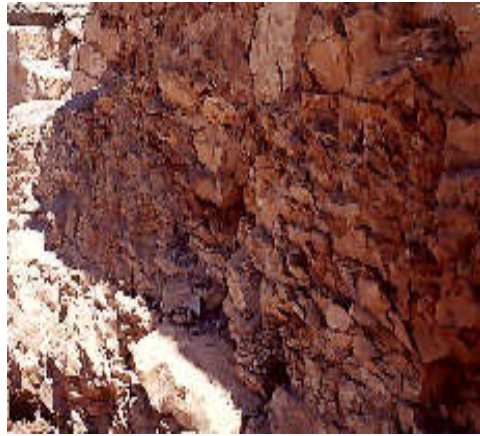
**Fig. 43** displays Oolitic structure in remains of the north tower of the first pylon of Seti I temple at Abydos similar to in the adjacent calcareous lower Eocene plateau

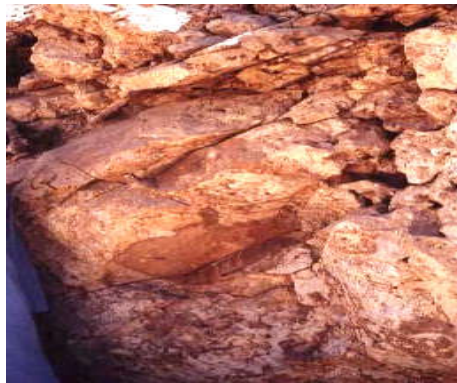
**Fig.44** displays Oolitic structure in the calcareous lower Eocene plateau similar to in remains of the north tower of the first pylon of Seti I temple at Abydos .

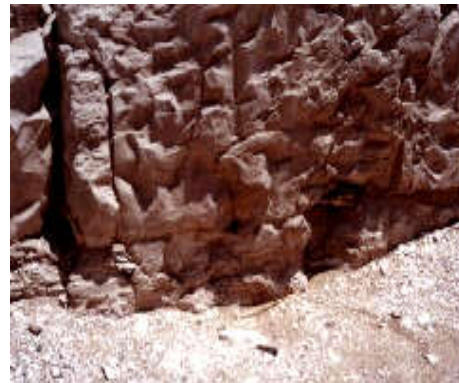
**Fig. 45** displays Oolitic texture in the inside southern wall at the temple Ramesses II at Abydos similar to in the adjacent calcareous lower Eocene plateau

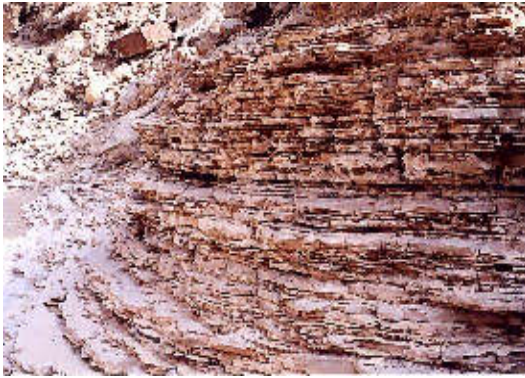
Fig. 46 displays the laminated or bedding limestone (Thebes and transitional Drunka formations ) in the adjacent calcareous lower Eocene plateau similar to in Seti I and Ramesses II temples at Abvdos

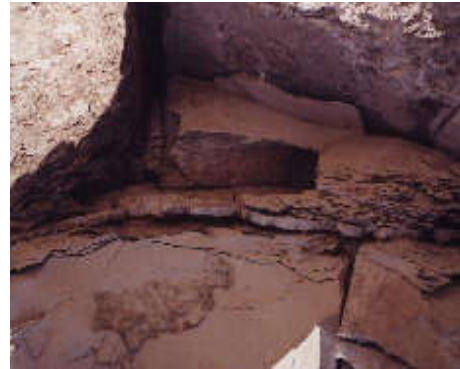
Fig. 47 displays the laminated or bedding limestone (Thebes and transitional Drunka formations ) in western wall of Ramesses II temple at Abydos **similar to in** the adjacent calcareous lower Eocene plateau .

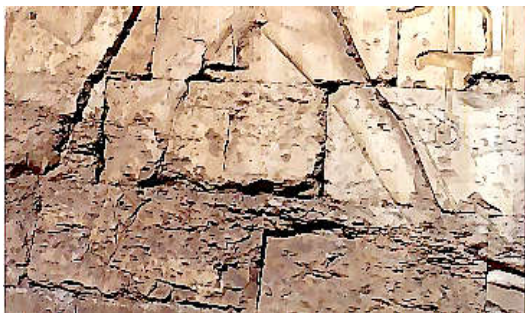
Fig. 48 displays the laminated or bedding limestone (Thebes and transitional Drunka formations ) in northern wall of Seti I temple at Abydos **similar to in** the adjacent calcareous lower Eocene plateau .

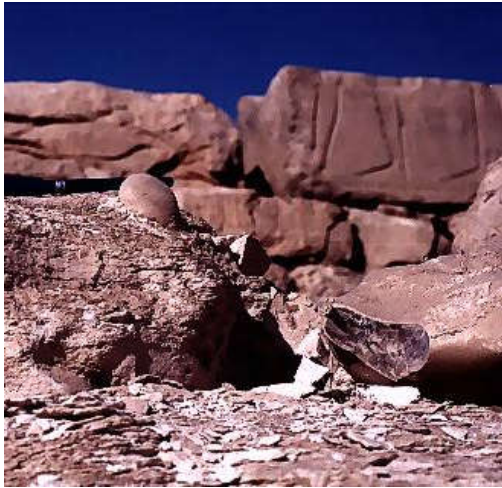
**Fig. 51** displays the **Flint Concretion** (Thebes and transitional Drunka formations ) to the south of the first staircase of **Seti I** temple at Abydos **similar to in** the adjacent calcareous lower Eocene plateau .

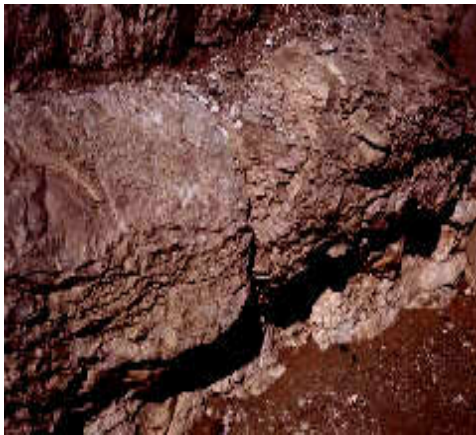
**Fig. 53** displays the **Marley lamelliform limestone** (Drunka formations) in the lateral terrace blocks of **Seti I** temple at Abydos **similar to in** the adjacent calcareous lower Eocene plateau .

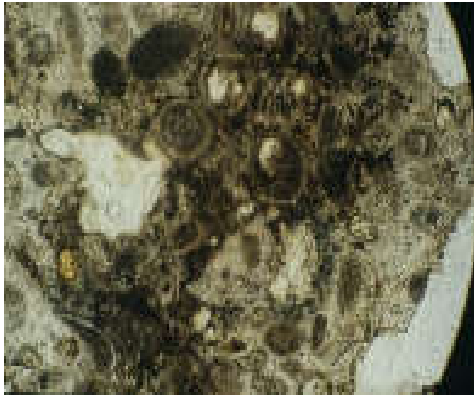
**Fig. 55** display thin section of limestone from archaeological buildings in Abydos cross sections (normal) (x 4) which contains Nummulitic (Thebes formation) , echinoids (Drunka transitional formation) sand some fossils void , And this indicates to the locality of the limestone which quarried from local quarries in the calcareous lower Eocene plateau

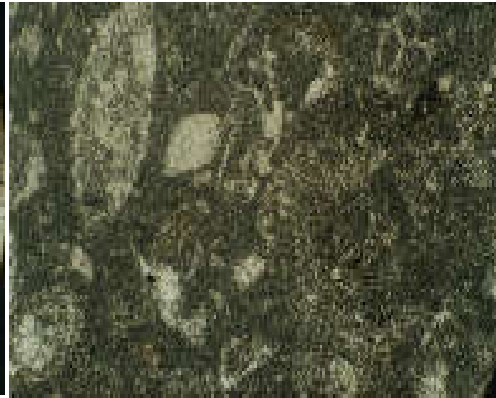
**Fig.45** display thin section of limestone from archaeological buildings in Abydos (cross Nikol) ( C.N) (x 4) (microscope which exhibits Nummulitic limestone (Thebes formation) which contains algae and a few fossils voids , and the main component Micrite , indicating to similarity in structure , , composition and features to the limestone from local quarries in the calcareous lower Eocene plateau

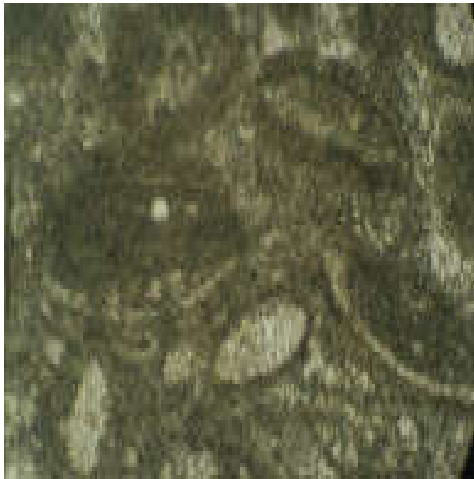
**Fig.46** display thin section of limestone from local quarries in the calcareous lower Eocene plateau (cross Nikol) ( C.N) (x 4) (microscope which exhibits Nummulities and some fossils voids

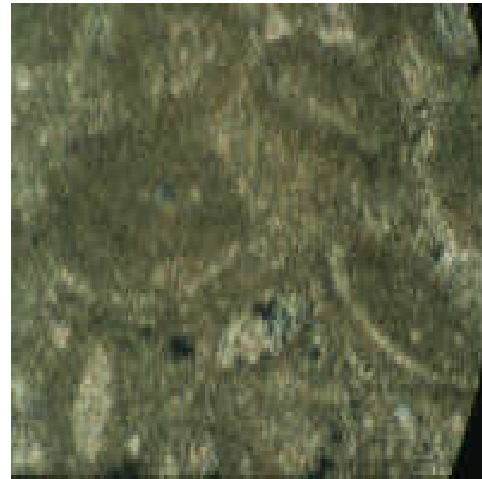
**Fig . 47.** display thin section of limestone from another local quarries in the calcareous lower Eocene plateau (cross Nikol)( C.N) (x 4) which exhibits the same

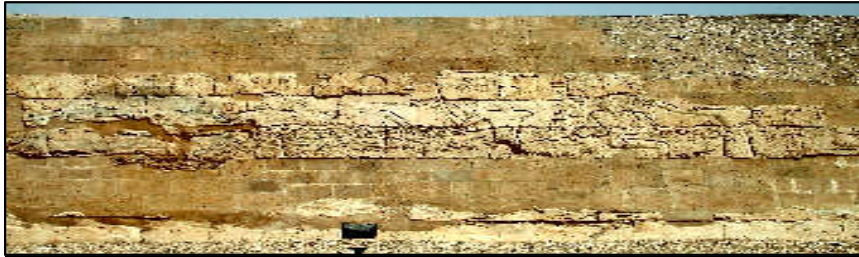
Fig.63) displays the weak and partial lost north wall of the Seti I temple at Abydos which are subjected to mechanical pressure and moistured & polluted soil , rubbish and garbage of the outraged urban context ,so it was compensated with an alternate stone of low permeability and high hardness from Eisawy limestone..

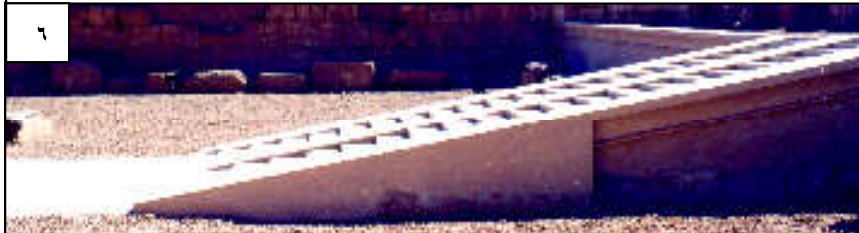
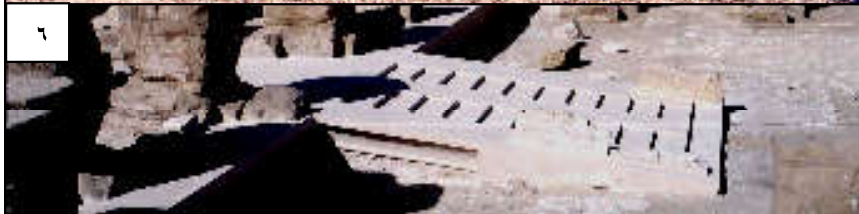
Figs.64 - 65) display the compensation with plastic repair (mortars) for the cavetto cornices , torie of the terrace of the second court and edges of staircases and balustrades of the staircases leading from the first to the second court of the temple of Seti I (64) and Ramesses II (65) at where the plastic repair is more suitable for formation and reconstruction of many of the ornamental and architectural elements with accuracy and homogeneity plus the possibility of addition of chemical additives to mortars to increase resistance of friction of the infantry, also prevents from disturbing fragile areas .

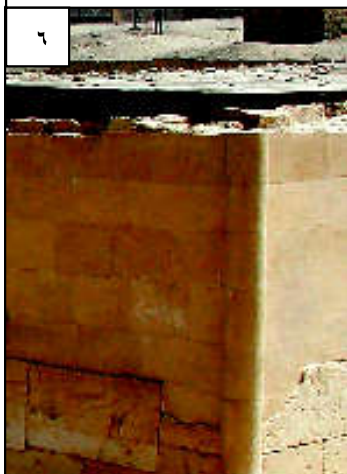
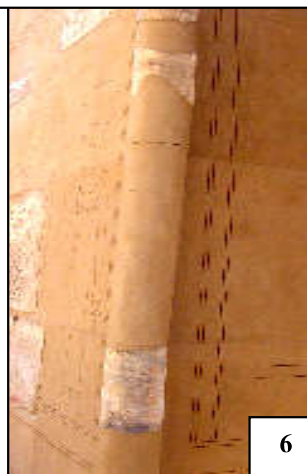
Figs.66) displays the replacement with stone in the corner torus of Ramesses II temple which affords more accurate and homogeneous compensations than that of mortar (such as the corner torus of Elvantine temple (fig. 67) .
