ENVIRONMENTAL IMPACT ASSESSMENT AND ECONOMIC LOSSES FOR THE DELAY OF CONSTRUCTION PHASES OF COASTAL BREAKWATER, EGYPT

Khyal A. Zahra

Ph. D. of Civil Engineering, Researcher, Director of Ras El-Bar Coastal Research Station, Coastal Research Institute, National Water Research Center, Alexandria, Egypt and E-mail address: khyalahmed@hotmail.com

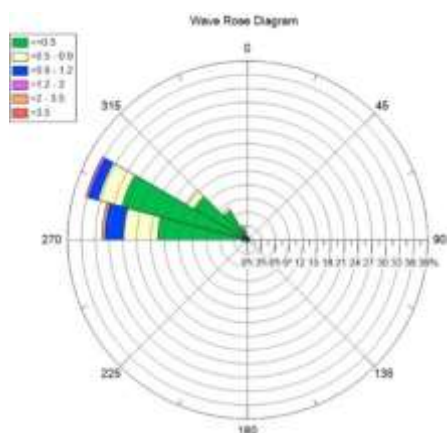
Figure 2: Rose waves of El-Dekhaila Harbor during 1994 [17].

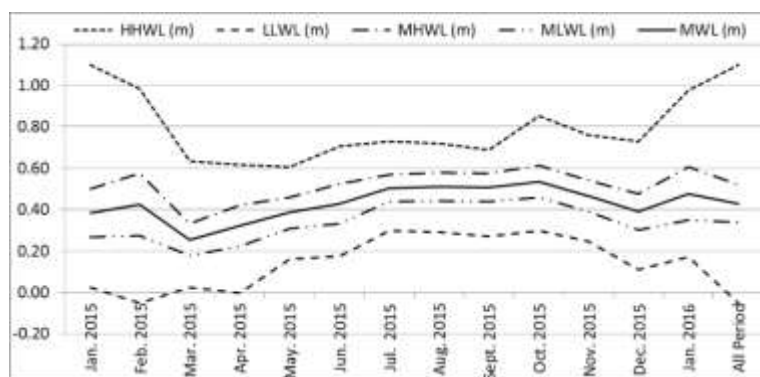
Figure 3: The measured daily variations of sea level at Rosetta City from Jan., 2015 to Jan., 2016 [16].

The information of the change in the sea level is of a great importance, especially in the case of port construction, protection works design, in the shoreline identification and in estimating the coastal flooding water on the coastal areas. The data of daily variations of sea level that measured during the period from January, 2015 to January, 2016 of the Rosetta City by CoRI [16], as demonstrated in Figure 3 that has been studied and analyzed. Consequently, the results of the analysis showed that the average sea level is about (0.40) m during the whole period. In

addition, the highest level of the sea was (0.76) m above MSL during November, 2015, while the lowest level of the sea is estimated at 0.05 m less than zero sea level during February, 2015, Generally, the tide of the Egyptian coast is classified of half daily tide.

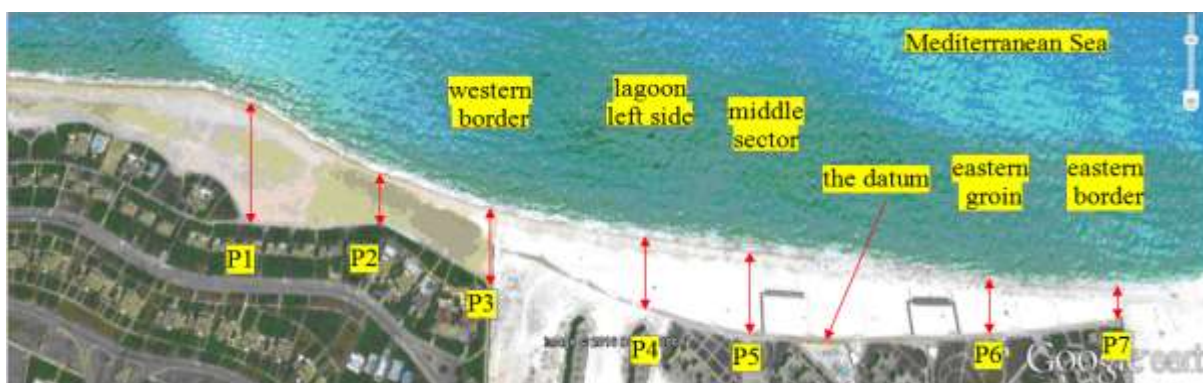
Figure 4: The shoreline of the area study in 26/6/2003 before the construction of WSR jetties.

The shoreline of the SSR was still stable up to 26/6/2003, as illustrated in Figure 4. While Figure 5 illustrates the shoreline changes in 7/2/2007 after the construction of long jetties and groins in the adjacent western sea resort (WSR), where erosion started to occur along the coast of the SSR and eastern coast of the WSR. Table 1 illustrates the values of shoreline positions relative to the alley of the SSR and the WSR as a datum. They are demonstrated in Figure 4, Figure 5, Figure 12, Figure 13, Figure 14 and Figure 15 of Google Earth satellite images. The values are estimated at seven profiles called; P1, P2, P3, P4, P5, P6 and P7, as shown in Figure 4. Profiles P1 and P2 are located in the WSR area. In addition, Profiles P3 and P7 are located at the western and eastern borders of the SSR respectively. Besides, the Profile P4 is located just at the western side of the artificial lagoon in the SSR that was constructed later in 25/9/2011. In addition, Profile P6 is located at the eastern groin in the SSR that was constructed later in 23/3/2012. The artificial lagoon and the eastern groin are illustrated on Figure 12. The values of

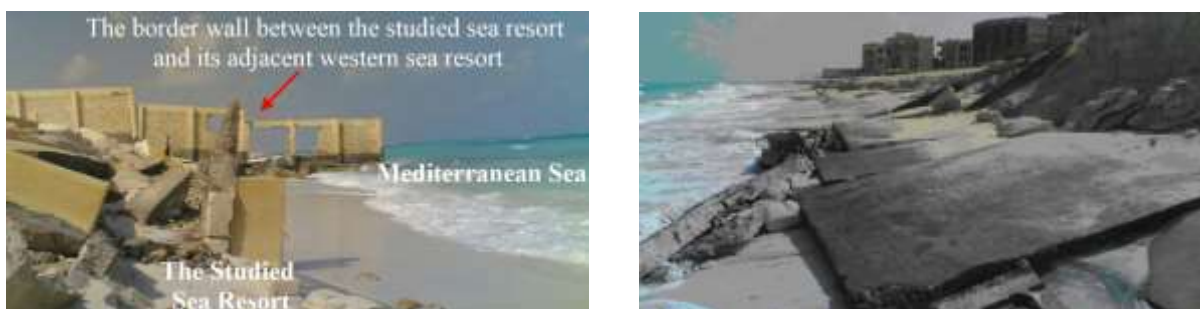
This erosion caused failure of the SSR beach and its parallel alley, as well as, its concrete wall, as shown in Figures 6 and 7 in 20/10/2008. In addition, much of beach replenishment sand was later lost, as shown in Figure 8, thus the beach has become very steep and forming a scarp as shown in Figure 9. The beach texture is calcium carbonate.

Figure 6 and Figure 7: Beach erosion of the SSR causing failure of its parallel alley and its concrete wall in 20/10/2008.

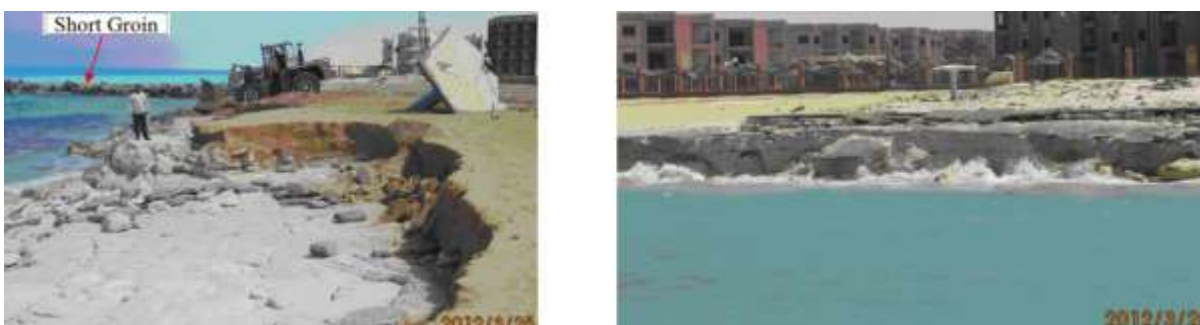
Figure 8: The loss of beach replenishment sand. Figure 9: The beach became very steep forming a scarp

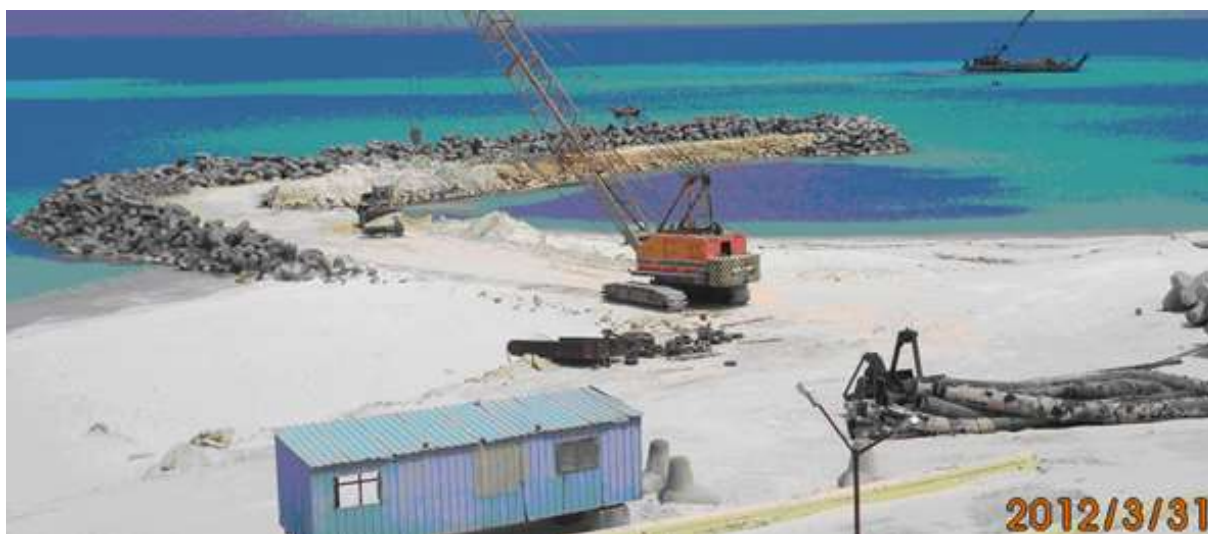
Figure 11: The artificial lagoon for executing utilities.

Due to difficulties facing the execution company in work during the last five years it started to perform an artificial lagoon at 200 m east of the WSR on 26/2/2011, as shown in Figure 11. This Lagoon was completed on 25/9/2011 and used for maintenance operations of the implementation utilities. In addition, the execution company has implemented on 23/3/2012 a short groin at 100 m distance westward of the eastern border of the SSR beach, as shown in Figure 8. The execution company started the deployment and alignment of the breakwater materials in 23/3/2012 until it completely stopped the work on 11/9/2014 because of the aforementioned reasons. Since that date, the project is still under implementation and only around 60 % of its recommended works have been achieved.

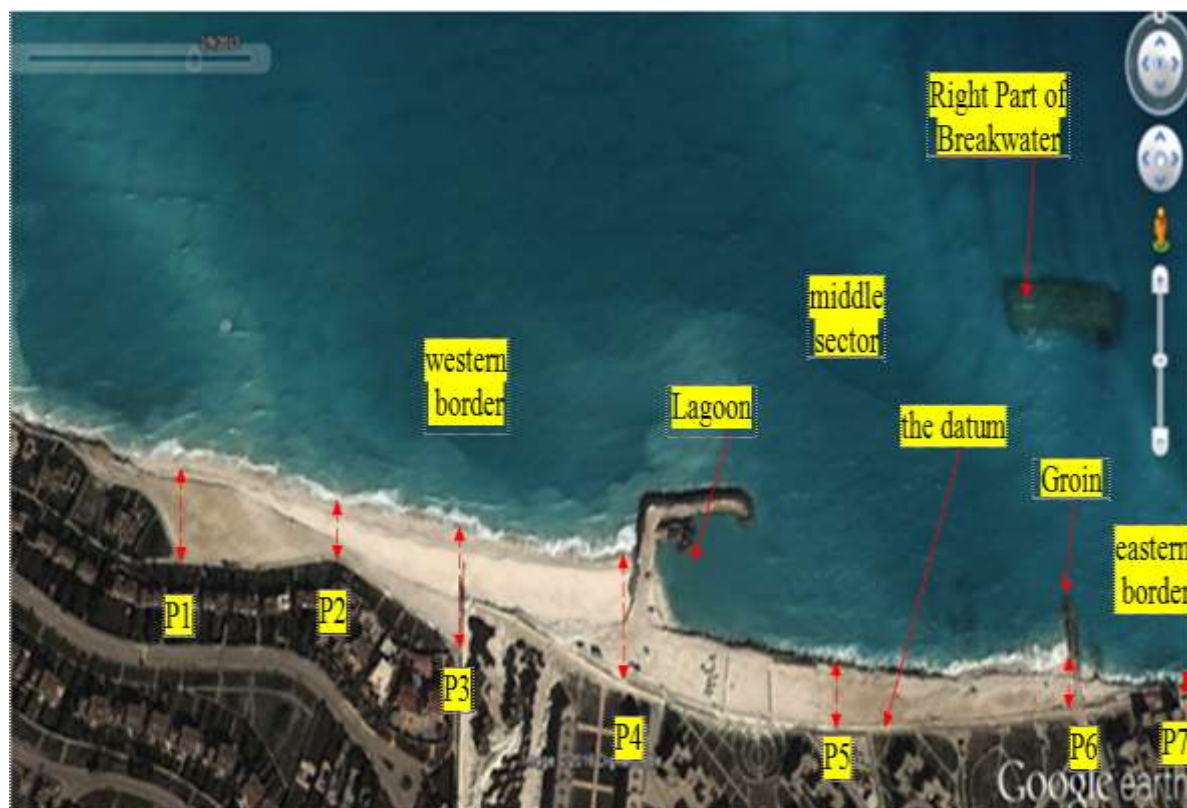
Figure 12: The area study on 9/2/2013 after the construction of an artificial lagoon.

Shoreline changes are illustrated in aforementioned Figure 12, Figure 13, Figure 14, Figure 15, and Figure 16. Figure 16 shows shoreline changes on November, 2011, September, 2012, January, 2013, April, 2015, June, 2015 and September, 2015. As demonstrated in Table 1 and Figure 12 until Figure 16, the shoreline has changed corresponding to the implementation stages of the submerged breakwater as the following:

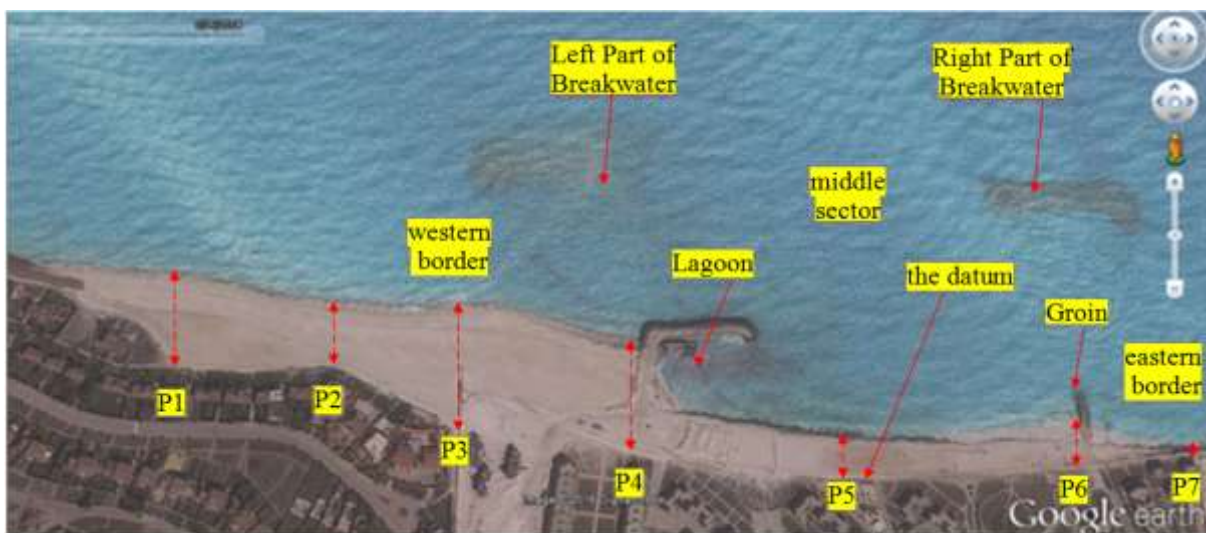
Figure 14: The study area on 26/3/2014.

Groins are intended to trap sand at the long-shore (surf-zone) current. If a groin is working correctly, more sand should be piled up on the up-drift side rather than the down-drift one. The problem with the groin is that it traps sand that it is probably flowing to a neighboring beach. Thus, if a groin on one beach is functioning well, it must be causing erosion elsewhere by “starving” another beach [19], which means that there was erosion at the eastern side of the SSR beach due to the construction of the aforementioned eastern groin. Besides, owing to the implementation of the aforementioned artificial lagoon, erosion has been occurred east lagoon at the middle sector the SSR beach. Furthermore, an accretion occurred west of the lagoon and extended westward at the WSR on 9/2/2013, as shown in Figure 12. The accretion is still increasing on 26/12/2013, 26/3/2014, and 31/1/2015, respectively, as shown in Figure 13, Figure 14 and Figure 15.

At Profiles P1, P2, P3 and P4 west of the lagoon there was an accretion by about 4.7 m, 11.2 m, 8.8 m and 8.1 m distance, respectively due to the construction of the lagoon, as shown in Table 1, Figure 13 and Figure 14. There is a Tombolo at Profile P3 due to the construction of the left part of the breakwater. Besides, at Profile P5, there was erosion by about 3.0 m distance due to delaying the construction of the middle part of the breakwater. Furthermore, at Profile P6, there it was an accretion by 7.6 m distance due to the construction of the groin. Moreover, at

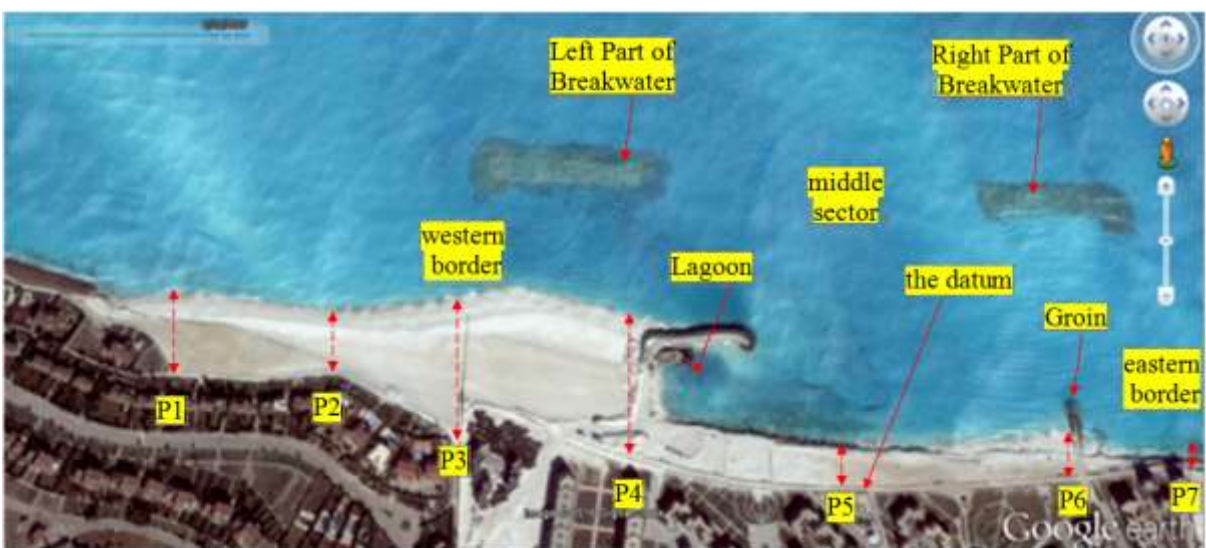
Figure 15: Google Earth satellite image on 31/1/2015.

At Profiles P1 and P2 west of the lagoon there it was an erosion by about 18.6 m and 4.3 m distance, respectively due to the construction of the left part of the breakwater, as shown in Table 1, Figure 14 and Figure 15, which there is a Tombolo at Profile P3 due to the left part of the breakwater. While, at Profiles P3 and P4 west of the lagoon there was an accretion by about 13.9 m and 30.6 m distance, respectively, as shown in Table 1 due to the construction of the lagoon. On the other hand, at Profile P5 and Profile P6, erosion occurred by a distance about 2.6 m and 3.0 m, respectively due to delaying the construction of the middle part of the breakwater. The currents attached these parts across the non-implemented middle part of the breakwater. Furthermore, at Profile P7 at the eastern border of the SSR, there was erosion by about 2.3 m distance because of the groin has trapped sand flowing at the longshore current from west to east.

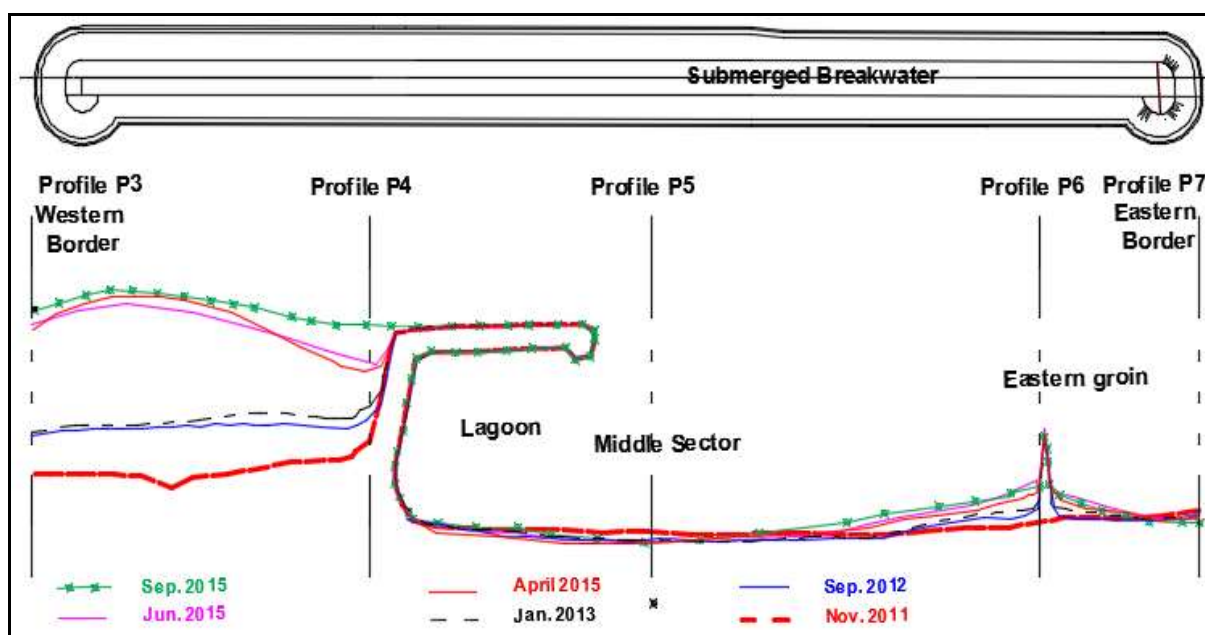
Figure 16: Shoreline changes of the SSR for November, 2011, September, 2012, January, 2013, April, 2015, June, 2015 and September, 2015.

At Profile P4 just west of the lagoon there was an accretion by about 22.3 m distance due to the construction of the lagoon, as shown in Figure 16. While, at Profile P5 at the middle sector, there was an erosion by about 2.2 m distance because of delaying the construction of this part of the breakwater. Furthermore, at Profile P6 at the west of the eastern groin, there was an accretion by 8.2 m distance due to the construction of the groin. Moreover, at Profile P7 at the eastern border of the SSR, there was erosion by about 3.8 m distance because of the groin has trapped sand flowing at the longshore current from west to east.
