International Roughness Index Analysis of Paved Road using MLS Data

Measuring the International Roughness Index (IRI) is a significant research field in developing intelligent transportation infrastructure systems. This study employed a mobile laser scanning (MLS) technique to measure the IRI from the standard deviation of longitudinal roughness (σ). The MLS technology provides a rapid and affordable alternative that produces precise and dense point clouds along route corridors. The IRI is often used as an indicator to assess the state of a pavement surface. Since the middle of the 20th century, several sensing technologies have been devoted to improving performance, functionality, and sensitivity. Using MLS, the IRI data were obtained from routes in Kuwait's Khiran city. The longitudinal sectors of the sections were extracted from the 3D point clouds collected by the MLS technique with a length of 2100 m. The longitudinal section was divided into the centerline, outer edge, and inner edge. The IRI was calculated every 100 m along the three longitudinal sections, and it was found that it changed from 4.9 mm to 19.3 mm for the centerline, from 7.9 mm to 41.9 mm for the outer edge,

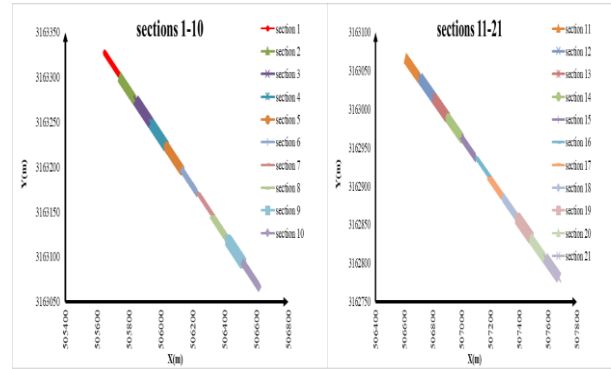
Figure 7: The sections along the longitudinal road section

standard deviation of longitudinal roughness (σ) was calculated every 100 m along the road. Figure 6 shows the three longitudinal sectors, and Figure 7 shows the sections along the longitudinal section.

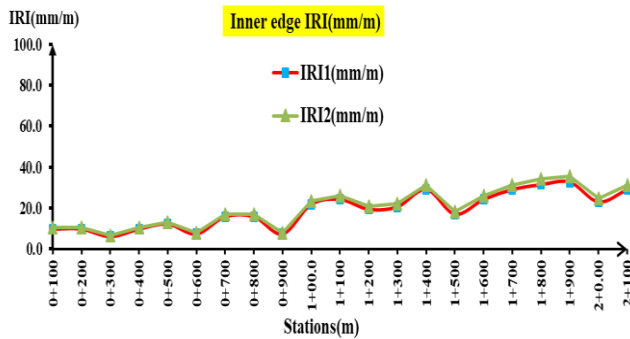
Figure 10 shows IRI (mm/m) from the start station section (0 + 100.00) to the end station section (2 + 100.00) for the inner edge longitudinal section. The IRI was found to change from 6.20 mm/m to 32.7 mm/m (equation 3) and from 6.60 mm/m to 35.4 mm/m (equation 4).

Figure 10: IRI for the inner edge longitudinal section
