*Sabil Muhammad Ali in Al-Aqqadin, Cairo: A Study in
Applied Geomorpho-Archaeology*

Abstract:

Keywords: Geomorpho-Archaeology; Weathering; Sabil Muhammad Ali.

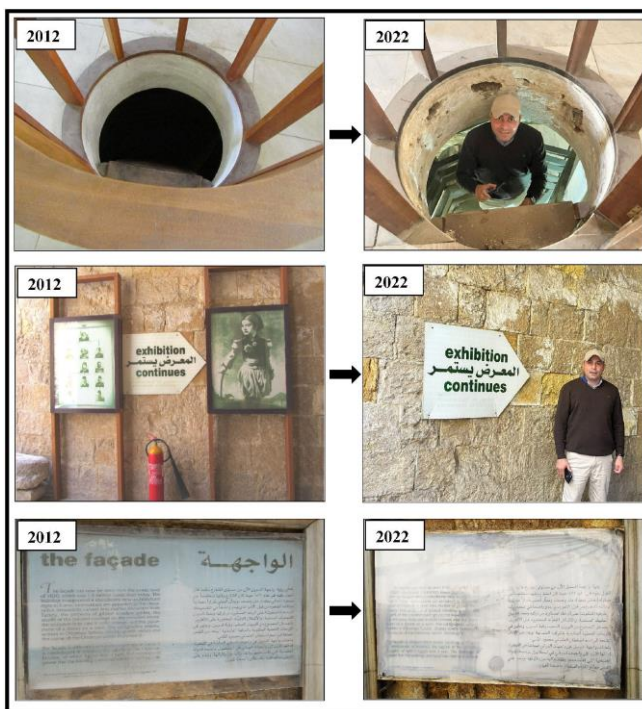
Figure 2: The Deterioration of the Cultural, Historical and Aesthetic Value of Sabil Muhammad Ali

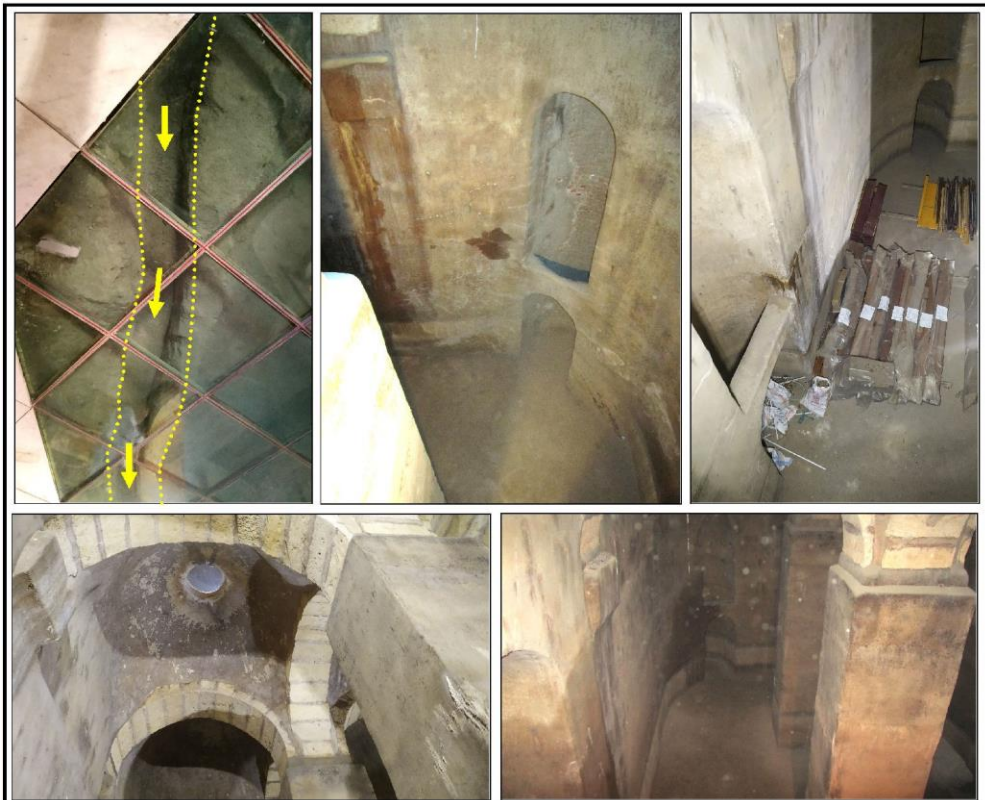
The water in Sabil Muhammad Ali is preserved in a huge cistern under the tasbil room, and it is one of the largest remaining cisterns in Cairo, with a depth of 9 meters and a capacity of 455,000 liters, sufficient to fill a million and a half cups of water. It is roofed with stone domes, and its walls are lined with waterproof mortar (Figure 6). It was fed with water by pipes filled by wheels on the Egyptian Gulf, which was penetrating the city at the time (Al-Sayed, 2021). However, the Gulf was neglected after the opening of the Suez Canal in 1869, the establishment of the Cairo Water Company, and the extension of pure water pipes to many neighborhoods in Cairo. Khedive Abbas Helmy II ordered it to be filled in, out of consideration for public health in 1898, and its location was transformed into a street called "Egyptian Gulf Street." In 1956, its name was changed to Port Said Street (Figure 7).

Figure 6: The Cistern in Sabil Muhammad Ali and the Channel for Water Transport from outside the Sabil to the Cistern

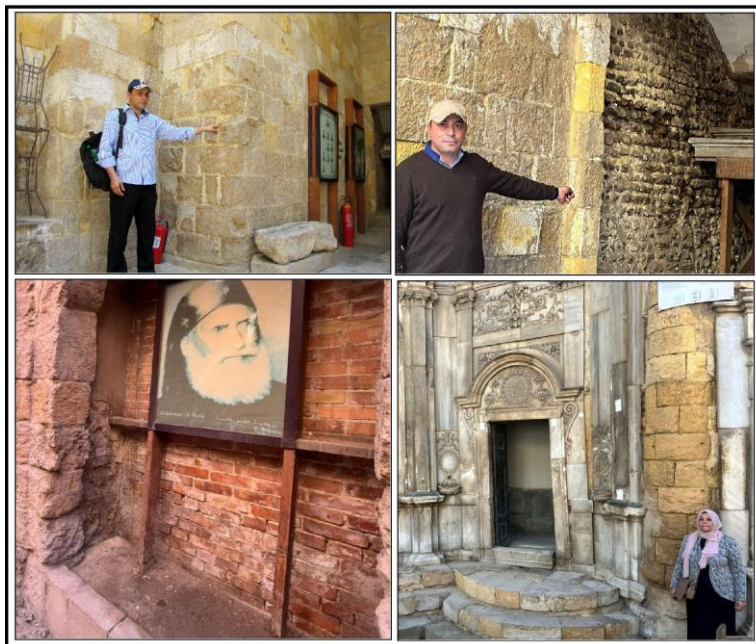
3.1. Mineral composition: Limestones were used in the construction of sabil Muhammad Ali as a basis for the building, in addition to red bricks and marble (Figure 8). The analysis of limestone samples by X-Ray indicates that the main component of limestone samples is calcium carbonate (CaCO_3), which is considered the basic stone material, with a percentage exceeding 80.0%, noting the presence of a small percentage of quartz mineral (SiO_2) ranging between 2.01% and 4.17 %. As for the chemical analysis of red bricks, it indicates that they contain quartz with the highest percentage of 31.2%. Hematite is also present in the sample in a significant proportion, and its presence with quartz along with orthoclase gives the red brick durability and strength (Darwish, 2007).

Figure 8: The Variety of Stones Used in the Construction of Sabil Muhammad Ali

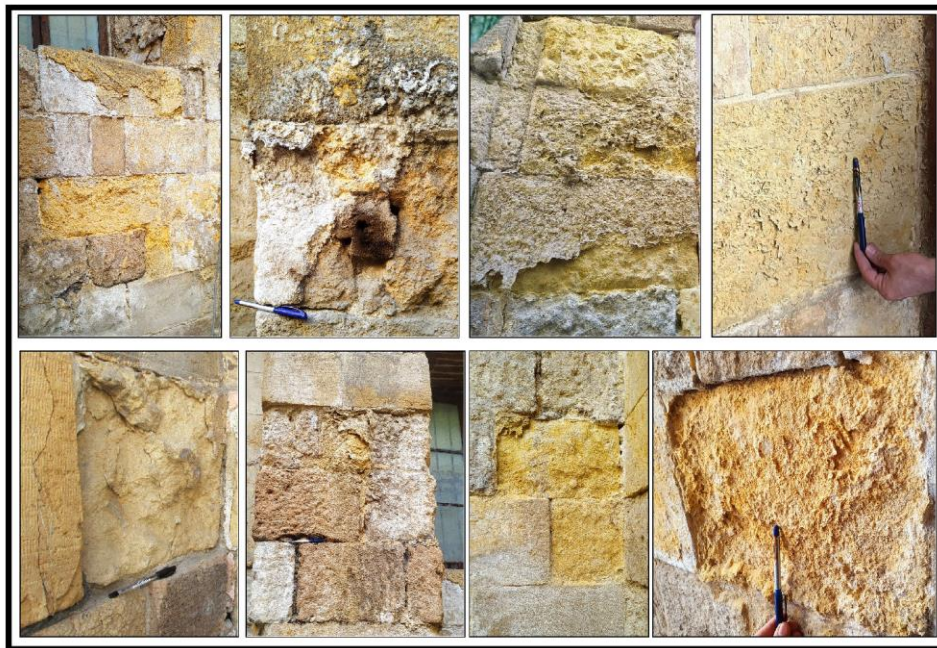
The phenomenon of flaking and fragmentation spreads in Sabil Muhammad Ali (Figure 16), where a contour flaking occurred, with a thickness ranging between 0.5 and 4 mm. This is due to the spread of sulphate salts, particularly sodium sulphate salts in the limestones, where the volume of sodium sulphate salts increases by 300% and pressures occur on the walls of the pores of the stone blocks, leading to destructive

hydration stresses to the environment of the stone and the occurrence of its flaking and fragmentation (Abdulhadi et al., 1996). This also occurs when the magnesium sulphate salt crystallizes behind the surface of the stone, causing it to flake and detach, as the magnesium sulphate salt causes damage and corrosion of the building materials used in the construction of Sabil Muhammad Ali, about 35% more than what is caused by the different phases of the sodium sulphate salt during the crystallization cycles of this salt. The magnesium sulfate salt is considered one of the fastest salts in the process of hydration, as the process of hydration of this salt takes place within 6 hours when exposed to moisture, while the process of hydration of sodium sulphate salt may take several days to complete (Hamida, 2003). The limestones with which Sabil Muhammad Ali was built were severely affected by the salt weathering process (crystallization of salts), which appears in the form of granular fragmentation, cracks, potholes and flakes in the limestone fabric. This caused severe fragmentation and erosion in the limestone fabric, which led to erosion or contour retraction in many stones (Figure 16). In the case of continuous damage and lack of maintenance and restoration of this deterioration, the sabil will be exposed to more erosion and danger.

Figure 16: The Spread of the Phenomenon of Flaking and Fragmentation in the Stones of Sabil Muhammad Ali

7.2.5. Carrying out periodic maintenance and restoration, speeding up its implementation, and dealing with the manifestations of damage in its early stages, so that the sabil is not exposed to erosion and the loss of its historical and archaeological value.

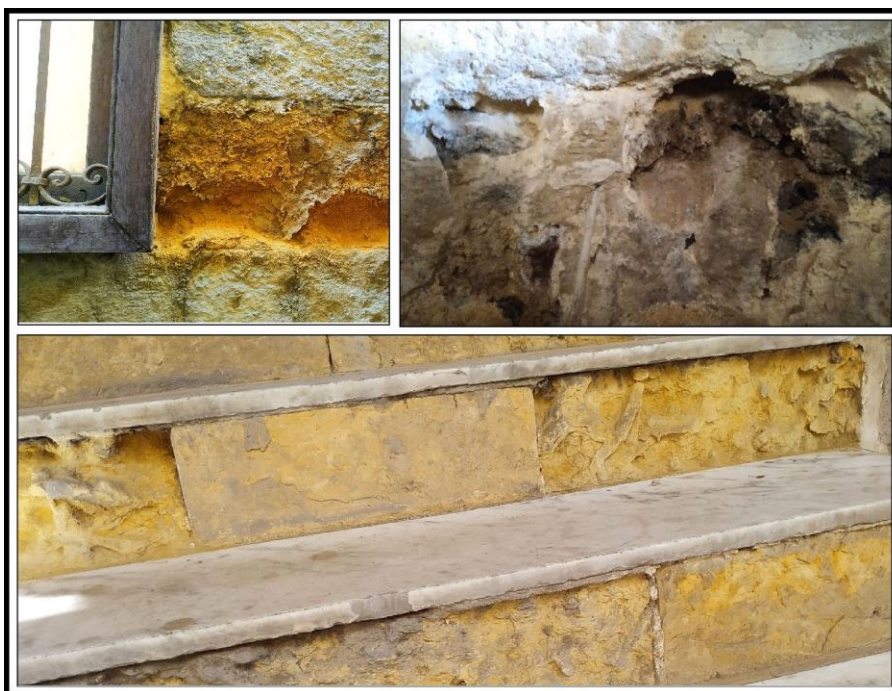
This phenomenon is widely spread in Sabil Muhammad Ali (Figure 17), where irregular erosion of stone surfaces was observed with the formation of voids or cavities of different sizes, along with the formation of gaps connected to each other, in a form resembling honeycomb and Tafoni pits. This phenomenon spreads in internal and external surfaces, and at the entrance to the reservoir (cistern), with average diameters ranging between 0.5 and 7.0 cm, and a depth of more than 5 cm in some stones. This, in turn, confirms that the sabil has reached a high level of deterioration. One of the main reasons for the spread of this phenomenon is the presence of sodium sulphate salts; they grow in one direction to take the prismatic shape, which increases their destructive force to the building stones due to the increase in size and its solubility. Moreover, the presence of these gaps is due to the susceptibility of calcium sulphate, whether present on the stone surface or inside it, to dissolve and be displaced by rainwater, noting that the successive sedimentation and dissolution cycles of salts lead to deepening these gaps more and more.

Figure 17: The Spread of Potholes and Gaps in the Stones of Sabil Muhammad Ali

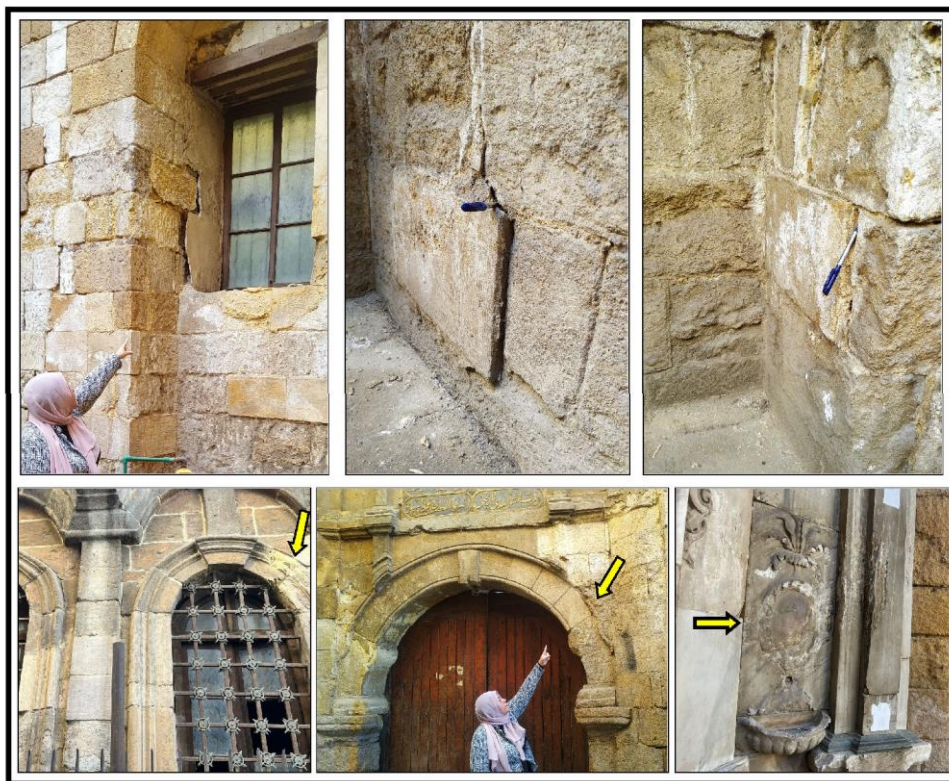
The problem of the detachment and falling of blocks and decorations is considered one of the most important, dangerous and destructive problems for Sabil Muhammad Ali. Due to the severe neglect that the sabil was subjected to, particularly in the last ten years, as well as the lack of any restoration or maintenance, it significantly deteriorated in its rocky and aesthetic structure. The field study monitored the detachment of many of the blocks that were intact in 2012 (Figure 18), where the phenomenon of detachment spread in all the walls of the sabil built with limestone, particularly the northern and eastern walls, which are two of the most neglected places in the sabil. In addition, it was shown that parts of the decorations and ornaments that adorn the façade of the sabil from the outside have fallen, which consist of limestone and surround the tasbil room and the northern entrance (Figure 19), which resulted during the crystal growth of salts in its walls because of the increase in the proportion of sulphate salts, particularly the calcium sulphate ones. In spite of its scarce solubility in water, it crystallizes in the dry and elevated parts. Besides, the formation of detached layers and agglomerations of calcium sulphate salt on the surfaces or under the surface of building materials may result in damage to these surfaces and their transformation into powder (Hamida, 2003). The field study also monitored the detachment of some marble decorations on the front side of the sabil (Figure 19). As previously mentioned, this indicates that the sabil has reached a very high degree of deterioration, and if neglect continues in this way, it will lead to the destruction of the monument in a way that its historical and archaeological origin would not be ever restored.

Figure 19: The Detachment and Falling of Stone Blocks, Decorations and Ornaments in Sabil Muhammad Ali

7.2.4. Changing worn-out stone blocks with new ones of the same type as the old stone.
