An applied analytical study of restoration of Qan-Amun tomb in the archaeological site of Al-Meskhouta in Ismailia

Dr. Abdalla Ali Sokar
Faculty of Archaeology Luxor university

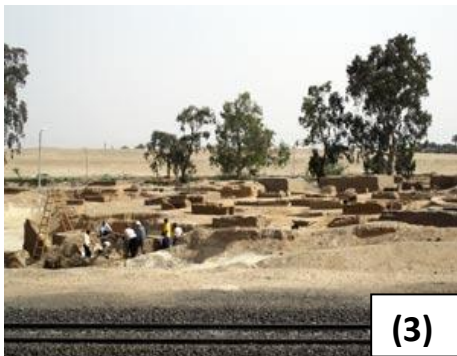
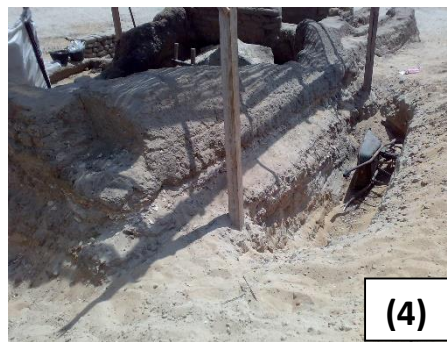
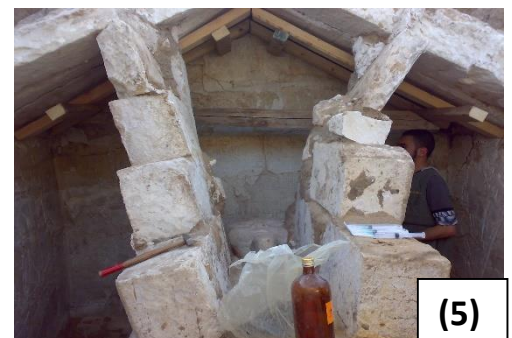
So it was found upon revealing that the mud brick ceiling had been removed from it in part and the stone gable roof had been broken in the middle, meaning that the tomb had been raided in the past and its contents were looted.

After removing the rubble, sand and dust around and inside the tomb so revealing the mud brick and stone elements of the tomb (photo no.4) It was found that the builder used the sarcophagus as a fulcrum for the stone gable ceiling to ease the load of the stone blocks of the roof of the tomb by building two rows of stones as columns resting on the sarcophagus lid as in (photo No. 5)

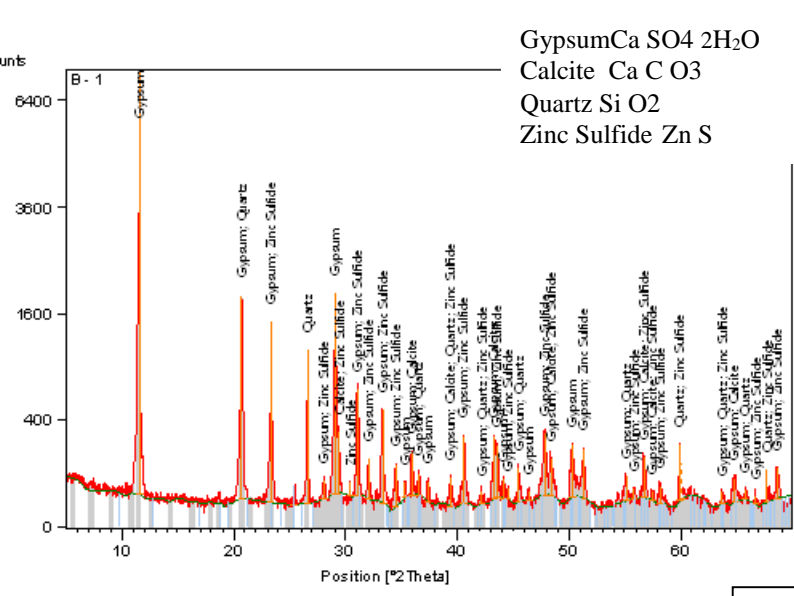
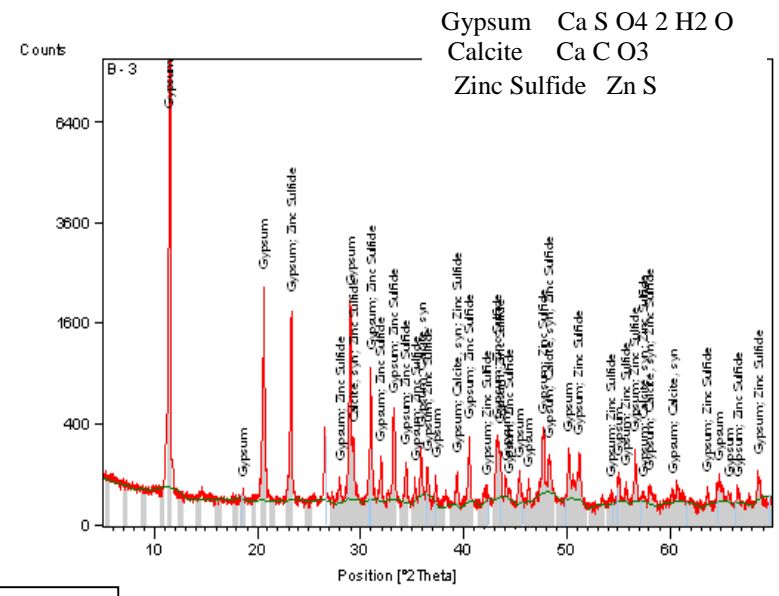
Fig No 8

The XRD analysis conducted on the examined mortar samples (Fig. B1, B3, and C2) revealed that the samples primarily consisted of gypsum ($\text{CaSO}_4 \cdot 2\text{H}_2\text{O}$), calcite (CaCO_3), quartz (SiO_2), and zinc sulfide (ZnS), as depicted in Figures 8 and 9.

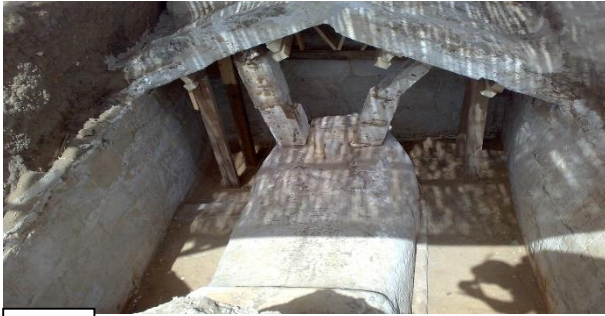
(7)

It was necessary to take quick procedures to prevent danger and risks for the ceiling, the sarcophagus, and the entrance. Strong wooden crucifixes were made in the same shape as the gabled ceiling, and they were installed on wooden pillars as shown in the pictures (No 7, 8). Then the two rows of stone pillars were gradually dismantled, so thus the load was transferred from the sarcophagus lid to the wooden crucifixes gradually. This process was the first step in preventing structural risks.

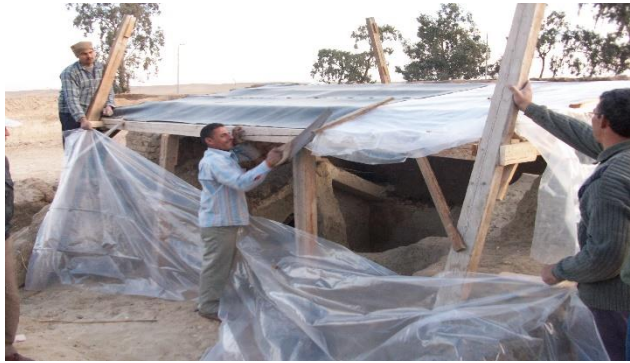
(11)

Cleaning and reduction salts are important and difficult stages of treating monuments, especially in buildings that suffer from deterioration and neglect in uninhabited desert areas such as Al-Maskhuta cemetery. Salts and dirt were found on all the stone walls, and therefore we find that this process needs a lot of patience and concentration. The following methods were used in cleaning and salt reduction:

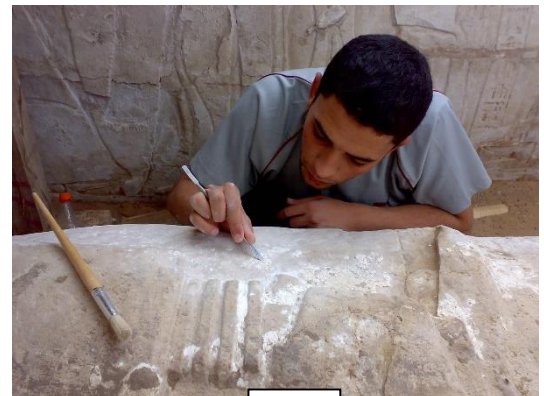
(13)

Mechanical cleaning using fine tools and brushes is used in removing salts and dirt from ancient surfaces. At this stage, brushes and tools of various sizes, shapes, and different heads are used to help with accuracy and skill in applying this technique. The result of this work is usually the removal of the largest amount of plankton and calcified salts, as in Picture No (13), where large quantities of salt calcifications were removed before moving on to other stages of cleaning and salt removal, which usually takes place after mechanical work. Stone cleaning can be to the advantage of a surface by displaying the true color of previously obscured and by revealing the quality of the carved detail ⁽⁷⁾.

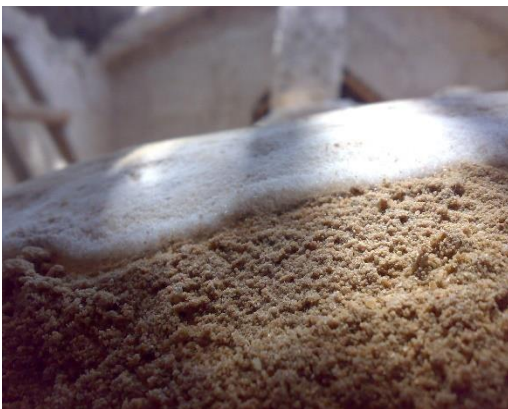
(14)

The third poultice consisted of sepiolite clay, to which carboxymethyl cellulose (CMC) dissolved in hot water was added in a ratio of 4 parts clay to 1 part CMC. This poultice was applied to walls with robust stones. Prior to the application of the sepiolite clay poultice, Japanese paper chips were spread over the stone's surface to facilitate the removal of the poultice without contaminating the archaeological surface once it dried. Conservators often favor this poultice, which incorporates sepiolite clay, for desalination purposes, as it aids in drawing out soluble salts. It is also utilized as a cleaning method on substrates like limestone that respond well to water-based cleaning (9).

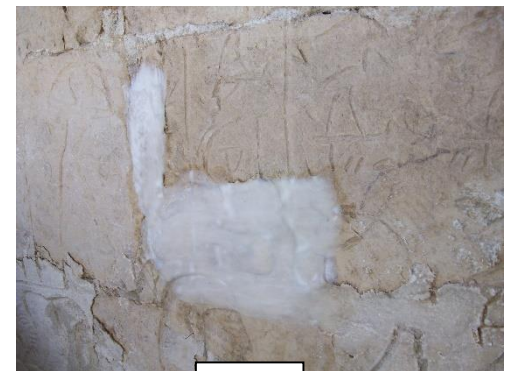
(16)

Various chemical techniques are employed for the removal of salts and calcified dirt from ancient surfaces, with the choice of cleaning method being contingent upon the condition of the monumental surface (8). When mechanical cleaning proves insufficient, chemical cleaning (wet cleaning) is implemented. Ingrained dirt, unsightly patchiness, and encrusted deposits of Potassium Sulfate (K_2SO_4) and Zinc Sulfide (ZnS) were addressed using three poultices.
