Diagnostic Investigation and Conservation Methods of the Wall Ceramic Mosaic in The Historical Church of the Blessed Virgin Mary, Mostorod, Egypt

This paper presents a diagnostic examination and conservation of a ceramic mosaic in the Church of the Blessed Virgin Mary in Mostorod, Egypt. The panel, located in the cave of the church, depicts the Holy Family and is named “Cave Mosaic Panel” However, various deterioration factors and previous restoration works have negatively affected the mosaic panel. The panel has suffered from many aspects of deterioration, particularly buckling, soot, dirt, salts, and the loss of some pieces. The study aims to identify the type and structure of the ceramic mosaic, determine and diagnose aspects of deterioration, and carry out the necessary conservation works on the panel to protect it in the future. A diagnostic study was carried out using Scanning Electron Microscopy with Energy Dispersive X-ray, X-Ray Diffraction and Fourier-Transform Infrared Spectroscopy. The results showed the chemical composition and the type of colouring oxides of the ceramics. Cobalt oxide was used to obtain a dark blue glaze, with alkali and lead alkaline as fluxes in th

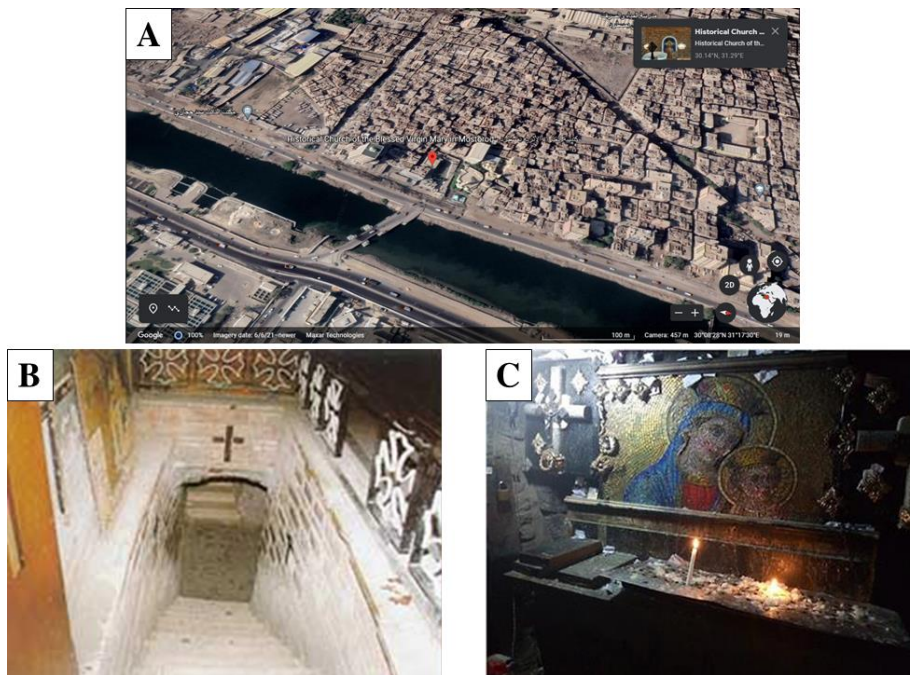
Figure 1. A. Location of the historical Church of the Blessed Virgin Mary in Mostorod, Egypt (Google Earth 15-9-2022); B. The staircase leading to the site of the wall mosaic; C. The cave mosaic panel of the Virgin Mary

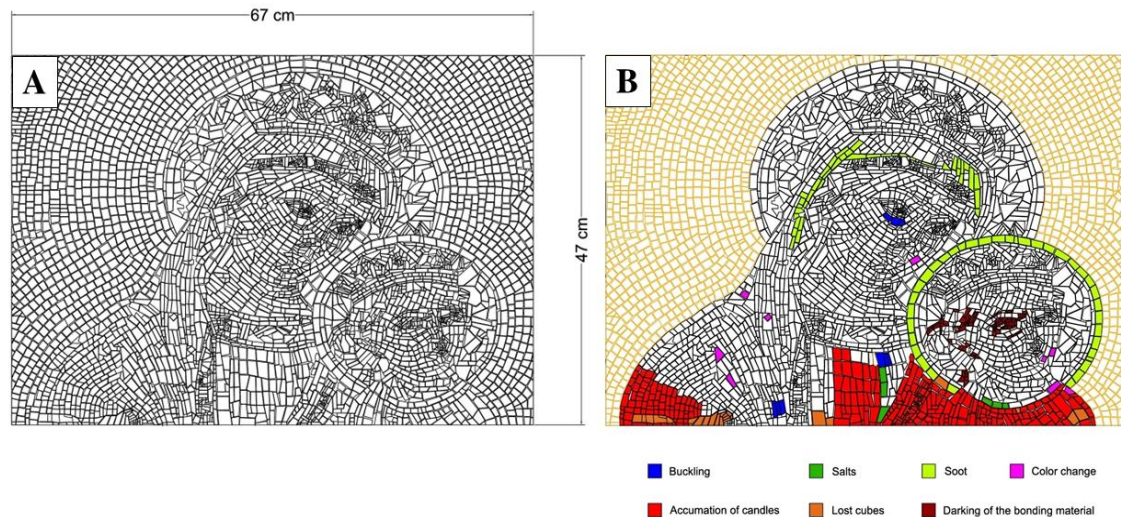
AutoCAD was used to document the mosaic mural panel (67 cm H.* 47 cm W.). It is a decorative mosaic depicting the Blessed Virgin Mary and Christ, using (dark and light blue, dark red, light and dark pink, yellow and white) mosaics on a (dark and light brown, beige and glass) mosaic background. In addition, various signs of deterioration were documented, including soot, wax, dirt, loss of some pieces, colour changes, and buckling in some parts (Mohamed M. I., Ayat A. H., and Sherif O, 2022, 1-14) (Fig. 7).

Figure 7 Autocade documentation; A. Dimensions, B. Deterioration map

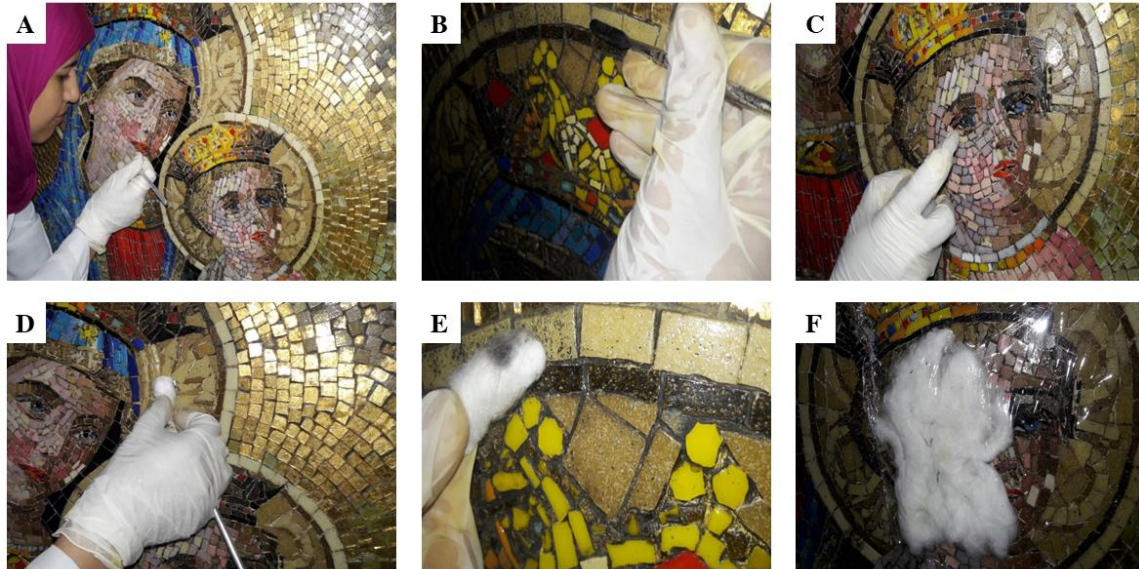
Figure 8 Mechanical and chemical cleaning and salt removal from the mosaic; A, B. Use of mechanical tools, C. Use of air pump, D, E. Chemical cleaning of the mosaic parts, F. Use of a cotton poultice for salt removal

The restoration of ceramic mosaics began with mechanical cleaning to remove dust and dirt from the surface of the ceramic pieces using mechanical methods that were easy to control compared to chemical cleaning. The cleaning methods depend on the nature and condition of the mosaic pieces as well as the type and nature of the dirt (Abd-Allah R., Al-Muheisen Z., and Al-Howadi S., 2010, 97-110). Mechanical cleaning mainly aims to remove or reduce the hard materials on the surface of the monuments in order to

The first solvent was distilled water to remove dust deposits. It has many advantages, such as being cheap and available without any negative effects on the condition of the pieces (Abd-Allah R., 2013, 14-97). In addition, acetone and alcohol were diluted with distilled water to avoid the effects of the high concentration of these solvents on the surface (Adrian G., and. Paez M. C., (2007, 180-188). Gasoline delivered good results in removing candle residues. A mixture of distilled water, soap and ammonia also produced good results in removing the soot residues that had been left by the use of candles in front of the mosaic portrait. In this case, before cleaning the ceramic mosaic, it was ensured that the surface was not brittle and had no coloured crusts. Mechanical cleaning began with the removal of dust and dirt with soft and hard brushes (Alberti L., Bourguignon E., and Roby Th., 2013, 89-90). Wooden sticks and scalpels were used to remove calcified parts (Fig 8 A, B), and the air pump was used to remove dust and dirt (Fig 8 C). Cleaning was carried out gradually and carefully from top to bottom (Arinat, 2019, 334-344). The heavy layers of wax on the surface were removed with different types of scalpels and a magnifying glass until the wax and dirt were completely removed. Then a chemical cleaning with distilled water was performed to remove some calcifications that were difficult to remove mechanically. Some organic solvents, such as ethyl alcohol, acetone and toluene, were then used. Acetone was diluted with distilled water, ethyl alcohol was used with distilled water (1:1) and neutral soap with water (1:1) (Casaletto M.P., Ingo G.M., Riccucci C., De caro T., Bultrini G., Fragala I., Leoni M., 2008, 35-42). Benzene was then used to remove wax residues. To clean wax soot, 1000 ml of a solution of water, 100 g soap, and 20 ml ammonia was used (Ricci S.S., Graham F., 2000, 37-56) (Fig 8 E). These treatments gave satisfactory results in removing dirt, dust, and adhesives from the surface.

The efflorescence salts were removed from the surface using mechanical tools and extracted. Cotton poultices and distilled water were then used and applied several times to achieve the best results. The type of salt, i.e. halite (sodium chloride), soluble salt (Abd-Allah R., Al-Muheisen, Z., Al-Howadi, S., 2010, 97-110), was then identified (Fig 8 F). The NaCl salts were extracted and removed using cotton poultices applied several times, giving good results. To extract salts from the surface of monuments in small areas, it is preferable to use paper and cotton fibres in the poultice as they are easily to remove (Woolfitt C., Abrey G., Poultices, The true or plain poultice and the desalination of historic Masonry and Sculpture, The Building Conservation Directory, <https://www.buildingconservation.com/articles/poultices/poultice.htm>)

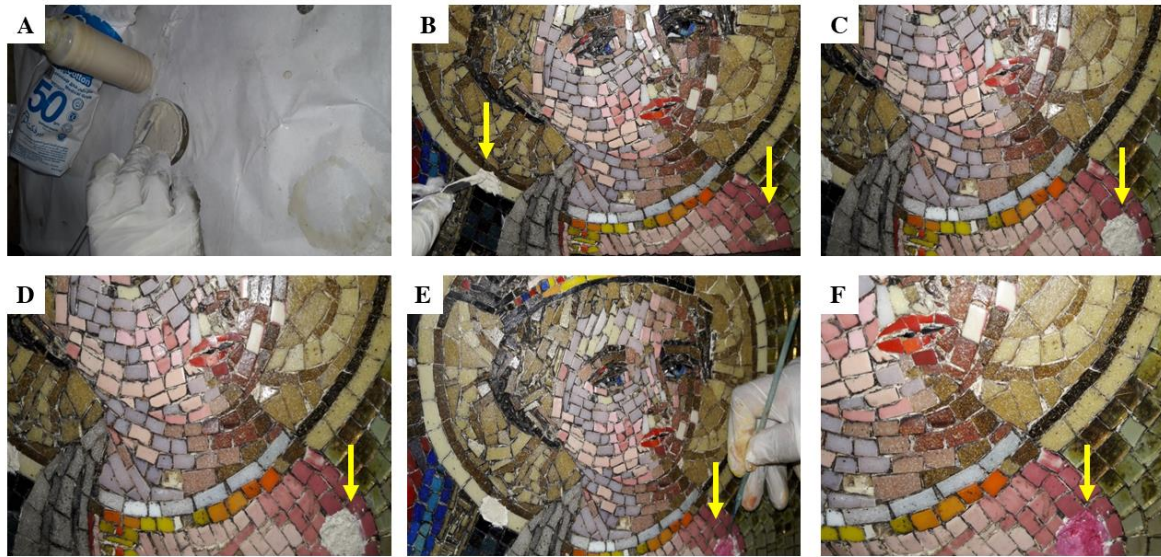
Figure 10. Completion of the missing parts of the mosaic pieces; A. Preparation of the completion material, B. Application with the metal spatula, C. D. After application of the completion material and drying, E. Colouring of the completed part and final shape of the completed part

The completion of the missing mosaic pieces was done with mortar (lime, sand, white cement and limestone powder) and the addition of nano-silica to the mortar components, as the use of nanoparticles in the mortar drastically changes its behaviour and improves the physical and mechanical structure (Senff L., Labrincha J. A., Ferreira V. M., Hotza D., and Repette W. L, 2009, 2487-2491). The use of nano-silica gel improved the compressive strength of the mortar compared to the structures without addition (Mondal P., Shah S. P., Marks L. D., and Gaitero J. J., 2010, 69).

In addition, nano-silica is the most commonly used material because of its effect on filling the pores. In the study of the adhesive pressure resistance and flexural strength, an increase in the strength of the paste was observed, which showed a significantly better mechanical potential and higher in compressive strength (Stefanidou M., 2012, 2706–2710). In terms of durability properties, e.g. permeability, pore structure, and particle size distribution, studies with nano-silica showed that the addition of nano-silica decreased water absorption and permeability (Zhang M. H., Islam J., 2012, 573-580). Several opinions were expressed to complete the missing mosaics. Majewski, for example, claimed that the gaps were filled with lime mortar. Then the surface was polished. After that, the surface was organized like the existing mosaic. The surface was painted with colours that corresponded to the original design of the mosaic (Majewski, 1977, 57). Another opinion argued that the gaps were filled with the appropriate mortar. It was then painted and coloured like the original. Hydraulic lime mortar is also used in emergencies when dismantled cubes have become detached from the mortar, requiring rapid intervention for fear of losing the cubes, especially at the edges (Nardi R., Schneider K., 2013, 55-70). The ceramic mosaic of *Sainte-Colombe-lès-Vienne* was finished with the same mortar used as a preparatory base with charcoal powder to obtain the black colour by filling in the lines of the missing with coloured mortar (Macchiarola M., Fiorella G., 2005). The process was completed here with the mortar (lime, sand, white cement, limestone powder and nano-silica) in a ratio of 3:2:2:1:1, which was applied underneath

the cubes with a scalpel. It was then left to dry and painted with oil paints according to the colours specific to each area of the painting (Fig. 10).

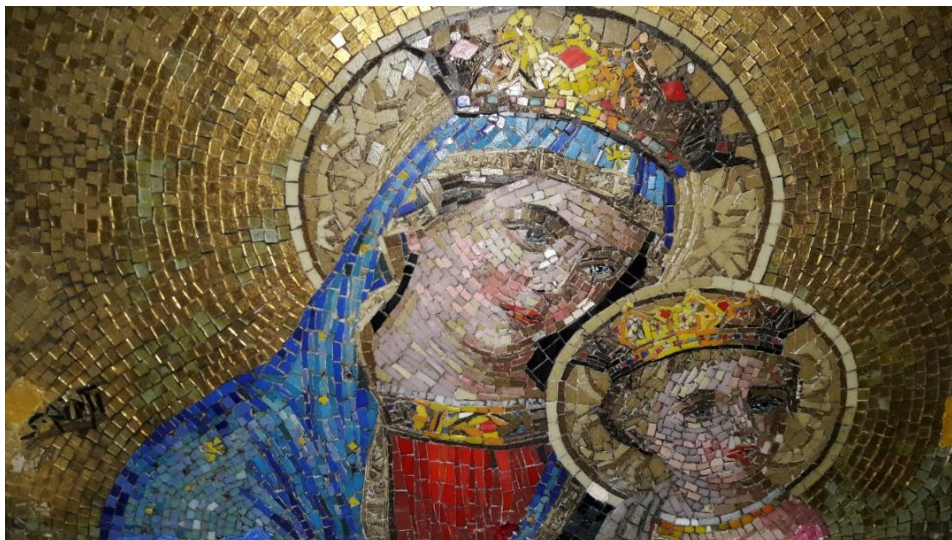
Figure 11 Ceramic mosaic after completion of restoration and protection

The final phase of the conservation of the mosaic panel consisted of finishing and chemical insulation to consolidate the weak mosaic pieces and isolate the panel from deterioration factors, especially moisture, as the panel is located in a well in the church. The aim of this process was to consolidate and reinforce the weak mosaic parts caused by the damage to the glaze layer (the protective layer of the body) and to isolate the mosaic from the high humidity, as the portrait is located in a well. It was carried out with the nanocomposite PF4. The protection was carried out with the nanocomposite PF4, which consists of titanium dioxide nanoparticles dispersed in an alkylalkoxysilane polymer produced by Chem Spec Company, Italy (Helmi F.M., Hefni Y.K. 2016, 87-96). It is one of the multifunctional nanocomposites produced by adding one or more nanocomposite to a polymer. These materials were well blended to obtain a nanocomposite with good properties that cannot be achieved by polymers alone. It also has a high hydrophobic property. It is homogeneous with silicates and can improve their physical, chemical, and mechanical properties. It is highly resistant to ultraviolet rays and microorganisms (Omar Sh., 2018, 222-223). It was applied after cleaning the surface and removing dust and surface residues by impregnation with a brush. Six successive coats of the consolidant were applied, waiting between each coat until the consolidation and isolation coating was complete (Ibrahim M. M., Mohamed S. O., Hefni Y. K. and Ahmed A. I., 2019, 39-48) to protect the mosaic from future damage. Figure (11) shows the ceramic mosaic after completion of the consolidation and protection.
