VERIFYING RIVER BANK FILTRATION APPLICABILITY IN IRAQ AGAINST IRAQI'S STANDARDS

Abstract: In terms of the importance of constructing mega agricultural projects in Iraq and within the rising water conflicts among its surrounding neighbors, this research was initiated with the objective of investigating an innovate technique to improve water quality of the river. Primarily, literature was reviewed in the field of solutions to water scarcity. Apparent was that many techniques are available, from which **River Bank Filtration "RBF"** was selected to be investigated to inspect its applicability and to test it against Iraqi's standards. Field visits were carried out along Tigris River, where data was assembled and 24 wells were dug perpendicular to the river centerline along 4 lines, 500 m apart. Each line had 4 near-wells, 5 m apart, and 2 far-wells, 100 m apart, on each line. A sampling campaign was carried out in November 2021 and water samples were extracted from the 16 near-wells, 8 far-wells and Tigris River. The laboratory results were obtained; plotted onto graphs; analyzed and tested against Iraqi's standards. Based on the laboratory results analysis, apparent was that the wate

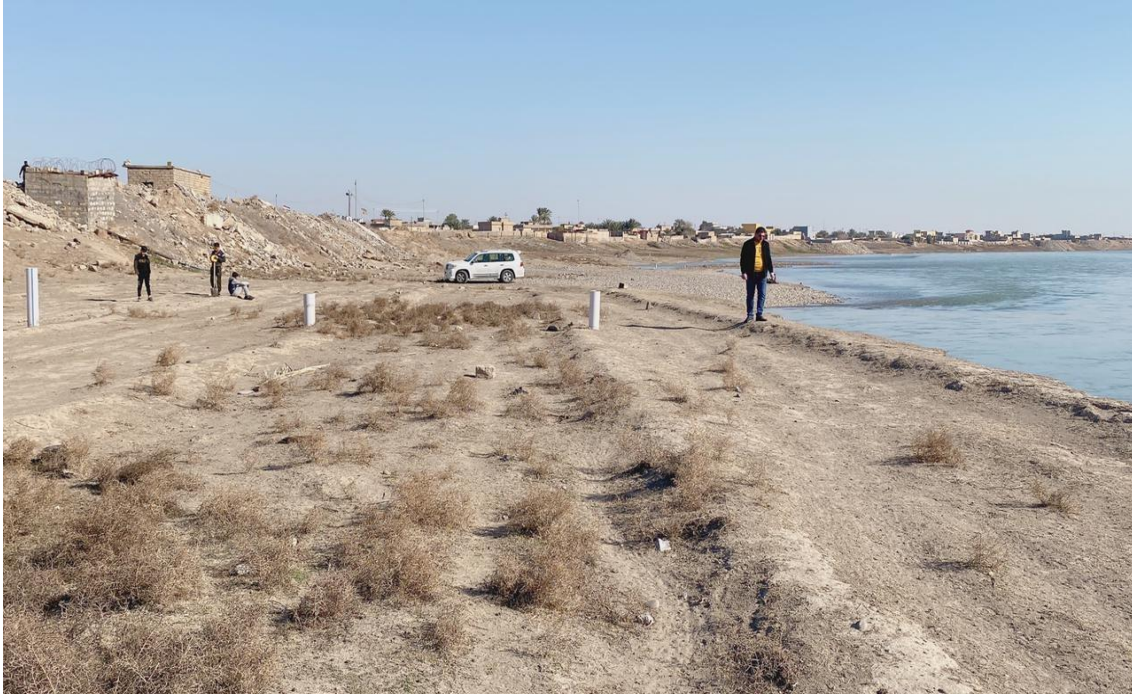
Photo 3: Drilling of wells

Throughout the site visits, 24 wells were drilled (i.e. 16 near-wells were dug along 4 lines perpendicular to Tigris Bank that were 500 m apart). Each line encompassed 4 wells at 5, 10, 15 and 20 m from Tigris bank. In addition, 8 far-wells were dug, 2 along each line at 100 and 200 m away from Tigris Bank.

Also, water samples were extracted from near-wells, far-wells and Tigris River; photos (2) and (3) present field inspection and drilling of wells.

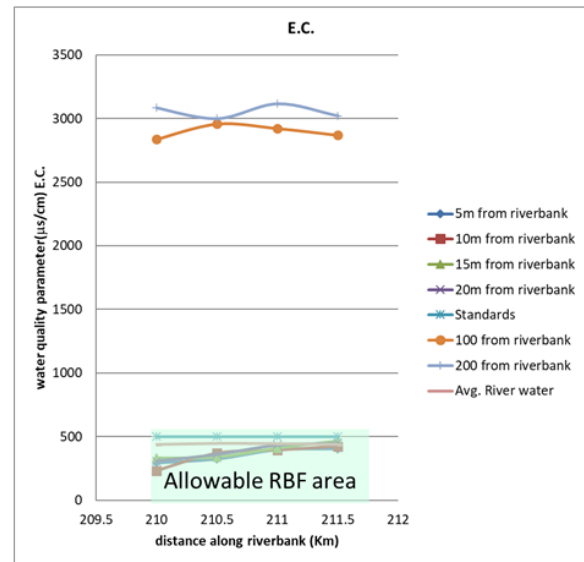
Graph 1: Verifying RBF applicability, in terms of EC

On the figures, a green area and a blue line were superimposed:

- The green area indicates the strip for reliable water quality results, where RBF is applicable within the area between the x-axis and the curve plotted for the "20 m apart from riverbank" results.
- The blue line indicates the Iraqi's acceptable value standards.

- The *near-wells* water quality parameters were within the permissible values of the Iraqi standards.
- This indicated that RBF could be applied within the shaded strip (i.e. between the *near-wells* curves of 5 to 20 m, away from Tigris Bank).
- The *far-wells* water quality was not compatible with the Iraqi standards.
- This designated that the *far-wells* water quality is not suitable for drinking, as many dangerous elements were higher than the allowable limits and the taste was nasty with water hardness more than allowable limit.
- *Tigris River* water quality was not suitable for drinking.

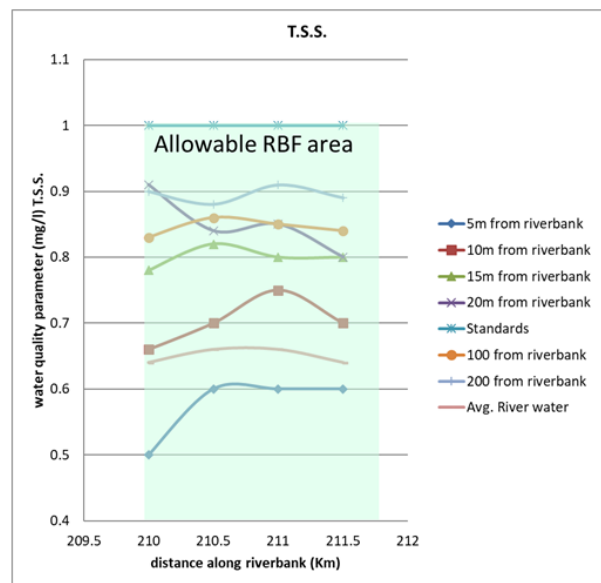
Graph 2: Verifying RBF applicability, in terms of TSS

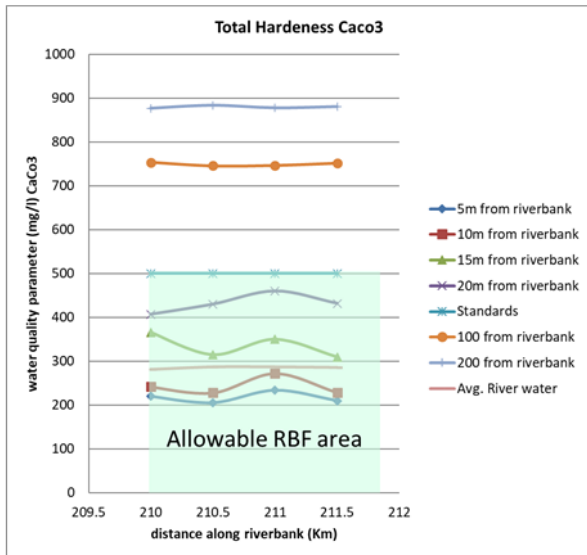
Graph 3: Verifying RBF applicability, in terms of CaCo3

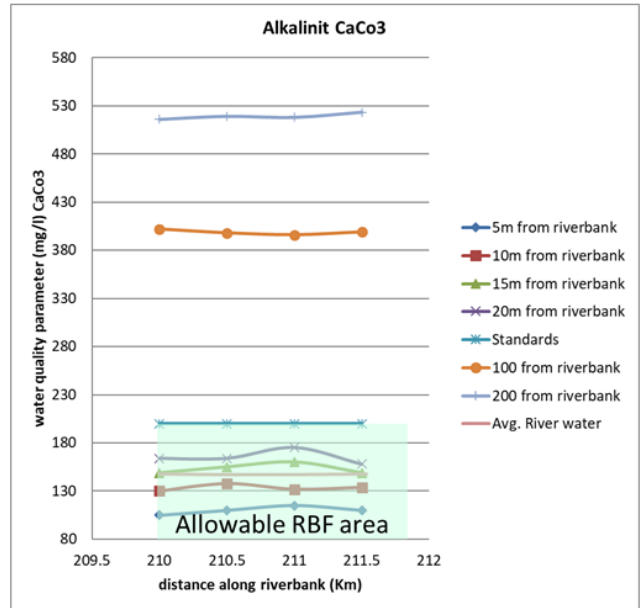
Graph 6: Verifying RBF applicability, in terms of Alkalinity

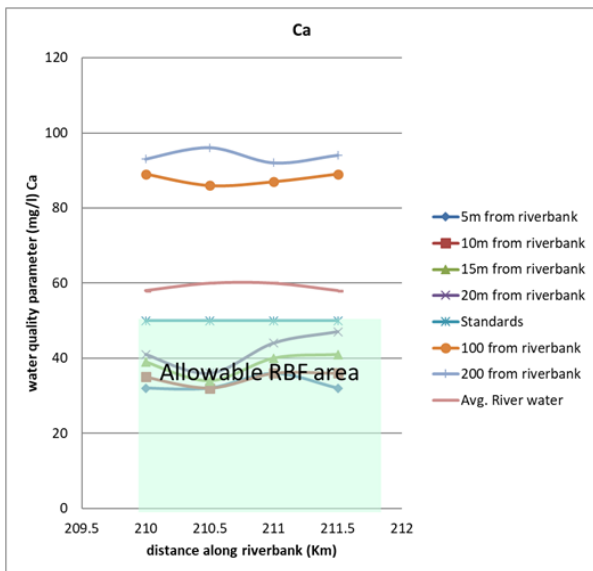
Graph 4: Verifying RBF applicability, in terms of Ca

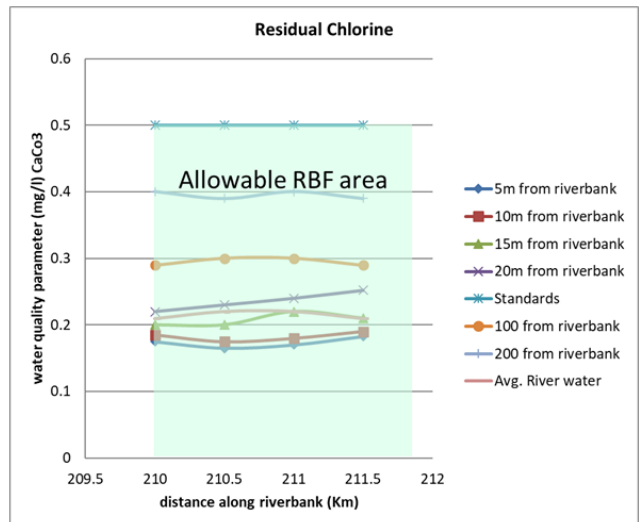
Graph 7: Verifying RBF applicability, in terms of Residual Chlorine

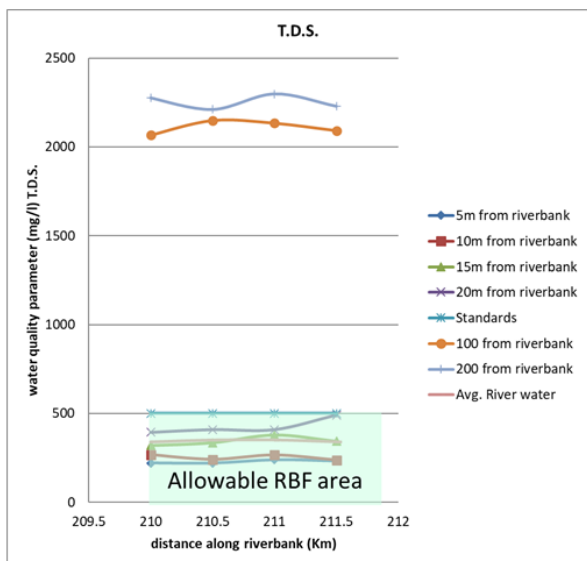
Graph 5: Verifying RBF applicability, in terms of TDS

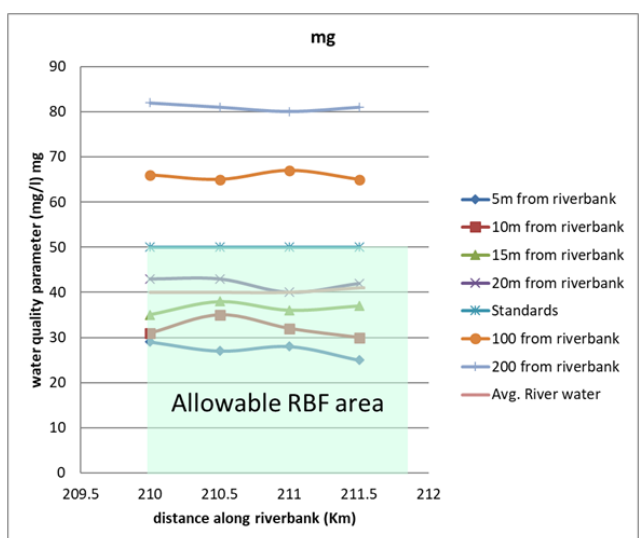
Graph 8: Verifying RBF applicability, in terms of Mg

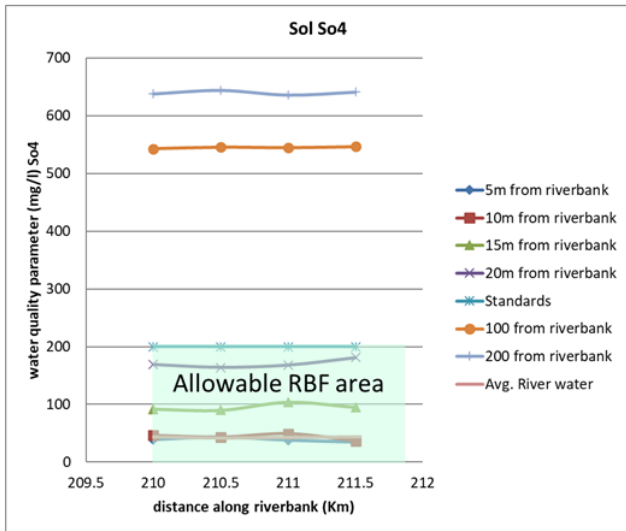
Graph 9: Verifying RBF applicability, in terms of SolSo4

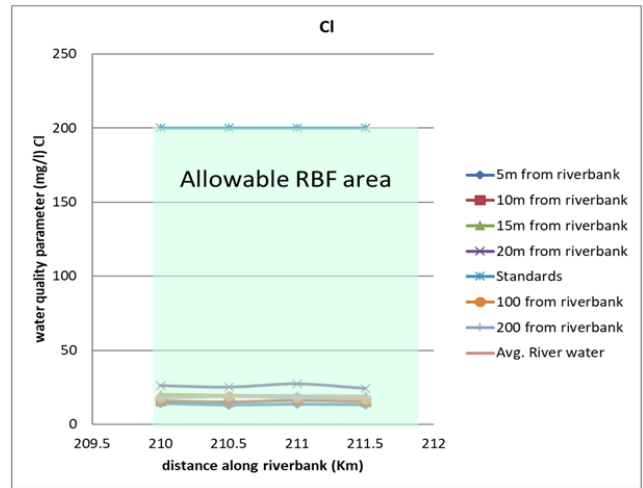
Graph 12: Verifying RBF applicability, in terms of Cl

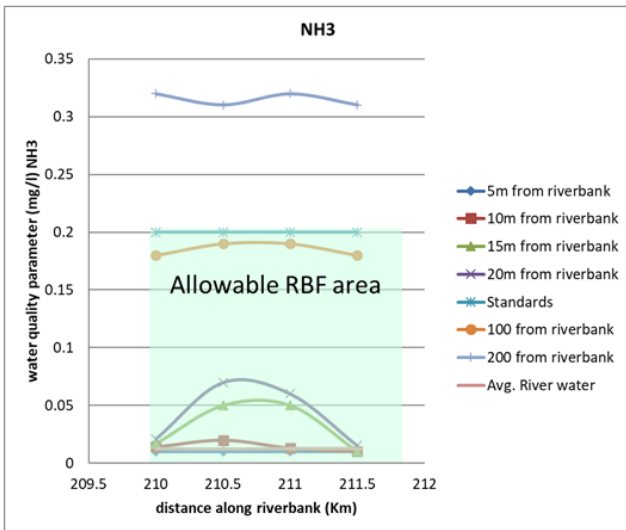
Graph 10: Verifying RBF applicability, in terms of NH3

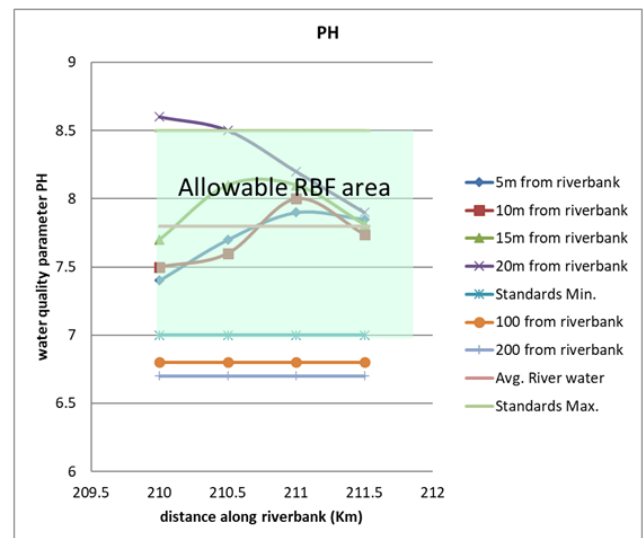
Graph 13: Verifying RBF applicability, in terms of pH

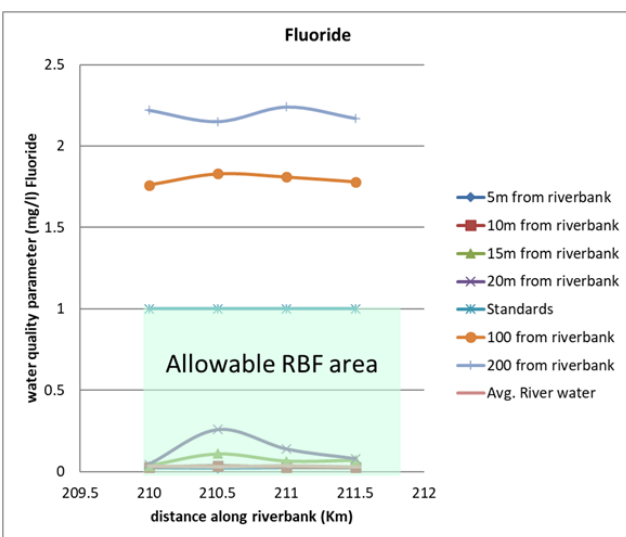
Graph 11: Verifying RBF applicability, in terms of Fluoride

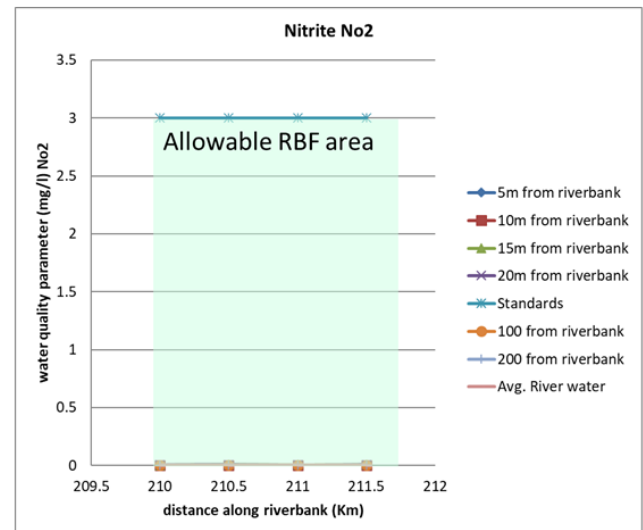
Graph 14: Verifying RBF applicability, in terms of No2

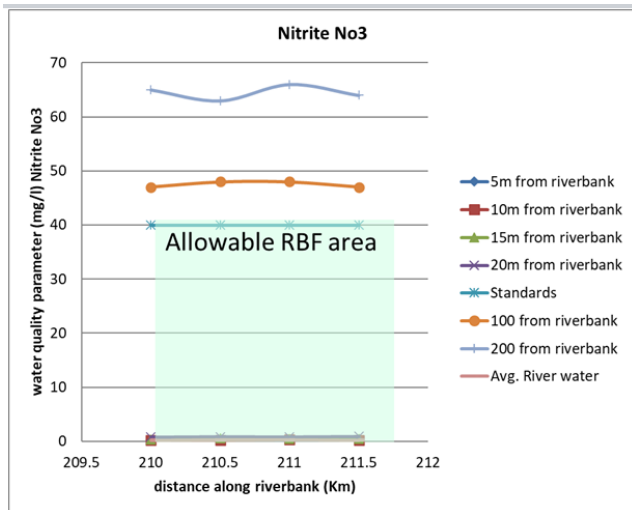
Graph 15: Verifying RBF applicability, in terms of No3

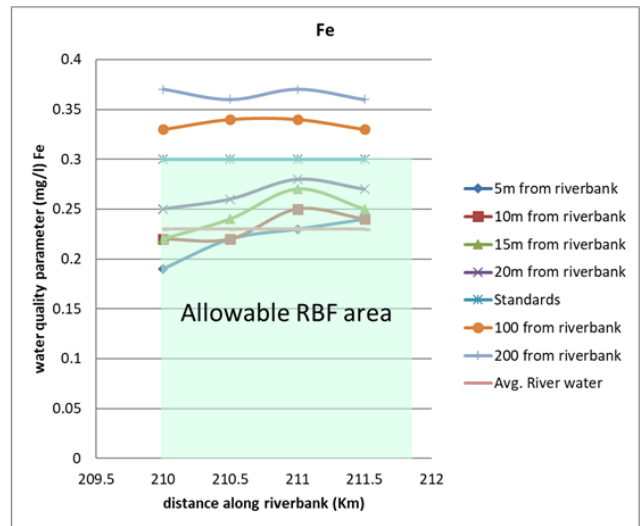
Graph 18: Verifying RBF applicability, in terms of Fe

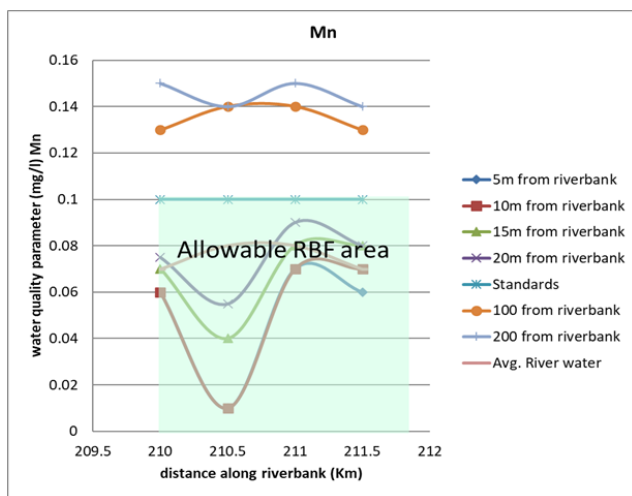
Graph 16: Verifying RBF applicability, in terms of Mn

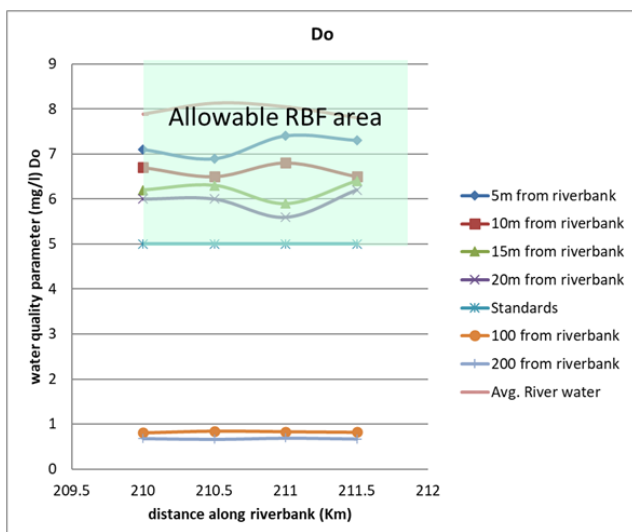
Graph 17: Verifying RBF applicability, in terms of DO
