Analysis of Pavement Distresses Using the Image Processing Technique for Egyptian Roads

George. L. Youssef^{a*}, Abdelzaher E. A. Mostafa^b, Mohamed. S. Ouf^b, Ahmed M. Wahby^c

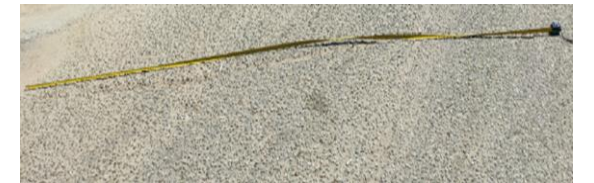
Fig. 7. Transverse crack No.6.

Crack no.	Distress type	Length (cm)	Width (cm)
1	longitudinal crack	970	3.03
2	longitudinal crack	1285	1.46
3	longitudinal crack	139	4
4	transverse crack	500	2.37
5	transverse crack	925	2.43
6	transverse crack	300	2.17
7	transverse crack	456	7.75
8	transverse crack	370	5.75

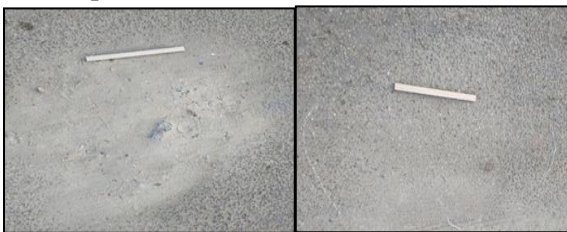
Fig. 12. Depression No.1.

Fig. 13. Depression No.2.

Depressi on no.	Distress type	Length (cm)	Width (cm)	Area (cm2)
1	Depression	210	180	37800
2	Depression	150	170	25500

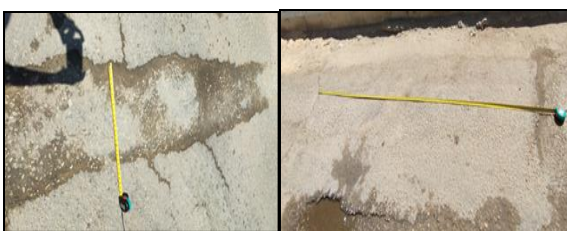
Fig. 14. Utility Patching No.1.

Fig. 15. Patching No.2.

Patching no.	Distress type	Length (cm)	Width (cm)	Area (cm2)
1	Utility cut patching	700	50	35000
2	patching	360	155	55800

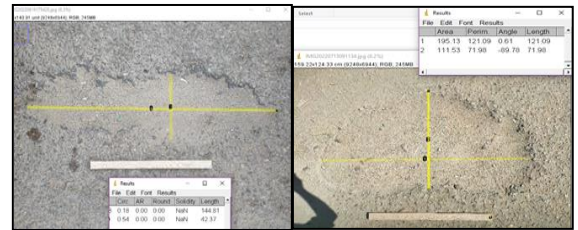
Fig. 26. Pothole No.1.

Fig. 27. Pothole No.2.

Pothole no.	Distress type	Length (cm)	Width (cm)
1	pothole	145	42.37
2	pothole	121	71.98

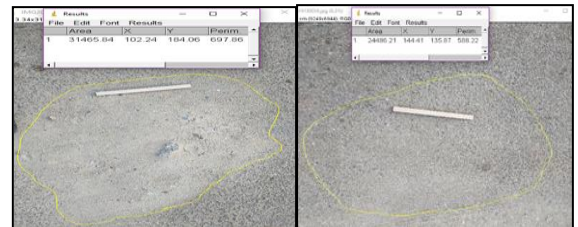
Fig. 28. Depression No.1.

Fig. 29. Depression No.2.

Depression no.	Distress type	Area (cm2)
1	Depression	31465
2	Depression	24496

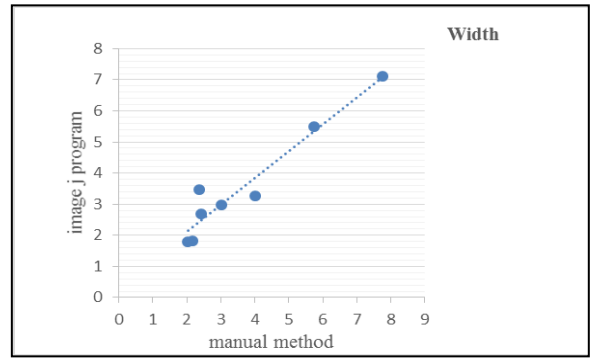
The results showed that the width of distresses measured by using the manual measurement method was often greater than that measured by using the

Image J program. This is likely due to the fact that the manual measurement method is more subjective than the Image J program. When using the manual measurement method, the human observer may be more likely to overestimate the width of a distress. The correlation of results obtained by using the Image J program with the manual measurement method showed high correlation, as indicated by the high coefficient of determination $R^2 = (0.9257)$. This means that there is a strong linear relationship between the two sets of results. In other words, the results obtained by using the Image J program were closely related to the results obtained by using the manual measurement method. Table 10 and Figure 33 provide more detailed information about the results. The table shows the width of distresses measured using the two methods for the images in the dataset. The figure shows a scatter plot of the results, with the width of distresses measured using the Image J program on the y-axis and the width of distresses measured using the manual measurement method on the x-axis. The line of best fit for the scatter plot is also shown. The results of this study suggest that the Image J program can be used to accurately measure the width of distresses in pavement images. The high correlation between the results obtained by using the Image J program and the manual measurement method indicates that the two methods are producing slightly close results. This suggests that the Image J program can be used as a reliable alternative to the manual measurement method for measuring the width of distresses in pavement images.

Fig. 33. The correlation between the widths of pavement distresses measured using the manual method and the Image J program.

Distress type	Manual measurements (cm)	Measurements of image j program (cm)
longitudinal crack No.1	3.03	2.98
longitudinal crack No.2	1.46	1.42
longitudinal crack No.3	4.00	3.28
transverse crack No.4	2.37	3.46
transverse crack No.5	2.43	2.70
transverse crack No.6	2.17	1.81
transverse crack No.7	7.75	7.10
transverse crack No.8	5.75	5.50
Regression model	$y = 0.8586x + 0.4094$	
R^2	0.9257
