## Repair Bond Strength and Surface Characteristics of Two Ceramic Materials Subjected to Different Laser Surface Treatment Combinations An in vitro study

*Zahraa Alhajaj<sup>1</sup>, Tarek Salah Morsi<sup>2</sup>, Doaa Taha Sayed Taha<sup>3</sup>*

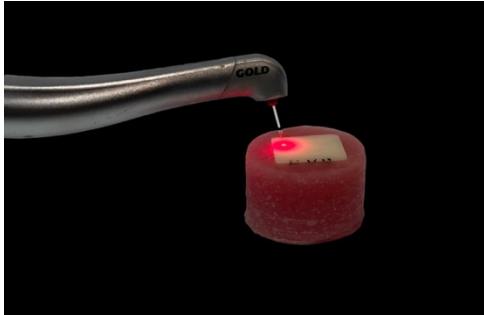
A 2,940 nm EY laser was used to thoroughly vaporise the surface of the specimens. Horizontal and vertical movements were done across the specimen with 900 µm diameter spot size EY laser handpiece from

1mm distance to surface (Figure 1). The surface was illuminated with a flow rate of 60% air and 50% water for 20 seconds with an output power of 3 W, a repeat rate of 20 Hz, and a duration of 300  $\mu$ s pulses.

Figure 1: Surface treatment by laser

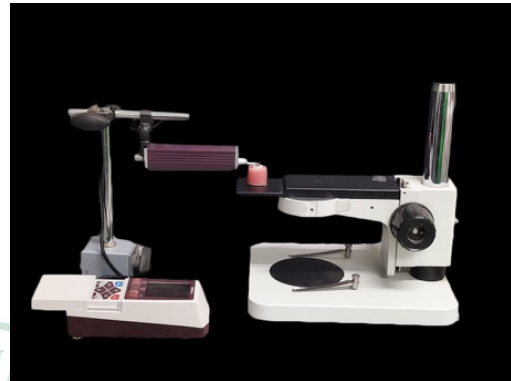
A stylus profilometer was used to measure the Ra (average roughness height) in micrometers ( $\mu$ m) for all samples after surface treatment and the data were

calculated by three single individual. (Figure 2)

Figure 2: Surface roughness tester

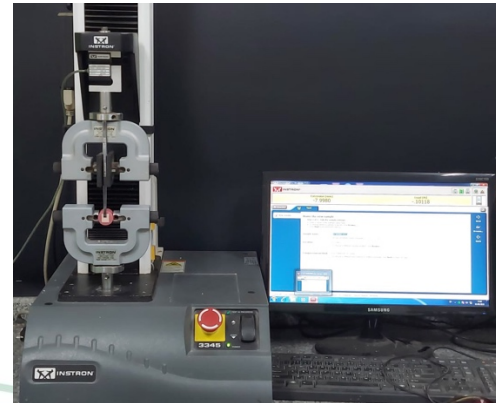
**Figure 6: Universal test machine for shear bond strength**

SBS test was performed in a universal test machine (Figure 5) at a 1 mm/min crosshead speed. The samples were positioned parallel to the loading direction of the jig of the testing machine (Figure 6). The following formula was used to calculate SBS data: fracture load/bonding surface area (inner diameter) = N/mm<sup>2</sup> = MPa.
