Comparing the Accuracy of Image Processing Softwares and Conventional Method for Pavement Distresses Measurement

Abstract

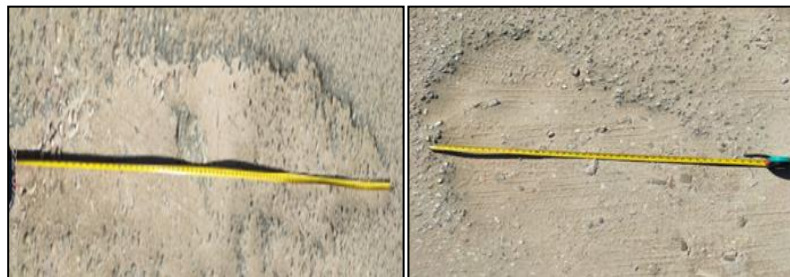
Fig. 10. Pothole No.1.

Fig. 11. Pothole No.2.

Table 2. Measurements of Potholes

Pothole no.	Distress type	Length (cm)	Width (cm)
1	pothole	140	34
2	pothole	110	61

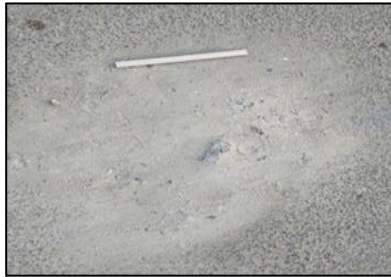
Fig. 12. Depression No.1.

Depression no.	Distress type	Length (cm)	Width (cm)	Area (cm ²)
1	Depression	210	180	37800
2	Depression	150	170	25500

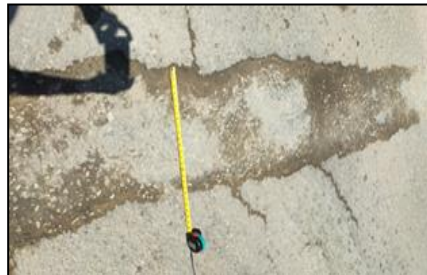
Fig. 14. Utility Patching No.1.

Patching no.	Distress type	Length (cm)	Width (cm)	Area (cm ²)
1	Utility cut patching	700	50	35000
2	patching	360	155	55800

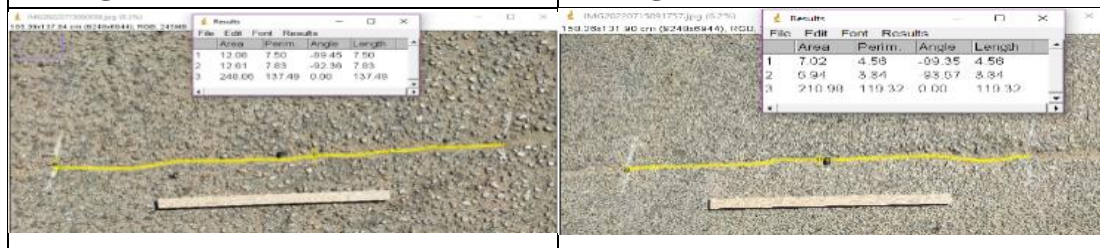
Fig. 16. Longitudinal crack No.1.

Fig. 17. Longitudinal crack No.2.

Fig. 18. Longitudinal crack No.3.

Fig. 19. Transverse crack No.4.

Fig. 20. Transverse crack No.5.

Fig. 21. Transverse crack No.6.

Fig. 22. Transverse crack No.7.

Fig. 23. Transverse crack No.8.

Crack no.	Distress type	Length (cm)	Width (cm)
1	longitudinal crack	995	2.98
2	longitudinal crack	1316	1.42
3	longitudinal crack	145	3.28
4	transverse crack	510	3.46
5	transverse crack	946	2.7
6	transverse crack	317	1.81
7	transverse crack	471	7.1
8	transverse crack	381	5.5

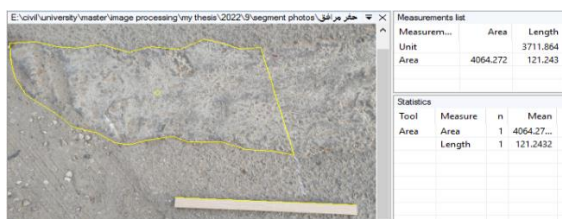
Fig. 42. Utility Patching No.1.

Patching no.	Distress type	Area (cm2)
1	Utility cut patching	24600
2	patching	46100

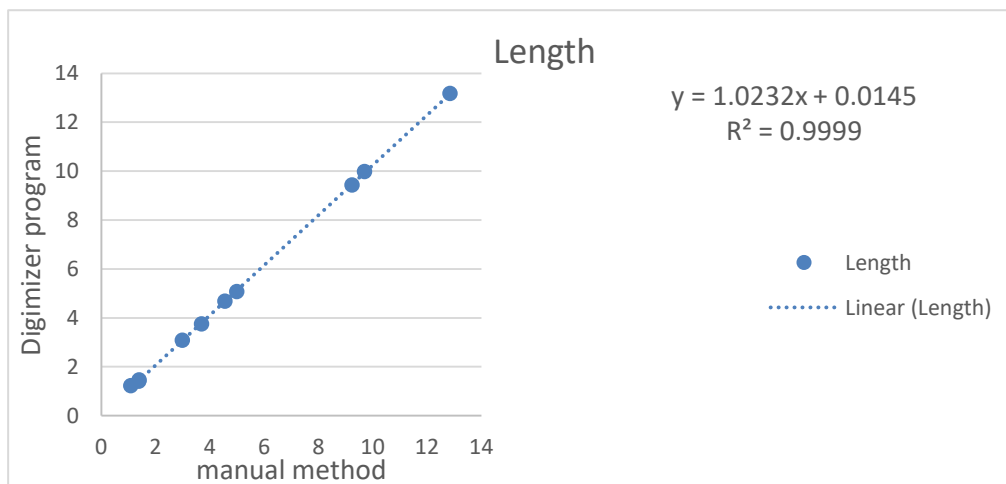
The results showed that the length of distresses measured using the Image J program, and the Digimizer program were greater than that measured by the manual measurement method. This is likely due to the fact that the Image J program, and the Digimizer program are able to detect smaller and thinner distresses than the manual measurement method. The correlation of results obtained by using the Image J program, and the Digimizer program with the manual measurement method showed a high correlation, as indicated by the high coefficient of determination $R^2 = (0.9999, \text{ and } 0.9999)$. This means that there is a strong linear relationship between the three sets of results. In other words, the results obtained by using the Image J program, and the Digimizer program were closely related to the results obtained by using the manual measurement method. Table 13 and Figures 44, and 45 provide more detailed information about the results. The table shows the length of distresses measured using the three methods for the images in the dataset. The figure shows a scatter plot of the results, with the length of distresses measured using the Image J program, and the Digimizer program on the y-axis and the length of distresses measured using the manual measurement method on the x-axis. The line of best fit for the scatter plot is also shown. The results of this study suggest that the Image J program, and the Digimizer program can be used to accurately measure the length of distresses in pavement images. The high correlation between the results obtained by using the Image J program, the Digimizer program and the manual measurement method indicates that the three methods are producing slightly close results. This suggests that the Image J program, and the Digimizer program can be used as a reliable alternatives to the manual measurement method for measuring the length of distresses in pavement images.

Fig. 45. The correlation between the lengths of pavement distresses measured using the manual method and the Digimizer program

6. The results of the study showed that the measurements obtained using the Digimizer program were slightly similar to those obtained using the conventional method with high coefficients of determination $R^2 = (0.9999, 0.5397, \text{ and } 0.9456)$ for length, width, and area respectively.

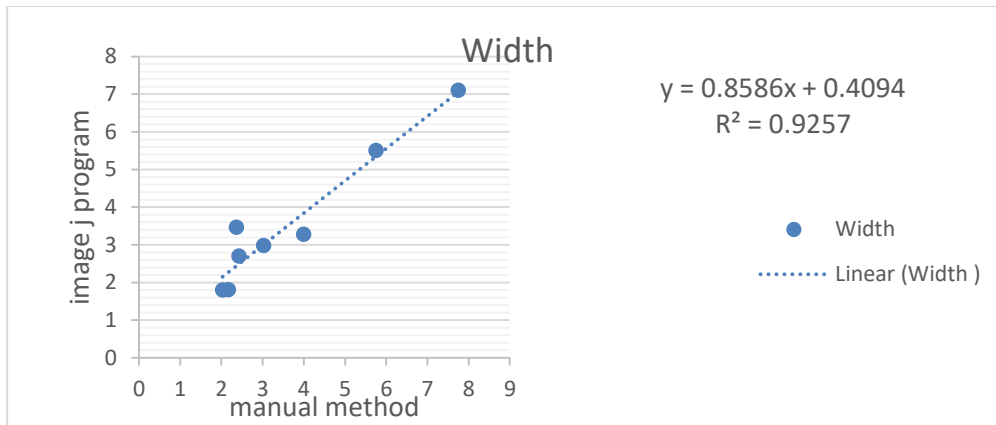
The results showed that the width of distresses measured by using the manual measurement method was often greater than that measured by using the Image J program. However, the width measured using the manual method is less than the measurements obtained through the Digimizer program. This is likely due to the fact that the manual measurement method is more subjective than the Image J program. When using the manual measurement method, the human observer may be more likely to overestimate the width of a distress. The Digimizer program isn't accurate because it may have sophisticated algorithms and image processing

capabilities that enable to detect and measure distress widths more precisely, leading to larger measurements compared to the manual method. The correlation of results obtained by using the Image J program with the manual measurement method showed high correlation, as indicated by the high coefficient of determination $R^2 = (0.9257)$, and moderate correlation, as indicated by the moderate coefficient of determination $R^2 = (0.5397)$ between the results obtained by using the Digimizer program with the manual measurement method. This means that there is a strong linear relationship between the results of Image J program, and the results of manual method. However there is a moderate linear relationship between the results of Digimizer program, and the results of manual method. Table 14 and Figures 46, and 47 provide more detailed information about the results. The table shows the width of distresses measured using the three methods for the images in the dataset. The figures shows a scatter plot of the results, with the width of distresses measured using the Image J program, and the Digimizer program on the y-axis and the width of distresses measured using the manual measurement method on the x-axis. The line of best fit for the scatter plot is also shown. The results of this study suggest that the Image J program can be used to accurately measure the width of distresses in pavement images. The high correlation between the results obtained by using the Image J program and the manual measurement method indicates that the two methods are producing slightly close results. This suggests that the Image J program can be used as a reliable alternative to the manual measurement method for measuring the width of distresses in pavement images.

Fig. 46. The correlation between the widths of pavement distresses measured using the manual method and the Image J program.

5. The results of the study showed that the measurements obtained using the image j program were similar to those obtained using the conventional method with high coefficients of determination $R^2 = (0.9999, 0.9257, \text{ and } 0.9451)$ for length, width, and area respectively.

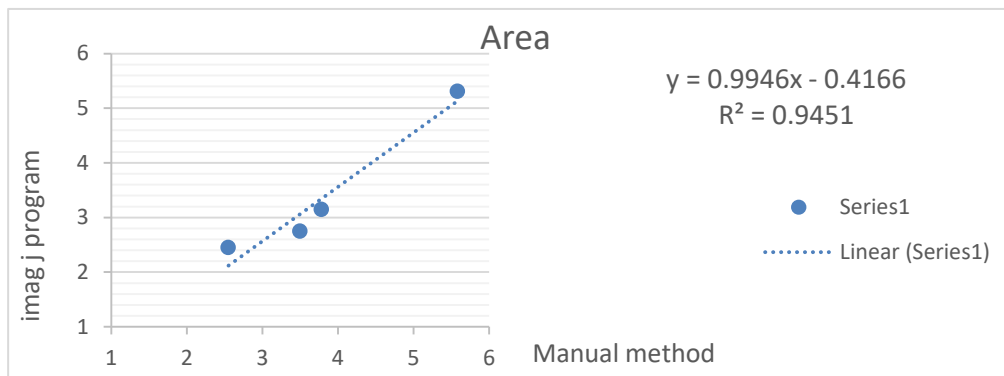
The results showed that the area of distresses measured by using the manual measurement method was greater than that measured by using the Image J program, and the Digimizer program. This is likely due to the fact that the manual measurement method is more subjective than the Image J program. When using the manual measurement method, the human observer may be more likely to overestimate the area of a distress. The correlation of results obtained by using the Image J program, and the Digimizer program with the manual measurement method showed high correlation, as indicated by the high coefficients of determination $R^2 = (0.9451, \text{ and } 0.9456)$ respectively. This means that there is a strong linear relationship between the three sets of results. In other words, the results obtained by using the Image J program, and the Digimizer program were closely related to the results obtained by using the manual measurement method. Table 15 and Figures 48, and 49 provide more detailed information about the results. The table shows the area of distresses measured using the three methods for the images in the dataset. The figures shows a scatter plot of the results, with the area of distresses measured using the Image J program, and the Digimizer program on the y-axis and the area of distresses measured using the manual measurement method on the x-axis. The line of best fit for the scatter plot is also shown. The results of this study suggest that the Image J program, and the Digimizer program can be used to accurately

measure the area of distresses in pavement images. The high correlation between the results obtained by using the Image J program, the Digimizer program, and the manual measurement method indicates that the three methods are producing slightly close results. This suggests that the Image J program, and the Digimizer program can be used as a reliable alternatives to the manual measurement method for measuring the area of distresses in pavement images.

Fig. 48. The correlation between the areas of pavement distresses measured using the manual method and the Image J program.

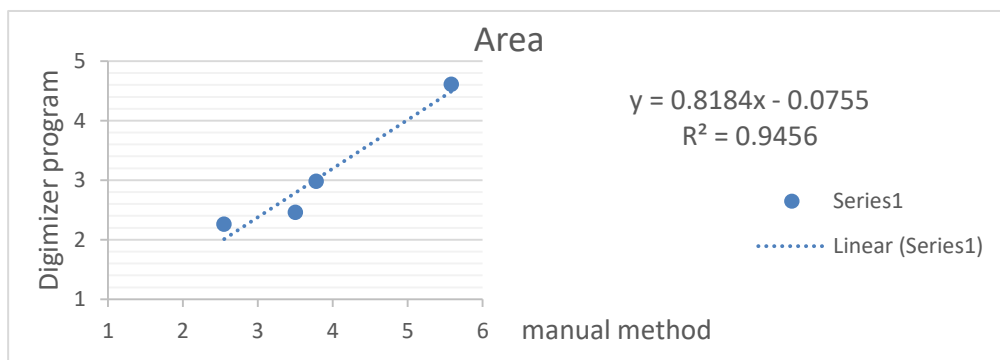
Fig. 49. The correlation between the areas of pavement distresses measured using the manual method and the Digimizer program
