**A Comparative Experimental Study to Evaluate the Efficiency of
Conventional and Nanosilica-enhanced Acrylic and Silicone Resins as
Consolidants for Sandstone Statues of Sphinxes Avenue, Luxor - Egypt**

The purpose of this study is to evaluate the effectiveness of acrylic, silicone and nano silica additives used to consolidate a sandstone statue in Sphinxes Avenue at Luxor, Egypt. Sandstone samples were taken from separate, hidden parts that do not affect the statue, X-ray diffraction (XRD) analysis, scanning electron microscopy (SEM-EDX) were used to determine its composition and current state, and a standard sample's selection. Six chemical materials were selected for the experimental studies. Two of them belong to acrylic resins (Addicon and Paraloid B72), Kemtekt and Wacker (OH 100) are silicone materials, Nanosilica is an additive material to Paraloid B72 and Wacker (OH 100), these materials were applied in concentrations of 2-5% ,the application was done in two ways : one was by immersing; the second was by brushing. Visual examination of standard and treated samples, physical properties such as density, porosity and water absorption, mechanical properties measurement (comp

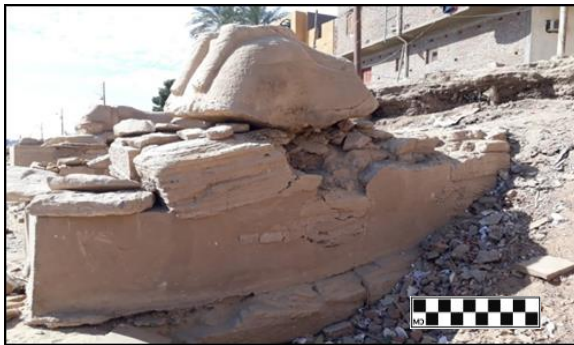
Figure 4. The statue where the samples were taken (as arrow refers)

Samples were taken from separated parts of a statue on Sphinxes Avenue and the composition of the sandstone was determined by X-ray diffraction analysis and scanning electron microscopy, in addition to elemental analysis by EDX (Fig.4).

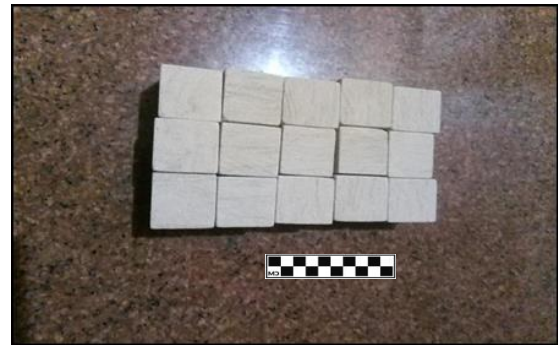
Figure 5. Preparation of the experimental samples

Through the study that took place on sphinxes avenue in Luxor, it was found that most of the stones used in its construction were sandstones brought from Jabal Al-Silsila quarry, so a group of sandstone blocks were brought from the same quarry, further refining them and cut into regular cubes with dimensions 3 cm x 3 cm x 3 cm, for use in the experimental study (Fig.5).

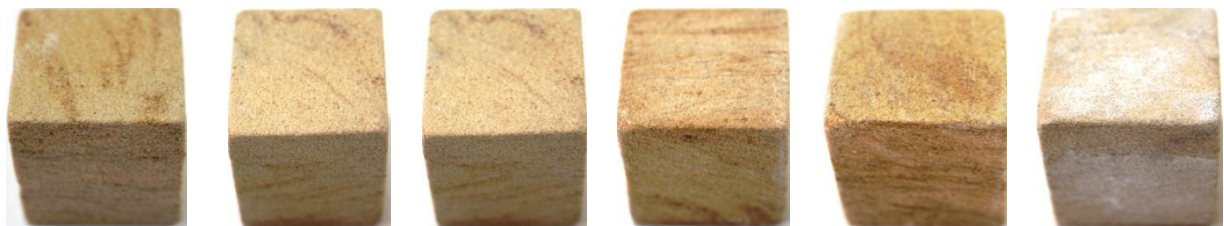
A B C D E F

Figure 9. The Treated samples after drying (visual examination before artificial aging)

As shown, there were some consolidation materials that had no effect and others that had a minor effect on the overall appearance; results differed with respect to appearance.

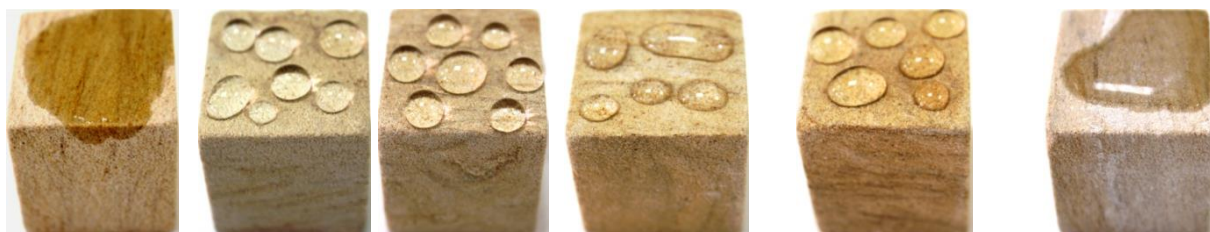
A B C D E F

Figure 10 . The consolidation materials effect on water repellence properties of the sandstone samples
